ABANDONED OR INACTIVE URANIUM MINES IN NEW MEXICO

A report of investigation carried out between August 1979 and May 1980 under contract with the New Mexico Energy and Minerals Department.

New Mexico Bureau of Mines and Mineral Resources
Open-File Report 148

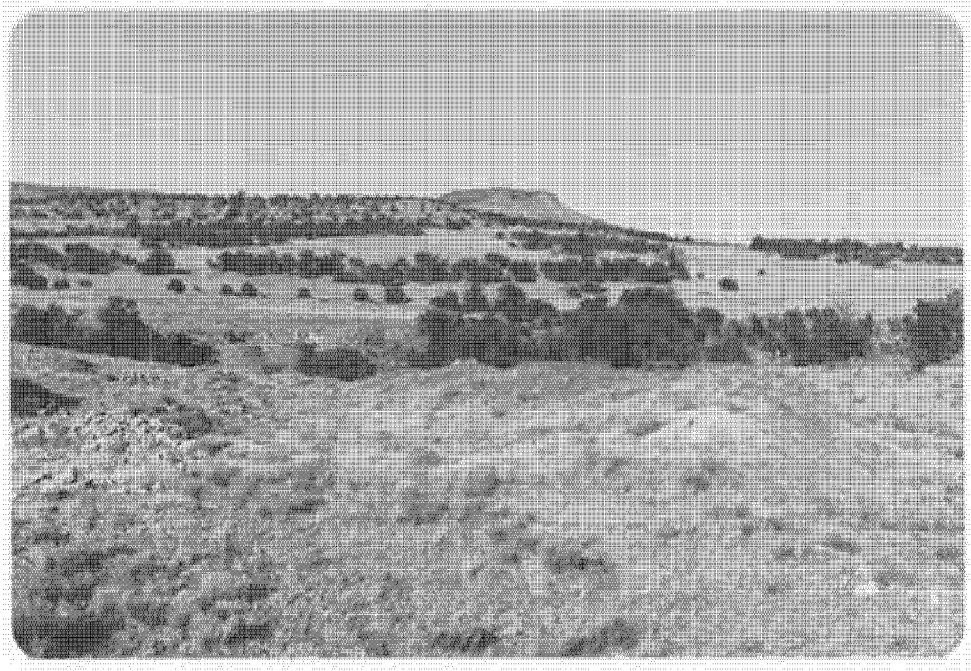
Photo (b) Looking northward near middle of workings, 200' north of photo (a); poorly defined cut is about 25' x 60'.
