Navajo Abandoned Uranium Mine Site Screen Report

Nanabah Vandever AUM Site

Navajo AUM Eastern Region

May 2009

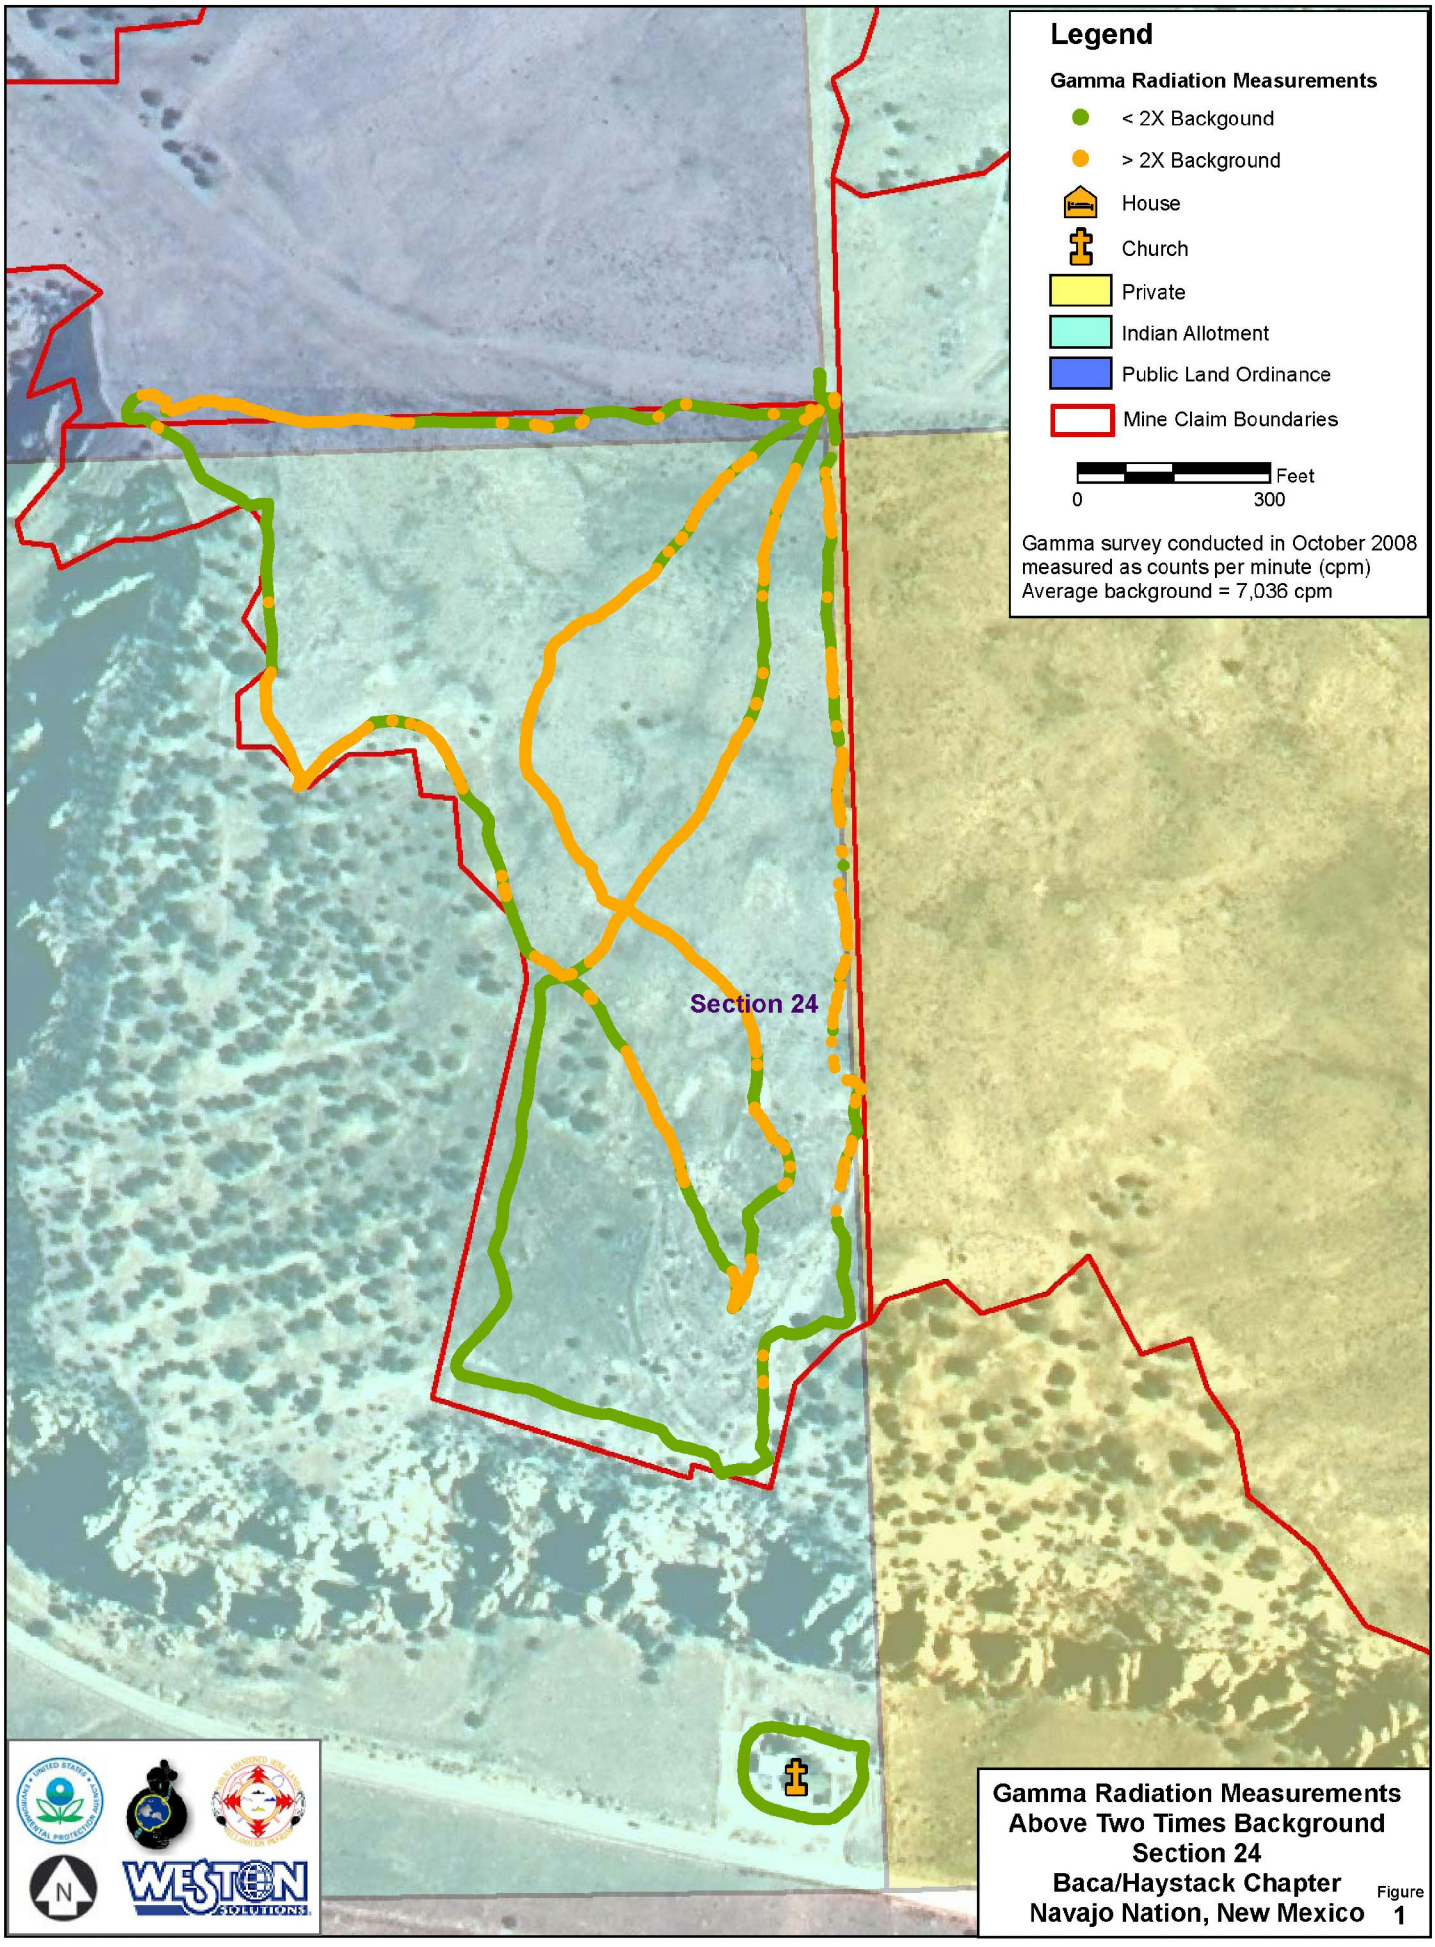
Figure 1

A total of 3,024 gamma radiation measurements were collected from mine sites, ranging from 4,569 cpm to 594,083 cpm. The measurements are represented in Figures 1 and 2.

Gamma Radiation Measurements
Above Two Times Background
Section 24
Baca/Haystack Chapter
Navajo Nation, New Mexico

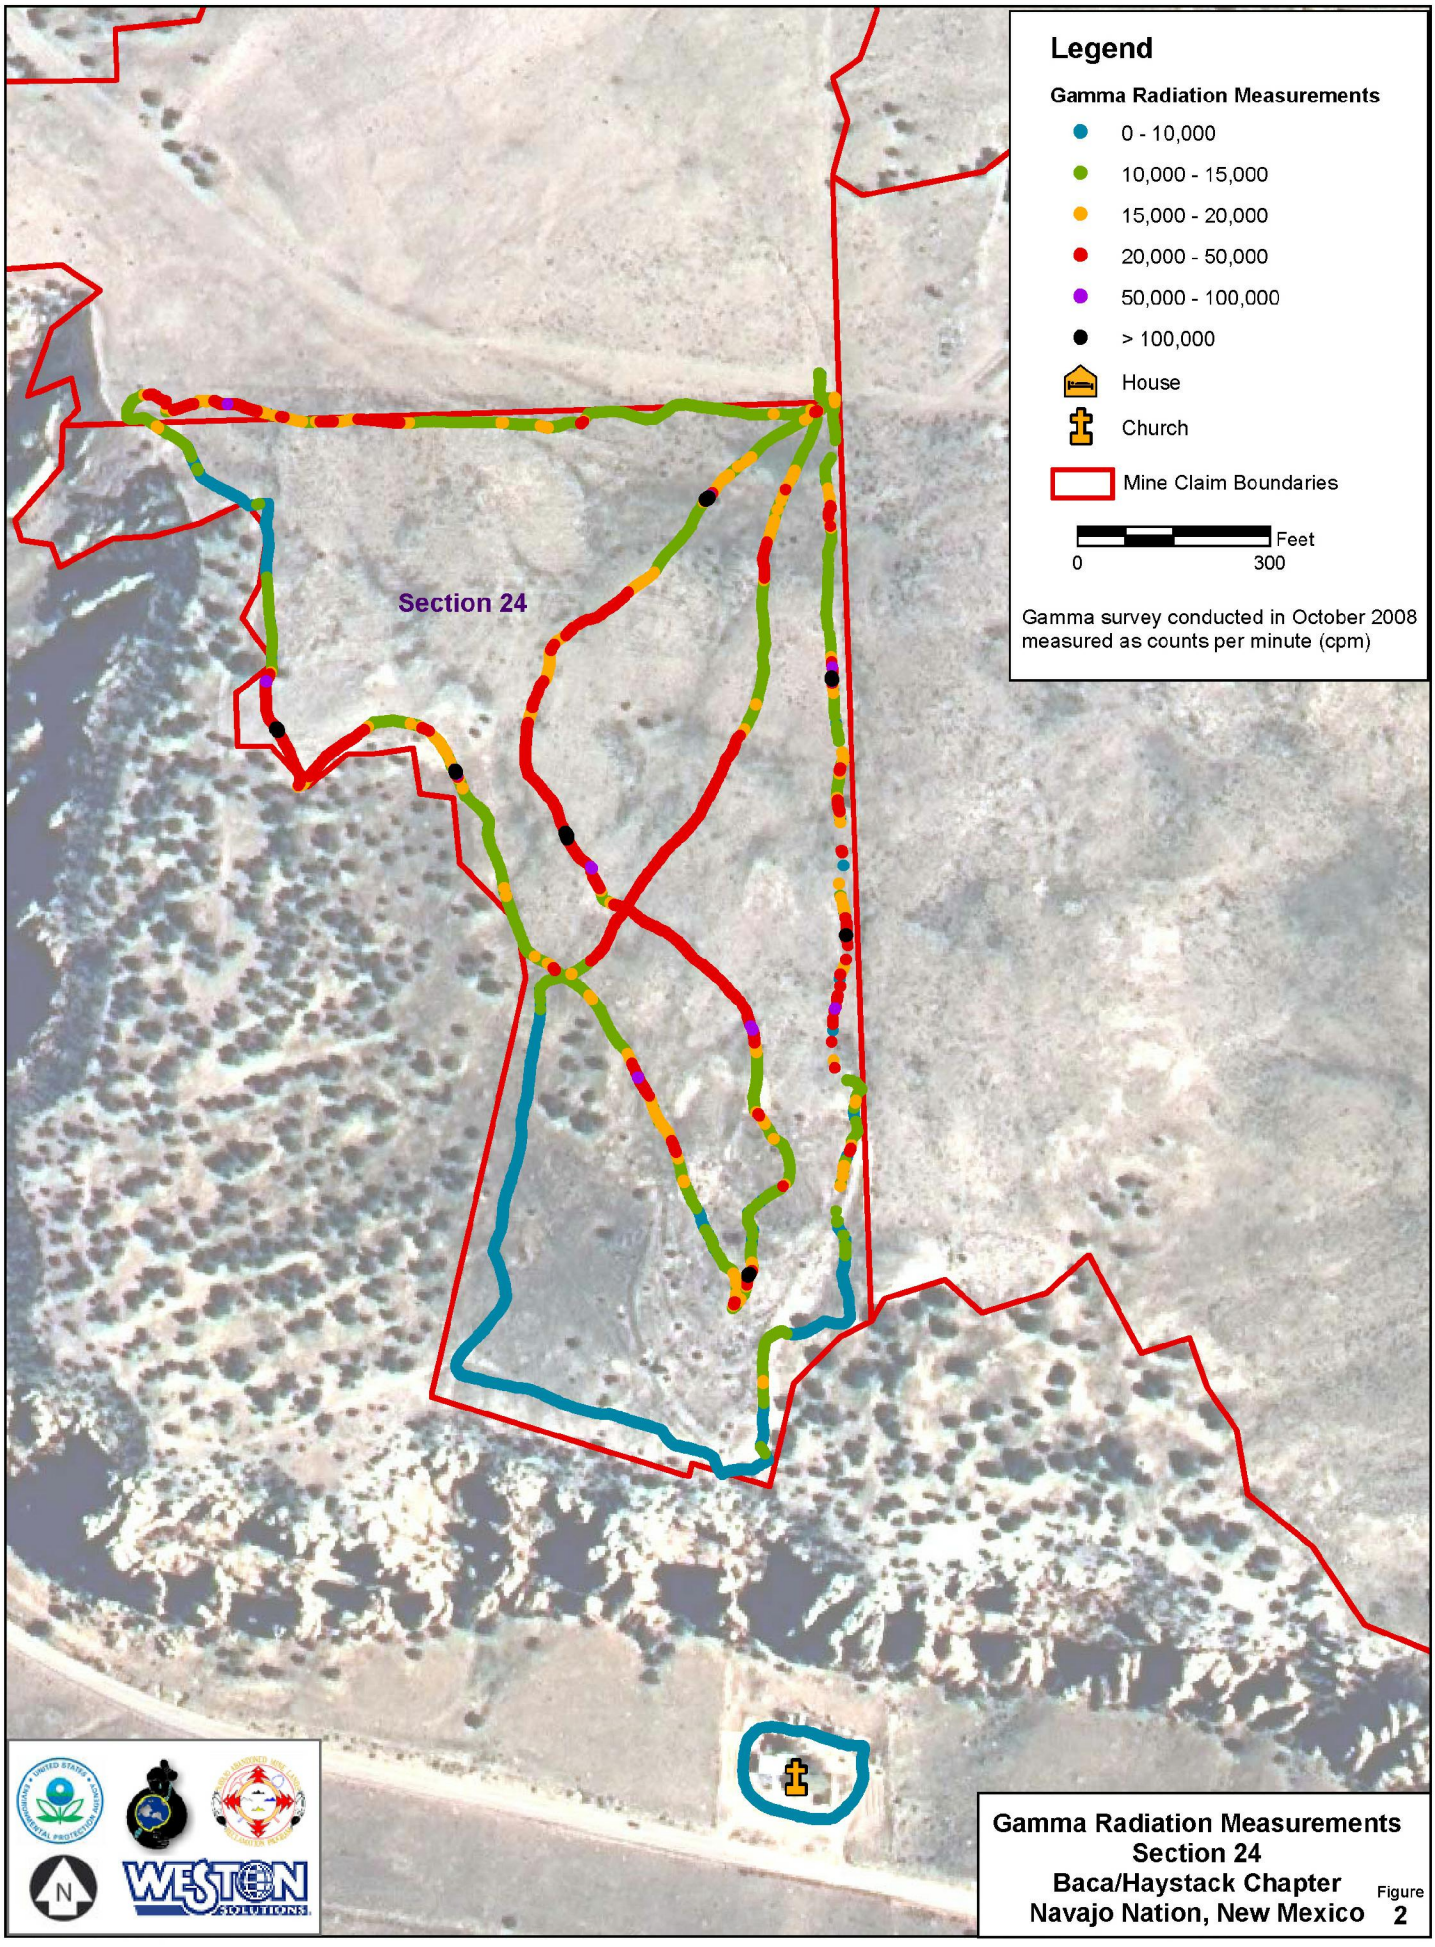
Figure 2

Gamma Radiation Measurements
Section 24
Baca/Haystack Chapter
Navajo Nation, New Mexico
