RISK-BASED REMEDIATION PLAN FOR PCB-CONTAMINATED CONCRETE

SPX LINDBERG FACILITY

DELTA PROJECT NO. 9M0909245

August 11, 2010

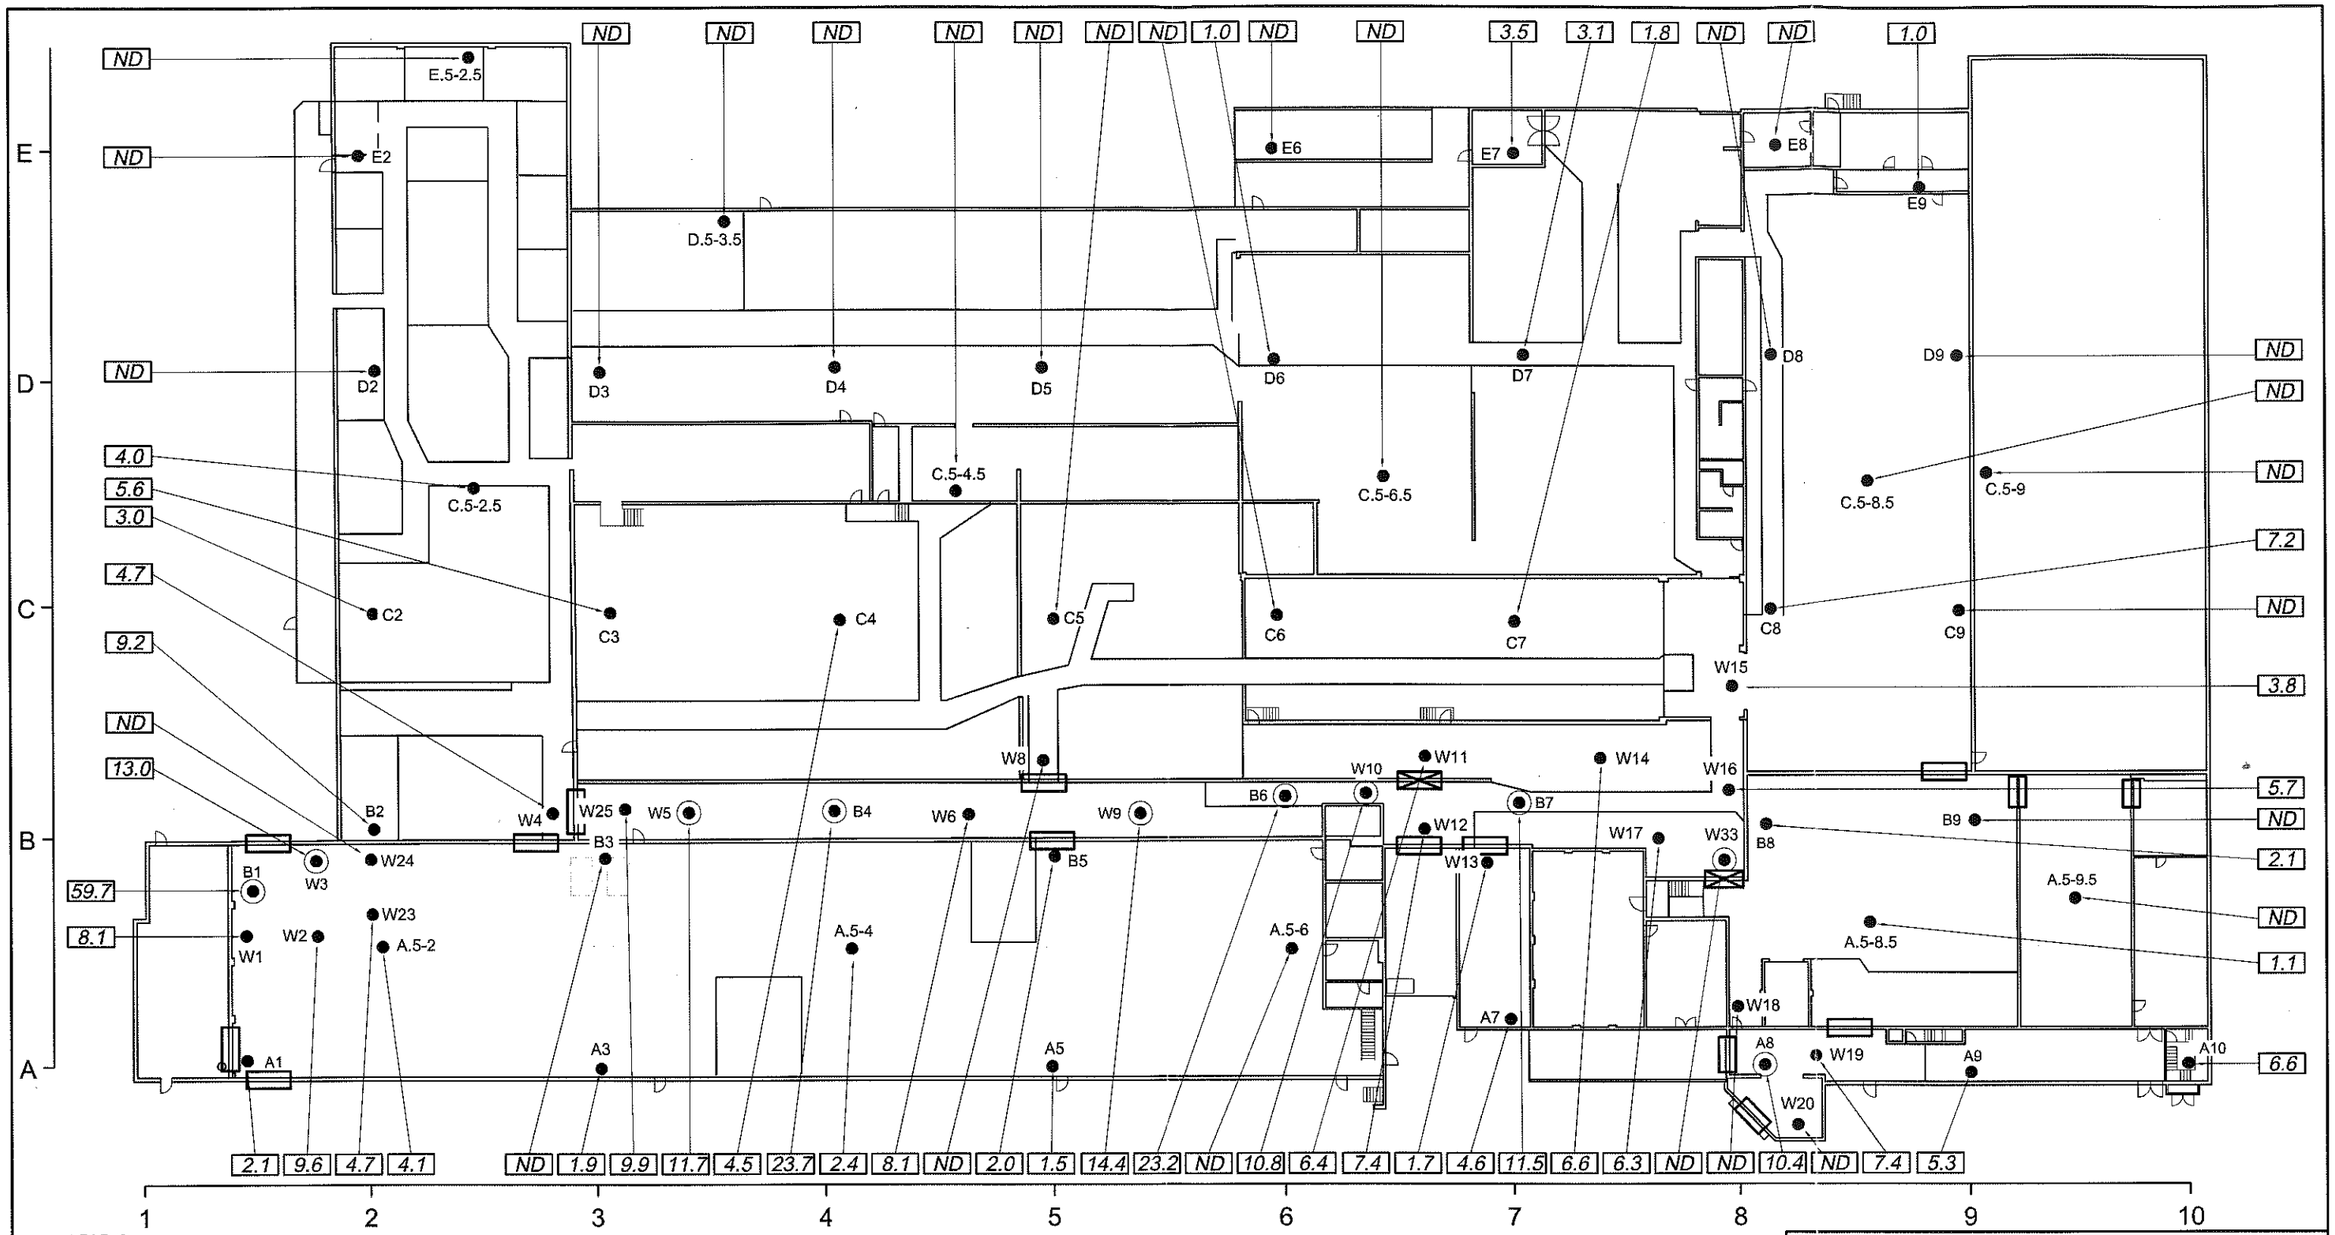
FIGURE 2
PCB WIPE SAMPLE RESULTS MAP
SPX LINDBERG FACILITY
304 HART STREET
WATERTOWN, WISCONSIN

Analytical results for surface wipe samples are summarized on **Table 1** and **Figure 2**. PCB concentrations ranged from less than the laboratory reporting limit of 1.0 µg per 100 cm^2 to 59.7 µg/100 cm^2. The PCB concentrations were compared against the TSCA PCB surface cleanup standard of 10 µg/100 cm^2. Twenty-six of the wipe samples did not indicate the presence of PCBs. Thirty-six wipe samples contained PCBs at concentrations between 1 and 10 µg/100 cm^2. Ten wipe samples indicated PCB concentrations greater than 10 µg/100 cm^2. These samples included:

- B1 (59.7 µg/100 cm^2) and W3 (13.0 µg/100 cm^2), located near the northeast corner of the "Big Bay" area in the vicinity of a loading area;
- W5 (11.7 µg/100 cm^2), B4 (23.7 µg/100 cm^2), W9 (14.4 µg/100 cm^2), B6 (23.2 µg/100 cm^2), and W10 (10.8 µg/100 cm^2), located along the "Heavy Assembly Materials" storage corridor;
- B7 (11.5 µg/100 cm^2) and W33 (12.4 µg/100 cm^2), located south of the "Heavy Assembly Materials" storage corridor near the old shipping office; and
- A8 (10.4 µg/100 cm^2), located in a loading dock area near the southwest corner of the facility.

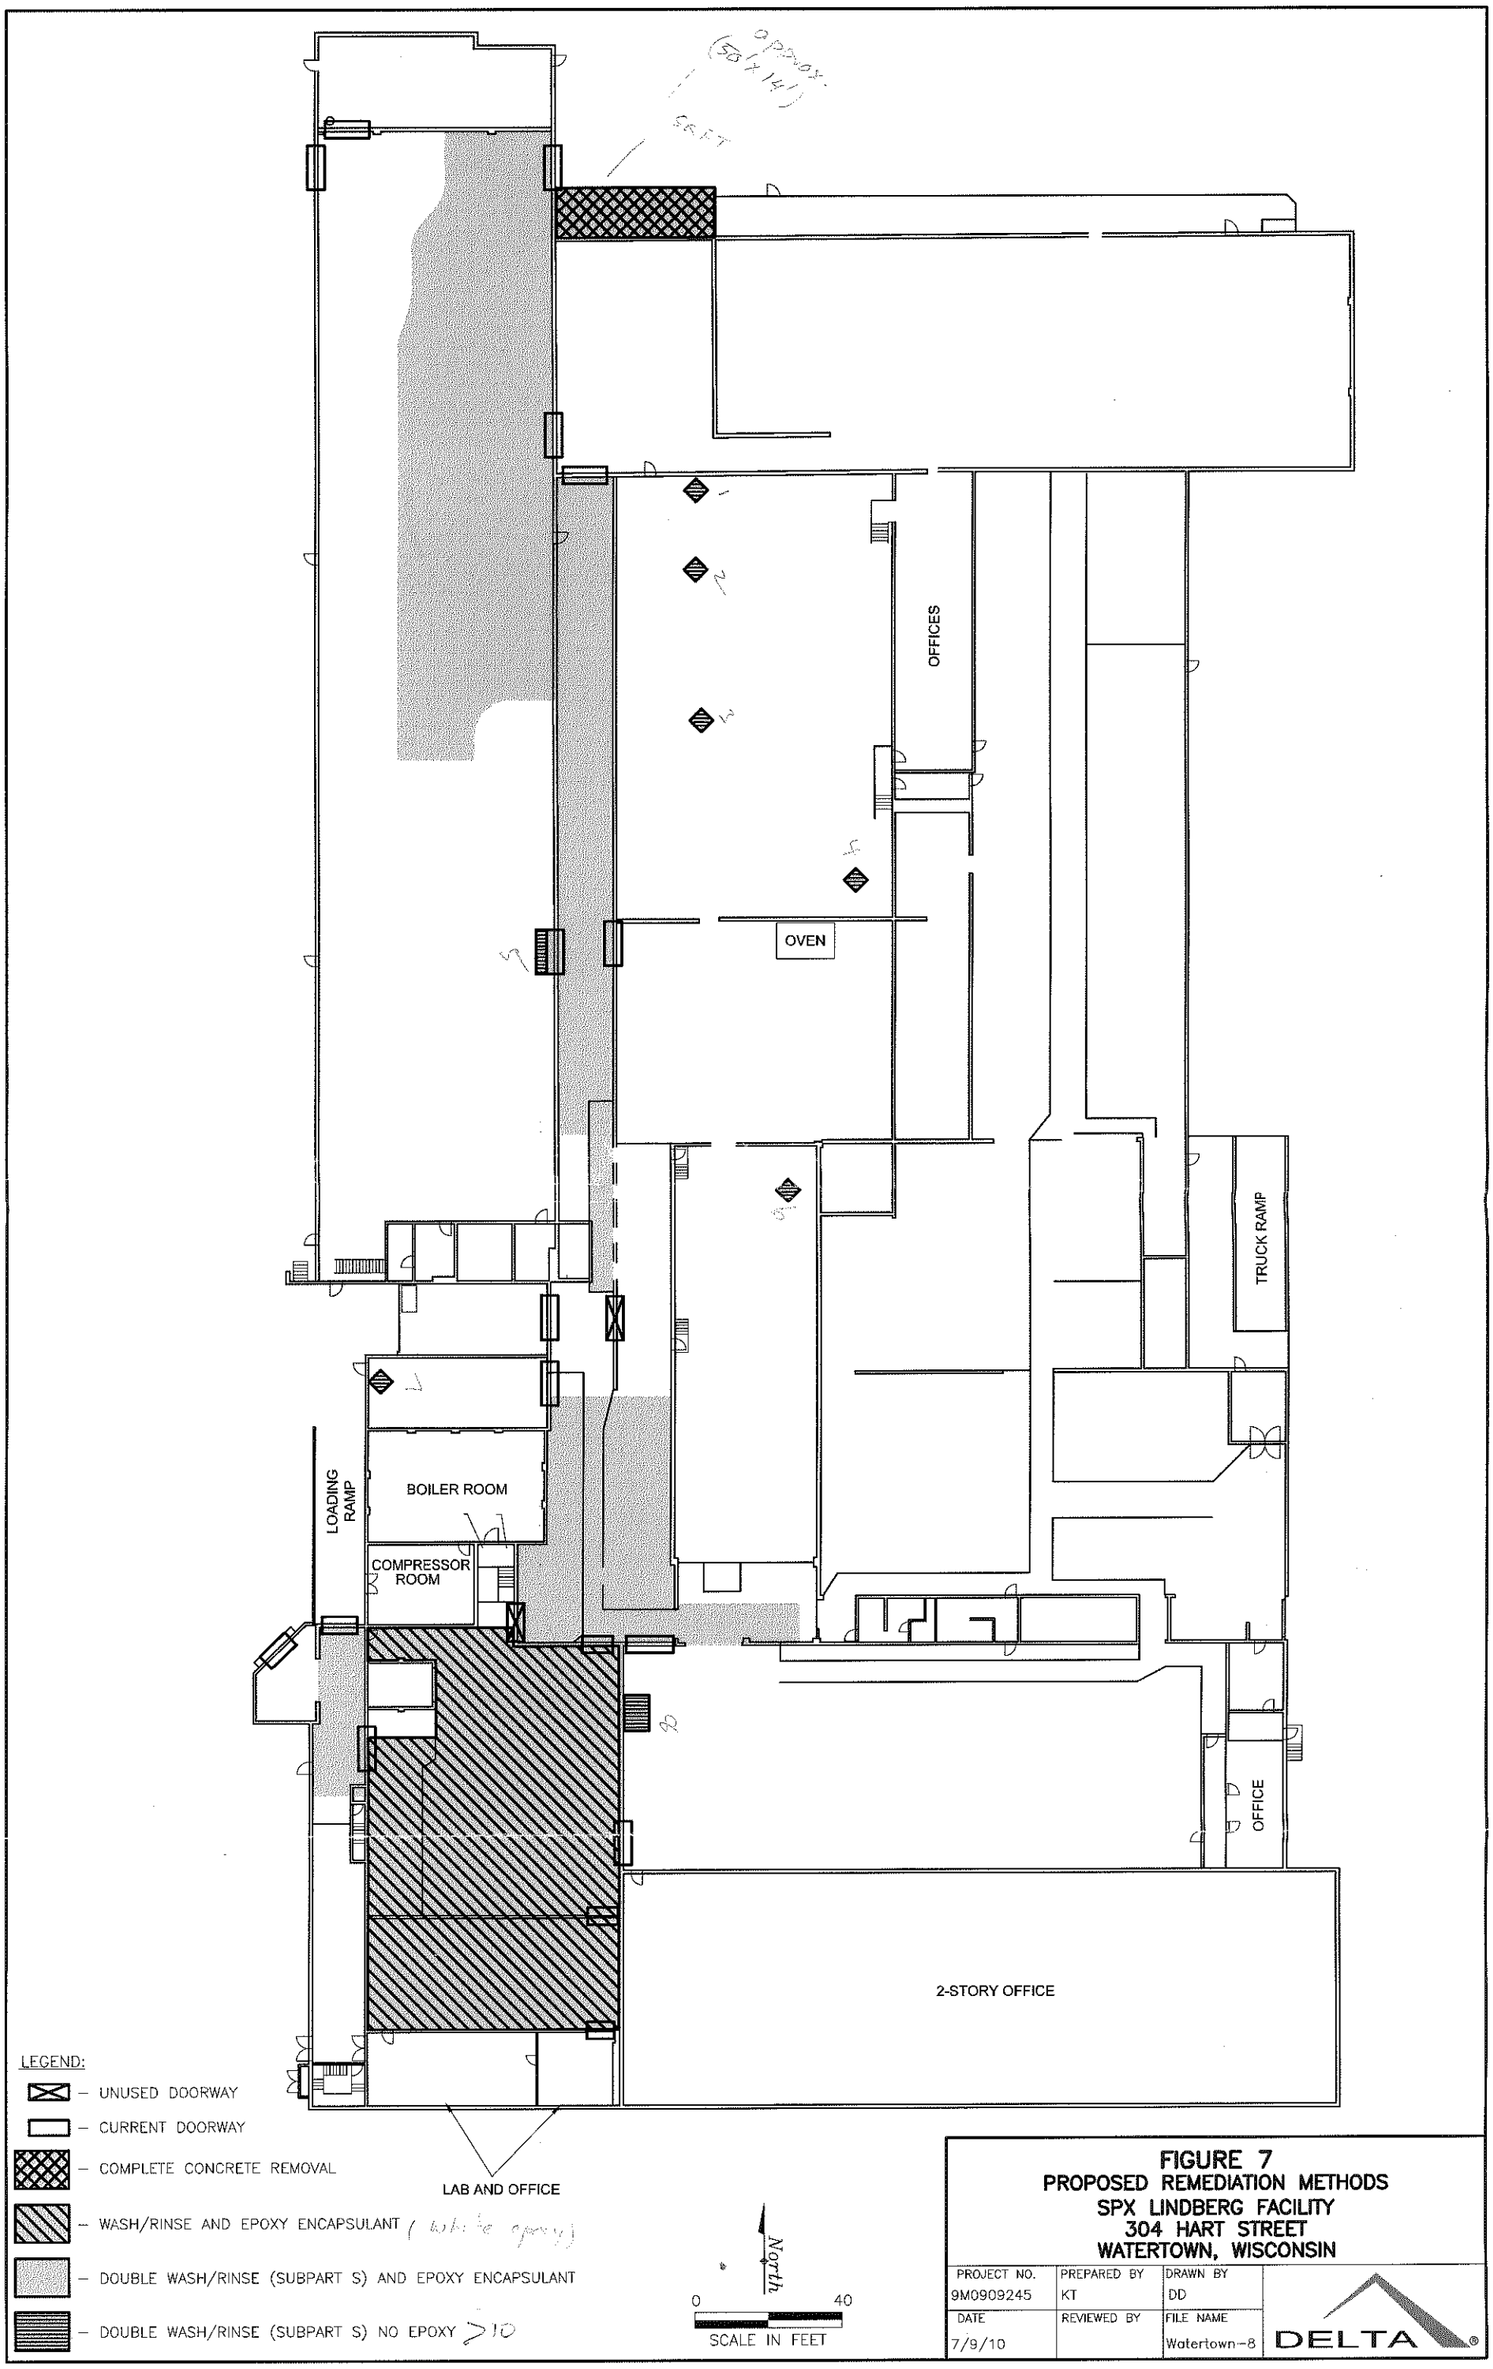
FIGURE 7
PROPOSED REMEDIATION METHODS
SPX LINDBERG FACILITY
304 HART STREET
WATERTOWN, WISCONSIN

- Bulk PCB Remediation Waste removal and off-site disposal of the 700 square-foot concrete pad in the rail spur loading area.
- Continued Use Authorization, which includes cleaning per Subpart S and two coats of epoxy, for the in-place management of 12,150 square feet of PCB-contaminated, bare concrete flooring.
- Continued Use Authorization, which includes superficial cleaning and two coats of epoxy, for the in-place management of 7,000 square feet of PCB-contaminated, epoxy-coated concrete flooring.
- Cleaning per Subpart S for the in-place management of approximately 800 square-feet of PCB-contaminated concrete flooring located at 8 non-contiguous locations.

The locations within the facility proposed to be cleaned by these remediation methods are shown in **Figure 7**.

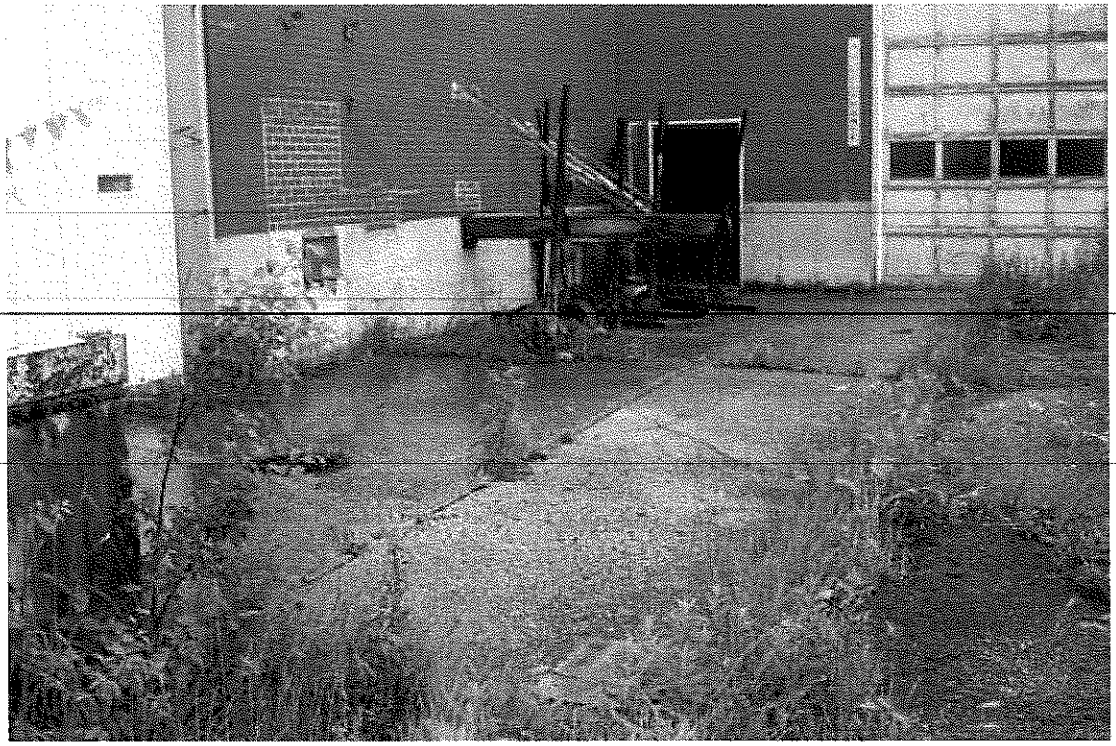
Photograph 1. Rail spur loading area on north side of facility, facing southwest.

A 16-foot by 43-foot concrete pad located in the in the rail spur loading area to the north the facility building was found to contain PCBs at concentrations greater than 10 mg/kg (**Figure 7; Appendix A, Photograph 1**). A bulk concrete sample collected from Concrete 36 contained 201 mg/kg PCBs in the 0 to 1 inch sample interval. In order to manage the PCBs in this area, SPX will remove the entire concrete pad in accordance with 40 CFR 761.61(a)(5)(i). The bulk PCB remediation wastes will be managed and disposed off-site according to the applicable waste classification and disposal regulations as specified under 40 CFR 761.61(a)(5)(i)(B)(2).

Following removal of the concrete pad, a confirmation sample will be collected from the soil beneath the location of Concrete 36. This sample will be analyzed for PCBs by EPA Method 8082. A bulk concrete sample previously collected from Concrete 36 contained 2.29 mg/kg PCBs in the 1 to 3 inch sample interval. Bulk concrete samples collected from the other five locations in the concrete pad did not detect the presence of PCBs at a depth of 1 to 3 inches, so no additional confirmation sampling will be performed beneath the concrete pad.

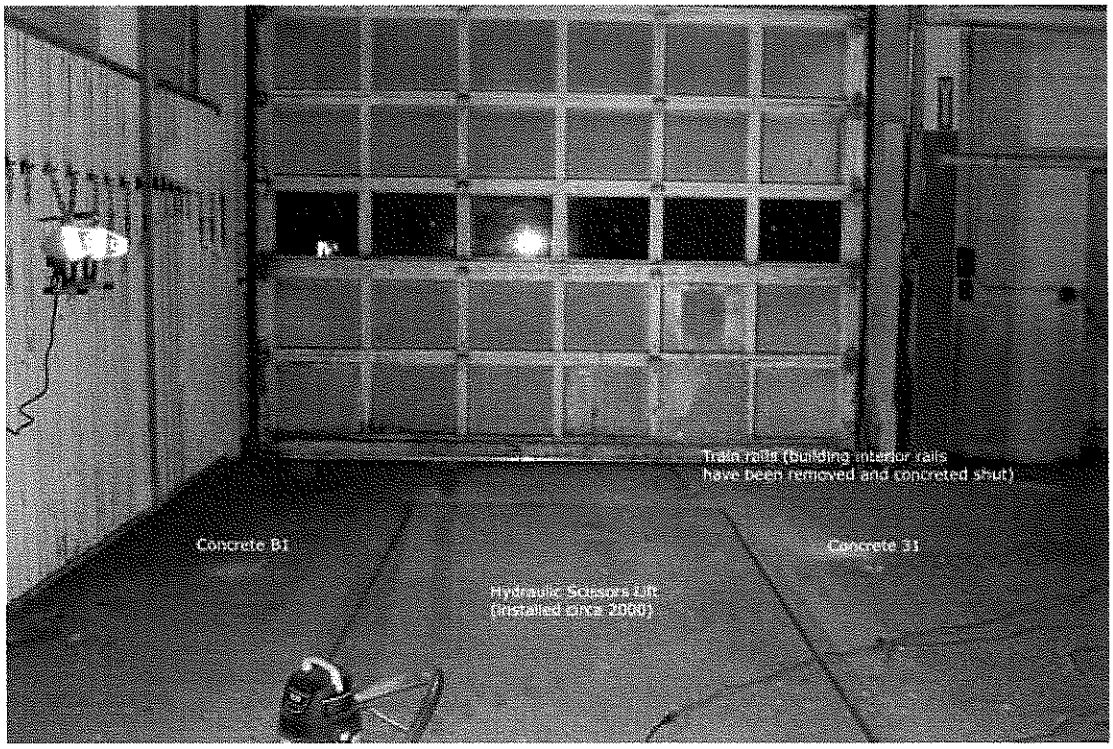
Photograph 2. Northwest loading dock, facing east.

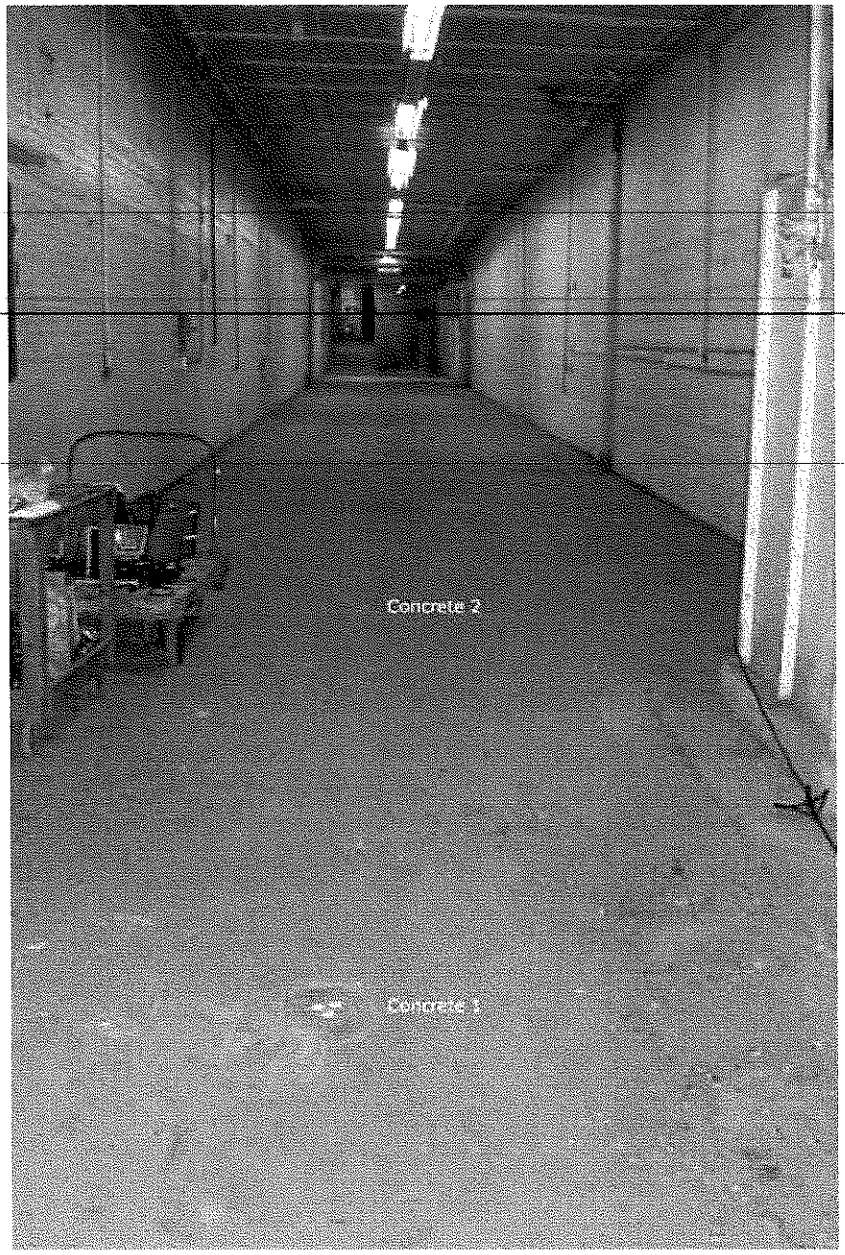
Photograph 3. Heavy Assembly Materials Storage Corridor, facing south from the northern end.

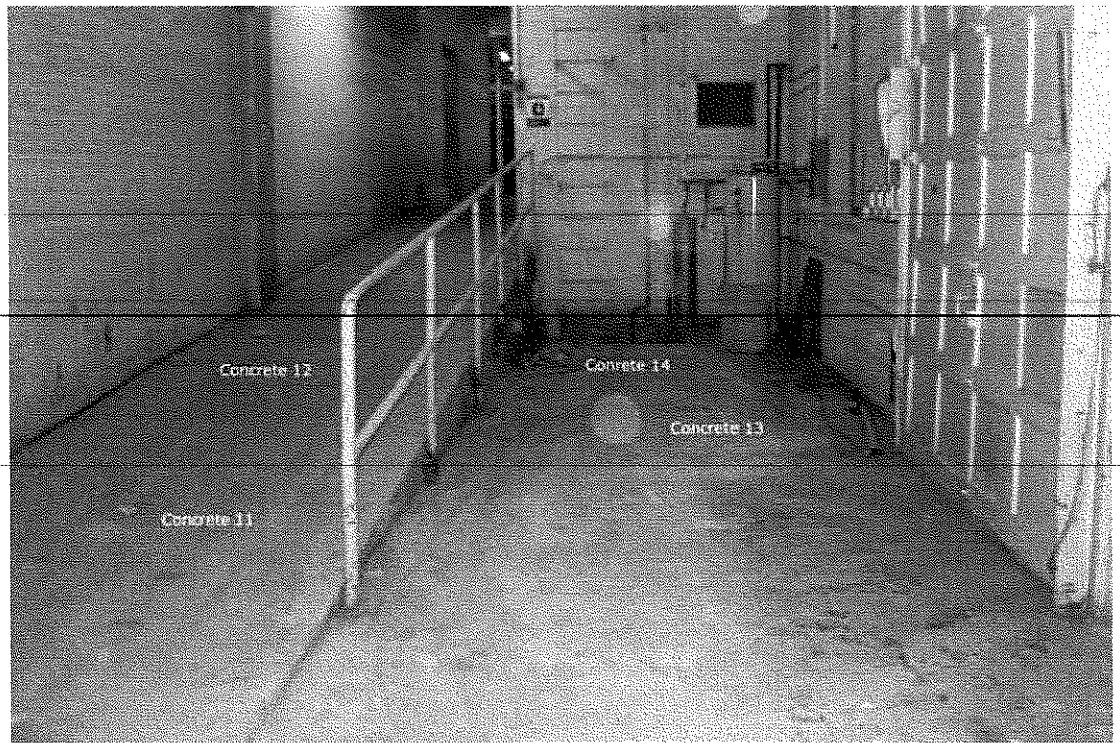
Photograph 4. Heavy Assembly Materials Storage Corridor ramp, facing south.

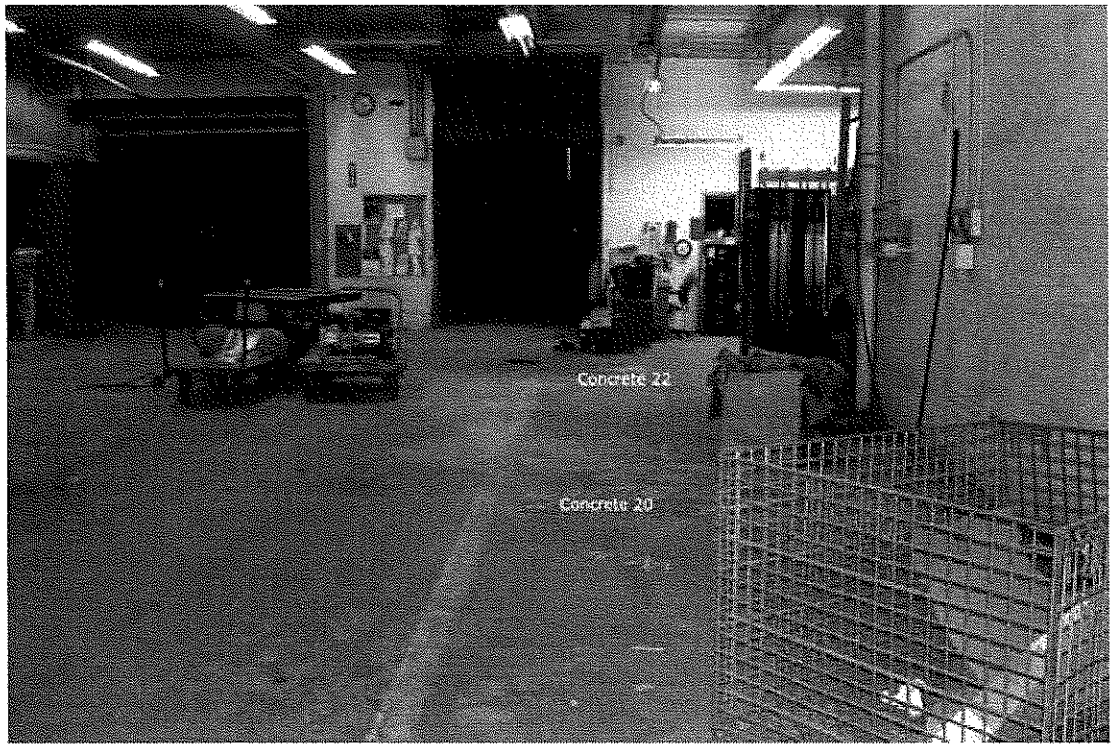
Photograph 5. Southern extent of concrete sampling near Old Shipping Office, facing south.

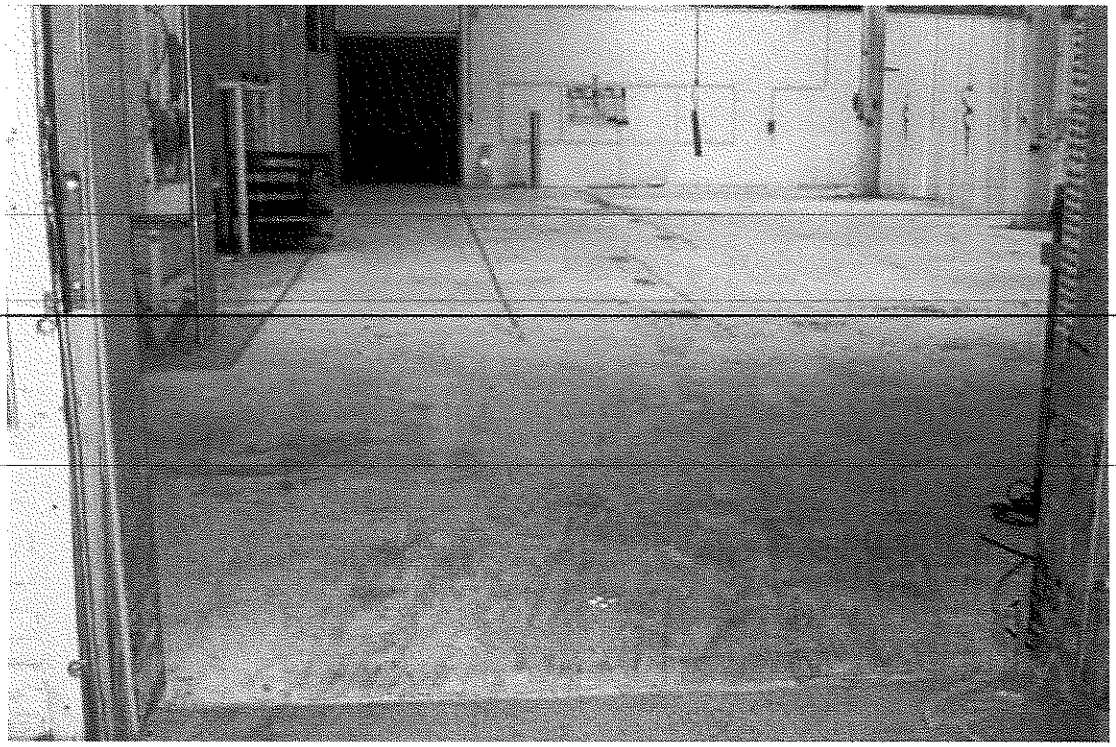
Photographs 6 and 7. Epoxy-coated floor in Environmental Assembly Room, near southwest corner of facility.

The proposed cleanup area has been subdivided into two distinct areas with respect to the surface condition of the concrete. The first area consists of 12,150 square feet of bare concrete flooring stretching from the north end of the facility to approximately 440 feet to the south, including the loading dock located on the west side of the building (**Figure 7; Appendix A, Photographs 2 through 5 and 8**). The second area consists of a 7,000-square foot former assembly area near the southern end of the facility (**Figure 7; Appendix A, Photographs 6 and 7**). The floor in this area is covered with a white epoxy coating.

The 7,000 square feet of epoxy-coated, PCB-contaminated concrete floors will be cleaned in a manner less stringent that the double wash/rinse procedure. The reason for this is that while bulk concrete samples collected from below the epoxy-coated surface in this area contained elevated levels of PCBs, wipe samples taken from the top of the epoxy-coated surface did not exhibit PCBs above 10 µg/100 cm^2. Following an initial vacuum to remove loose dust and bird waste, the surface washing steps in this area will include a 1) high-pressure steam wash with concrete cleaner/degreaser, 2) a light scuffing of the epoxy-coated surface with 100+ grit sandpaper, and 3) a final vacuum and rinse.

Following the surface washing activities and once the surface has been allowed to dry for a minimum of 24 hours, an epoxy encapsulant will be placed on the concrete surface according to the requirements of 40 CFR 761.30(p)(1)(iii)(A). Two coats of epoxy will be applied to the floor surface. The two coats of epoxy will consist of contrasting colors so that any wearing of the topcoat can be detected. In the area where a white epoxy coating already exists, one additional coat will be applied in a contrasting color.

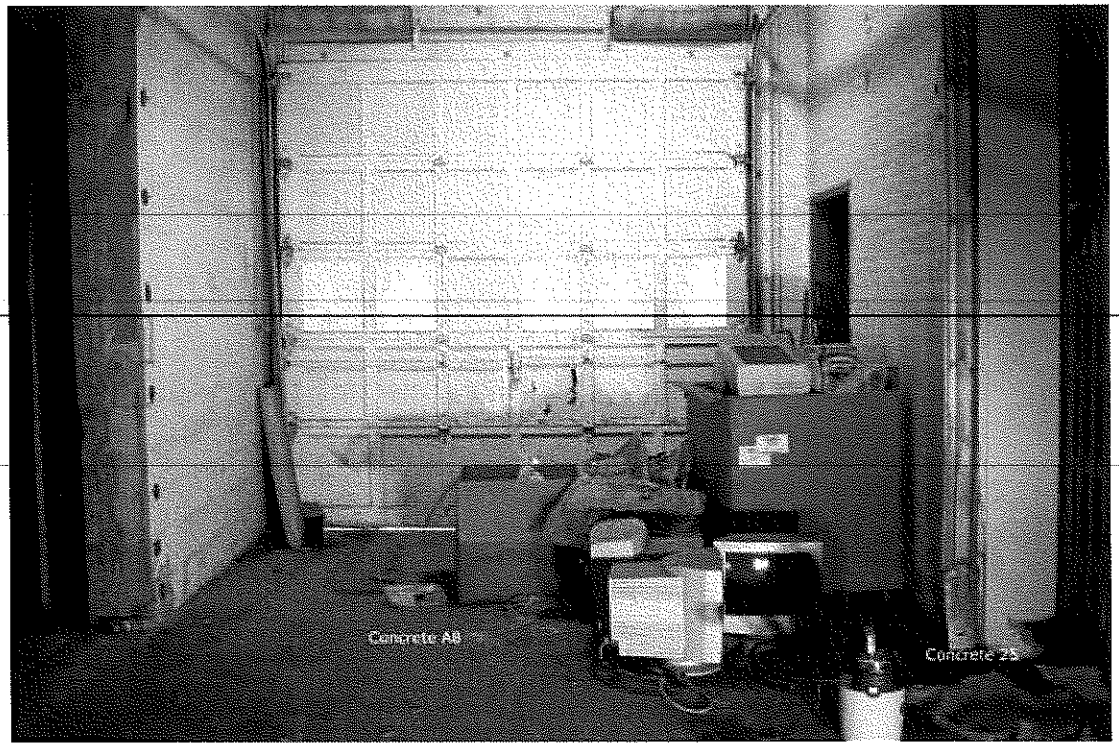
Photograph 8. Southwest loading dock, facing north.
