Subject: **Phase I Targeted Brownfields Assessment, Hazardous Materials Survey, Revision 01**
Recovery-West High Complex, 1810 and 1829 Madison Avenue, Kansas City, Missouri
U.S. EPA Region 7, START 3, Contract No. EP-S7-06-01, Task Order No. 0163
Task Monitor, Ron King, EPA Site Assessment Team Leader

PHASE I TARGETED BROWNFIELDS ASSESSMENT
HAZARDOUS MATERIALS SURVEY
REVISION 01

RECOVERY-WEST HIGH COMPLEX
1810 AND 1829 MADISON AVENUE, KANSAS CITY, MISSOURI

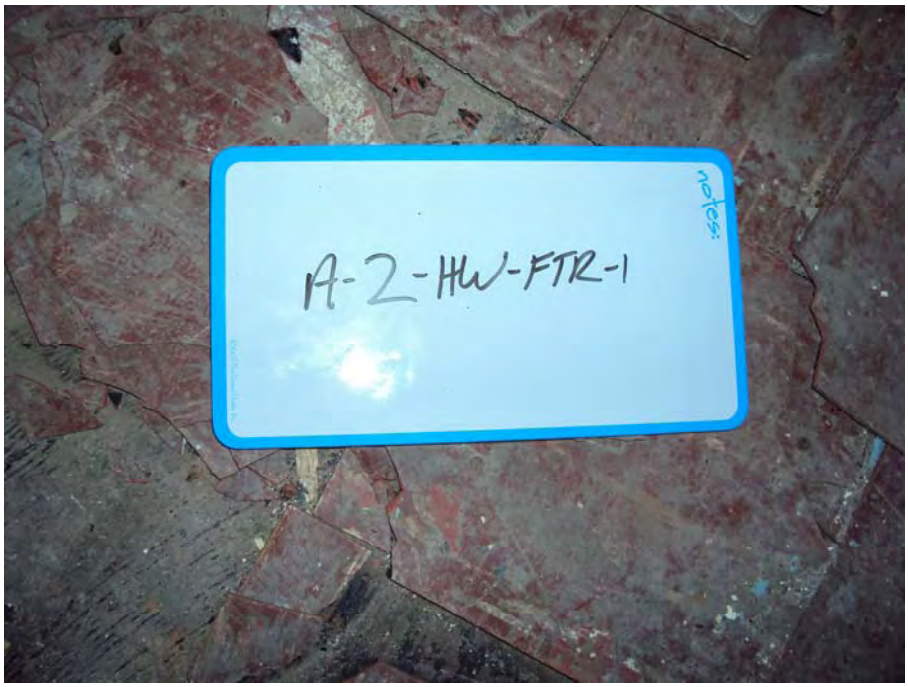
Red 9x9 floor tile and associated mastic represented by sample number A-2-HW-FTR-1 located on the 3rd floor hallway of Building A.

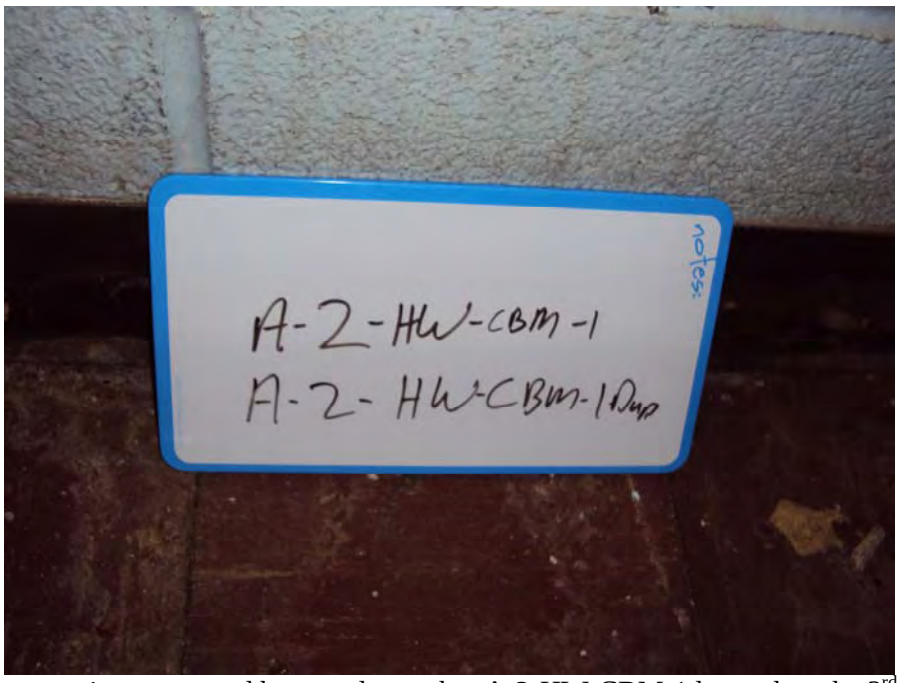
Black cove base mastic represented by sample number A-2-HW-CBM-1 located on the 3rd floor hallway of Building A.

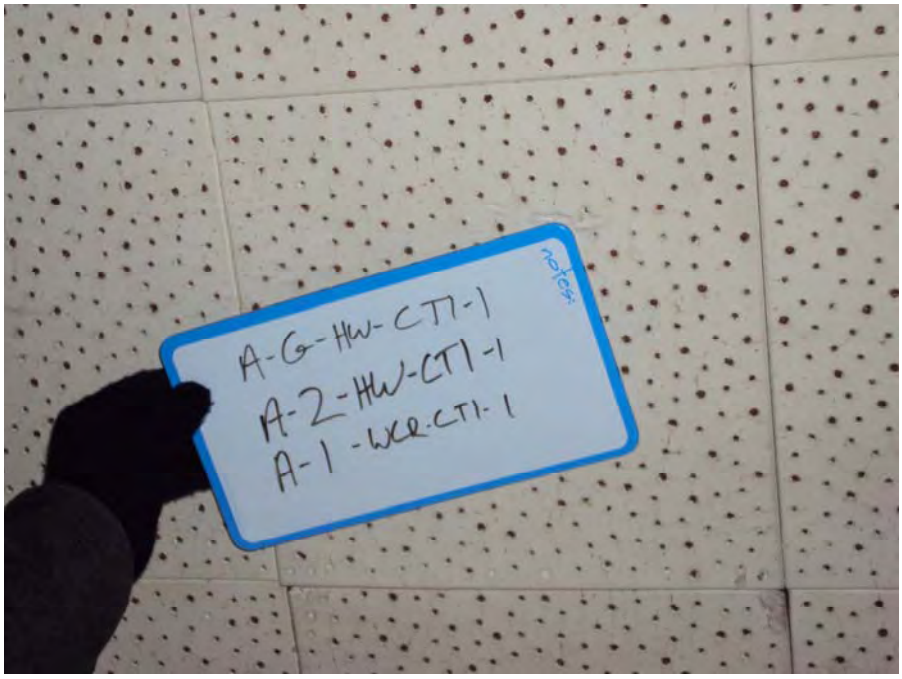
White 12x12 ceiling tile represented by sample number A-G-HW-CT1-1, A-2-HW-CT1-1 and A-1-WCR-CT1-1 located on the 1st, 2nd and 3rd floor of Building A.

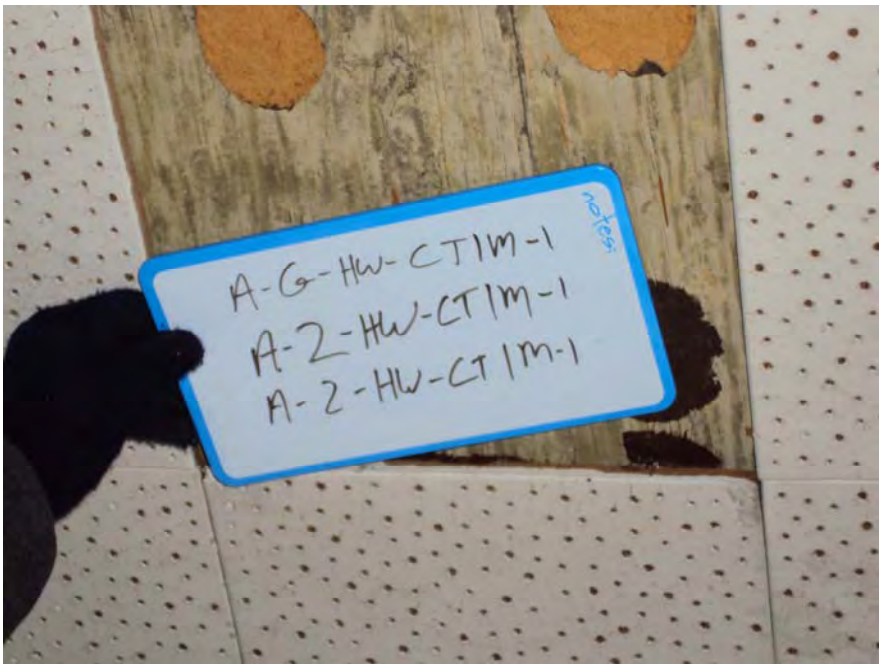
White 12x12 ceiling tile represented by sample number A-G-HW-CT1M-1, A-2-HW-CT1M-1 and A-1-WCR-CT1M-1 located on the 1st, 2nd and 3rd floor of Building A.

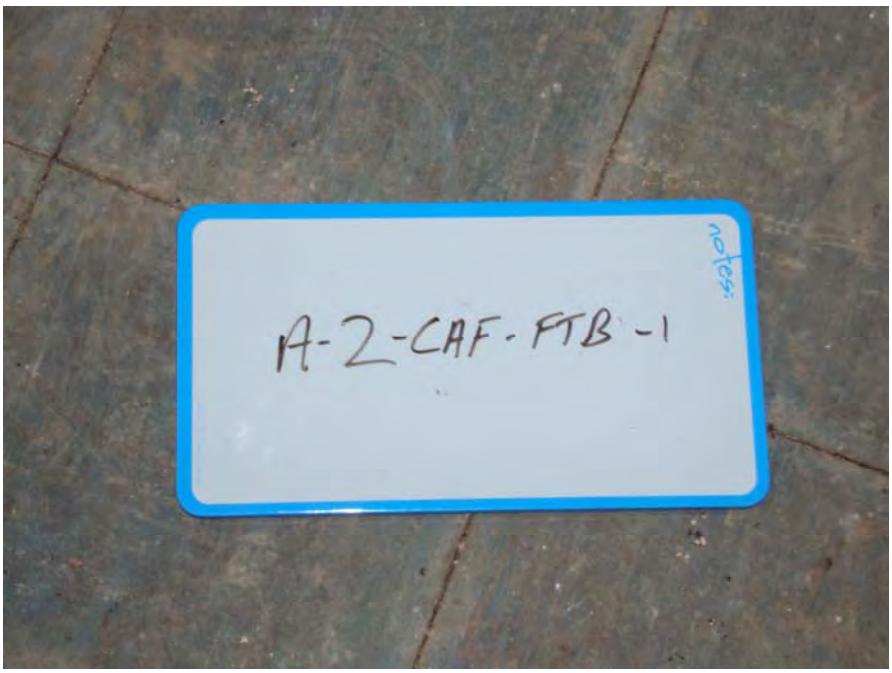
Brown 9x9 floor tile and associated mastic represented by sample number A-2-CAF-FTB-1 located on the 3rd floor of Building A.

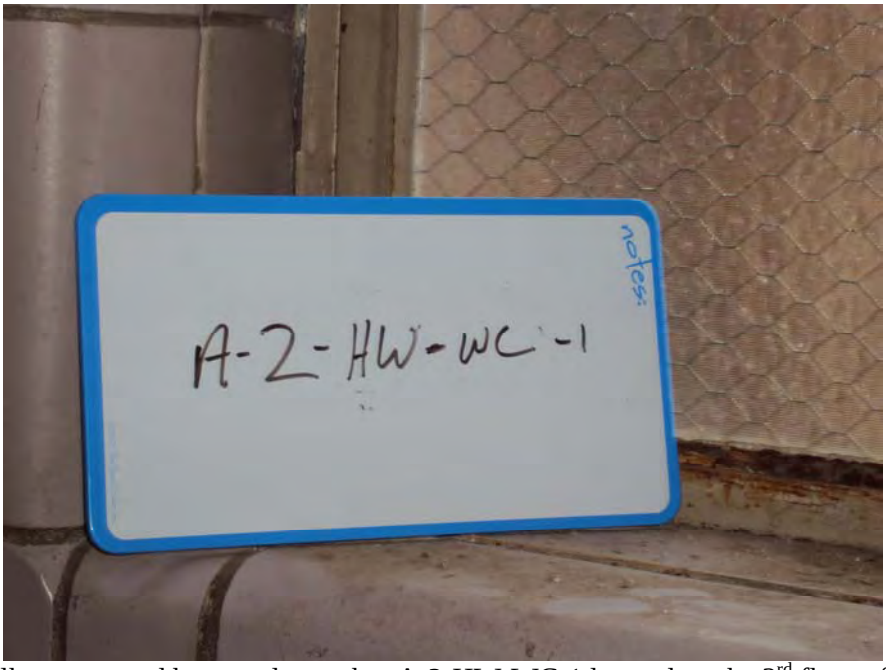
Window caulk represented by sample number A-2-HW-WC-1 located on the 3rd floor of Building A.

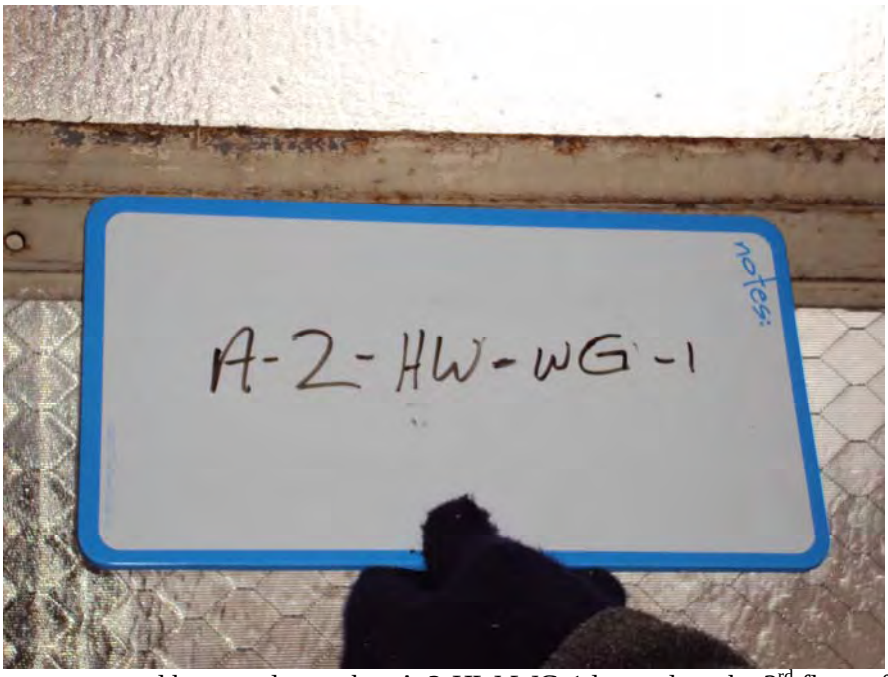
Window glaze represented by sample number A-2-HW-WG-1 located on the 3rd floor of Building A.

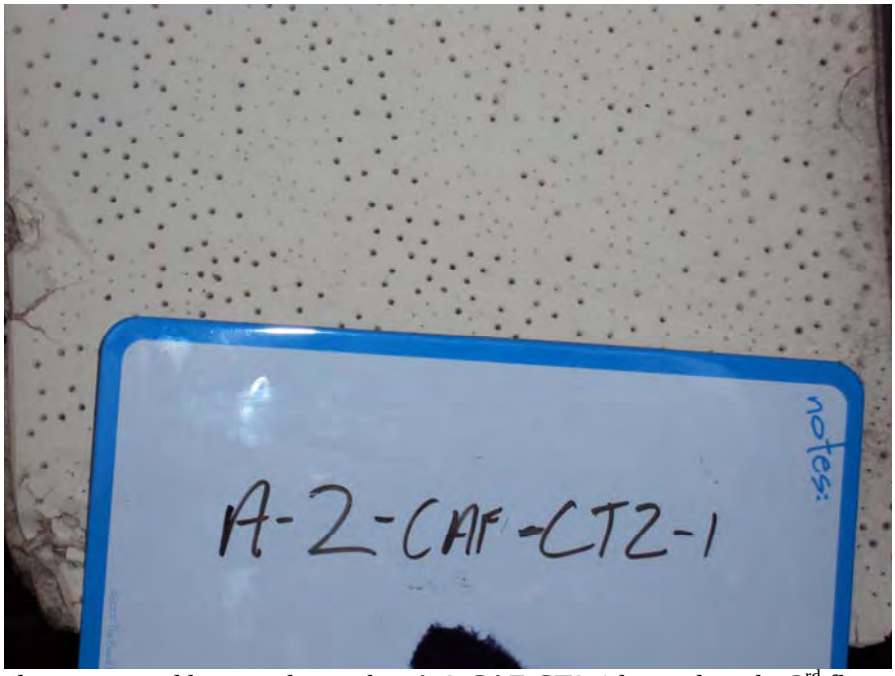
12x12 ceiling tile represented by sample number A-2-CAF-CT2-1 located on the 3rd floor of Building A.

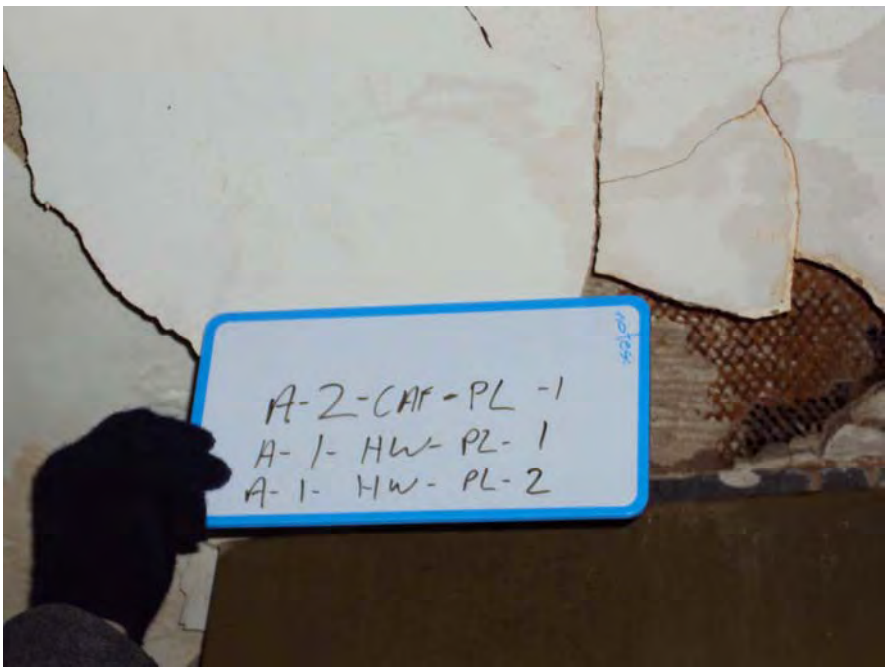
Plaster walls represented by sample numbers A-2-CAF-PL-1, A-1-HW-PL-1 and A-1-HW-PL-2 located on the 1st, 2nd and 3rd floor of Building A.

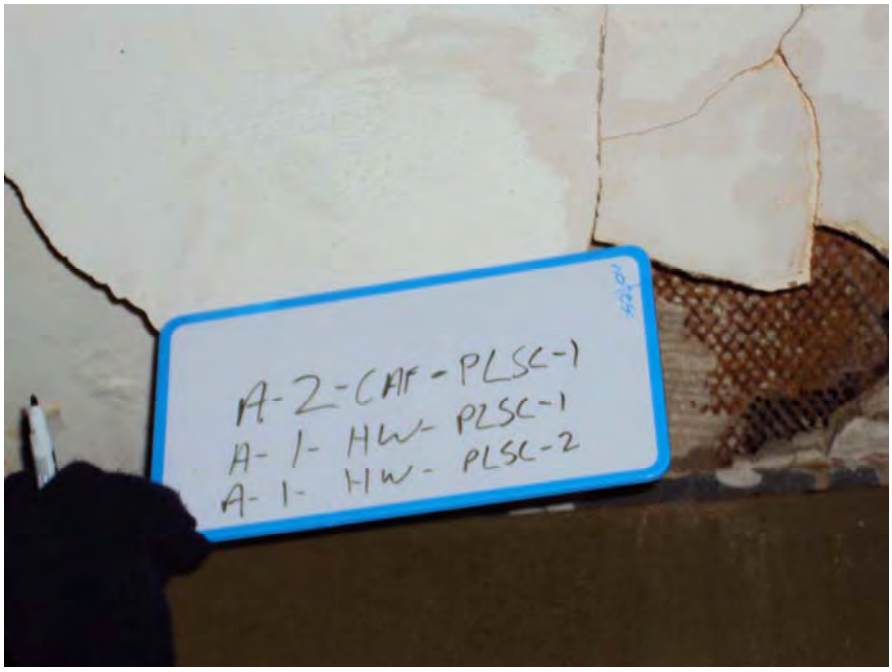
Plaster skim coat represented by sample numbers A-2-CAF-PLSC-1, A-1-HW-PLSC-1 and A-1-HW-PLSC-2 located on the 1st, 2nd and 3rd floor of Building A.

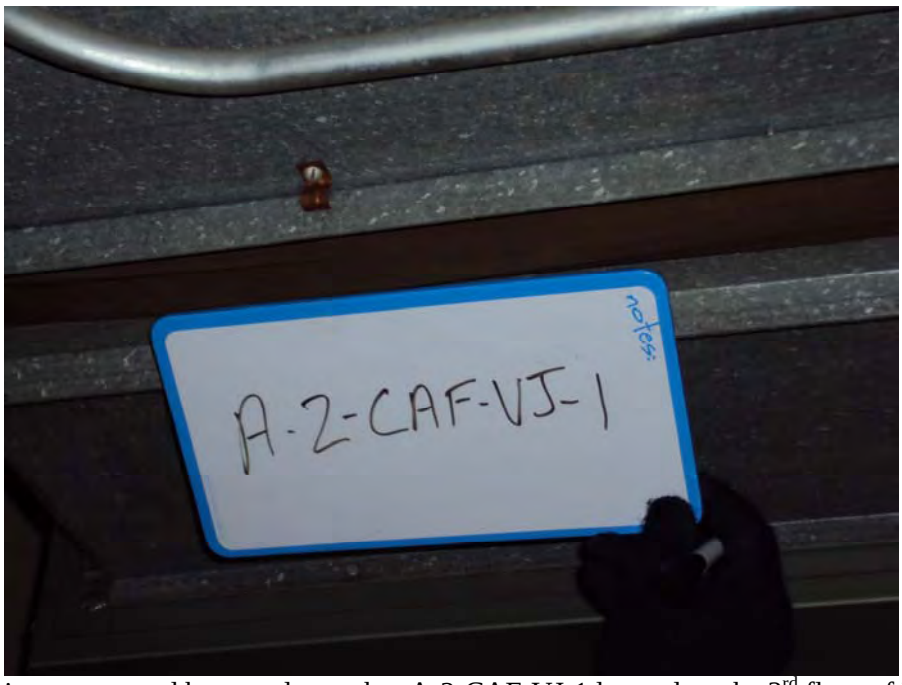
Vibration joint represented by sample number A-2-CAF-VJ-1 located on the 3rd floor of Building A.

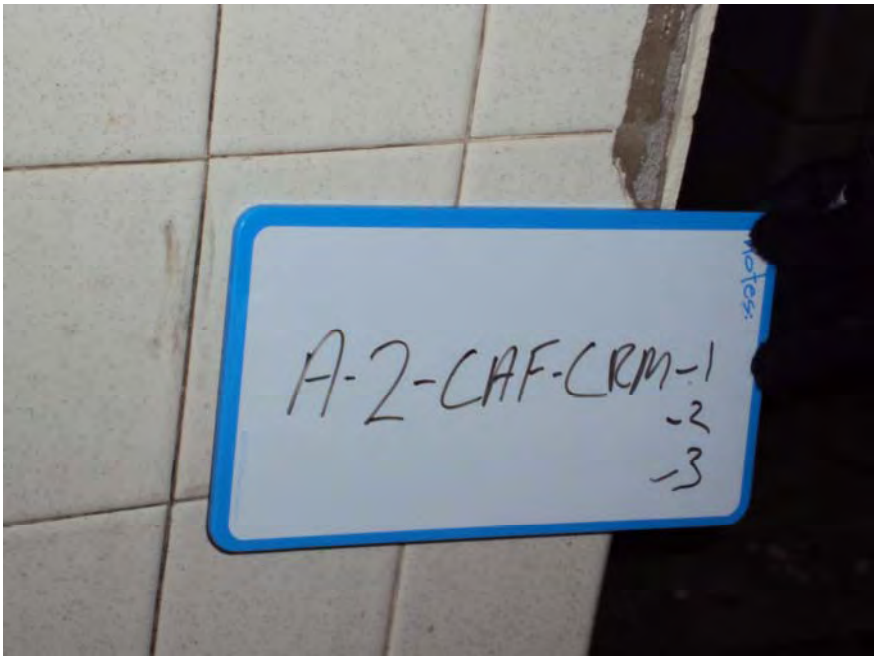
Ceramic tile mastic represented by sample numbers A-2-CAF-CRM-1, 2 and 3 located on the 3rd floor of Building A.

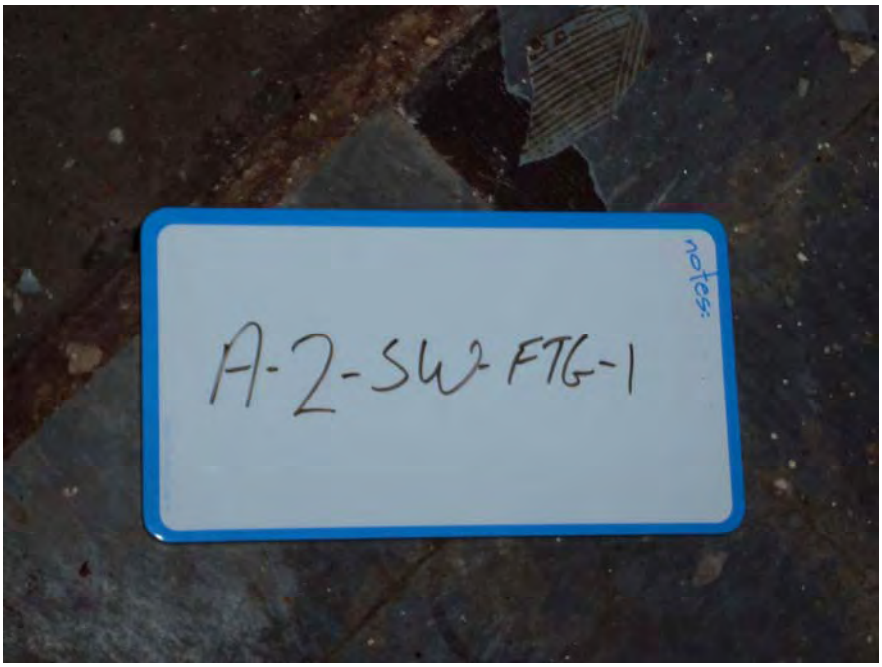
12x12 gray floor tile represented by sample number A-2-SW-FTG-1 located on the 3rd floor of Building A.

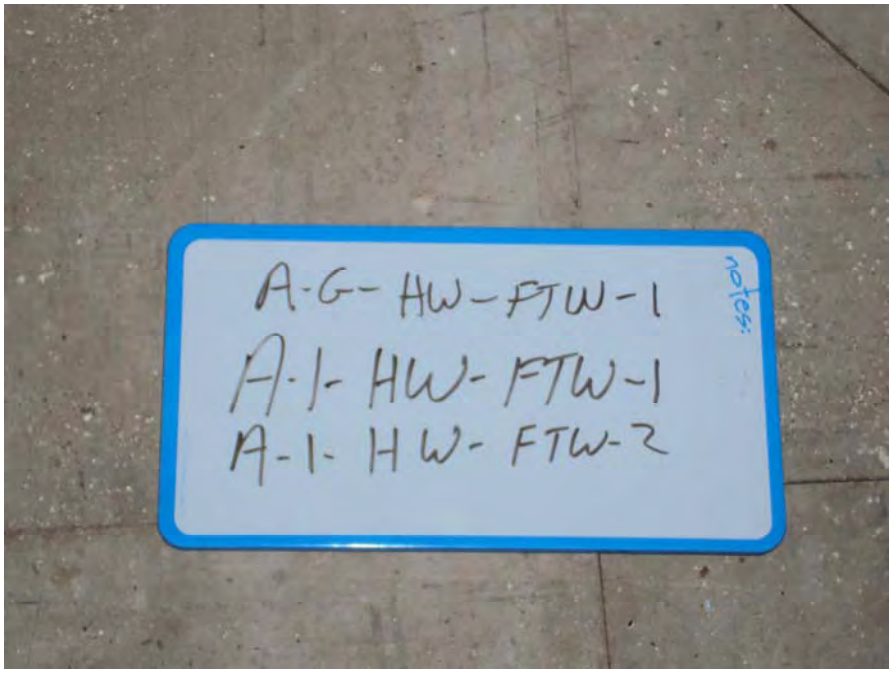
12x12 white floor tile and associated mastic represented by sample numbers A-G-HW-FTW-1, A-1-HW-FTW-1, and A-1-HW-FTW-2 located on the 1st, 2nd and 3rd floor of Building A.

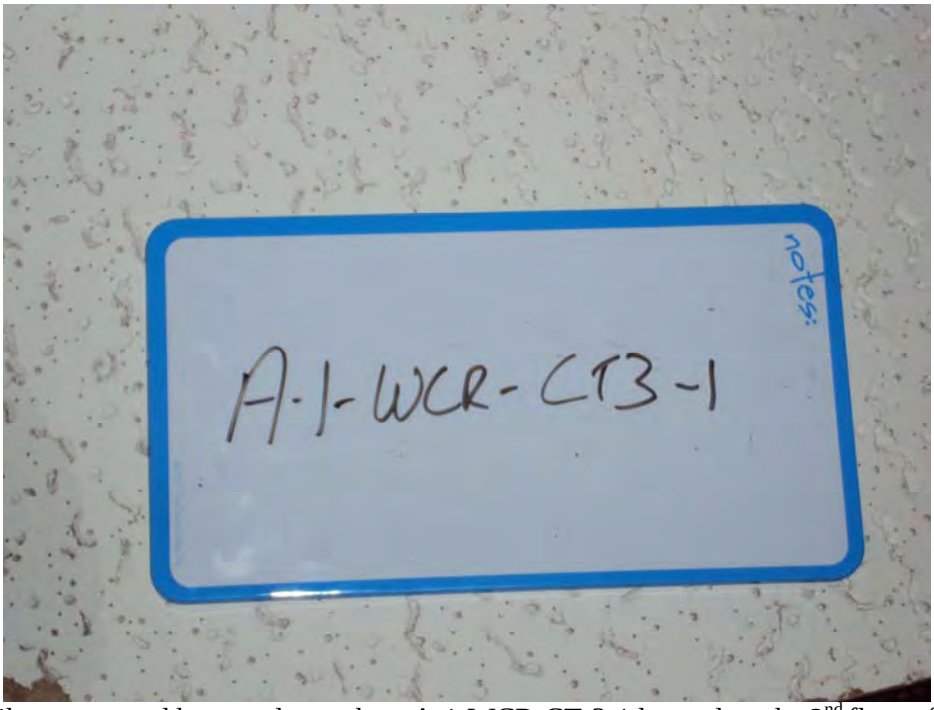
2x4 ceiling tile represented by sample numbers A-1-WCR-CT-3-1 located on the 2nd floor of Building A.

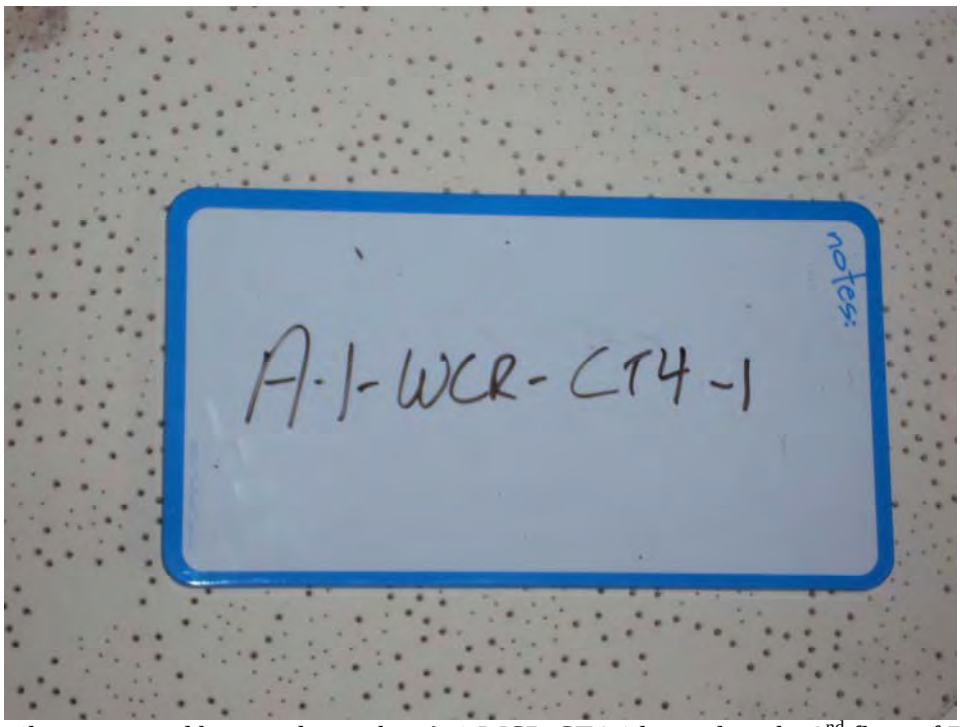
2x4 ceiling tile represented by sample number A-1-WCR-CT4-1 located on the 2nd floor of Building A.

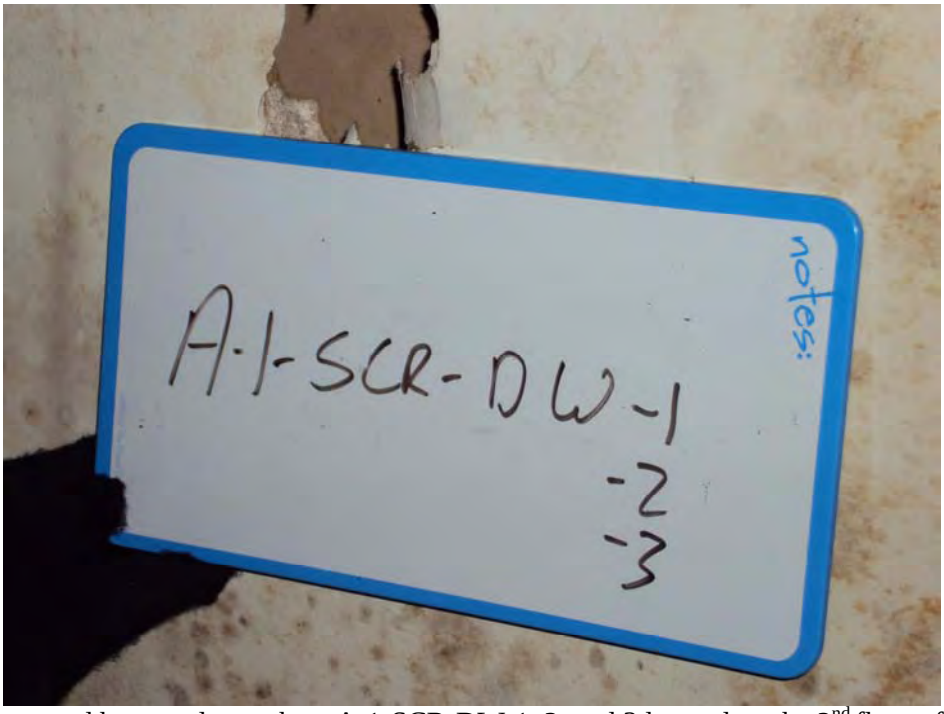
Drywall represented by sample numbers A-1-SCR-DW-1, 2, and 3 located on the 2nd floor of Building A.

Joint compound represented by sample numbers A-1-SCR-JC-1, 2, and 3 located on the 2nd floor of Building A.

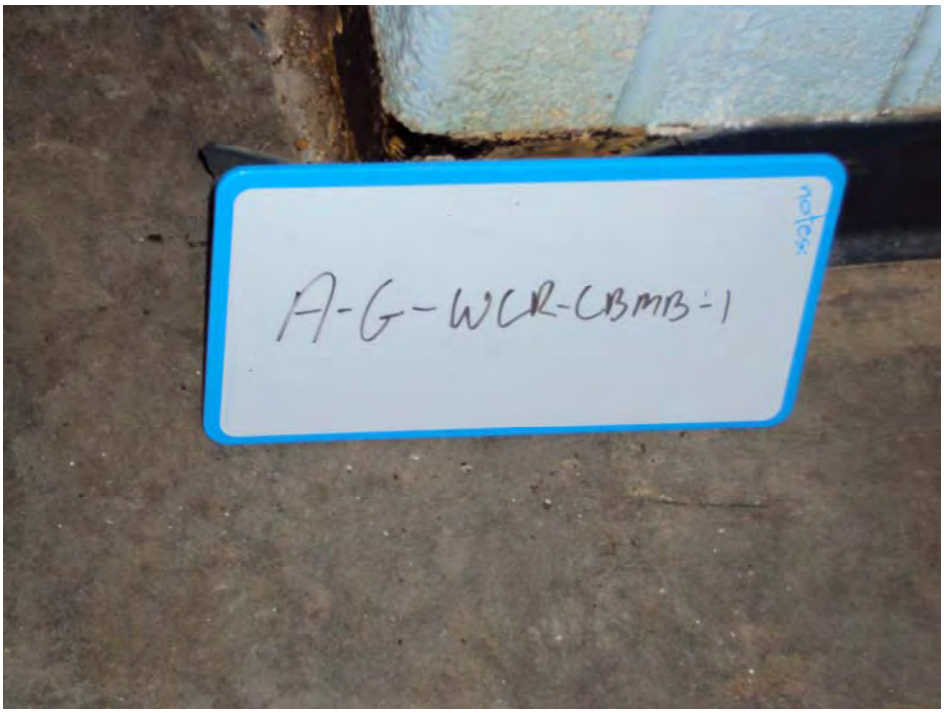
Blue cove base mastic represented by sample number A-G-WCR-CBMB-1 located on the 1st floor of Building A.

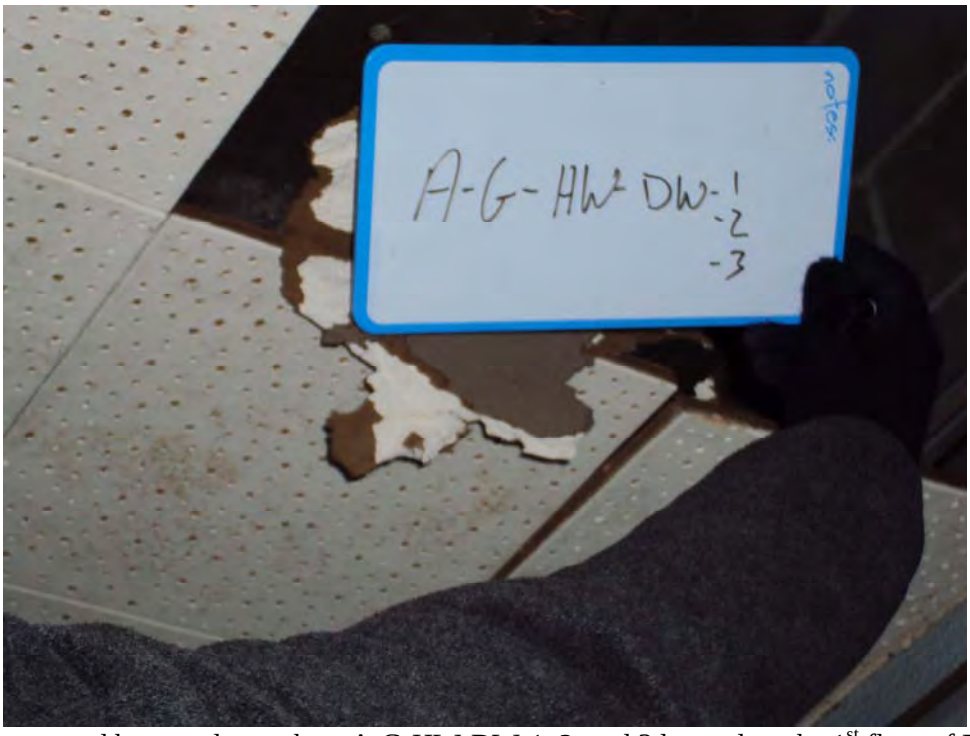
Drywall represented by sample numbers A-G-HW-DW-1, 2, and 3 located on the 1st floor of Building A.

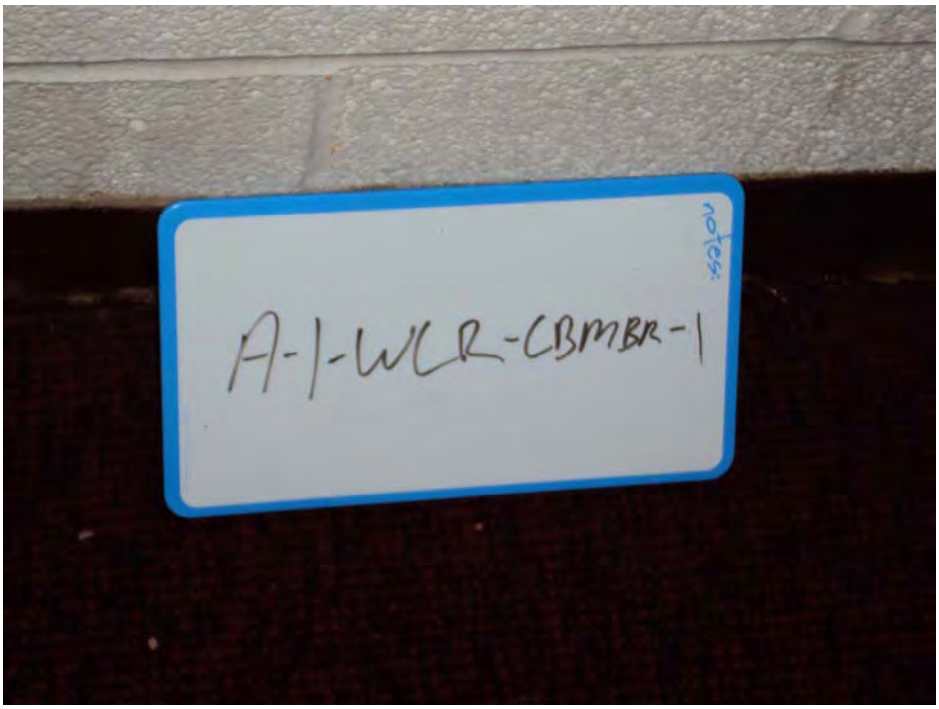
Brown cove base mastic represented by sample number A-1-WCR-CBMBR-1 located on the 2nd floor of Building A.

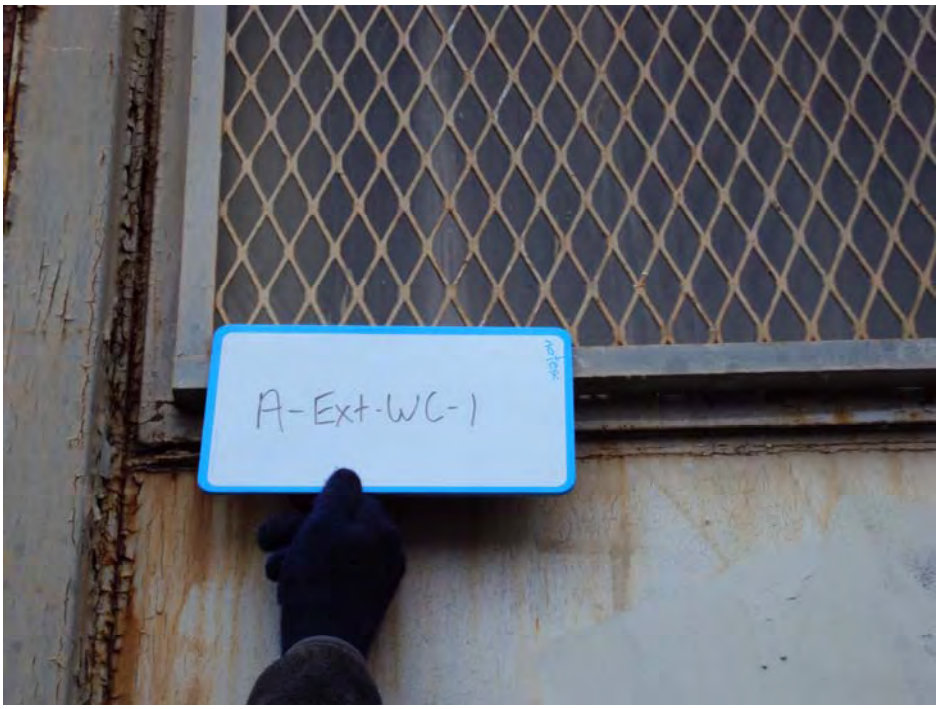
Exterior window caulk represented by sample number A-EXT-WC-1 located on the exterior of Building A.

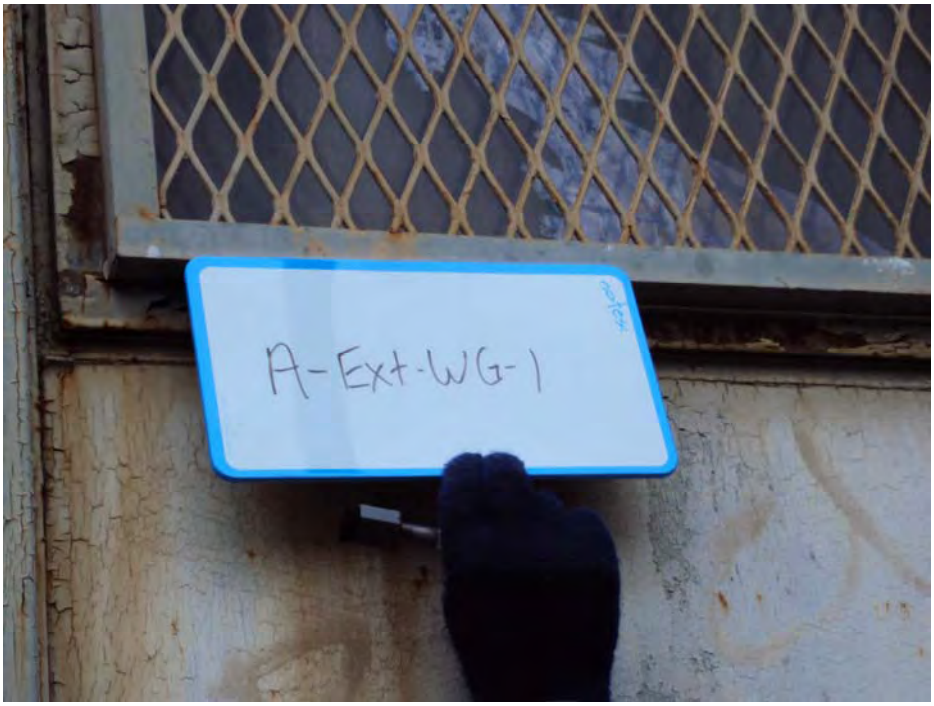
Exterior window glaze represented by sample number A-EXT-WG-1 located on the exterior of Building A.

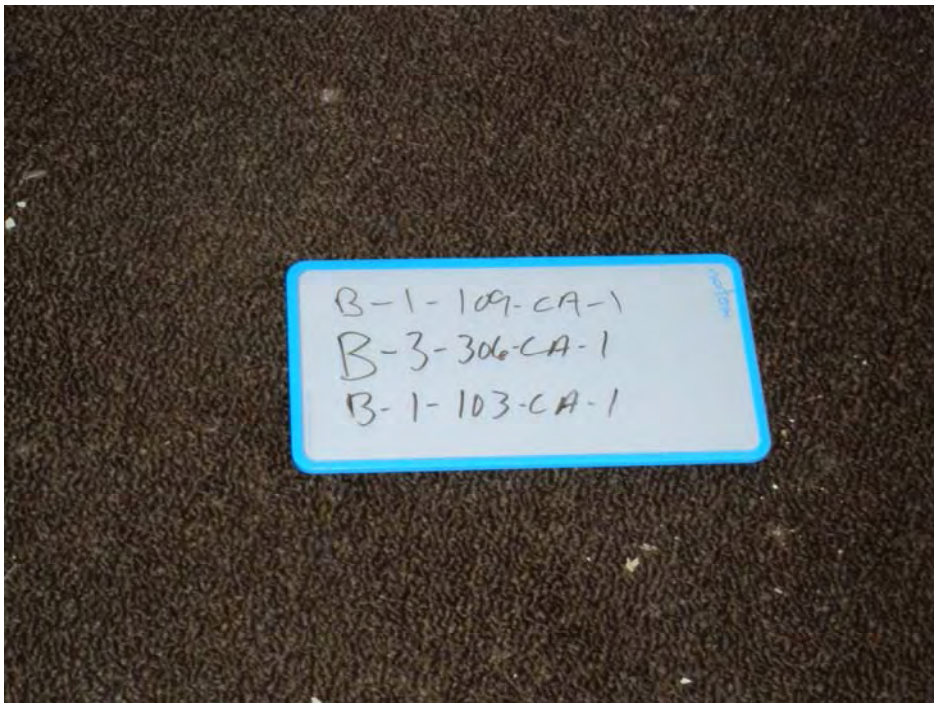
Carpet adhesive represented by sample numbers B-1-109-CA-1, B-3-306-CA-1, and B-1-103-CA-1 located on the 1st and 3rd floor of Building B.

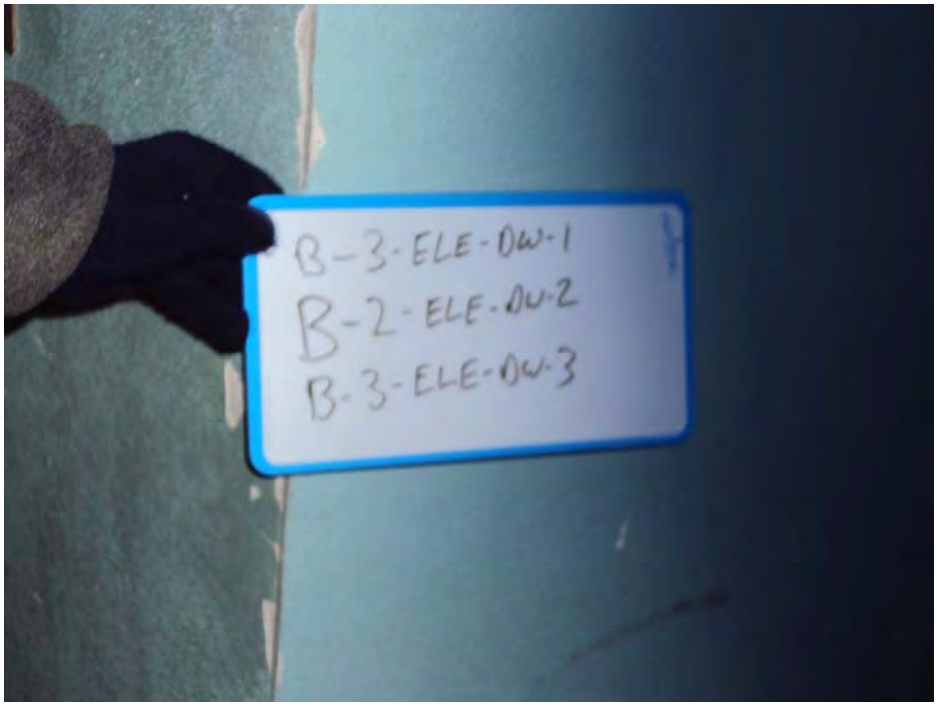
Drywall represented by sample numbers B-3-ELE-DW-1, B-2-ELE-DW-2, and B-3-ELE-DW-3 located on the 1st and 2nd floor of Building B at the elevator shaft.

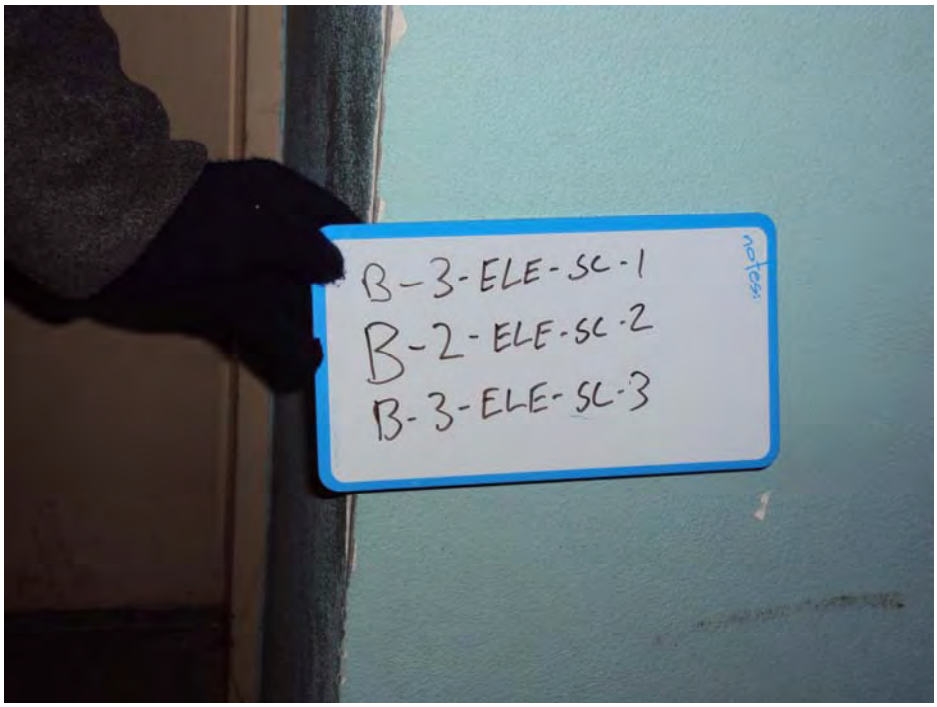
Drywall skim coat represented by sample numbers B-3-ELE-SC-1, B-2-ELE-SC-2, and B-3-ELE-SC-3 located on the 1st and 2nd floor of Building B at the elevator shaft.

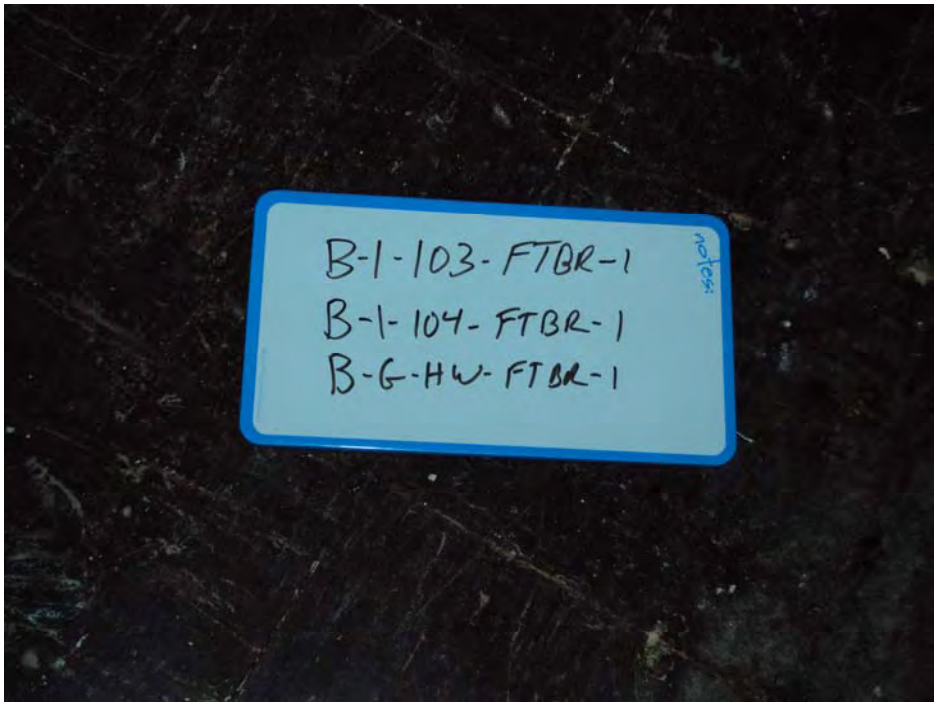
12x12 brown floor tile and associated mastic represented by sample numbers B-1-103-FTBR-1, B-1-104-FTBR-1, and B-G-HW-FTBR-1 located on the 1st floor and ground floor of Building B.

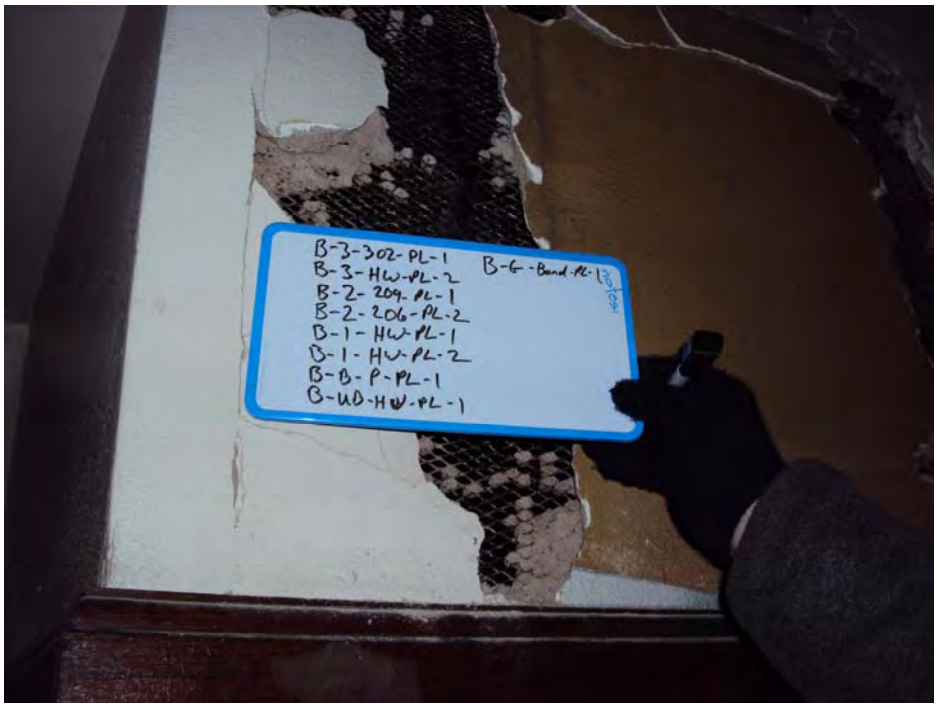
Plaster represented by sample numbers B-3-302-PL-1, B-3-HW-PL-2, B-2-204-PL-1, B-2-206-PL-2, B-1-HW-PL-1, B-1-HW-PL-2, B-B-P-PL-1, B-UB-HW-PL-1 and B-G-BAND-PL-1 located on the basement, ground floor, upper boiler room, 1st, 2nd and 3rd floors of Building B.

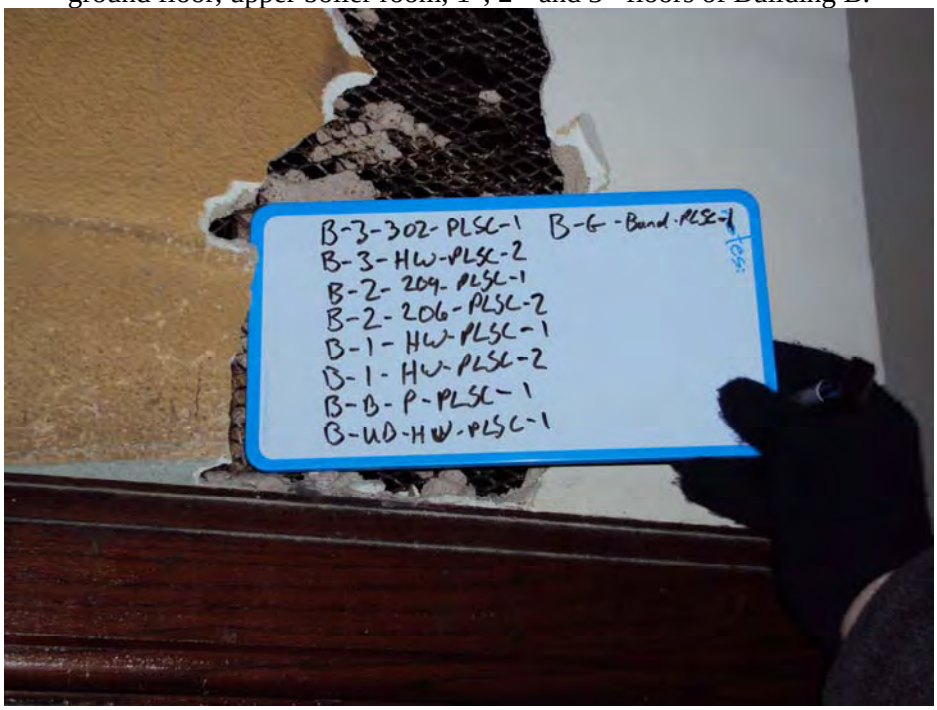
Plaster skim coat represented by sample numbers B-3-302-PLSC-1, B-3-HW-PLSC-2, B-2-204-PLSC-1, B-2-206-PLSC-2, B-1-HW-PLSC-1, B-1-HW-PLSC-2, B-B-P-PLSC-1, B-UB-HW-PLSC-1 and B-G-BAND-PLSC-1 located on the basement, ground floor, upper boiler room, 1st, 2nd and 3rd floors of Building B.

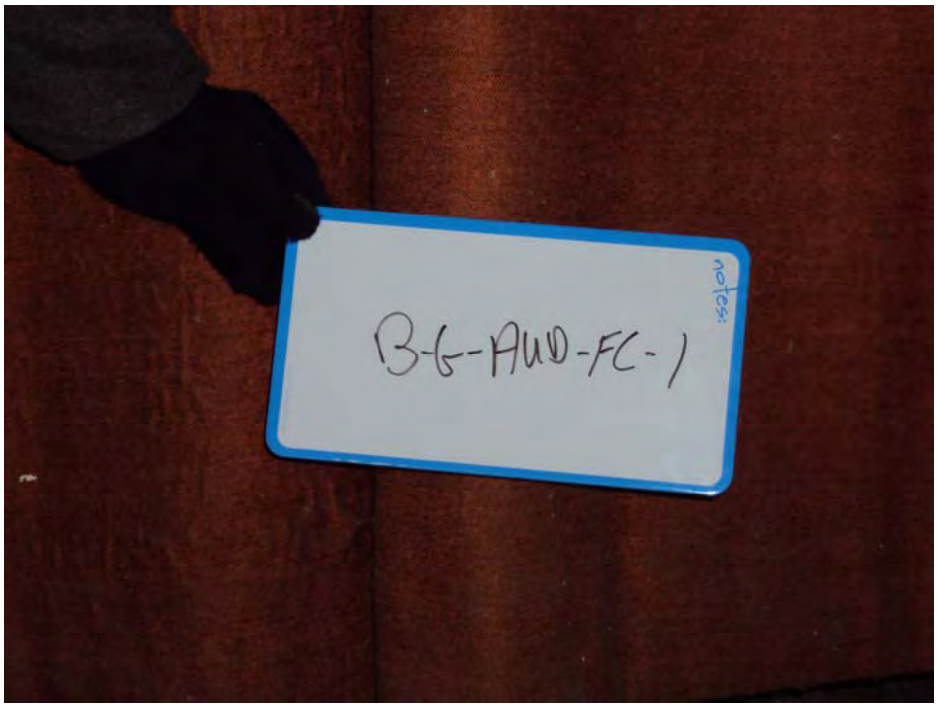
Fire curtain represented by sample number B-G-AUD-FC-1 located in the auditorium of Building B.

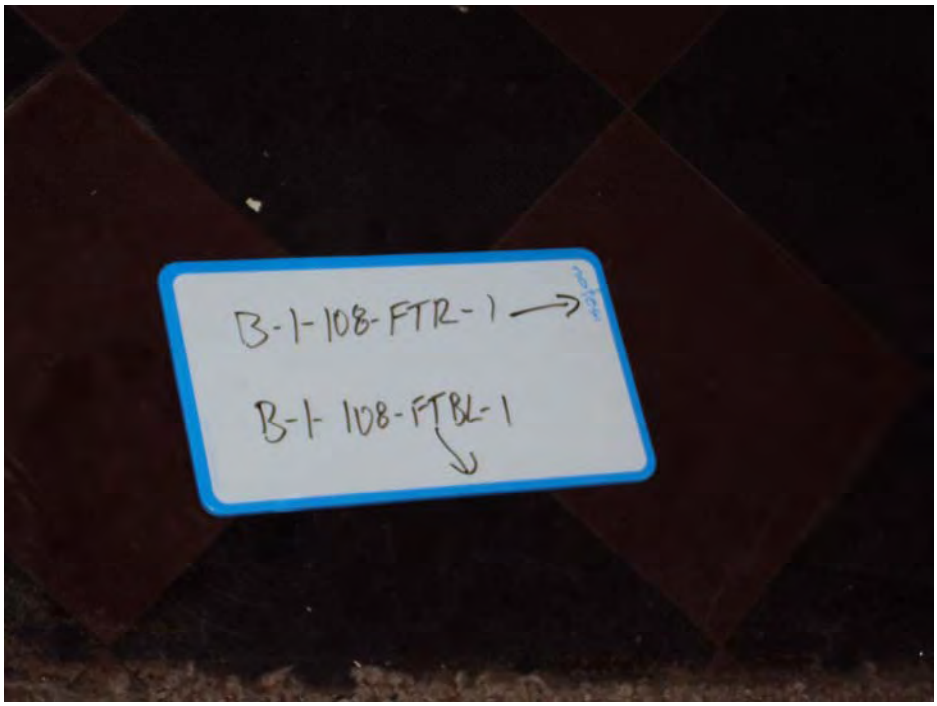
12x12 black floor tile and 12x12 red floor tile and associated mastic represented by sample numbers B-1-108-FTR-1, B-1-108-FTBL-1, located in room 108 of Building B.

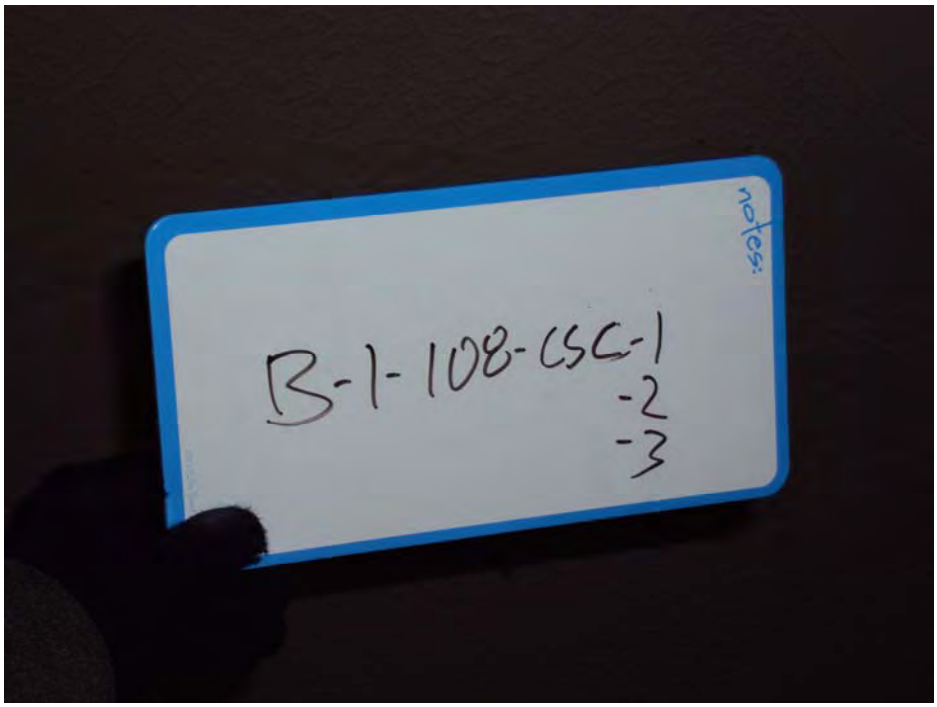
Ceiling skim coat represented by sample numbers B-1-108-CSC-1, 2 and 3 located in room 108 of Building B.

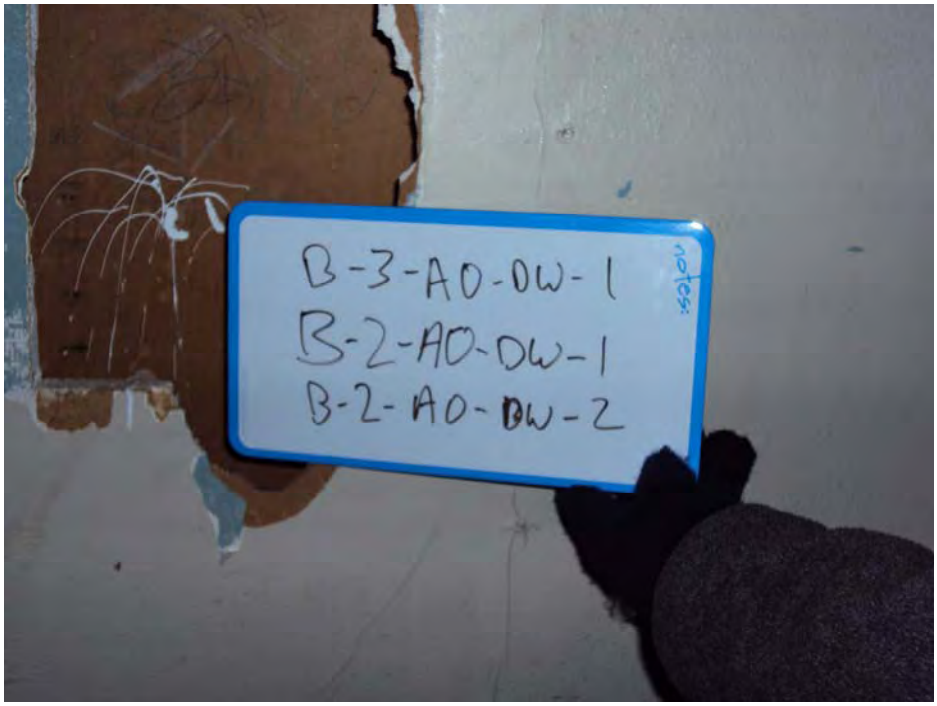
Drywall represented by sample numbers B-3-AO-DW-1, B-2-AO-DW-1 and B-2-AO-DW-2 located on the 2nd and 3rd floor of Building B.

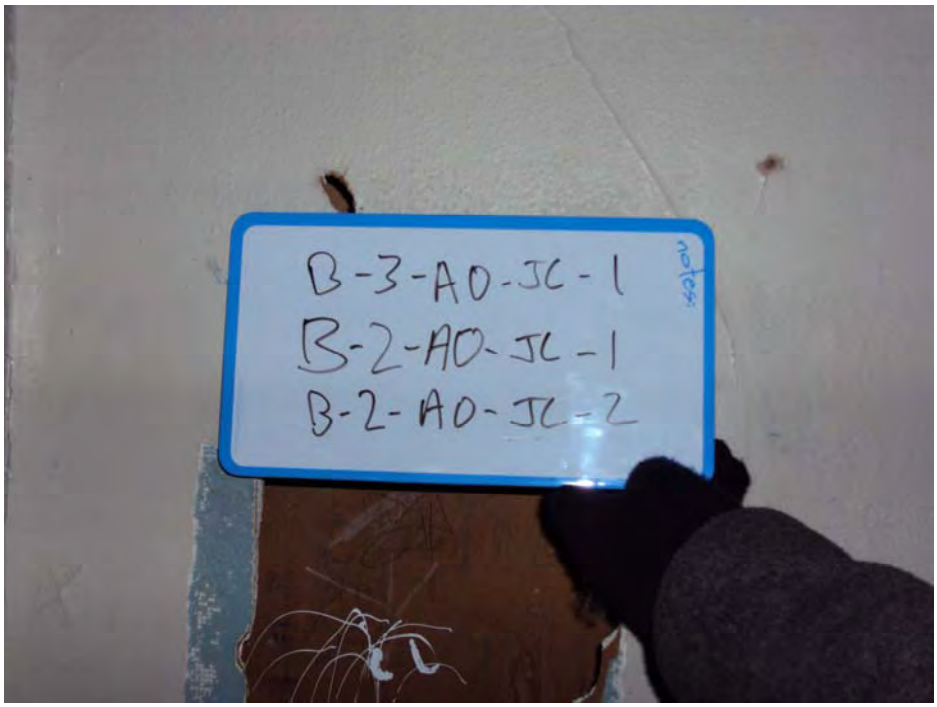
Joint compound represented by sample numbers B-3-AO-JC-1, B-2-AO-JC-1 and B-2-AO-JC-2 located on the 2nd and 3rd floor of Building B.

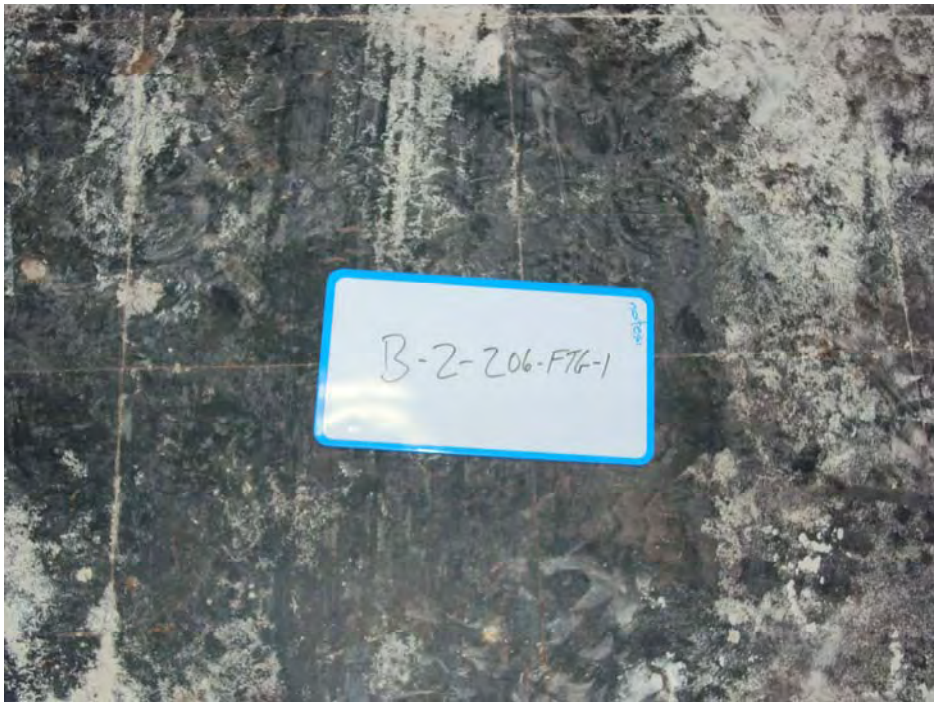
12x12 gray floor tile and associated mastic represented by sample number B-2-206-FTG-1 located in room 206 of Building B.
