Subject: **Phase I Targeted Brownfields Assessment, Hazardous Materials Survey, Revision 01**
Recovery-West High Complex, 1810 and 1829 Madison Avenue, Kansas City, Missouri
U.S. EPA Region 7, START 3, Contract No. EP-S7-06-01, Task Order No. 0163
Task Monitor, Ron King, EPA Site Assessment Team Leader

PHASE I TARGETED BROWNFIELDS ASSESSMENT
HAZARDOUS MATERIALS SURVEY
REVISION 01

RECOVERY-WEST HIGH COMPLEX
1810 AND 1829 MADISON AVENUE, KANSAS CITY, MISSOURI

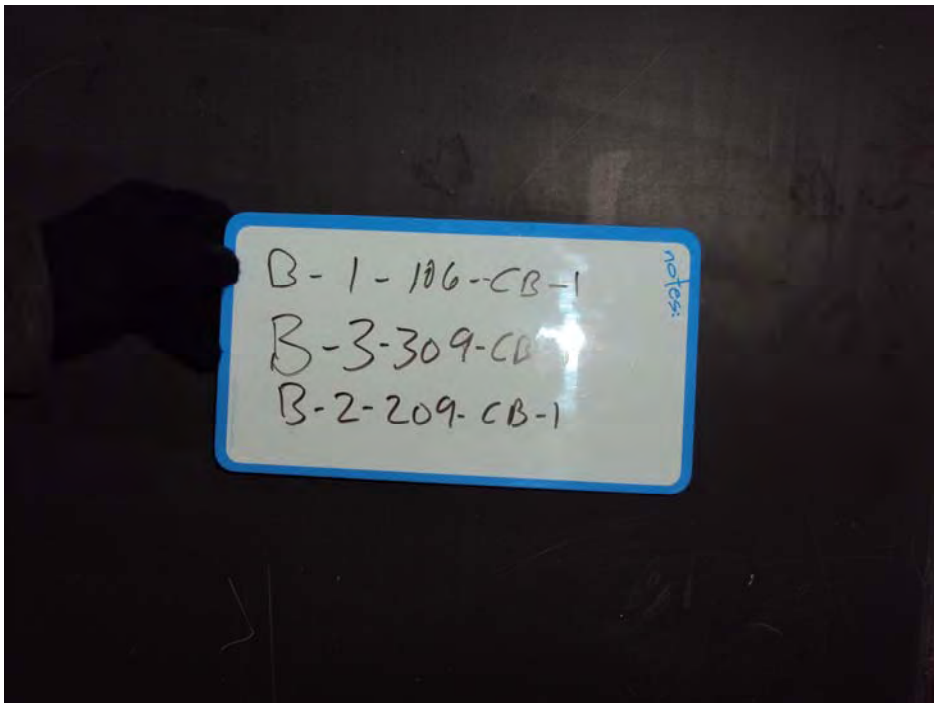
Chalkboard represented by sample numbers B-1-106-CB-1, B-3-309-CB-1 and B-2-209-CB-1 located in rooms 106, 209 and 309 of Building B.

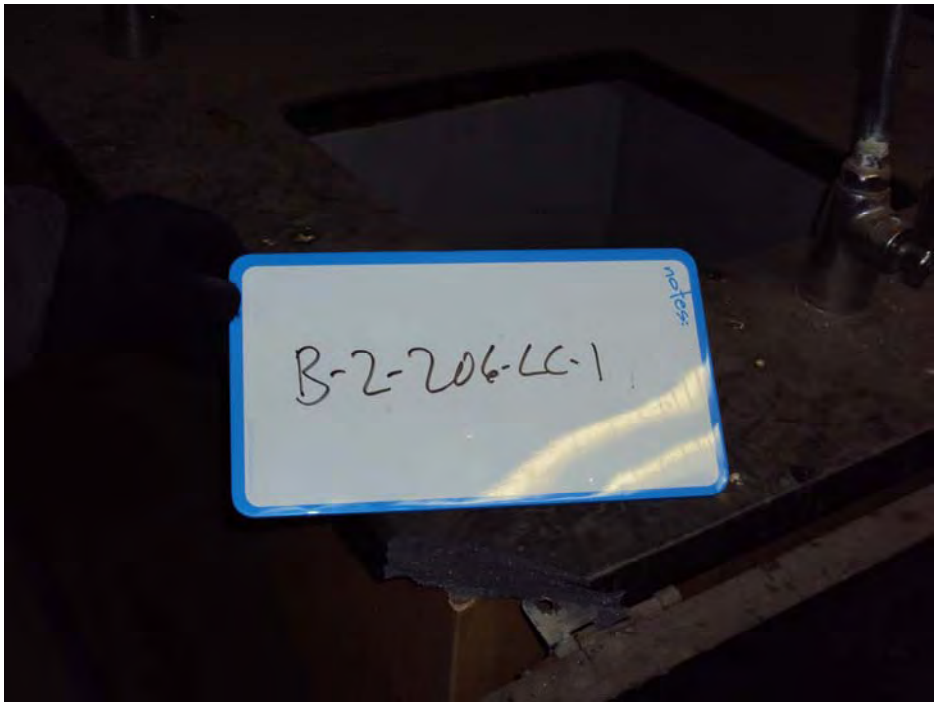
Lab counter represented by sample number B-2-206-LC-1 located in room 206 of Building B.

12x12 tan floor tile and associated mastic represented by sample numbers B-G-BAND-FTT-1, B-3-301-FTT-1 and B-3-309-FTT-1 located in the band room and rooms 301 and 309 of Building B.

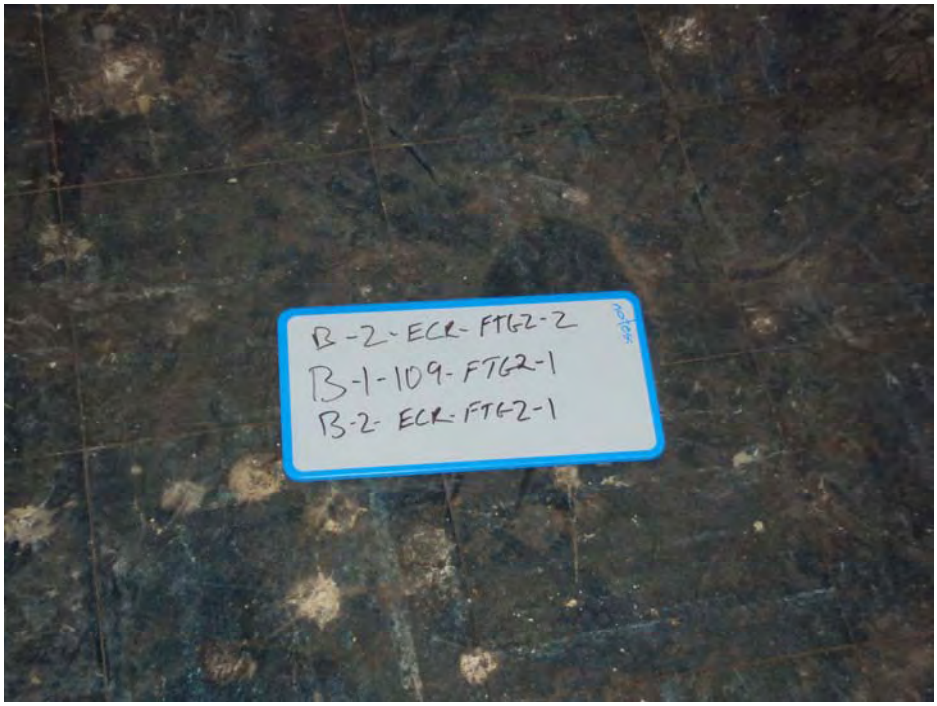
12x12 dark gray floor tile and associated mastic represented by sample numbers B-2-ECR-FTG2-1, B-1-109-FTG2-1 and B-2-ECR-FTG2-2 located on the 1st and 2nd floor of Building B.

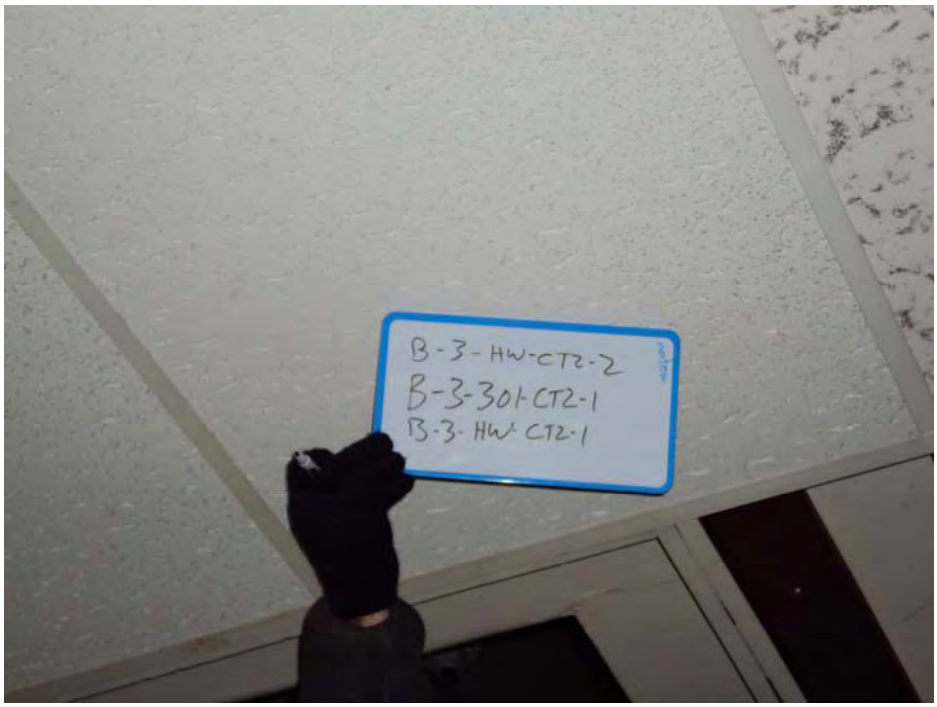
2x4 ceiling tile represented by sample numbers B-3-HW-CT2-1, B-3-HW-CT2-2 and B-3-301-CT2-1 located on the 3rd floor of Building B.

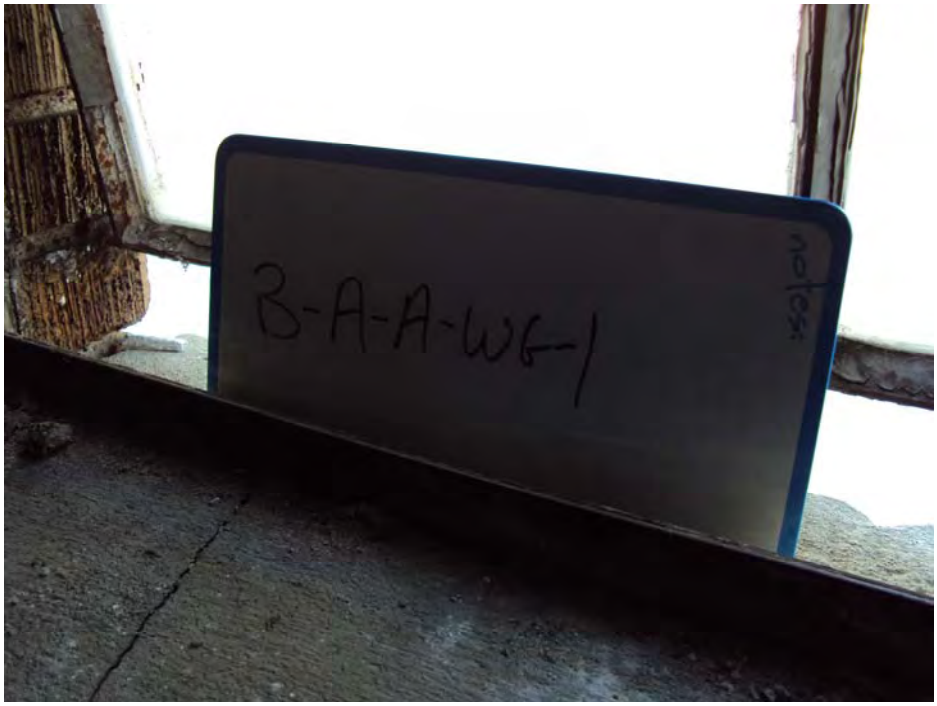
Window glazing represented by sample number B-A-A-WG-1 located in the attic of Building B.

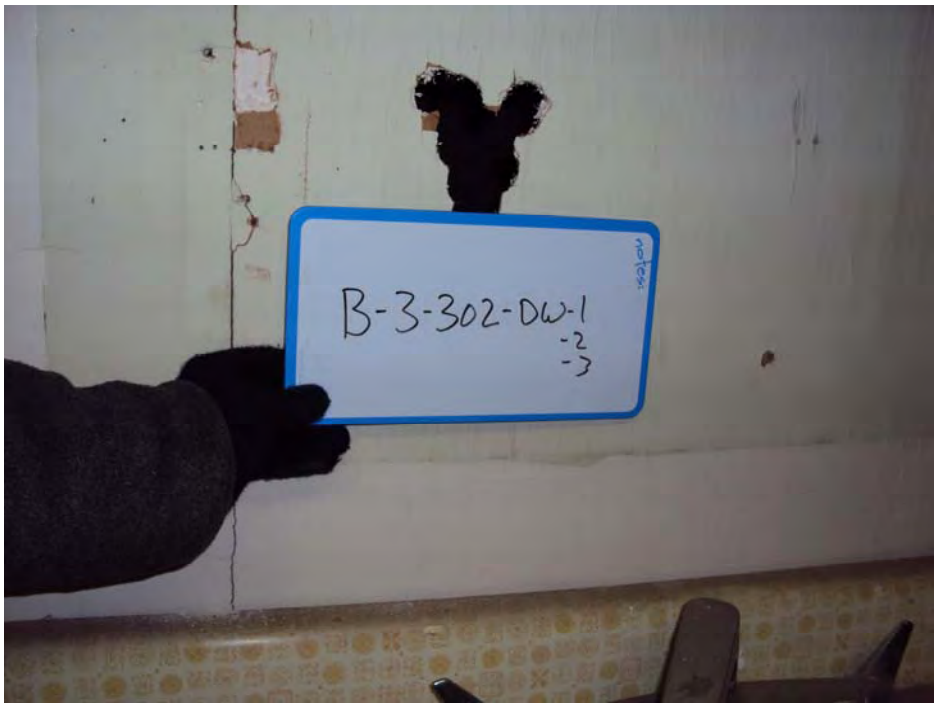
Drywall represented by sample number B-3-302-DW-1, 2 and 3 located in room 302 of Building B.

Joint compound represented by sample number B-3-302-JC-1, 2 and 3 located in room 302 of Building B.

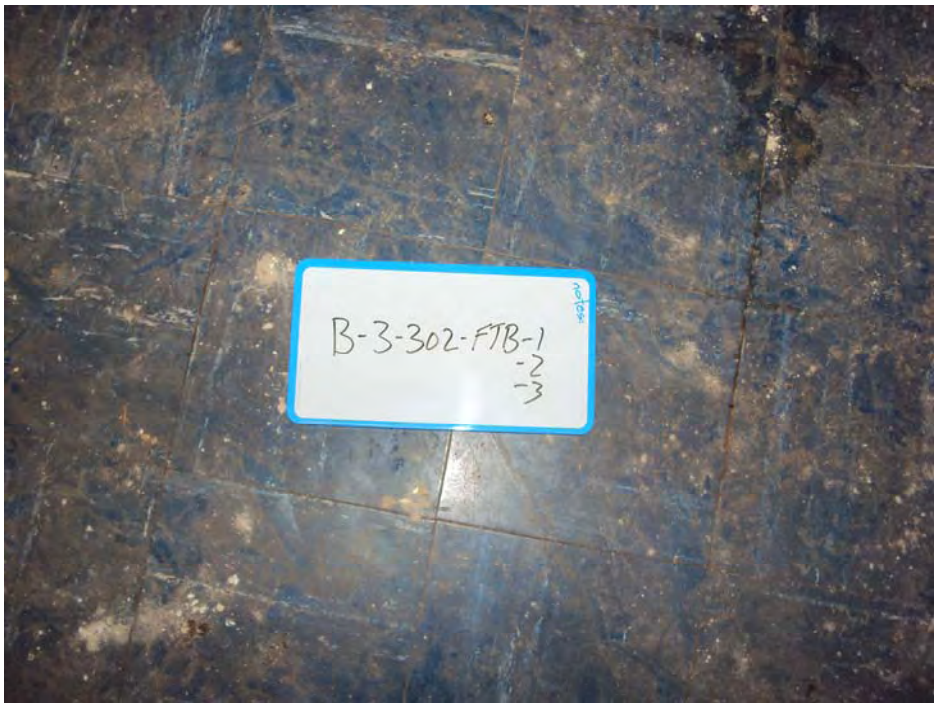
12x12 blue floor tile and associated mastic represented by sample numbers B-3-302-FTB-1, 2 and 3 located in room 302 of Building B.

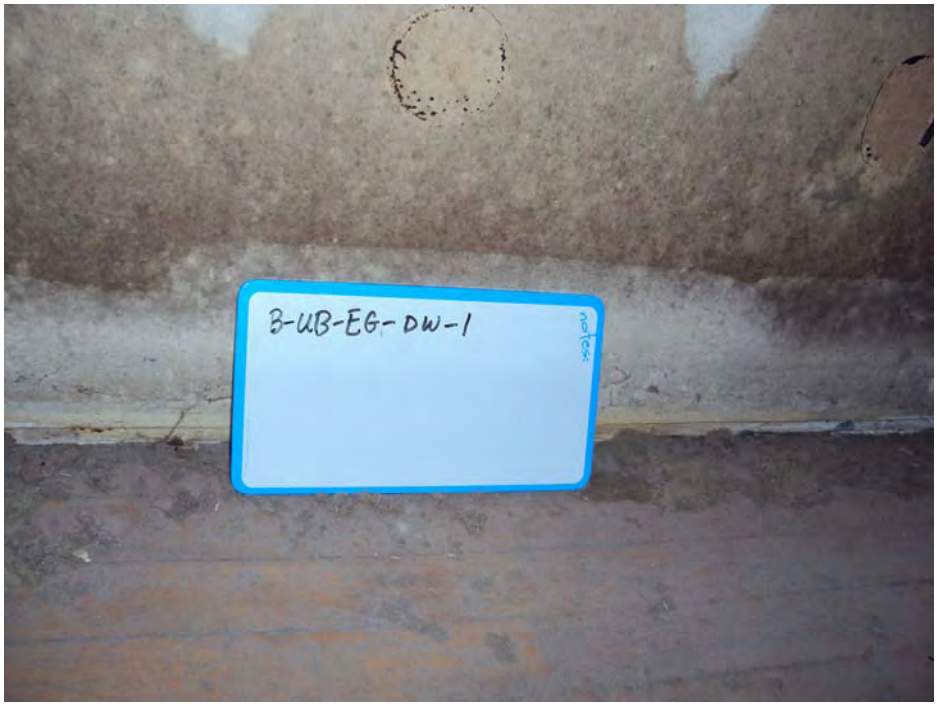
Drywall represented by sample number B-UB-EG-DW-1 located in the upper boiler room of Building B.

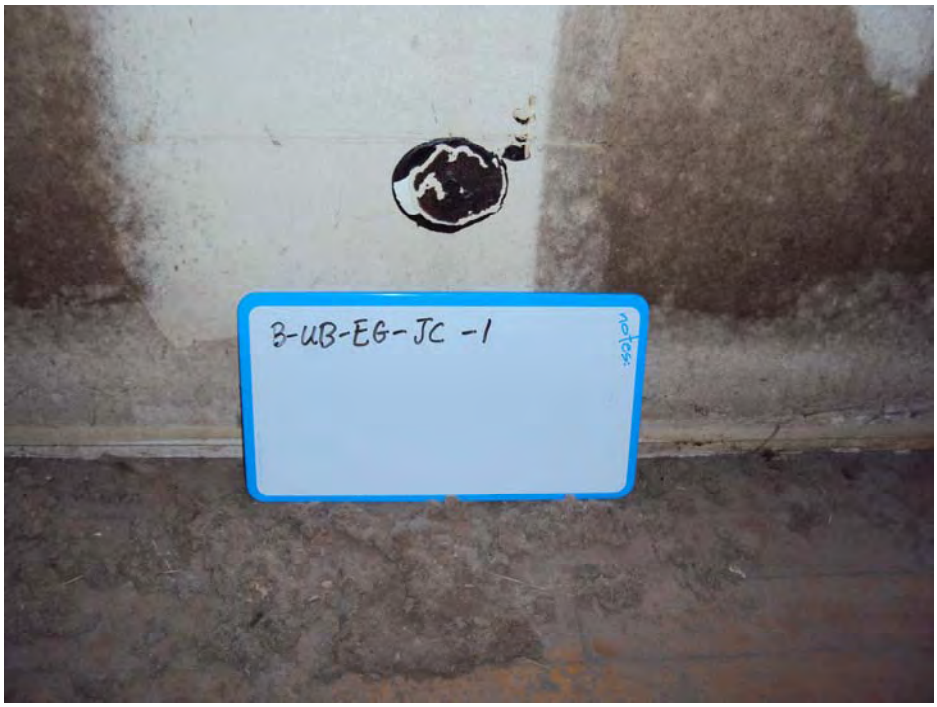
Joint compound represented by sample number B-UB-EG-JC-1 located in the upper boiler room of Building B.

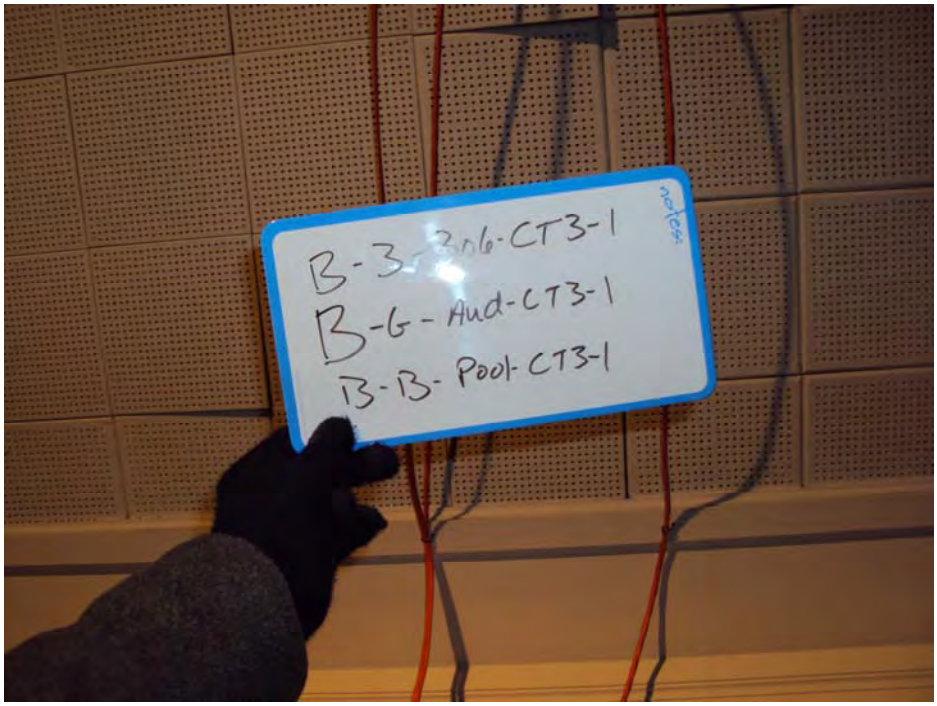
12x12 ceiling tile represented by sample numbers B-3-306-CT3-1, B-G-AUD-CT3-1 and B-B-Pool-CT3-1 located in the pool, auditorium and room 306 of Building B.

Ceiling tile mastic represented by sample numbers B-G-AUD-CT3M-1, 2 and 3 located in the auditorium of Building B.

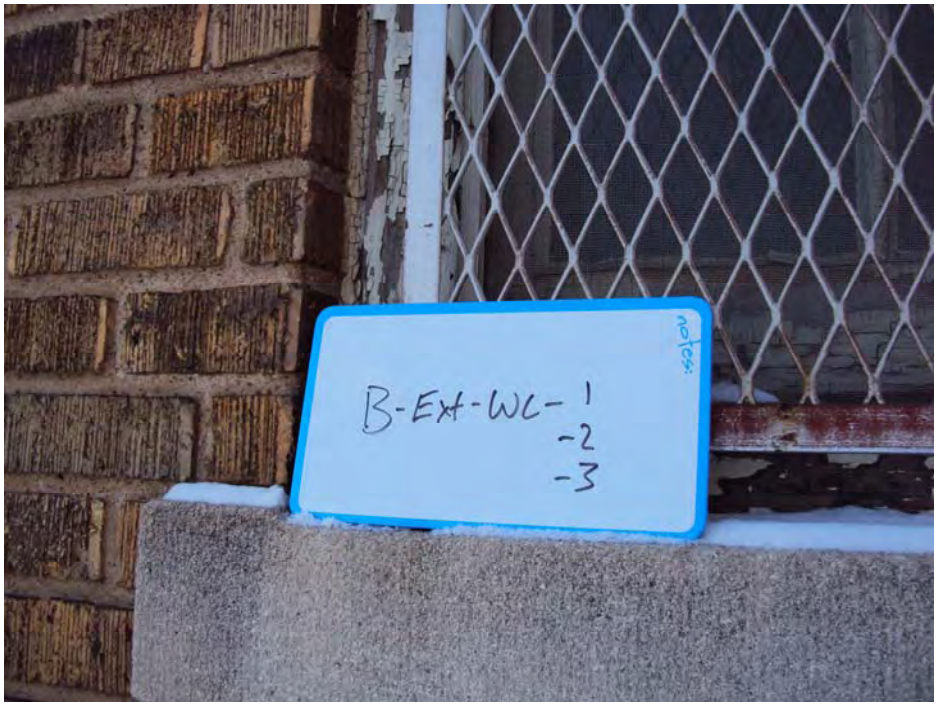
Exterior window caulking represented by sample numbers B-EXT-WC-1, 2 and 3 located on the exterior windows of Building B.

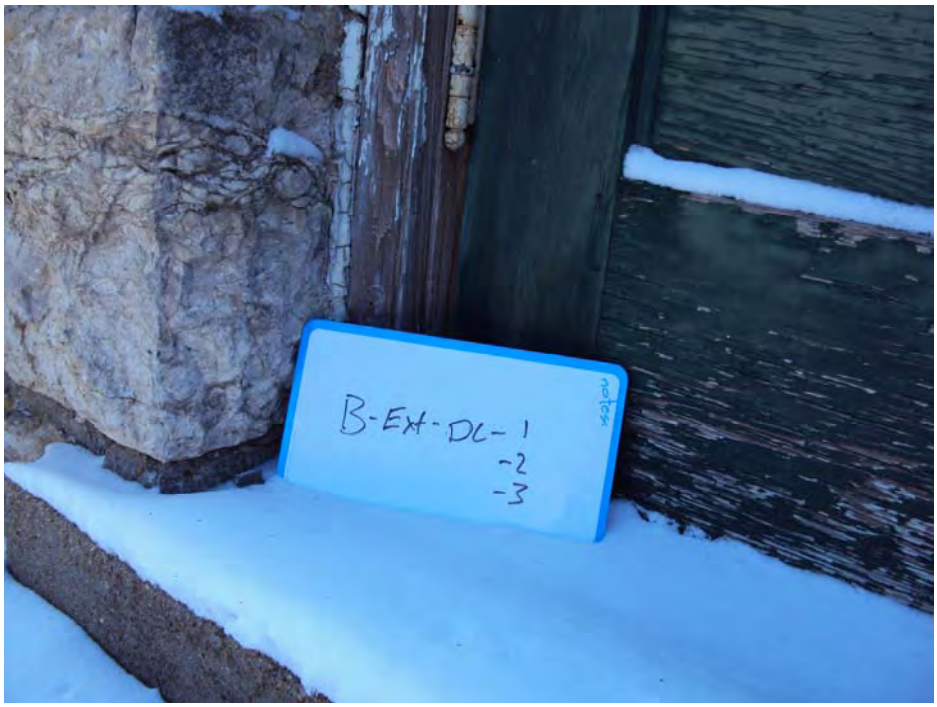
Exterior door caulking represented by sample numbers B-EXT-DC-1, 2 and 3 located on the exterior doors of Building B.

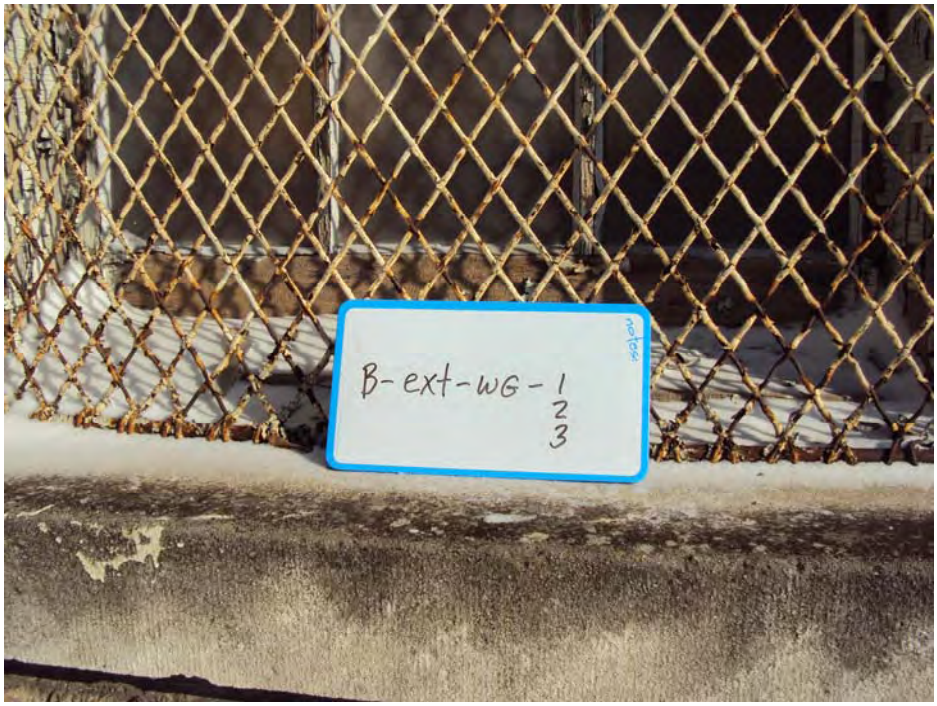
Exterior window glazing represented by sample numbers B-EXT-WG-1, 2 and 3 located on the exterior windows of Building B.

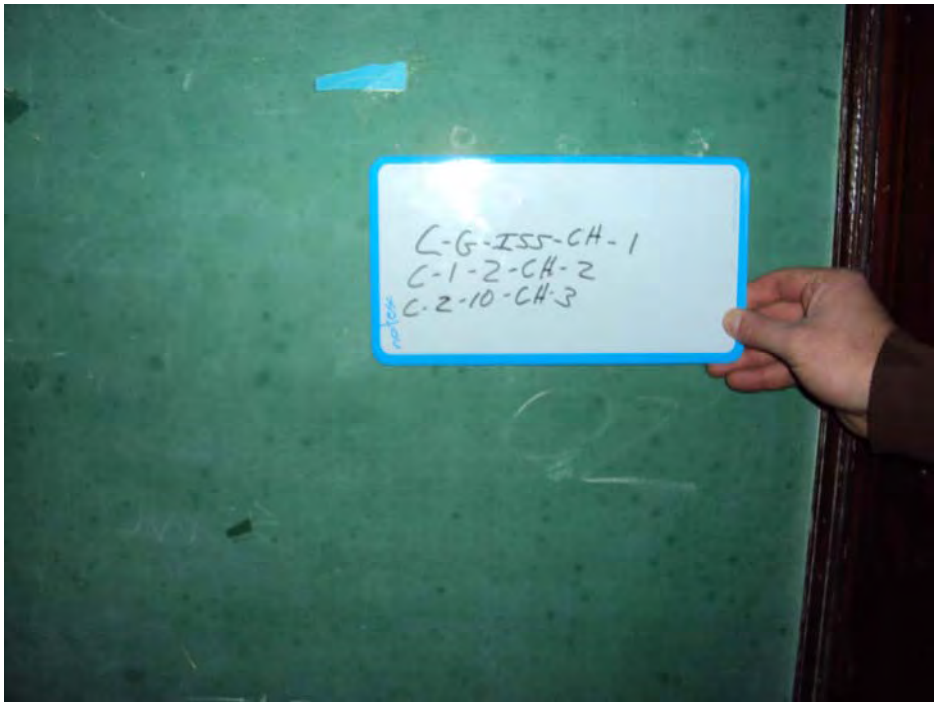
Chalkboard represented by sample numbers C-G-ISS-CH-1, C-1-2-CH-2 and C-2-10-CH-3 located on the ground, 1st and 2nd floor of Building C.

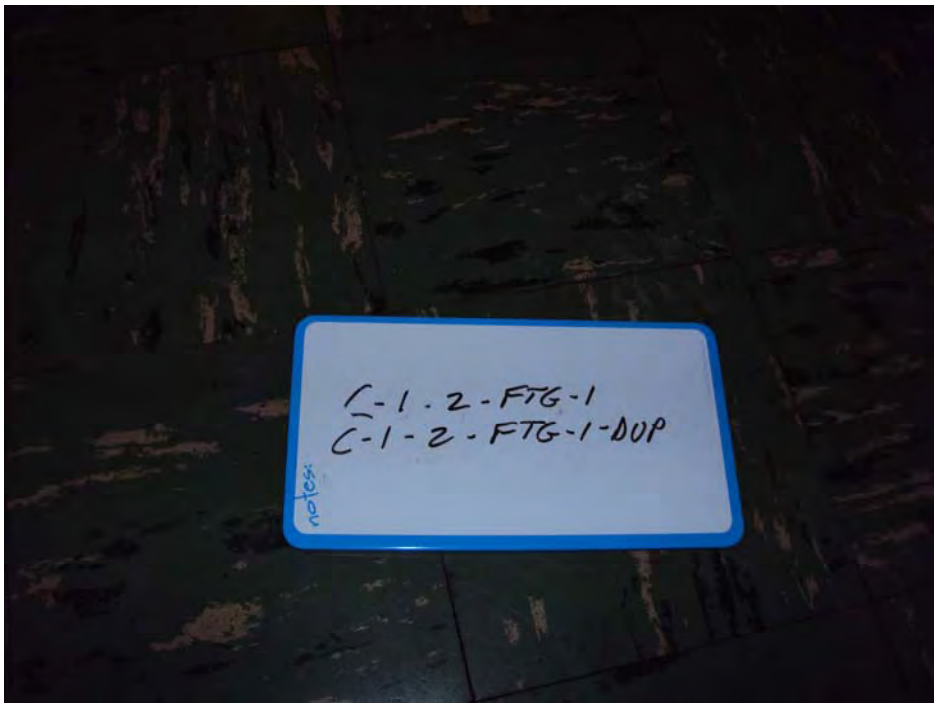
12x12 green floor tile and associated mastic represented by sample numbers C-1-2-FTG-1 and C-1-2-FTG-1-DUP located in room 2 of Building C.

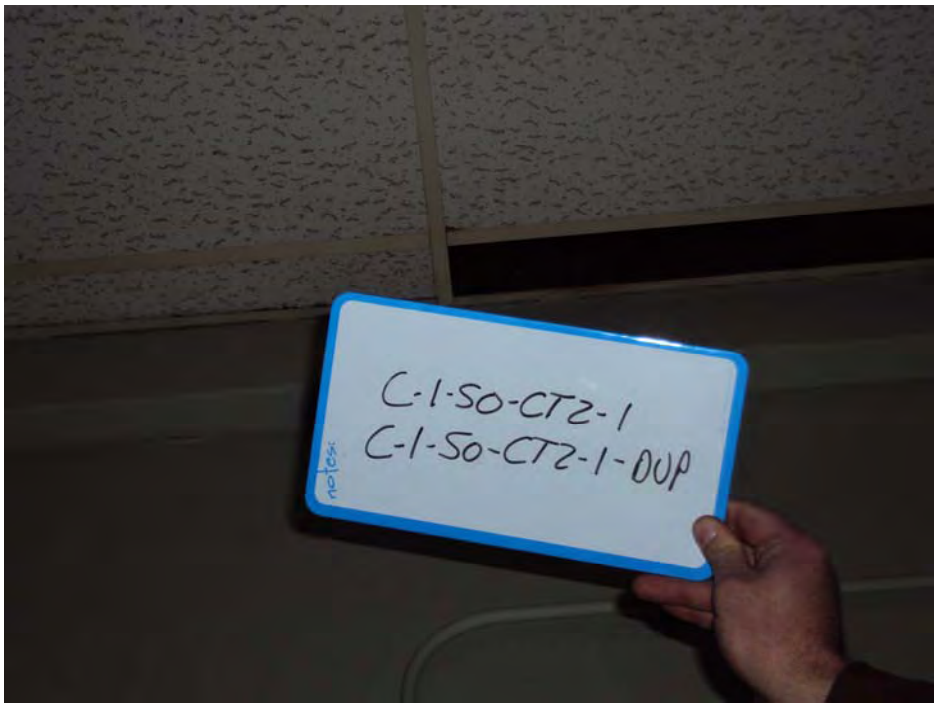
2x4 ceiling tile represented by sample numbers C-1-SO-CT2-1 and C-1-SO-CT2-1-DUP located on the 1st floor of Building C.

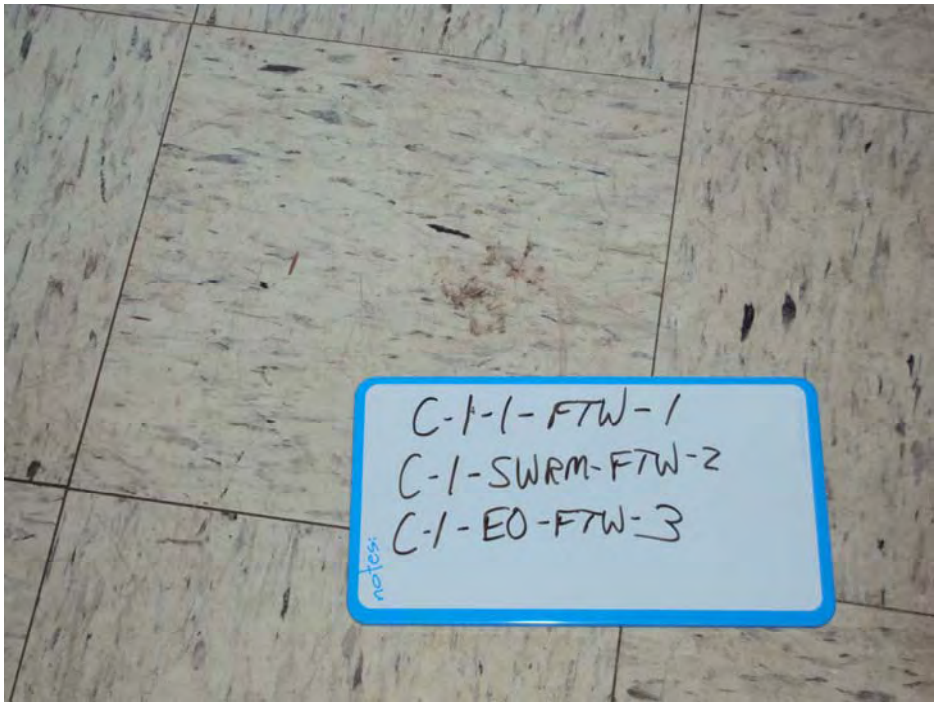
12x12 white floor tile and associated mastic represented by sample numbers C-1-1-FTW-1, C-1-SWRM-FTW-2 and C-1-EO-FTW-3 located on the first floor of Building C.

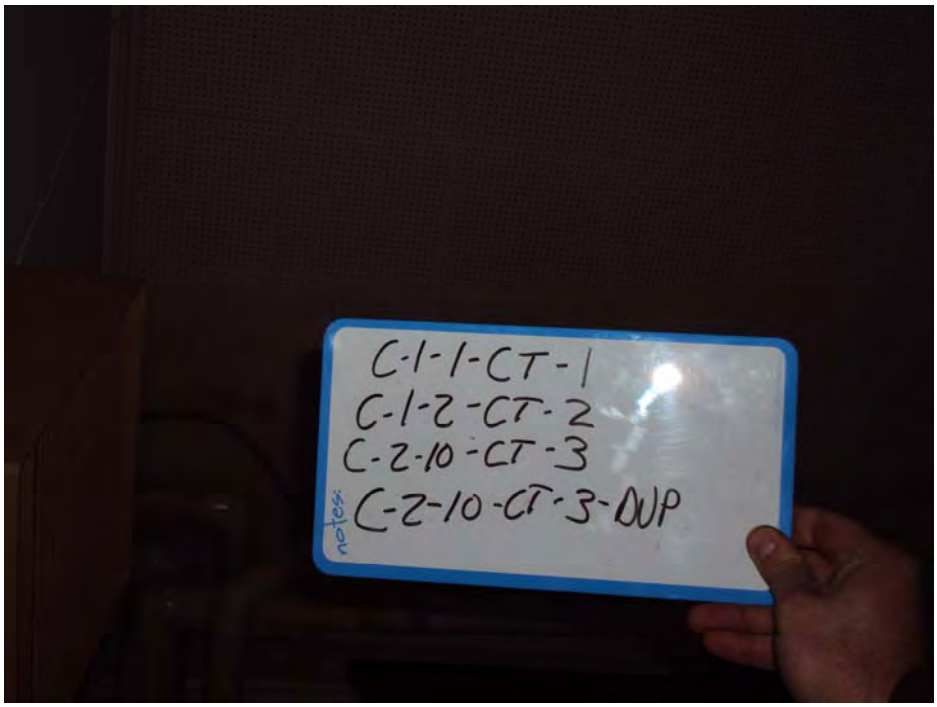
Ceiling tile represented by sample numbers C-1-1-CT-1, C-1-2-CT-2, C-2-10-CT-3 and C-2-10-CT-3-DUP located on the 1st and 2nd floor of Building C.

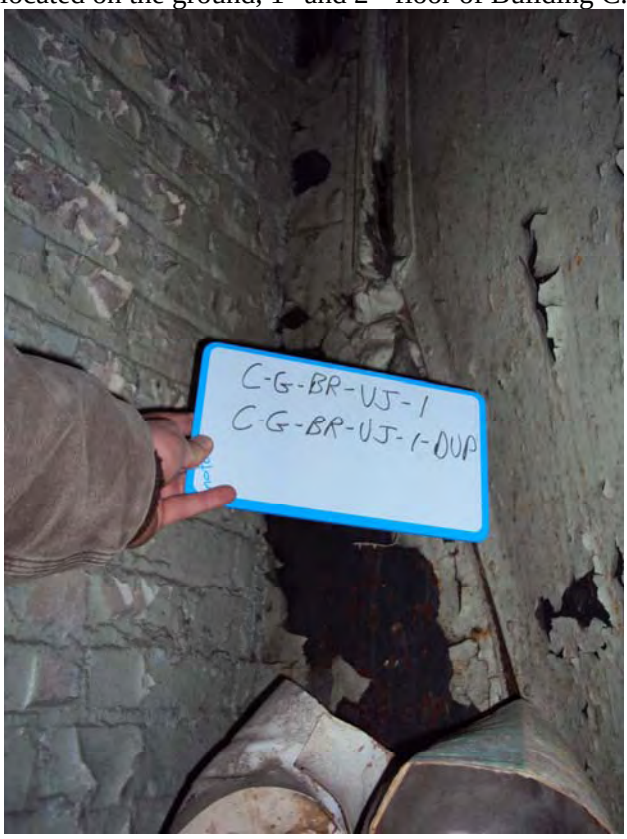
Vibration joint represented by sample numbers C-G-BR-VJ-1 and C-G-BR-VJ-1-DUP located in the boiler room of Building C.

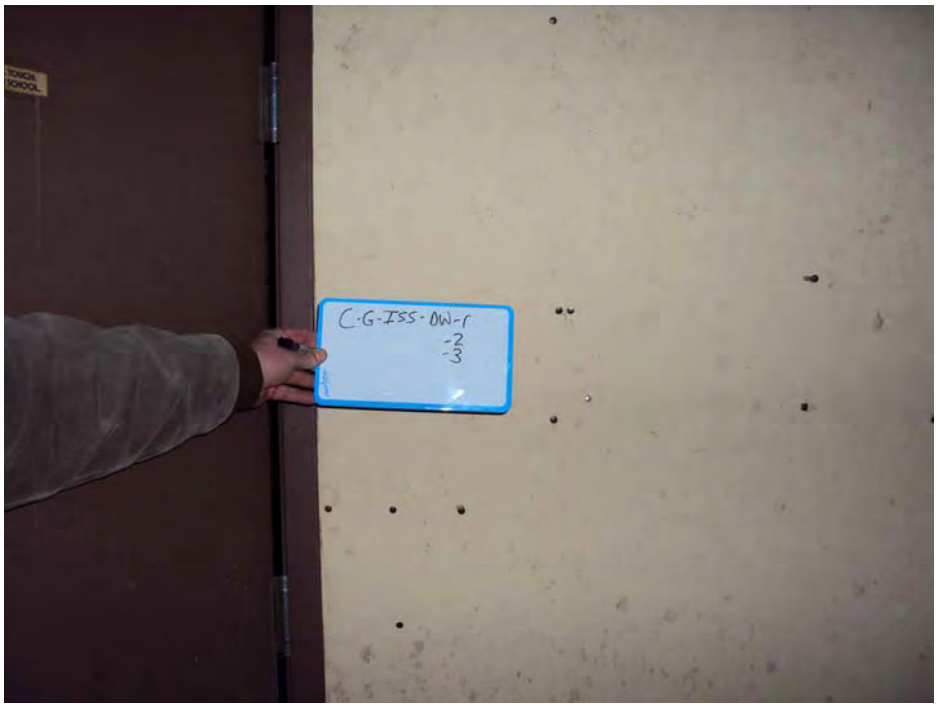
Drywall represented by sample numbers C-G-ISS-DW-1, 2 and 3 located in the ISS room of Building C.

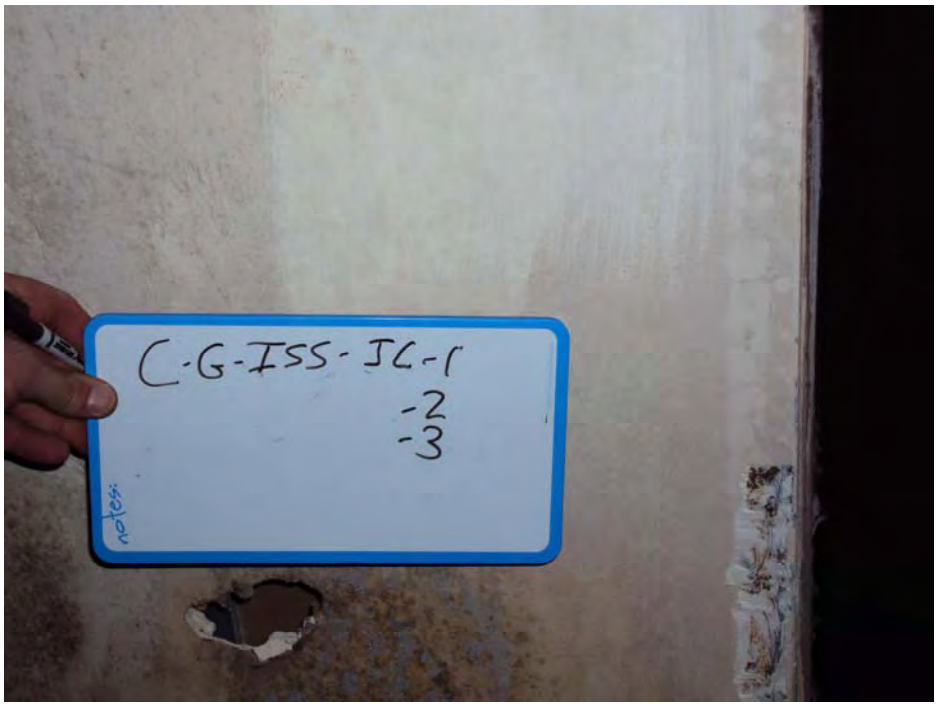
Joint compound represented by sample numbers C-G-ISS-DW-1, 2 and 3 located in the ISS room of Building C.

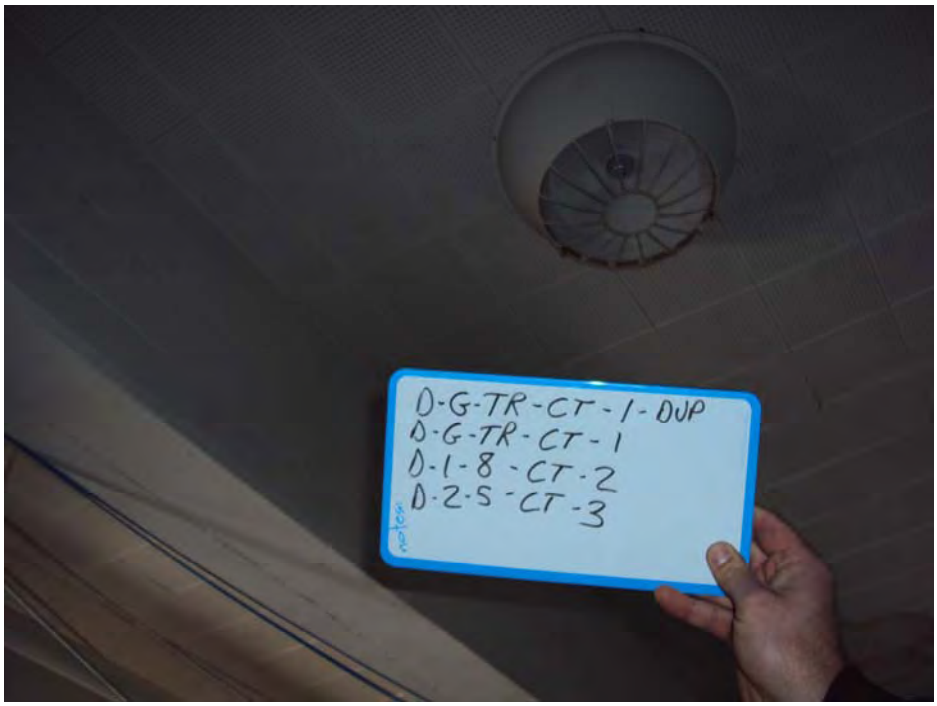
Ceiling tile represented by sample numbers D-G-TR-CT-1, D-G-TR-CT-1-DUP, D-1-8-CT-2 and D-2-5-CT-3 located on the ground, 1st and 2nd floor of Building D.

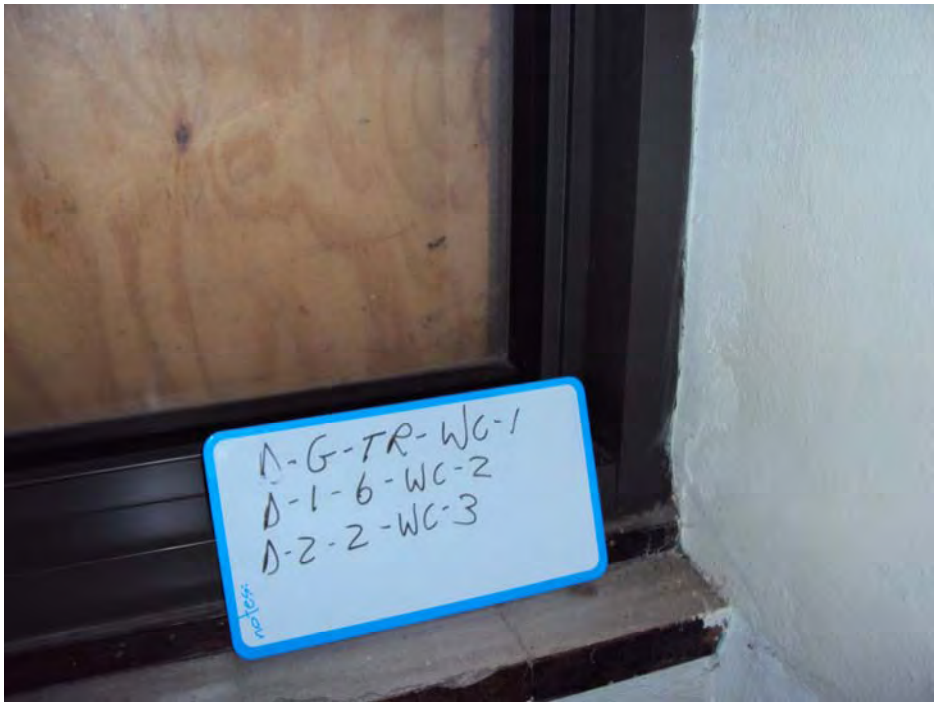
Window caulking represented by sample numbers D-G-TR-WC-1, D-1-6-WC-2 and D-2-2-WC-3 located on the ground, 1st and 2nd floor of Building D.

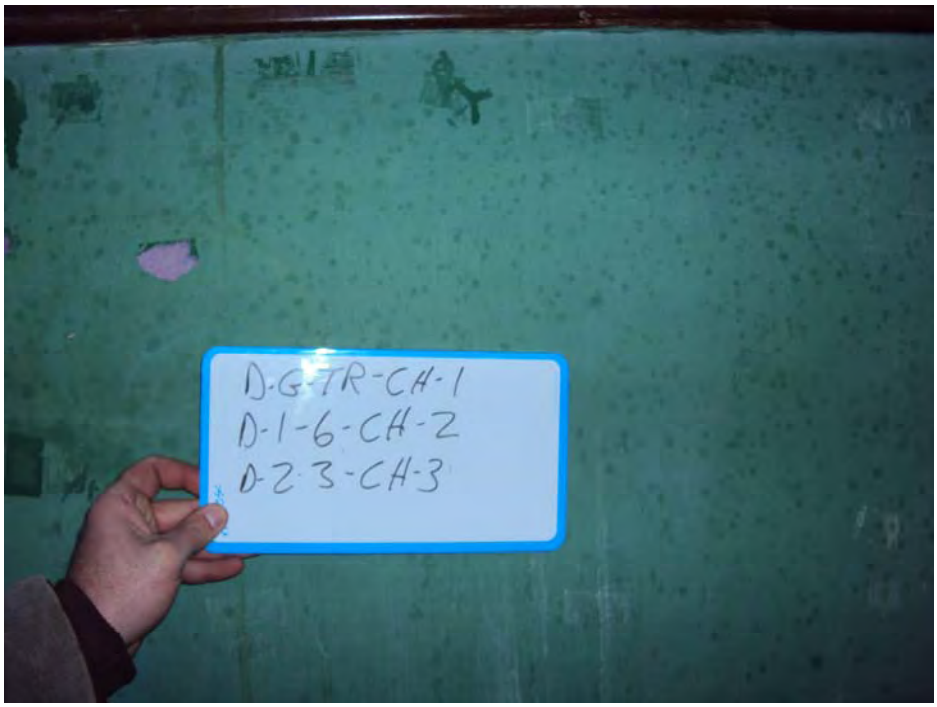
Chalkboard represented by sample numbers D-G-TR-CH-1, D-1-6-CH-2 and D-2-3-CH-3 located on the ground, 1st and 2nd floor of Building D.

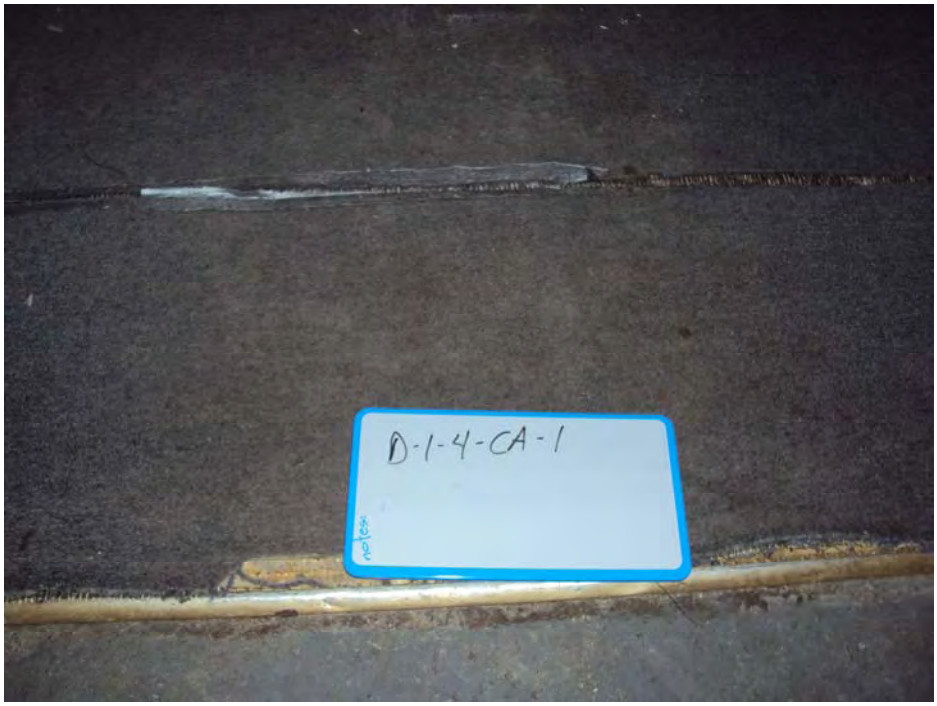
Carpet adhesive represented by sample number D-1-4-CA-1 located in room 4 of Building D.

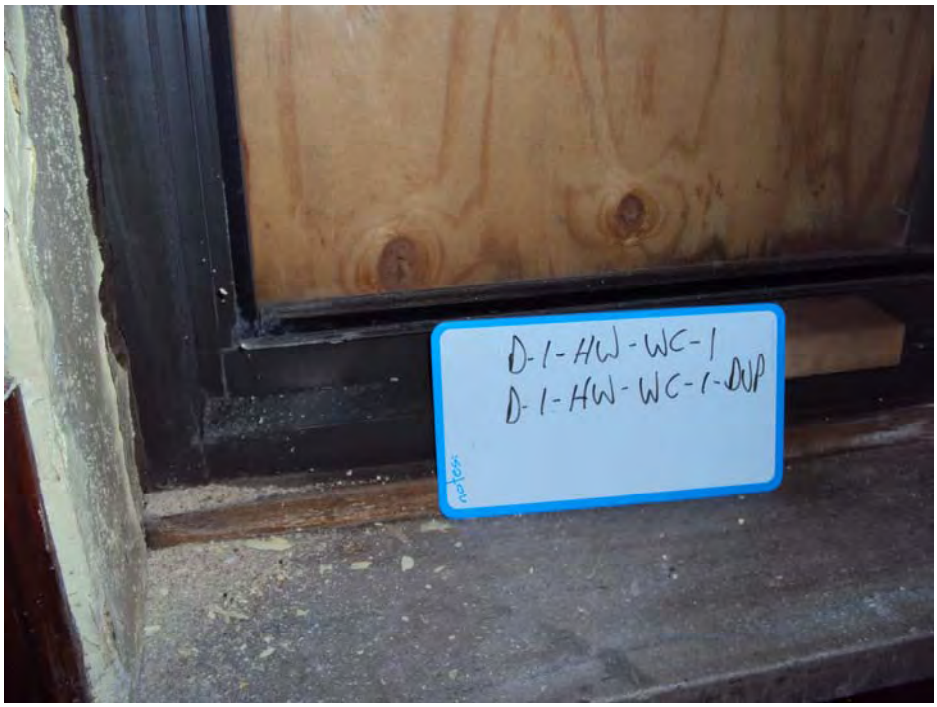
Window caulking represented by sample numbers D-1-HW-WC-1 and D-1-HW-WC-1-DUP located on the 1st floor of Building D.

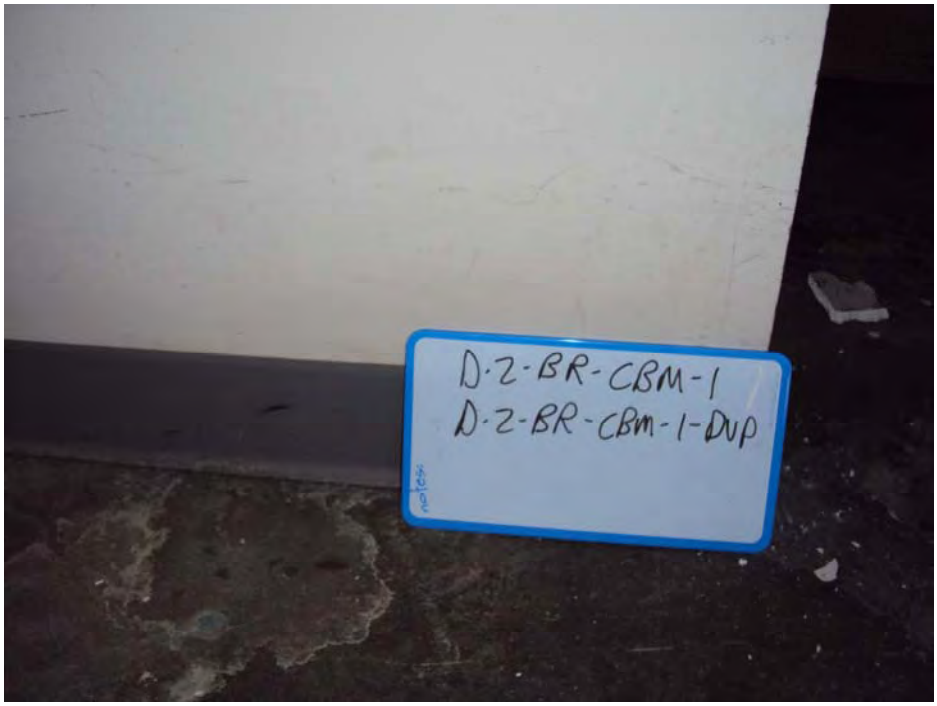
Cove base mastic represented by sample numbers D-2-BR-CBM-1 and D-2-BR-CBM-1-DUP located in the bathroom on the 2nd floor of Building D.

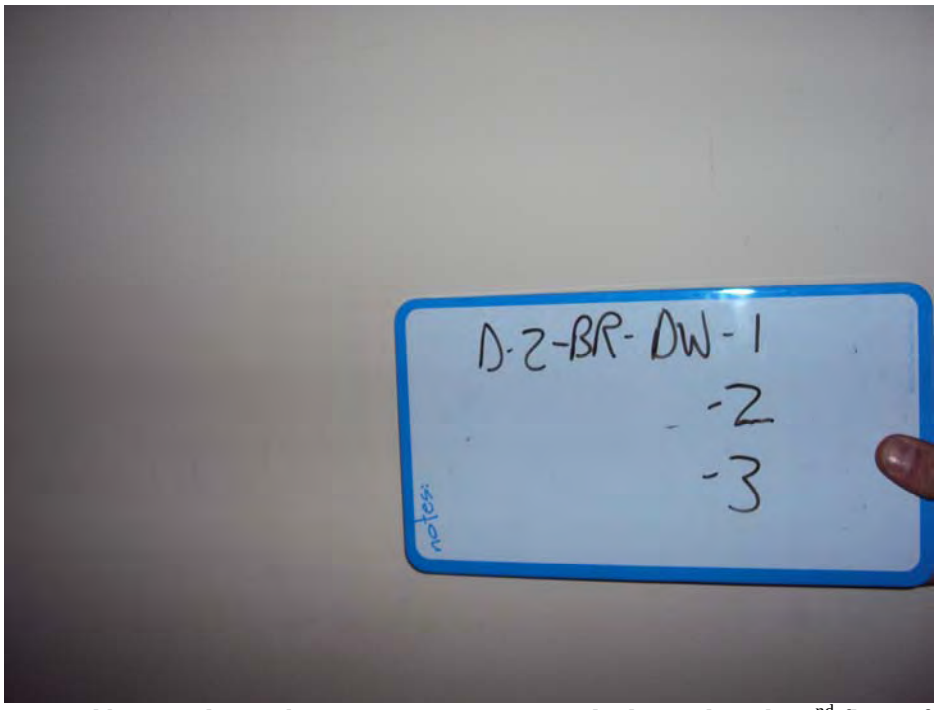
Drywall represented by sample numbers D-2-BR-DW-1, 2 and 3 located on the 2nd floor of Building D.

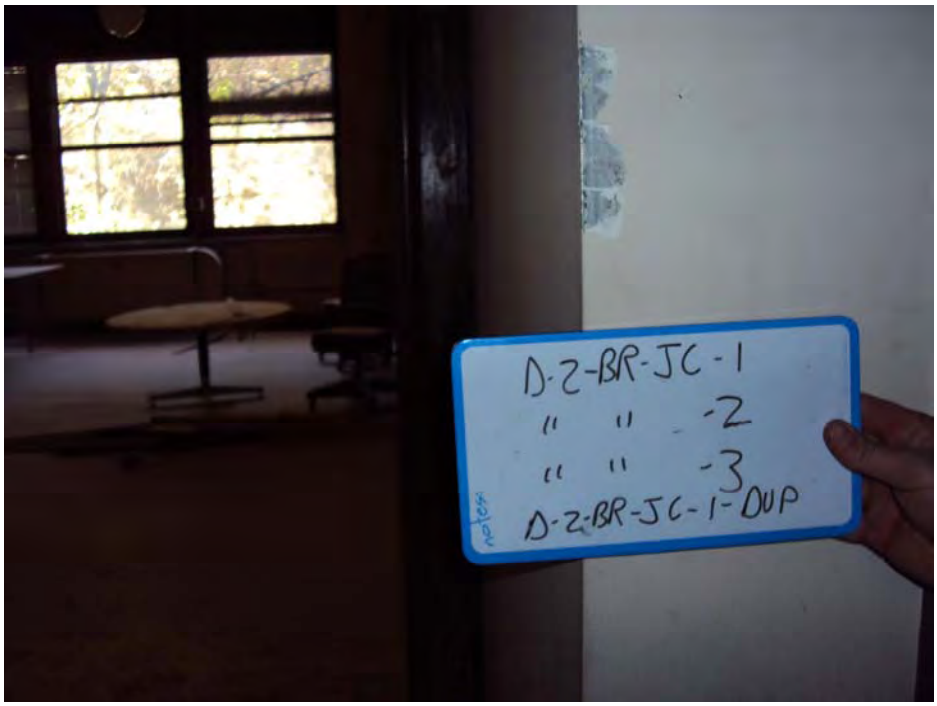
Joint compound represented by sample numbers D-2-BR-JC-1, 2, 3 and 1-DUP located on the 2nd floor of Building D.

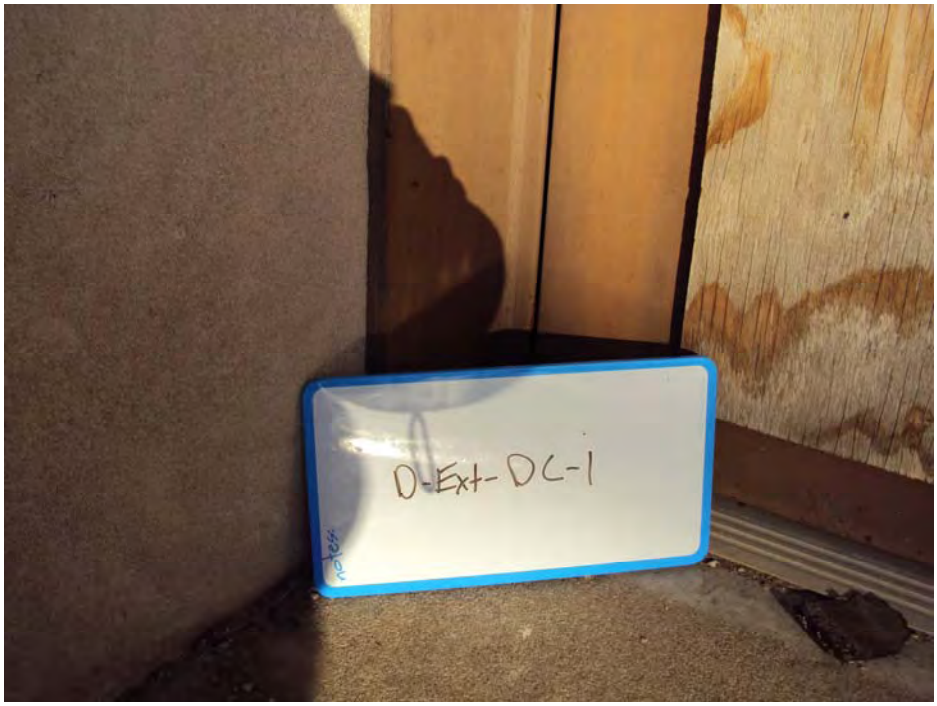
Exterior door caulking represented by sample number D-EXT-DC-1 located on the exterior doors of Building D.

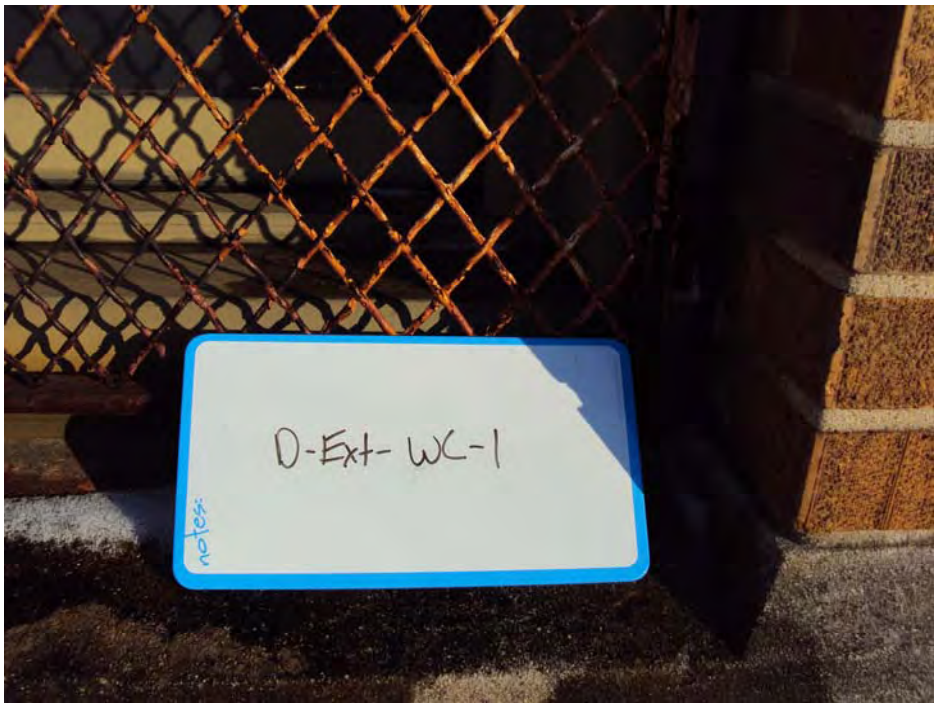
Exterior window caulking represented by sample number D-EXT-WC-1 located on the exterior windows of Building D.

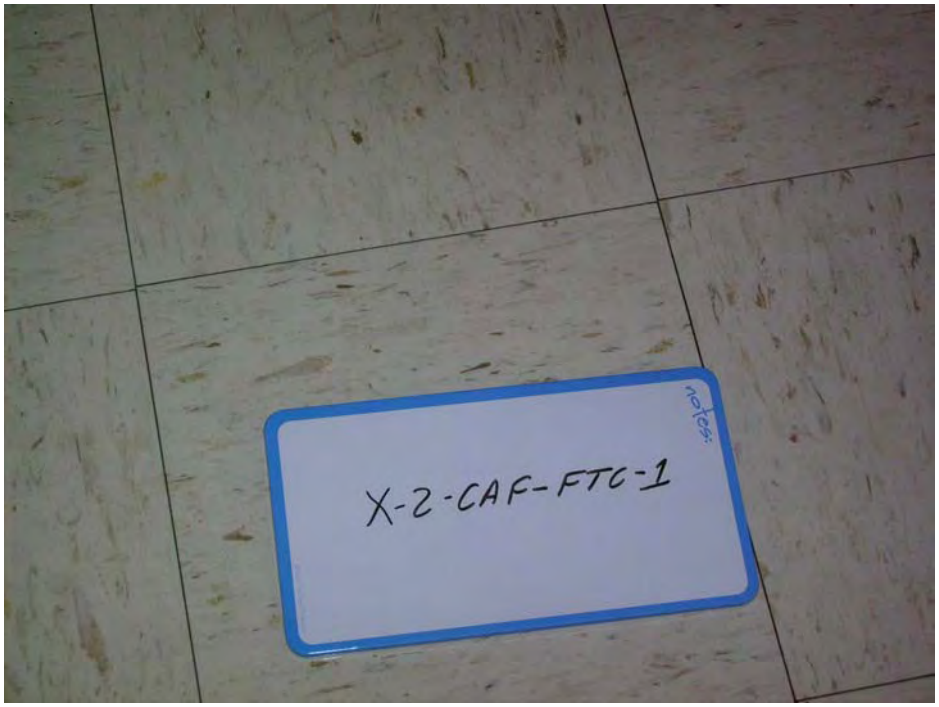
12x12 cream floor tile and associated mastic represented by sample number X-2-CAF-FTC-1 located in the cafeteria of the Annex Building.

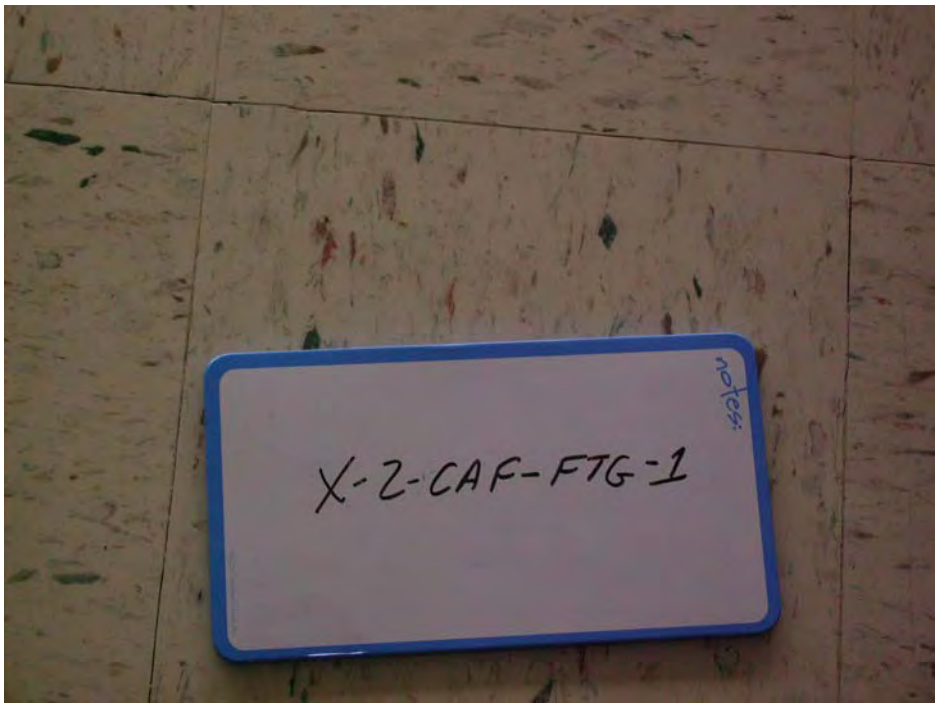
12x12 gray floor tile and associated mastic represented by sample number X-2-CAF-FTG-1 located in the cafeteria of the Annex Building.
