Subject: **Phase I Targeted Brownfields Assessment, Hazardous Materials Survey, Revision 01**
Recovery-West High Complex, 1810 and 1829 Madison Avenue, Kansas City, Missouri
U.S. EPA Region 7, START 3, Contract No. EP-S7-06-01, Task Order No. 0163
Task Monitor, Ron King, EPA Site Assessment Team Leader

PHASE I TARGETED BROWNFIELDS ASSESSMENT
HAZARDOUS MATERIALS SURVEY
REVISION 01

RECOVERY-WEST HIGH COMPLEX
1810 AND 1829 MADISON AVENUE, KANSAS CITY, MISSOURI

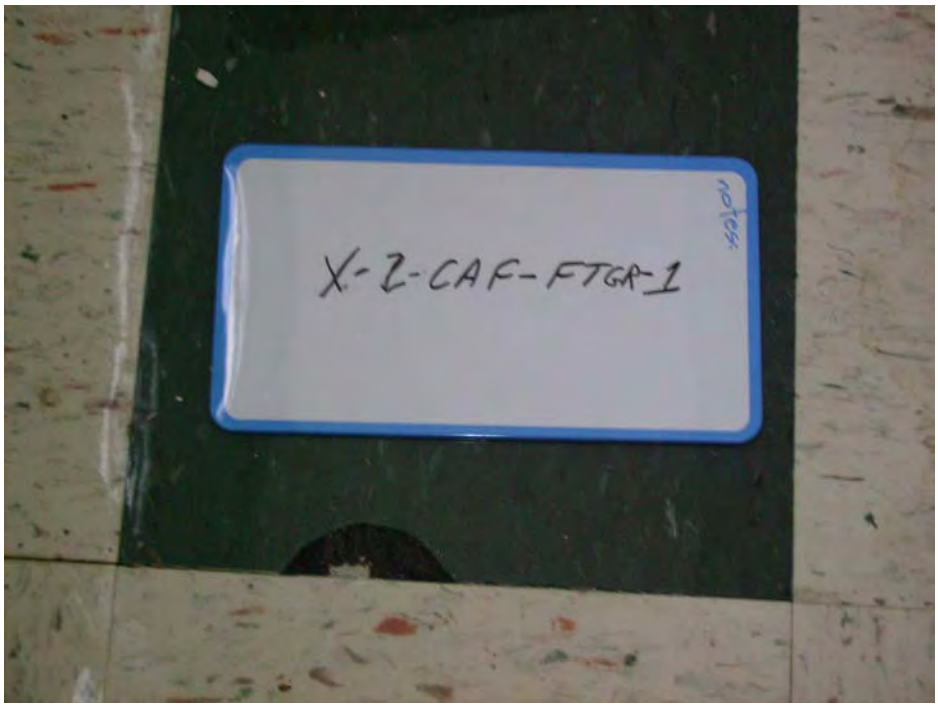
12x12 green floor tile and associated mastic represented by sample number X-2-CAF-FTGR-1 located in the cafeteria of the Annex Building.

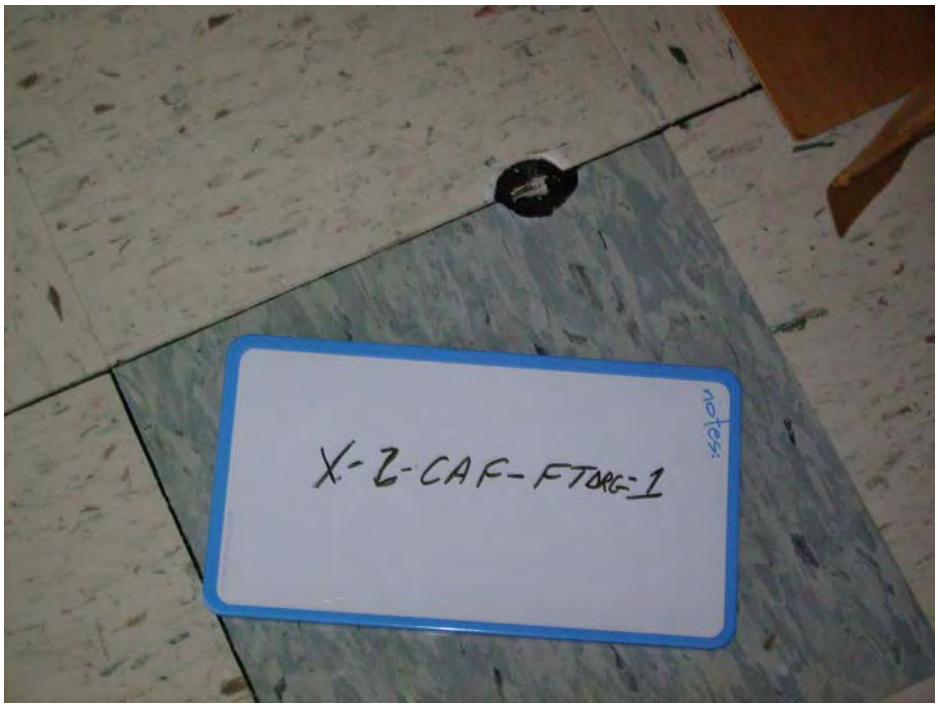
12x12 dark gray floor tile and associated mastic represented by sample number X-2-CAF-FTDRG-1 located in the cafeteria of the Annex Building.

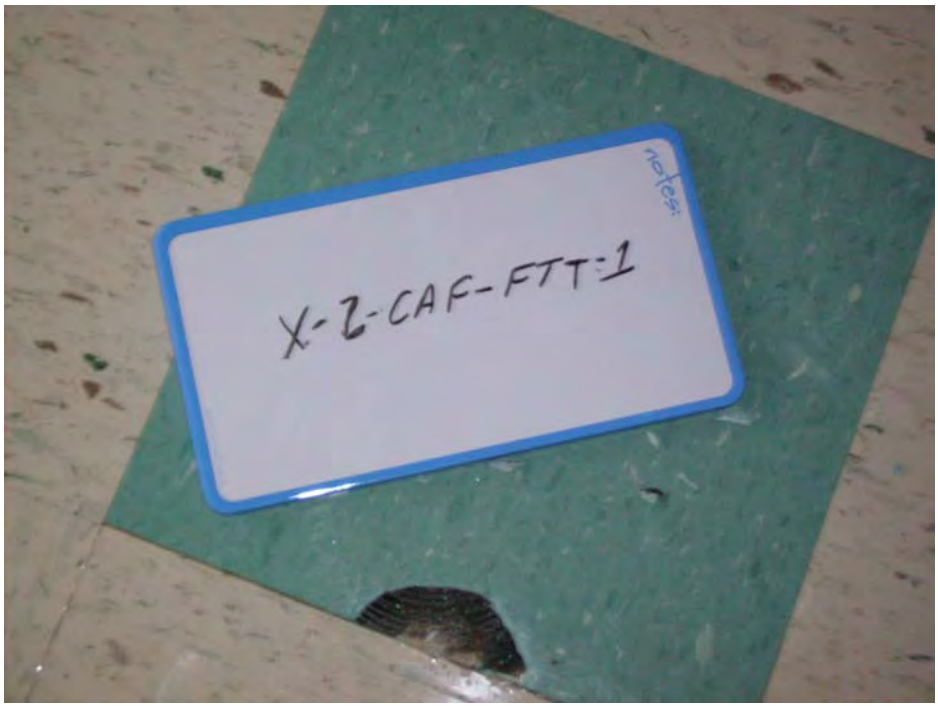
12x12 teal floor tile and associated mastic represented by sample number X-2-CAF-FTT-1 located in the cafeteria of the Annex Building.

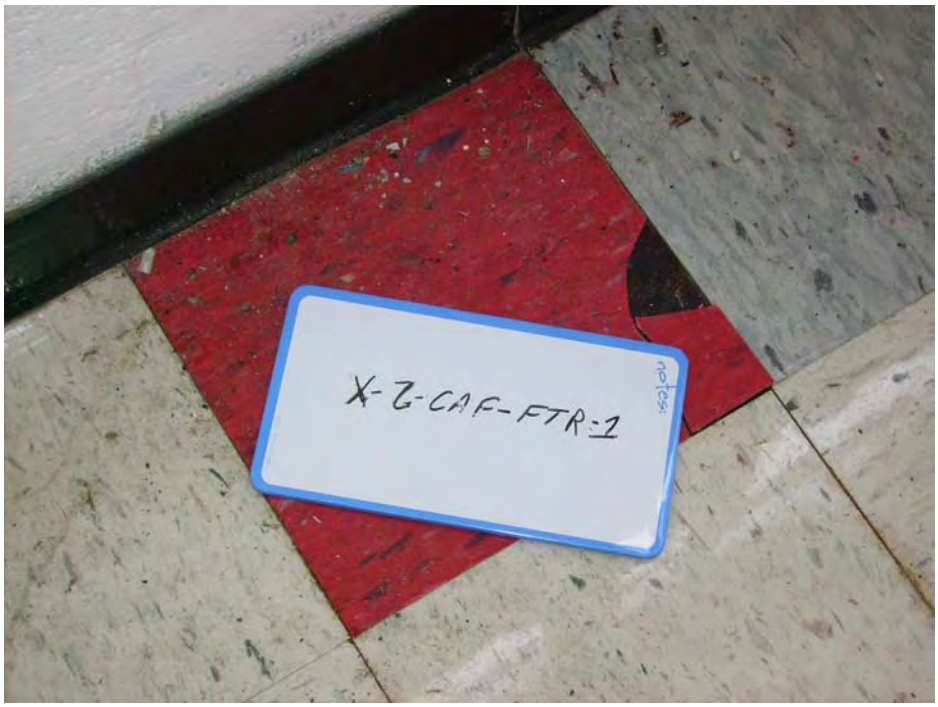
12x12 red floor tile and associated mastic represented by sample number X-2-CAF-FTR-1 located in the cafeteria of the Annex Building.

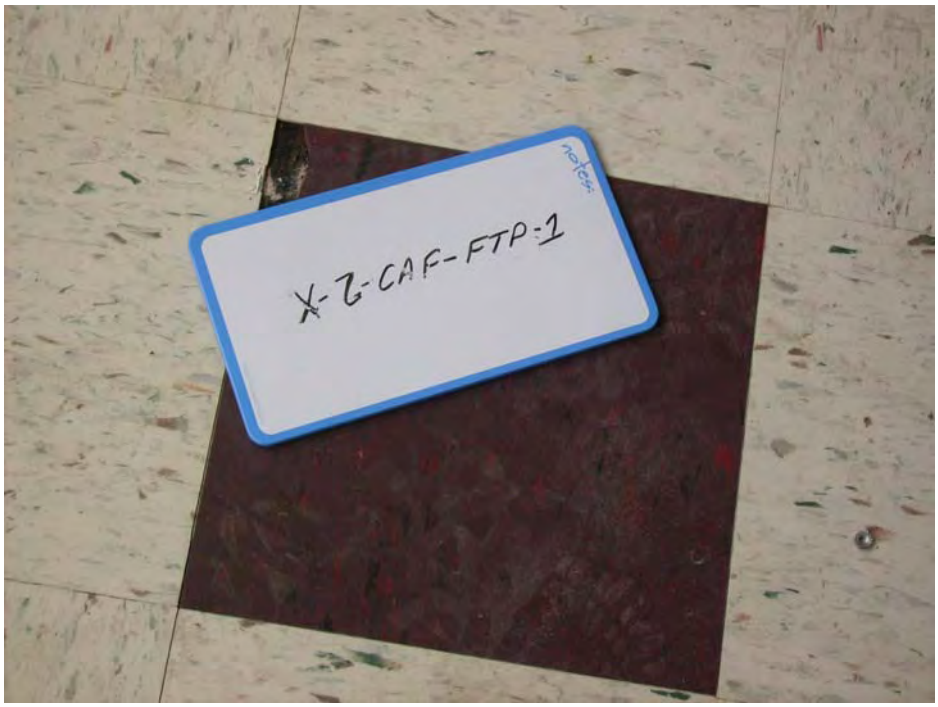
12x12 purple floor tile and associated mastic represented by sample number X-2-CAF-FTP-1 located in the cafeteria of the Annex Building.

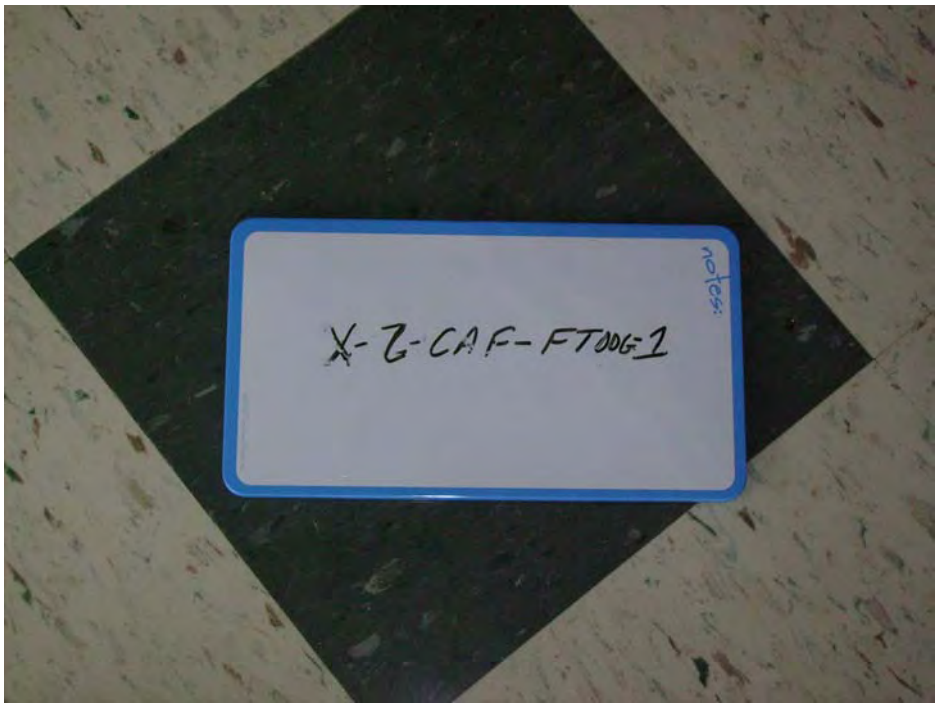
12x12 dark gray floor tile and associated mastic represented by sample number X-2-CAF-FTDDG-1 located in the cafeteria of the Annex Building.

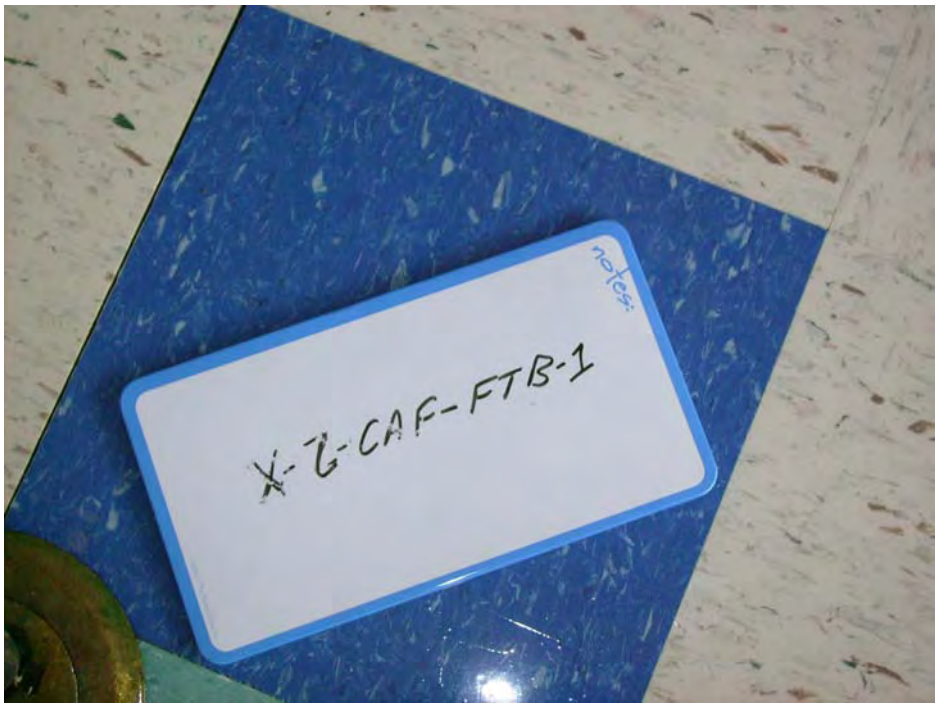
12x12 blue floor tile and associated mastic represented by sample number X-2-CAF-FTB-1 located in the cafeteria of the Annex Building.

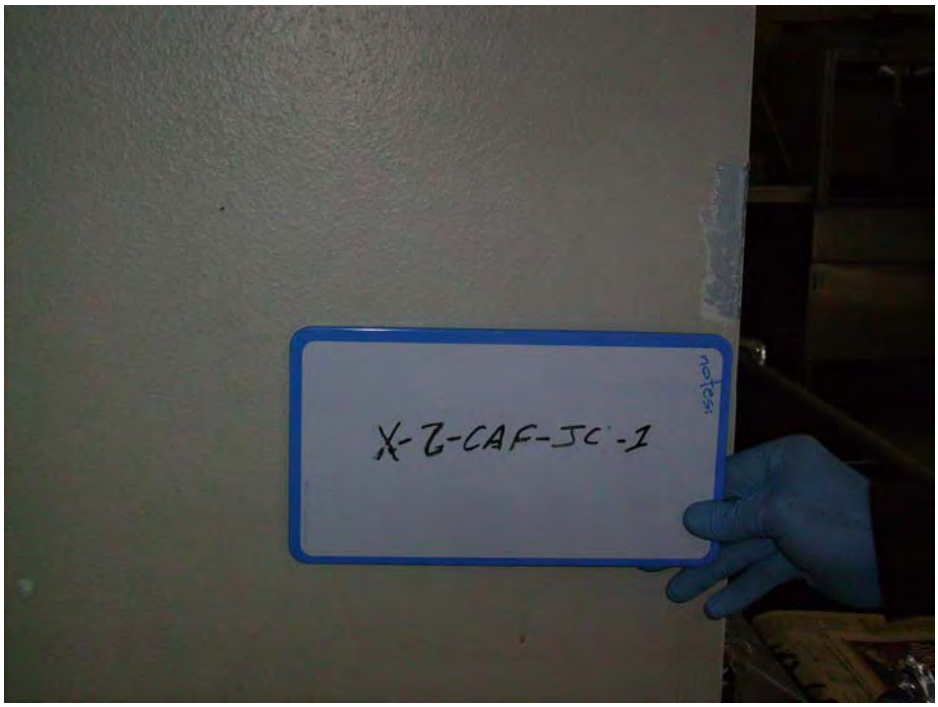
Joint compound represented by sample number X-2-CAF-JC-1 located in the cafeteria of the Annex Building.

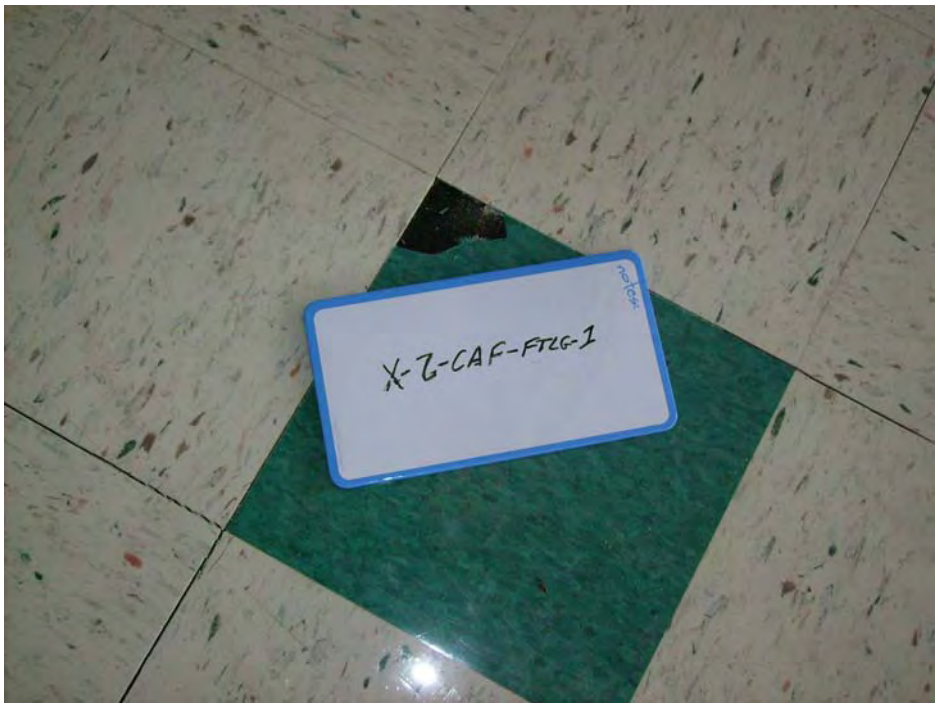
12x12 light green floor tile and associated mastic represented by sample number X-2-CAF-FTLG-1 located in the cafeteria of the Annex Building.

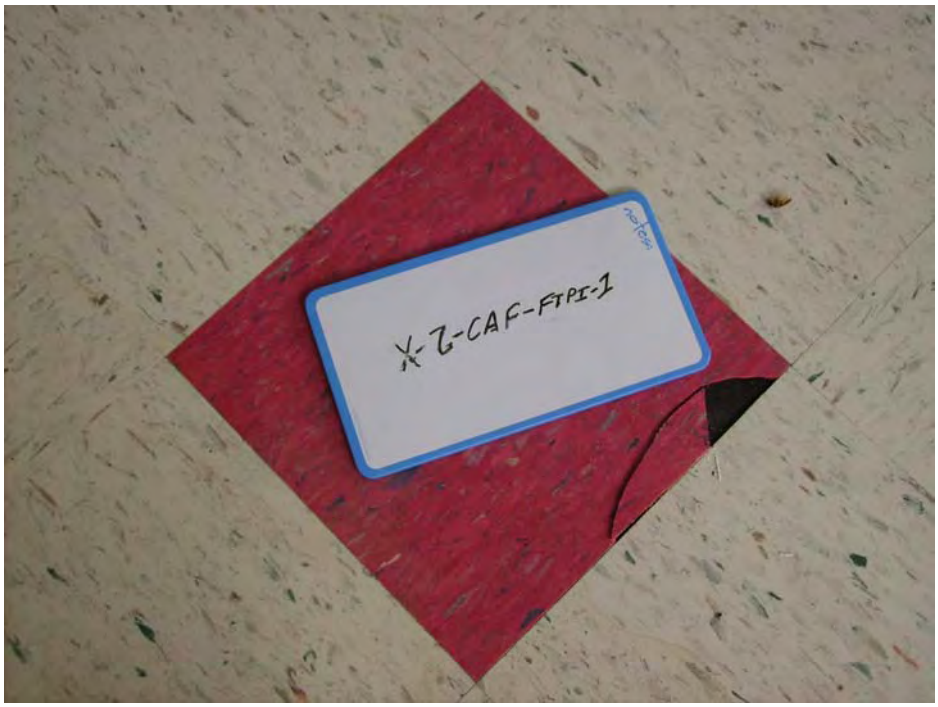
12x12 pink floor tile and associated mastic represented by sample number X-2-CAF-FTPI-1 located in the cafeteria of the Annex Building.

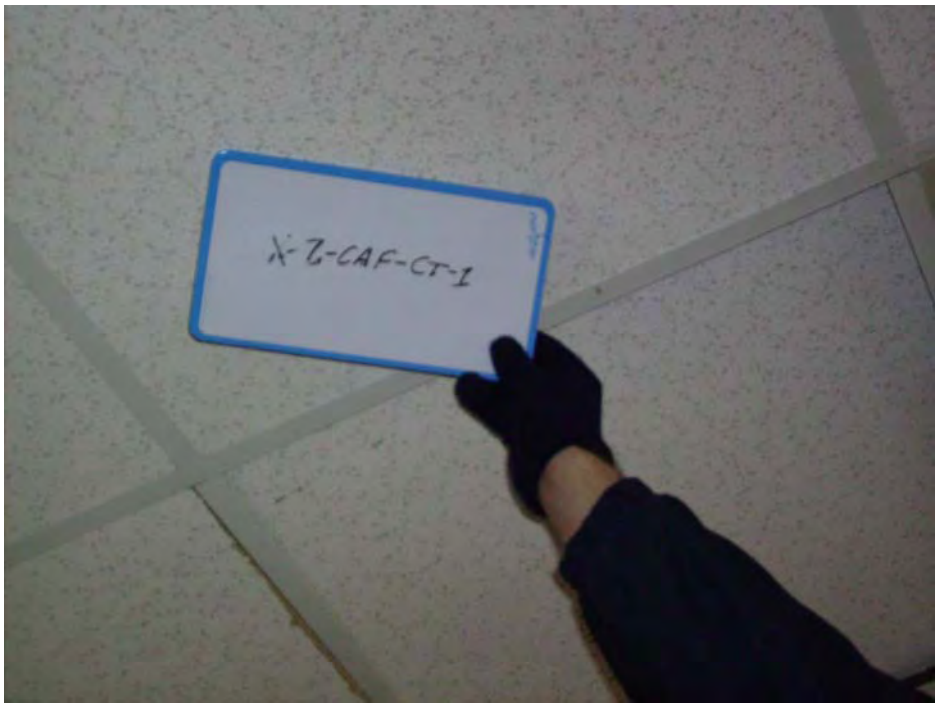
2x4 ceiling tile represented by sample number X-2-CAF-CT-1 located in the cafeteria of the Annex Building.

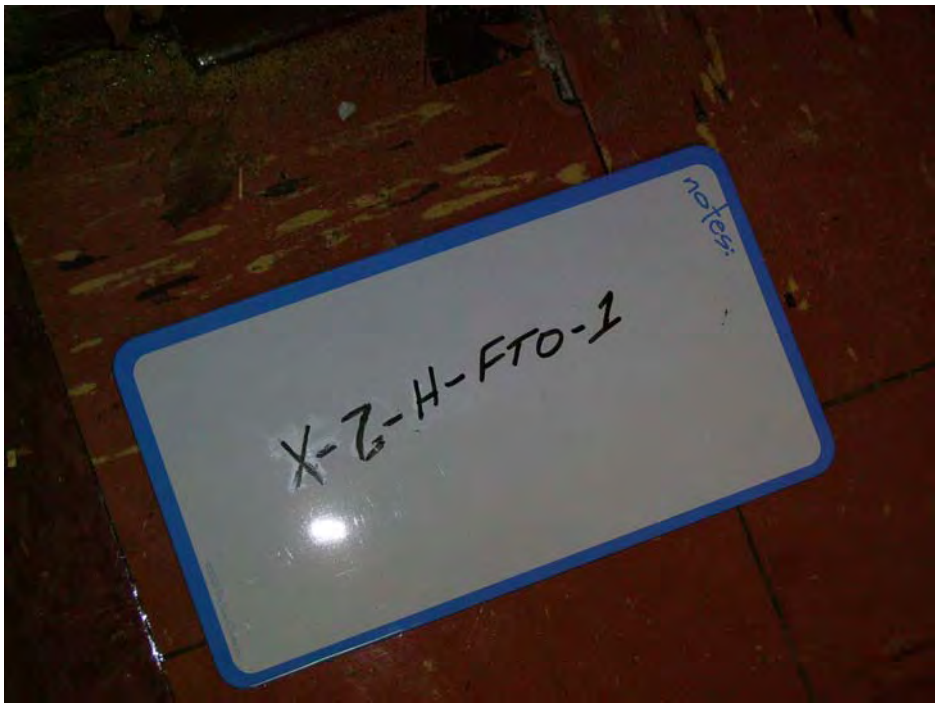
12x12 orange floor tile and associated mastic represented by sample number X-2-CAF-FTO-1 located in the cafeteria of the Annex Building.

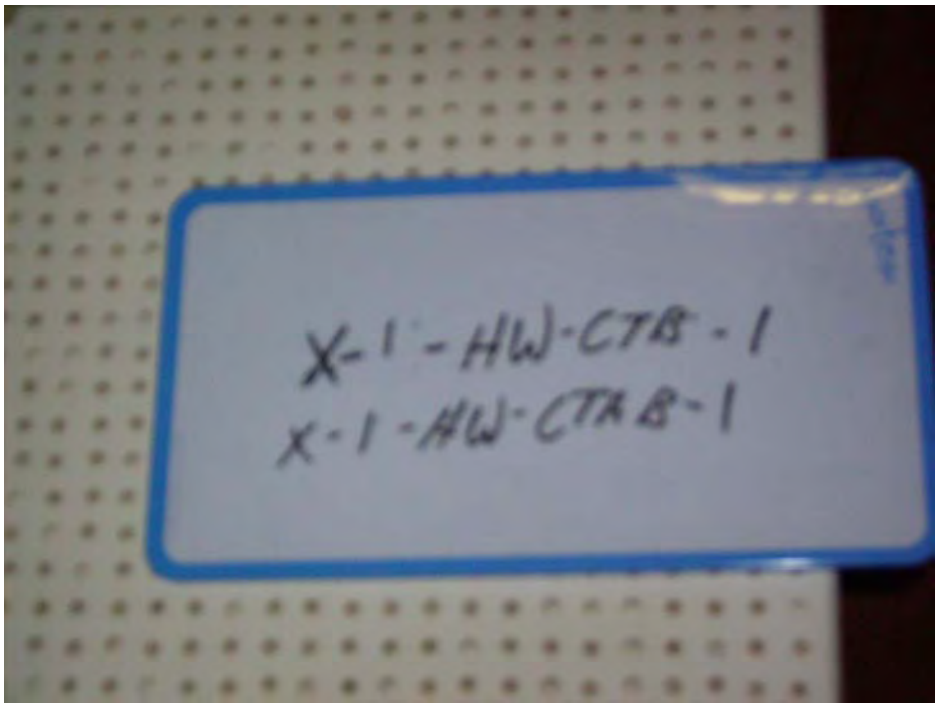
12x12 ceiling tile with large holes and associated mastic represented by sample numbers X-2-HW-CTB-1 and X-2-HW-CTAB-1 located in the hallway of the 1st floor of the Annex Building.

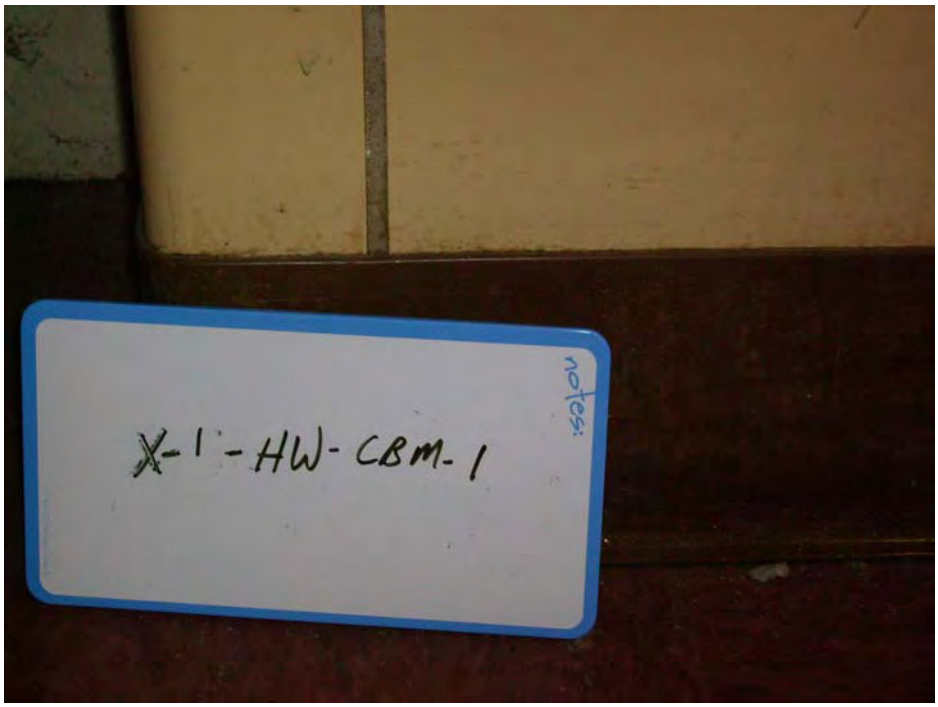
Cove base mastic represented by sample number X-1-HW-CBM-1 located in the hallway of the 1st floor of the Annex Building.

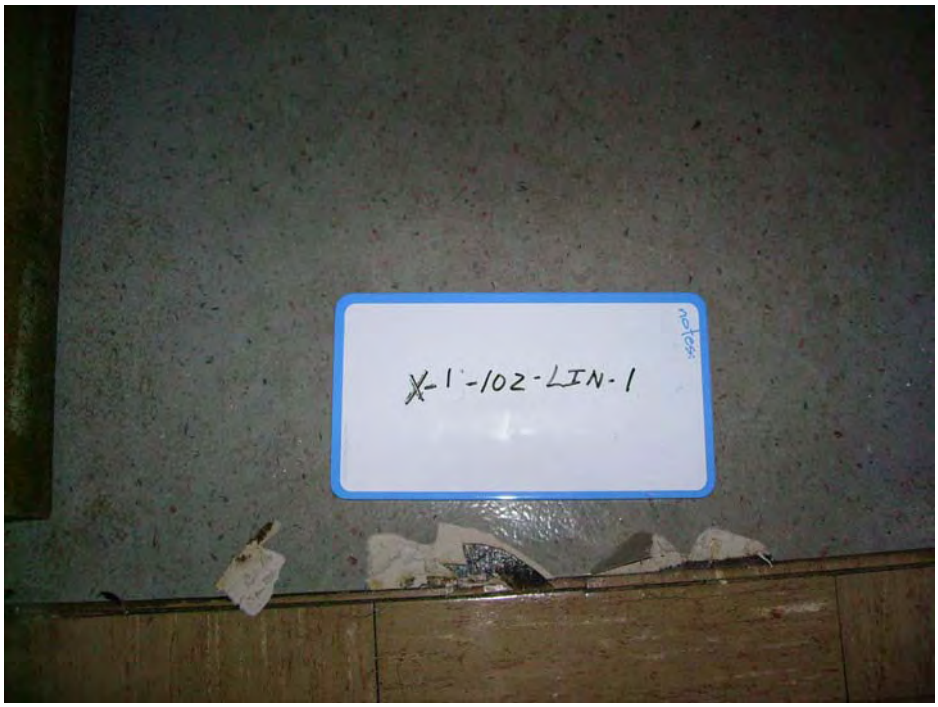
Linoleum represented by sample number X-1-102-LIN-1 located in room 102 of the Annex Building.

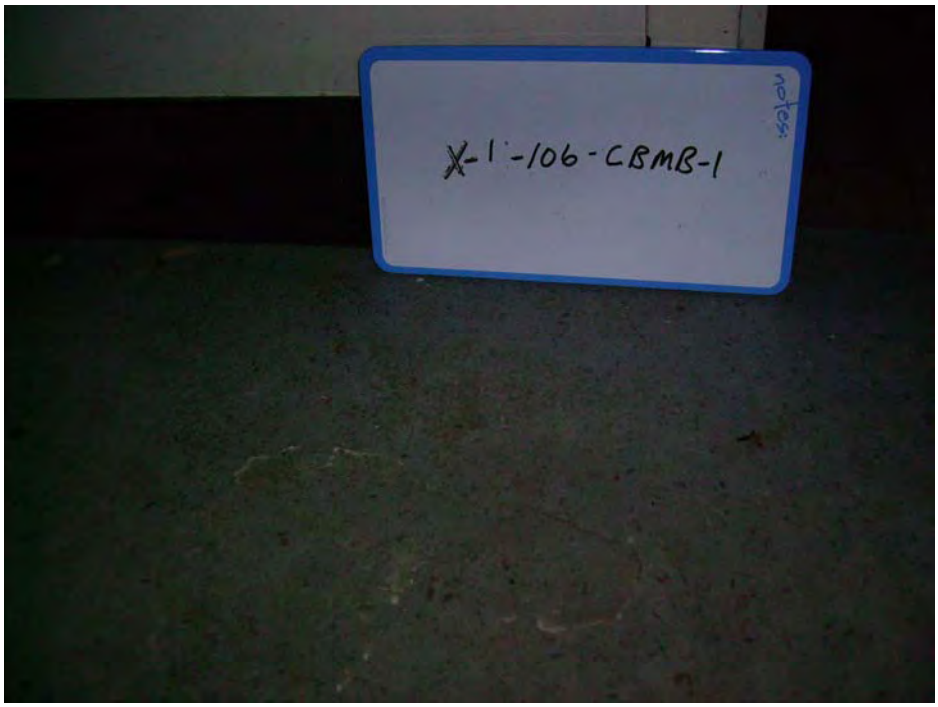
Black cove base mastic represented by sample number X-1-102-CBMB-1 located in room 106 of the Annex Building.

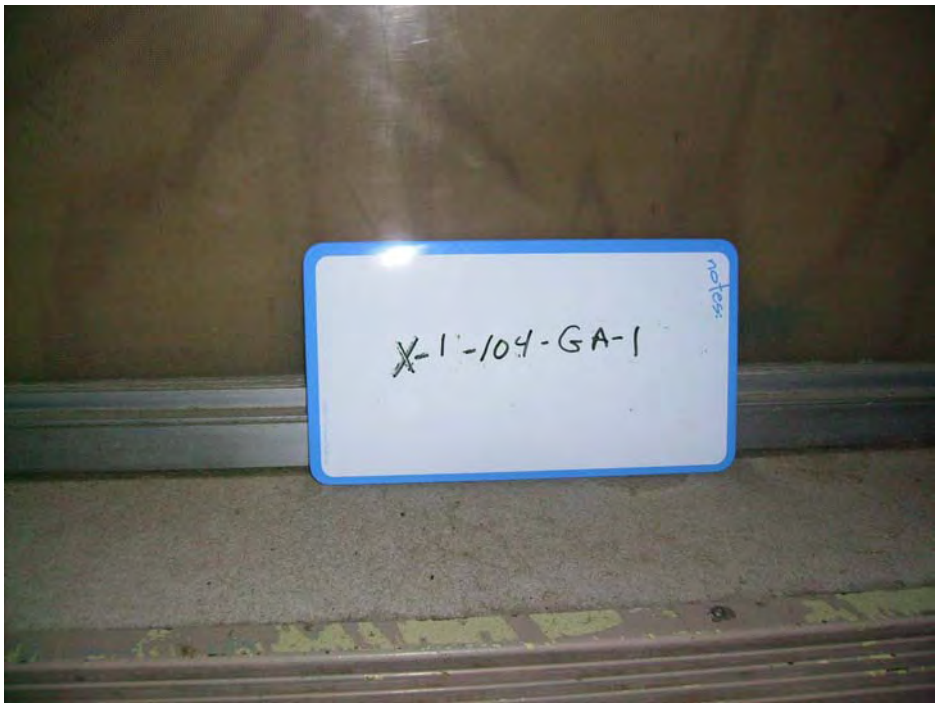
Window glazing represented by sample number X-1-104-GA-1 located in room 104 of the Annex Building.

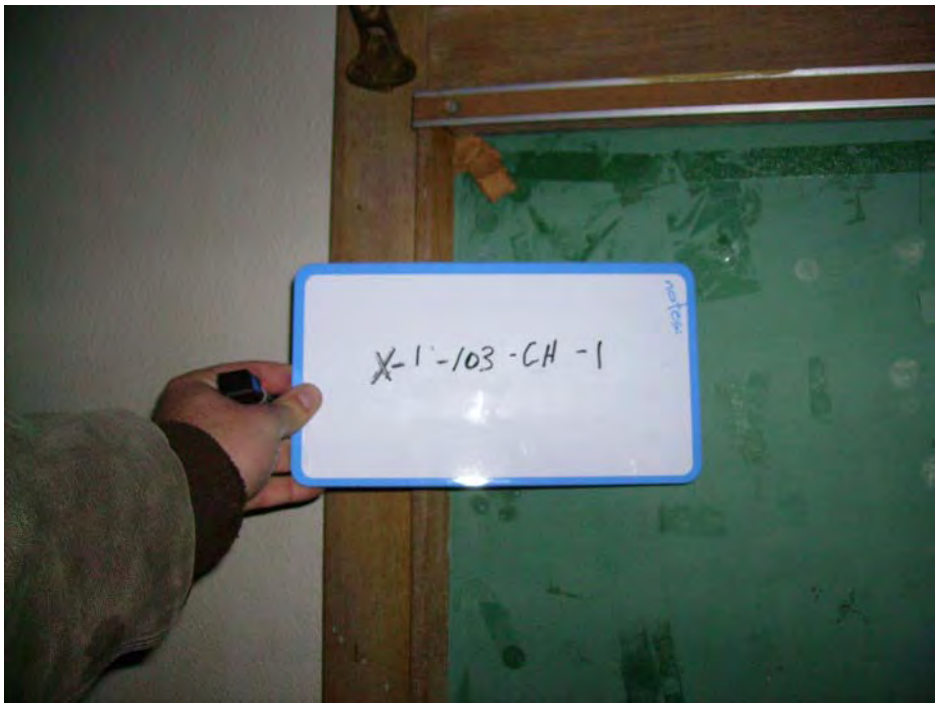
Chalkboard represented by sample number X-1-103-CH-1 located in room 103 of the Annex Building.

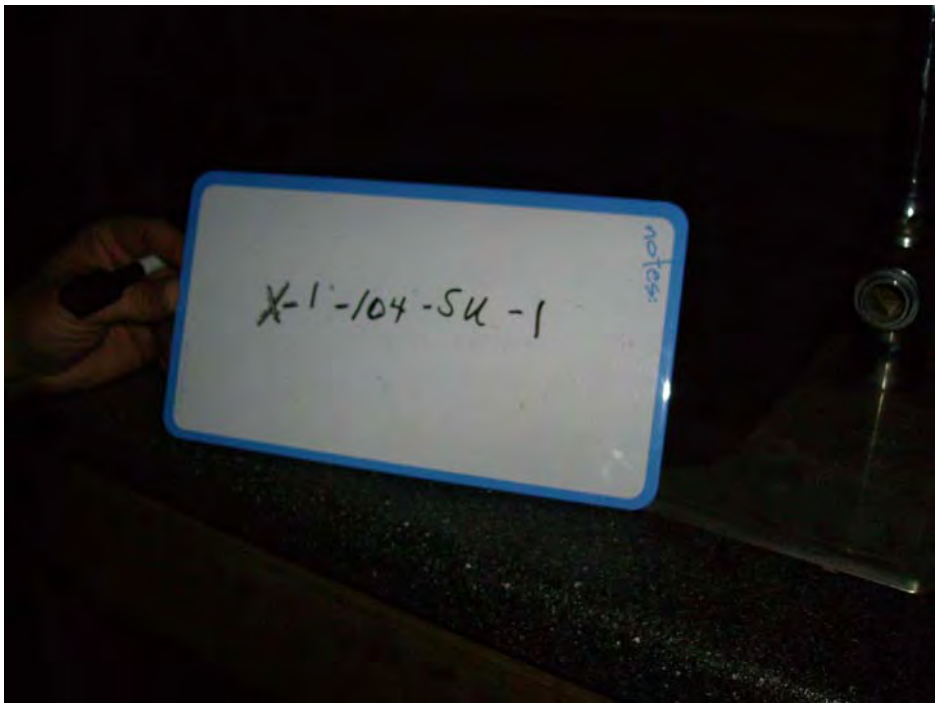
Sink underlayment represented by sample number X-1-104-SU-1 located in room 104 of the Annex Building.

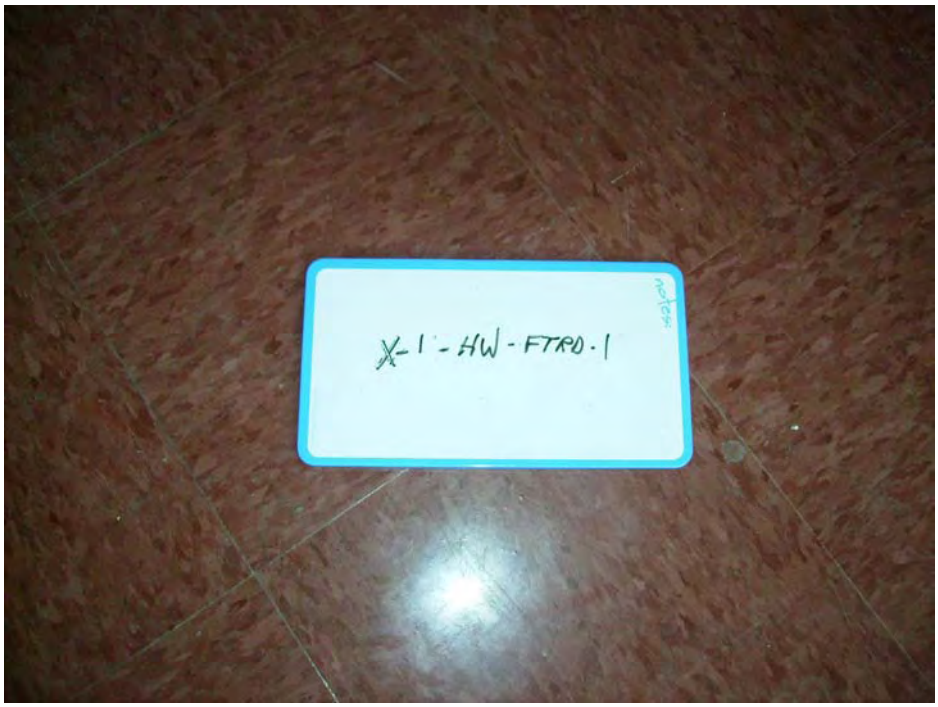
12x12 red floor tile and associated mastic represented by sample number X-1-HW-FTRD-1 located in the hallway of the first floor of the Annex Building.

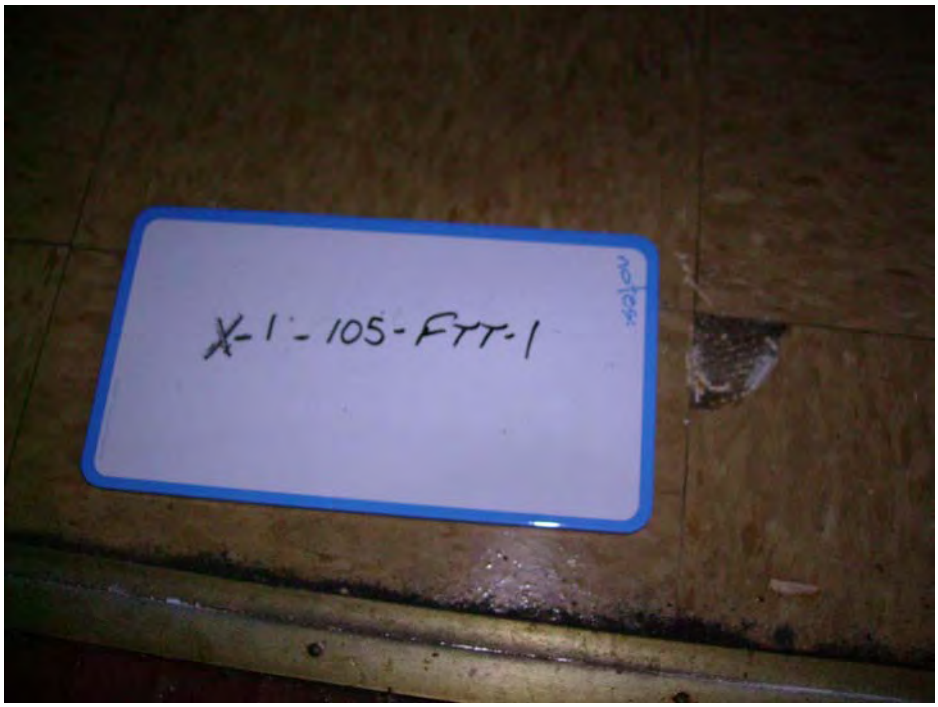
12x12 tan floor tile and associated mastic represented by sample number X-1-105-FTT-1 located in room 105 of the first floor of the Annex Building.

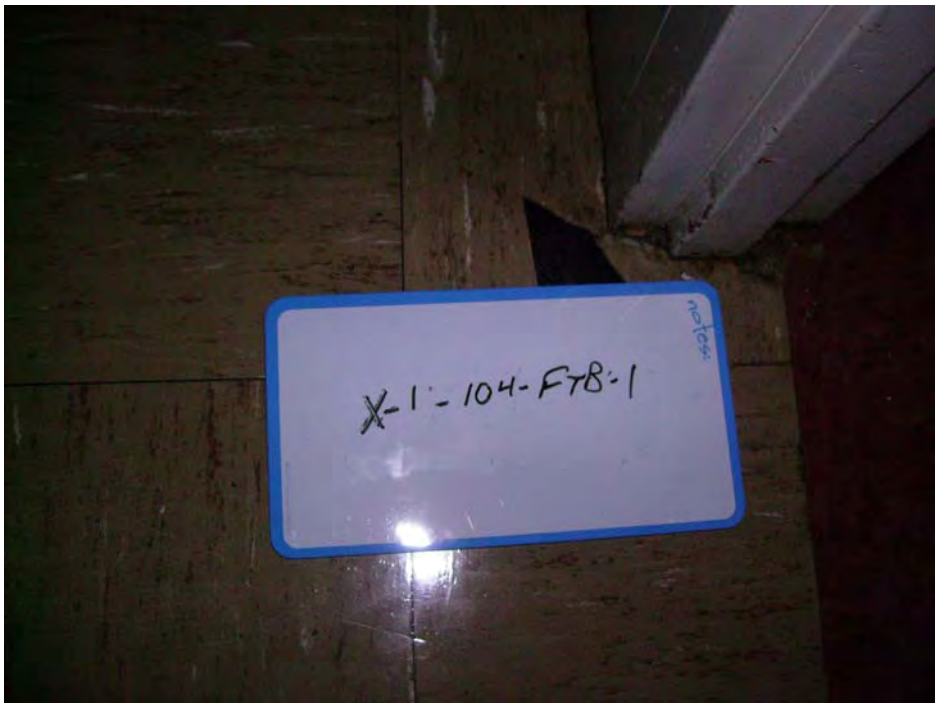
12x12 brown floor tile and associated mastic represented by sample number X-1-105-FTB-1 located in room 104 of the first floor of the Annex Building.

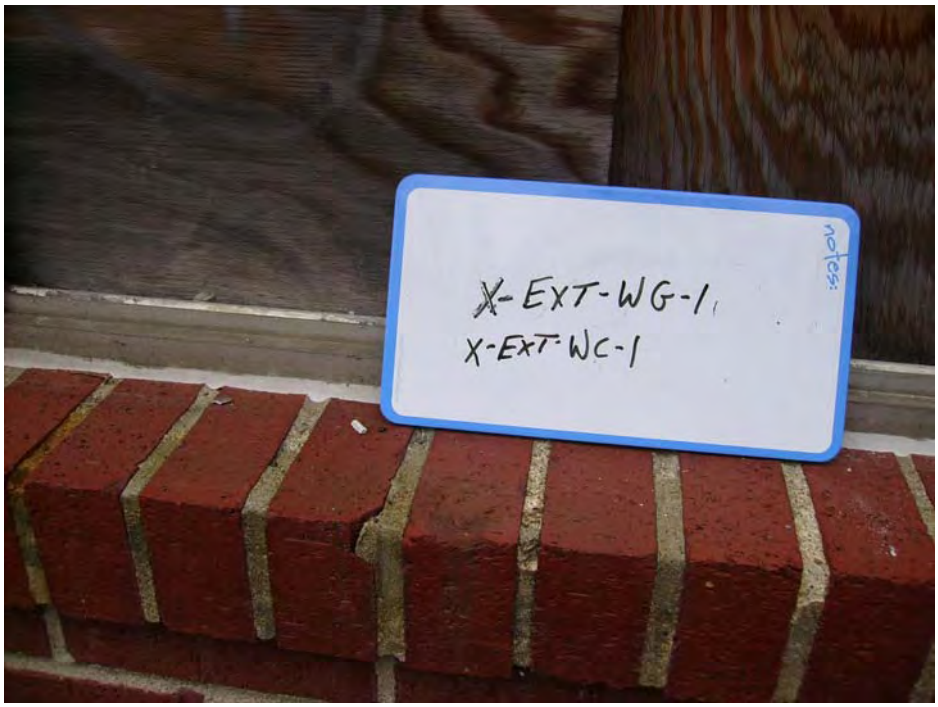
Exterior window glazing represented by sample number X-EXT-WG-1 located on the exterior windows of the Annex Building.

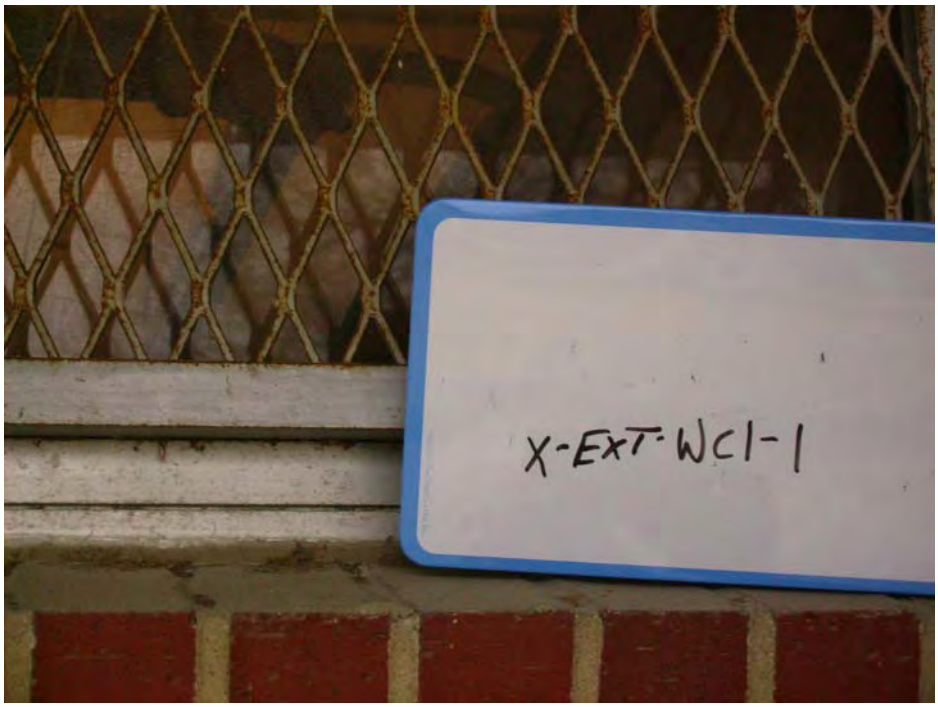
Exterior window caulking represented by sample number X-EXT-WC1-1 located on the exterior windows of the Annex Building.

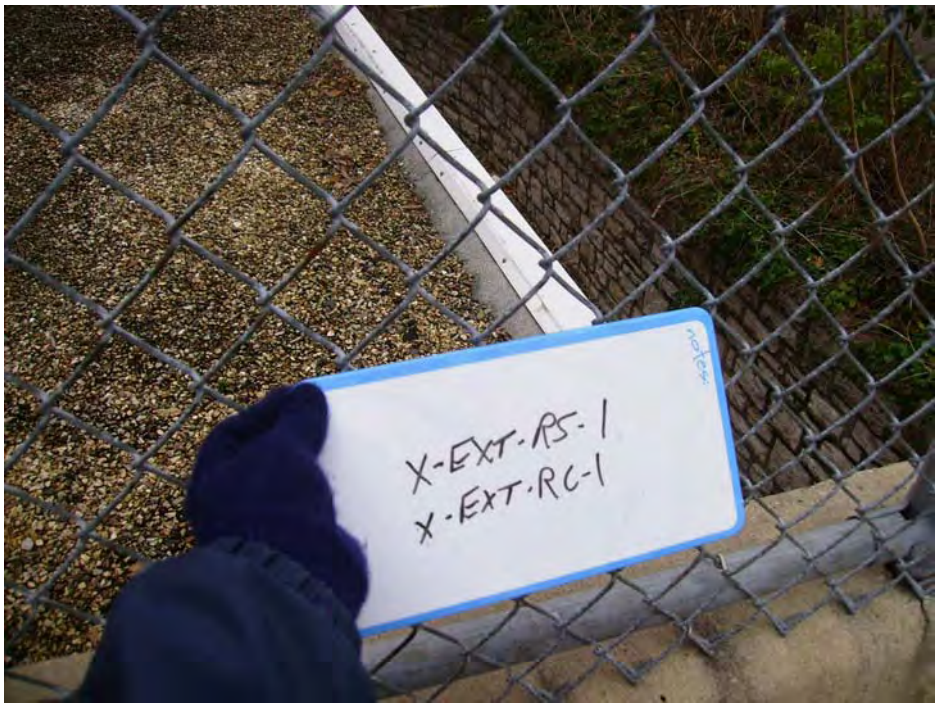
Exterior roof caulking and roof shingles represented by sample numbers X-EXT-RS-1 and X-EXT-RC-1 located on the roof of the Annex Building.
