Seattle Iron & Metals
12/10/85
7/16/86

Seattle Iron & Metals
12-10-85

7/16/86

SEATTLE IRON & METALS CORP.

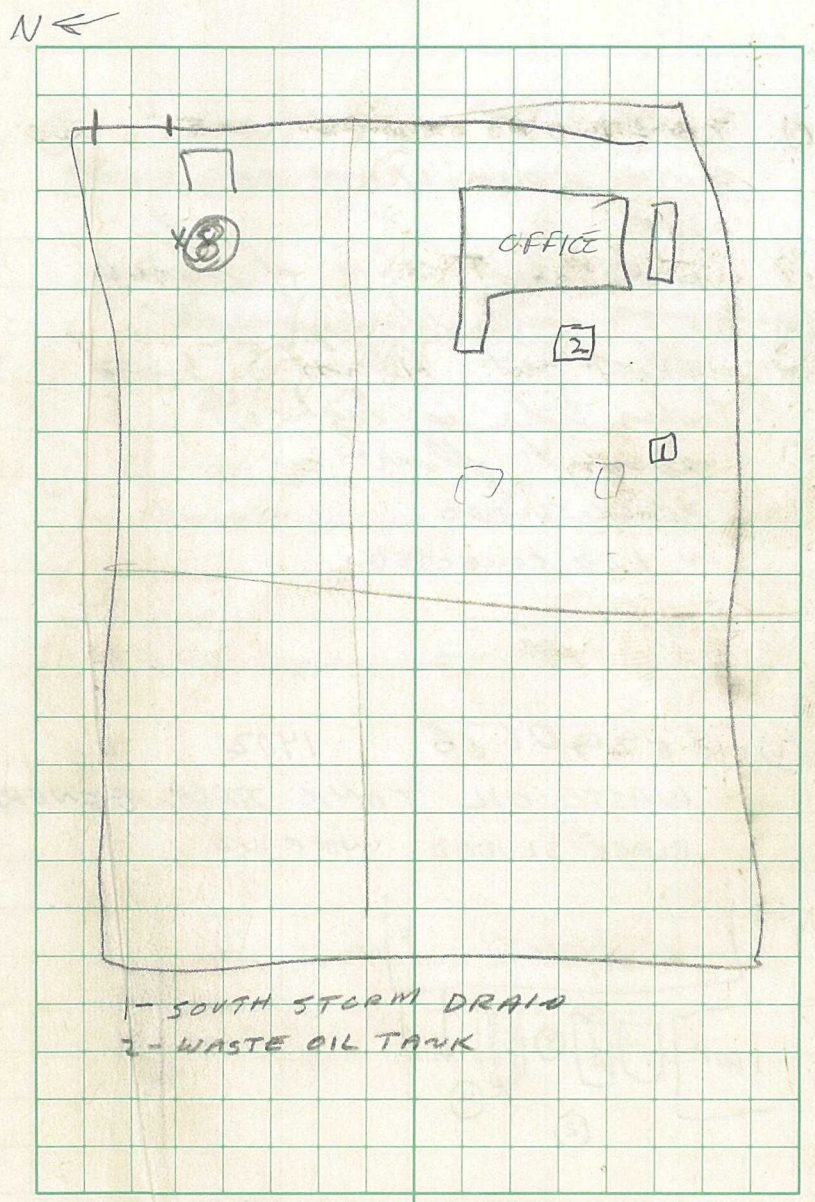
1 - SOUTH STORM DRAIN
2 - WASTE OIL TANK

① 86290675
SOUTH STORM DRAIN SEDIMENT
1350
under about 8-10" of standing
② ~~86 29~~ water. No apparent
flow out. Alan S. said
when tide is high it
doesn't flow.
BLACK SLUDGE
~ 1 oz COLLECTED

② 86290676 1402
WASTE OIL TANK AREA GENERAL
BLACK SLUDGE UNDER H_2O

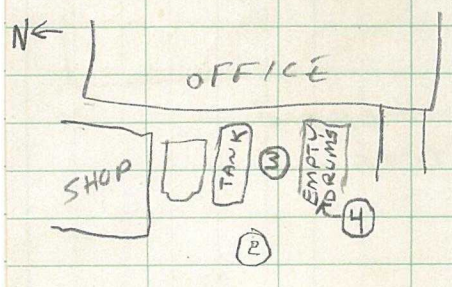
③ 86290677
ADJACENT TO WASTE OIL TANK
1407
GRAB
OILY BROWN/BLACK

④ 86290678
SEDIMENT UNDER EMPTY DRUM STORAGE
1412
GRAB
DARK BROWN DIRT

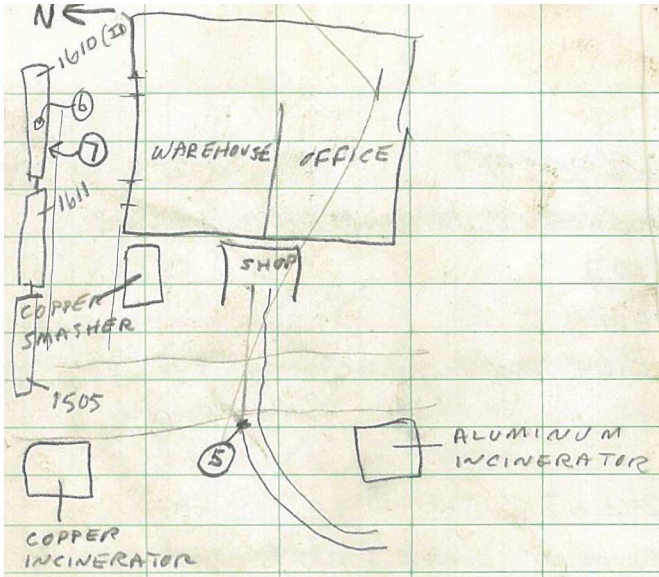
7 86290681
1447
SEDIMENT UNDER ENGINE #1610
GRAB

5 86290679
SED NEXT TO R.R. TRACT
1422
GRAB
BROWN, FINE

6 86290680
1434
OIL ON BOTTOM OF TRAIN ENGINE #1610
ALASKA RAILROAD
OILY/SLUDGE
