J092-RP
Rev. No. 0

FINAL DRAFT
ENVIRONMENTAL PRIORITIES INITIATIVE
PRELIMINARY ASSESSMENT REPORT
THE BATES MANUFACTURING COMPANY
HACKETTSTOWN, NEW JERSEY

JUNE 26, 1992

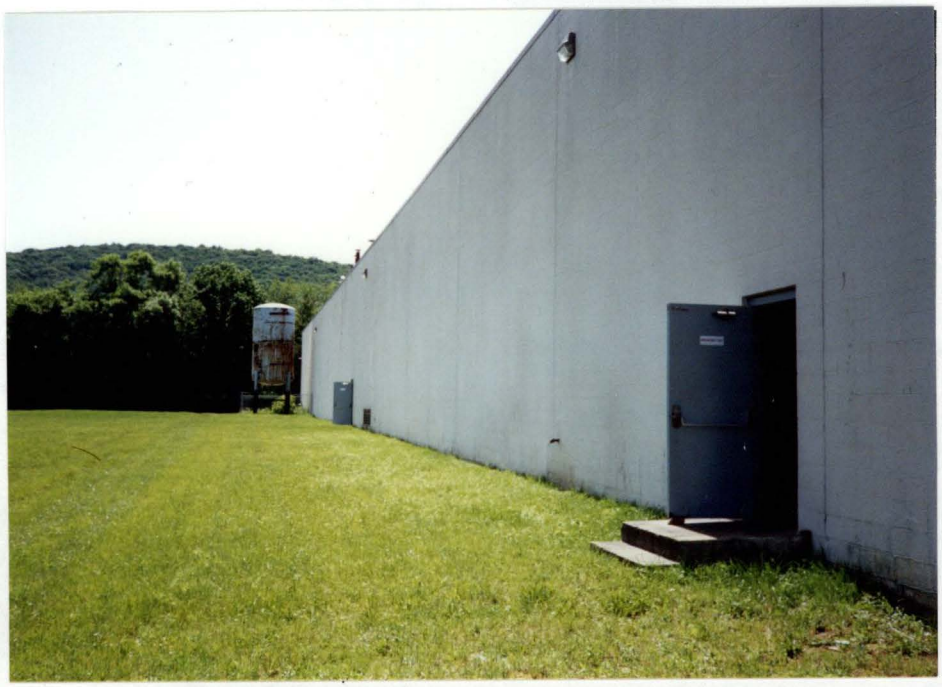
1P-1 June 11, 1992 1055
View of back of manufacturing building looking southwest. Unused water tower in background.

1P-2 June 11, 1992 1105
View of drum storage area looking southwest.

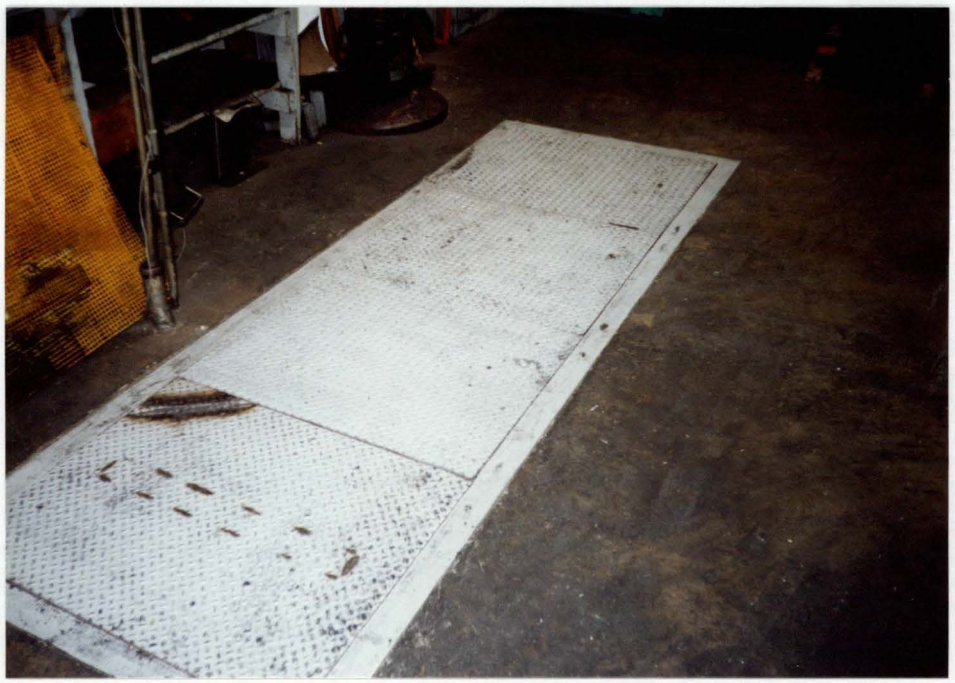
1P-6 June 11, 1992 1116
View of collection pit inside manufacturing building.
