ENVIRONMENTAL PROTECTION AGENCY STATE OF ILLINOIS IL-0237-10

OBSERVATION REPORT - SITE INVENTORY NO. 19704521
(11) (18)

Will CO. - L.P.C. Region # N Date 03/25/81
(20) (25)

Joliet / Process Alliance Letter Sent (Yes or No) No
(Location) (Responsible Party) (26)

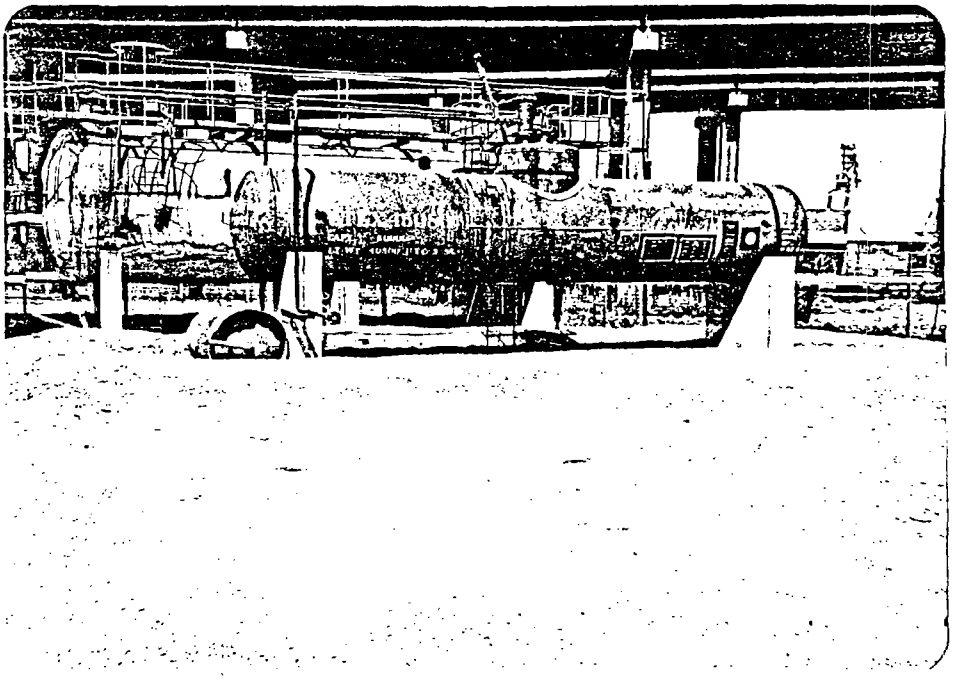
Comments: Photograph taken toward the north from south of facility

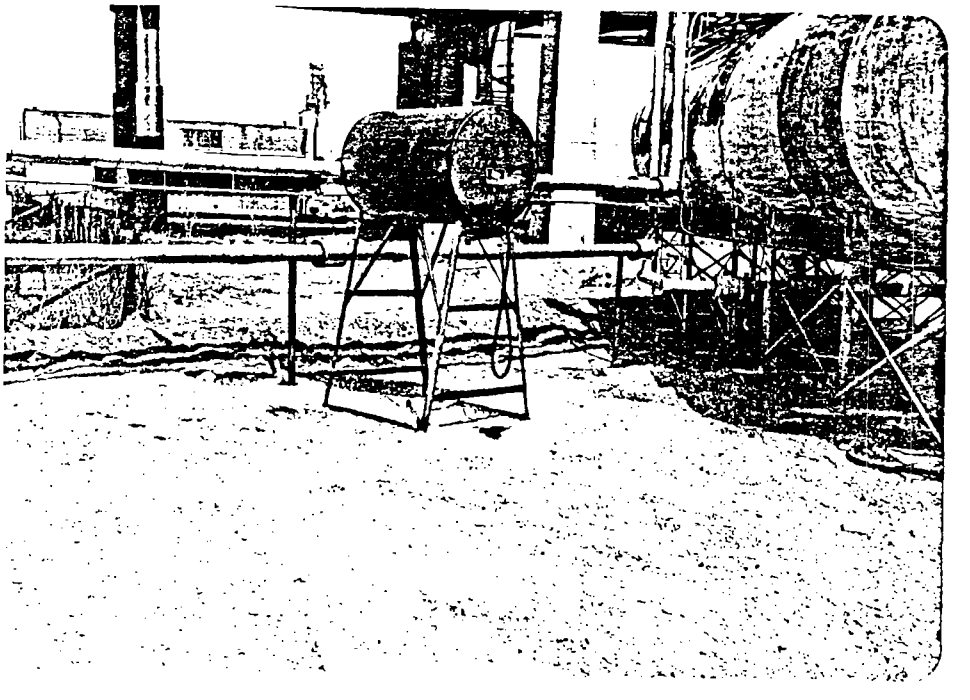
Comments: Photograph taken toward the north from south of tanks

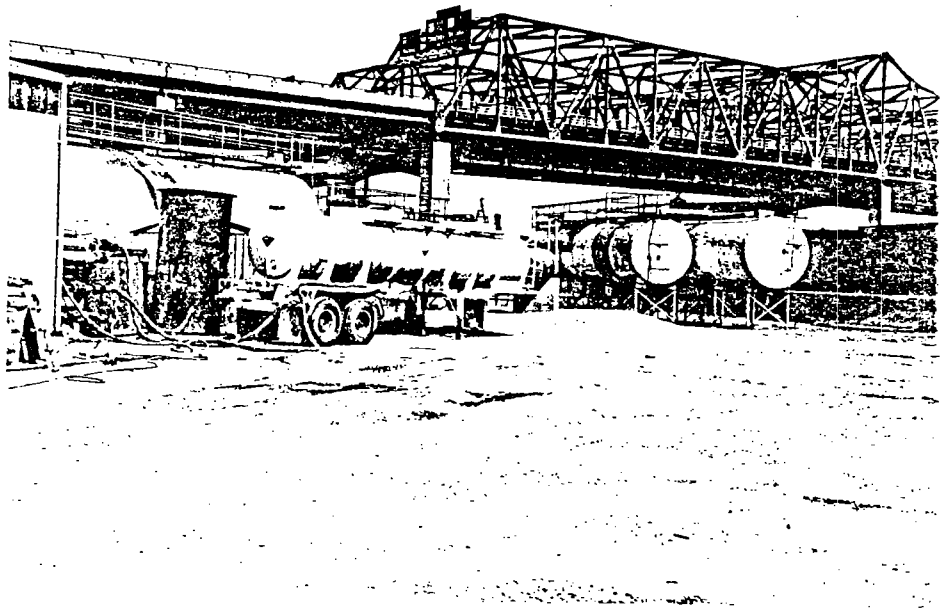
Comments: Photograph taken toward the N.E. from center of facility

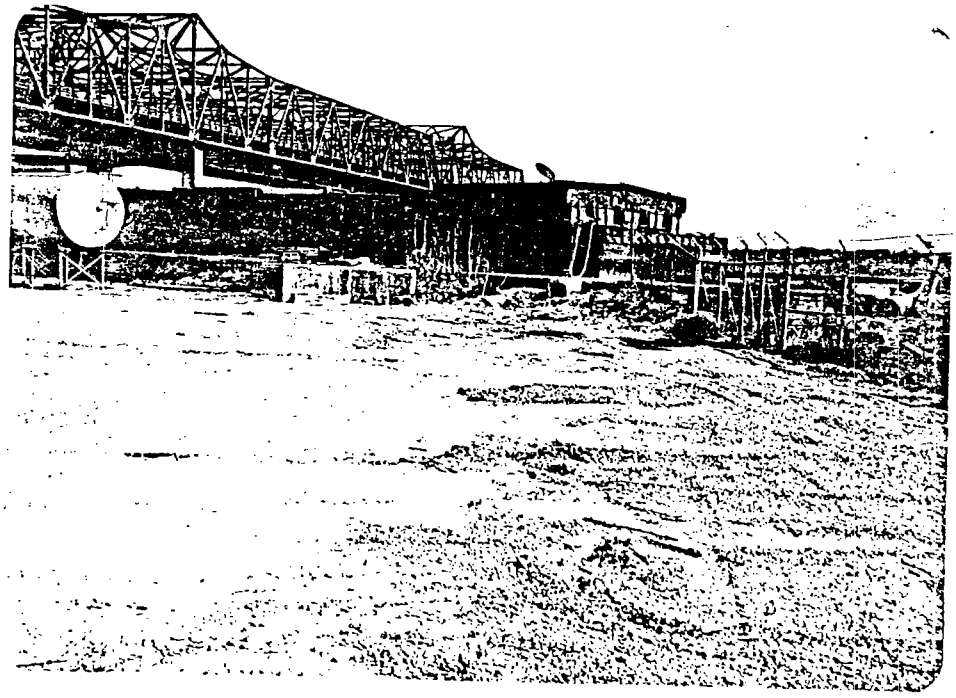
Comments: Photograph taken toward the east from center of facility

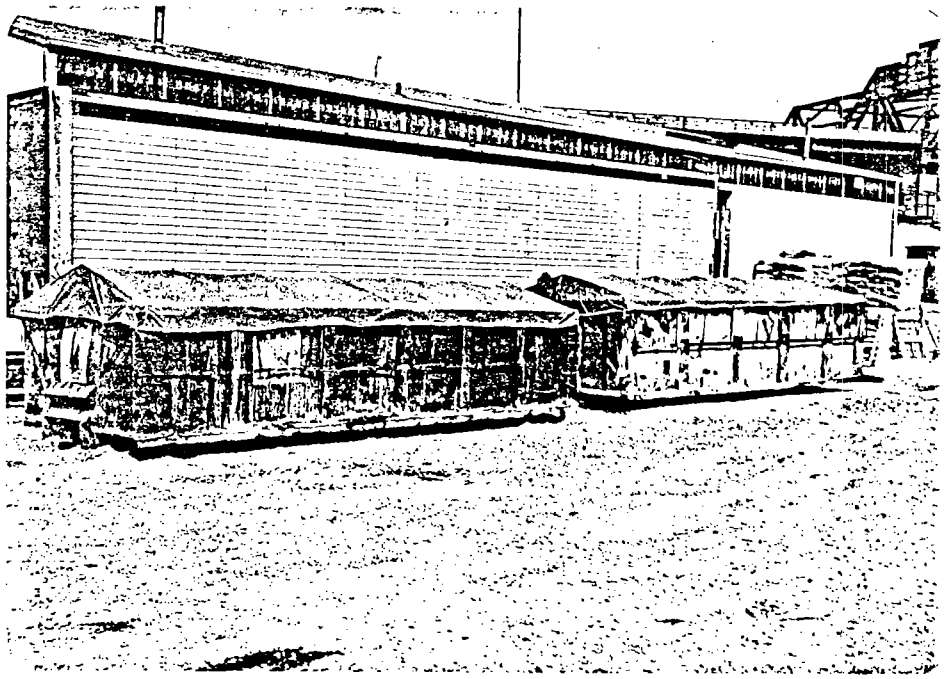
Comments: Photograph taken toward the N.E. from west end of facility

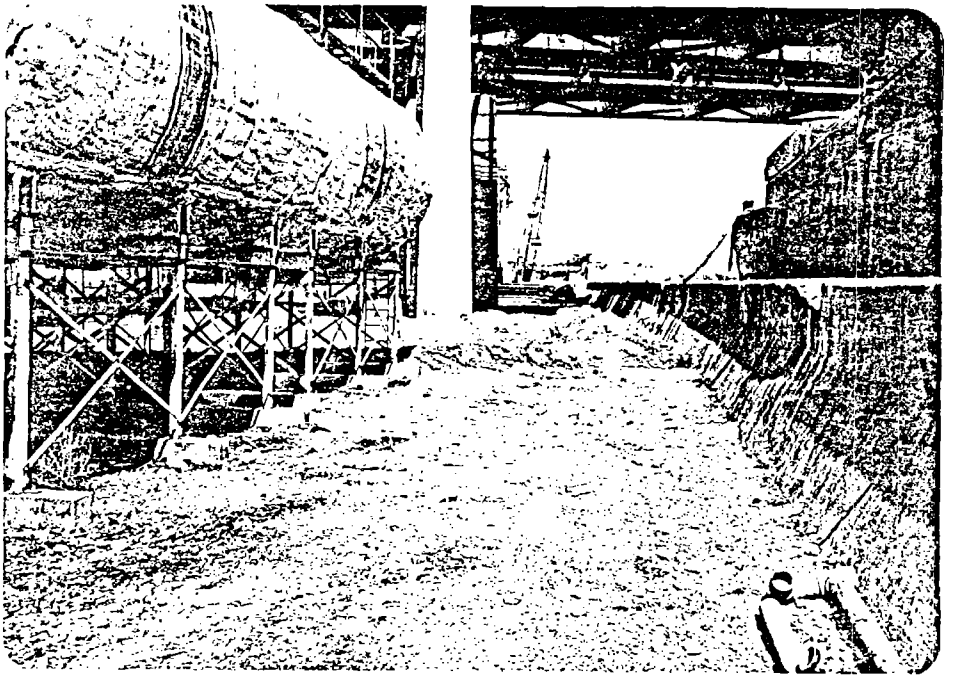
Comments: Photograph taken toward the north from east of storage Tanks

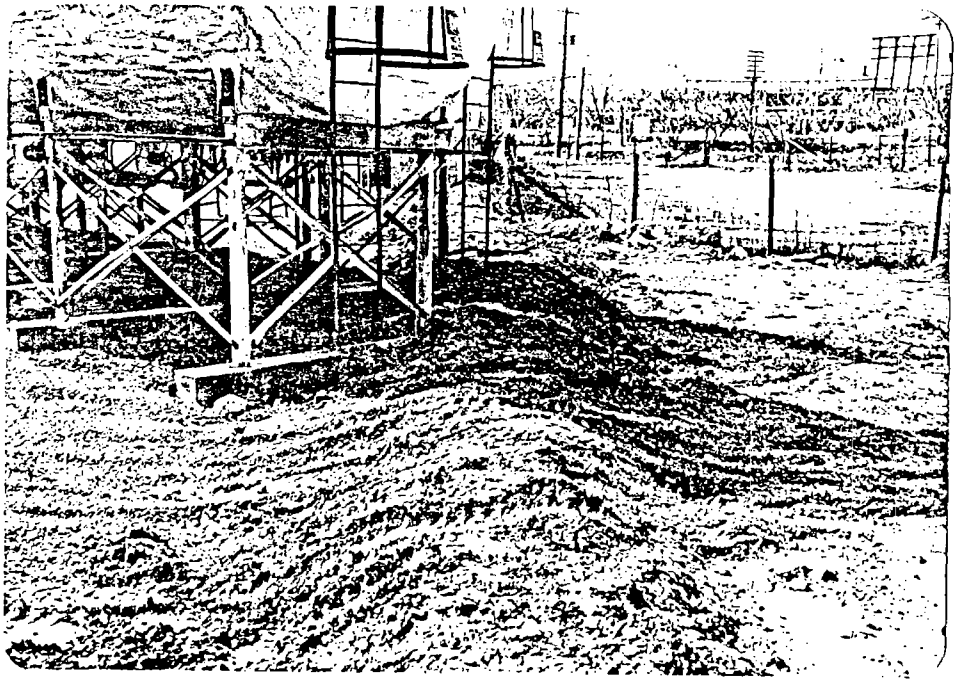
Comments: Photograph taken toward the west from N.E. corner of site
