DOCUMENTATION OF ENVIRONMENTAL INDICATOR DETERMINATION

RCRA Corrective Action
Environmental Indicator (EI) RCRIS code (CA750)

Migration of Contaminated Groundwater Under Control

Facility Name: **Ball and Socket Manufacturing Co. (former)**
Facility Address: **493 West Main Street, Cheshire, CT 06410**
Facility EPA ID #: **CTD001167493**

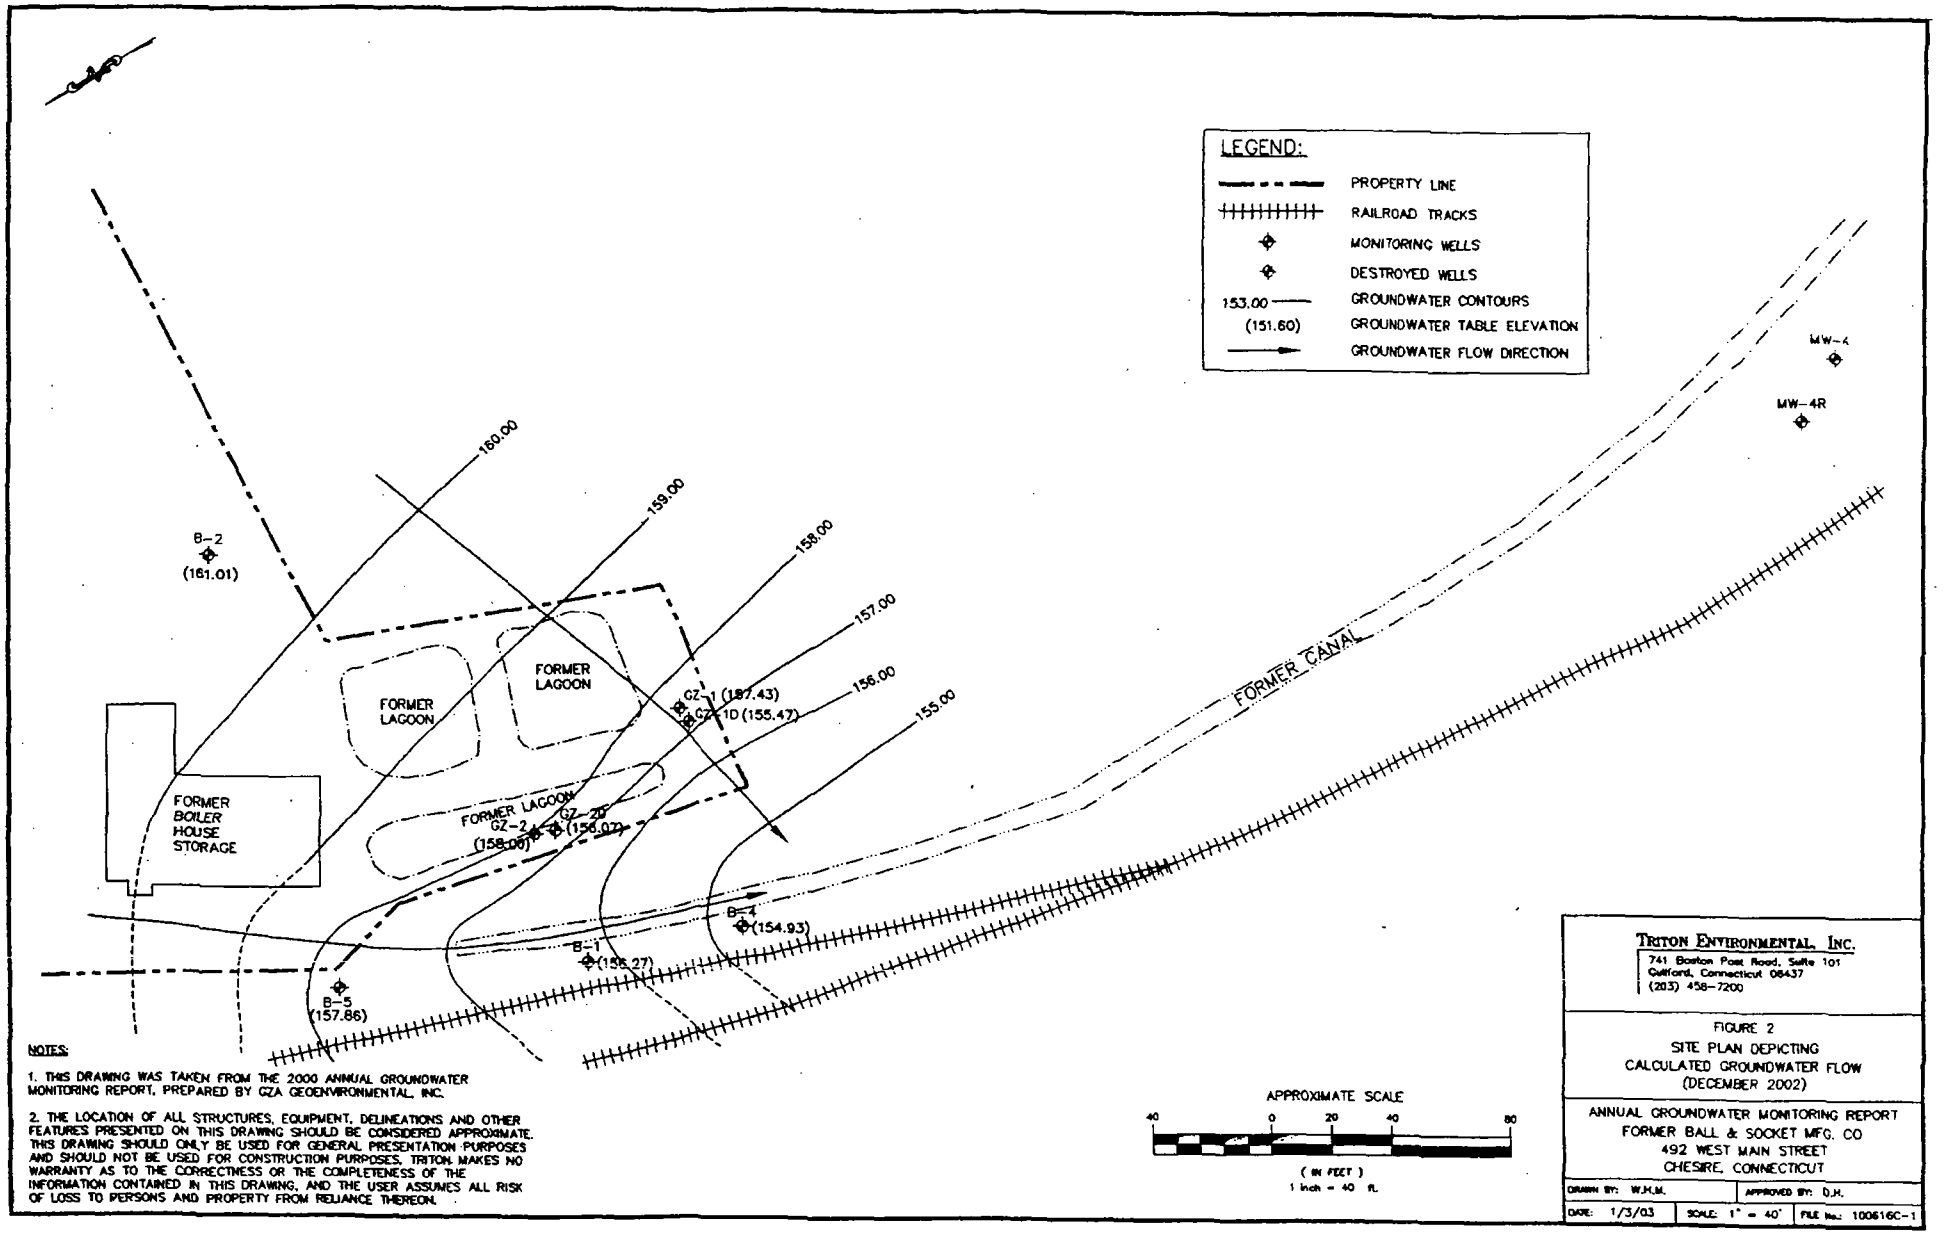
(203) 458-7200
FIGURE 2
SITE PLAN DEPICTING
CALCULATED GROUNDWATER FLOW
(DECEMBER 2002)
ANNUAL GROUNDWATER MONITORING REPORT
FORMER BALL & SOCKET MFG. CO
492 WEST MAIN STREET
CHESIRE, CONNECTICUT
DRAWN BY: W.H.M.
APPROVED BY: D.H.
DATE: 1/3/03
SCALE: 1" = 40'
FILE No.: 100616C-1

The Facility property is currently used for storage of dry goods and a pavement sealant manufactured by Dalton. Dalton maintains a pump and treat system that includes 11 extraction wells and the former production well. Based on conversations with a Dalton representative during the TtNUS sampling event, a new well located in the solvent management area, has been added to the treatment system. The treatment system consists of pumping the groundwater through activated carbon filters and discharging the water to the municipal sewer. Refer to GZA Figure 2 in Attachment B for extraction well locations.
