2007 Remedial Action Annual Report

Medley Farm NPL Site
Gaffney, South Carolina

February 2008

Prepared For
Medley Farm Site Steering Committee

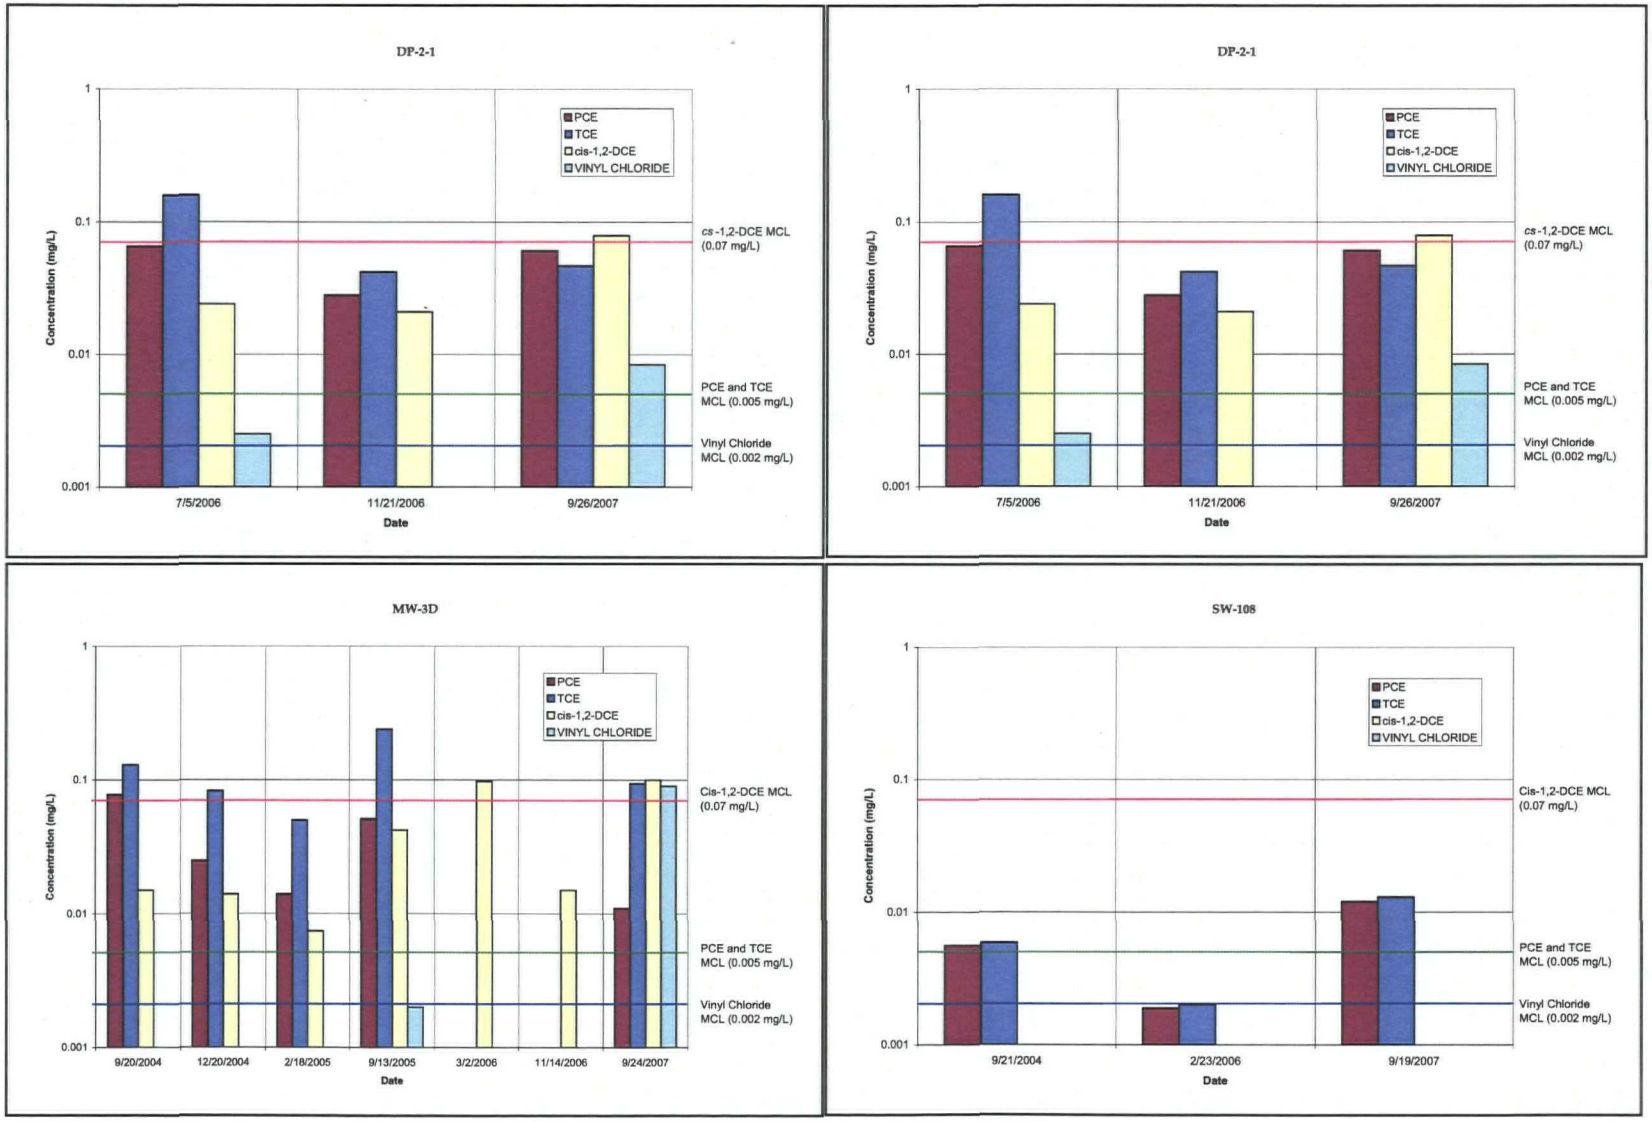
Figure 3a
Time versus Concentration in Northern-Trending Plume Wells
(DP-2-1, SW-3, MW-3D, and SW-108)

- **Area 2 near wells DP-2-1, SW-3, MW-3D, A-4, and SW-108 in the northern-trending plume:** Increases in VOC concentrations in this area indicate that VOCs are migrating in groundwater along the top of rock. Targeted nutrient injections in DP-2-1 and MW-3D are recommended to treat remaining VOC concentrations in groundwater in the upgradient portion of this plume. In addition, nutrient injections in wells A-4 and A-7 are also recommended to treat VOCs that were detected in the more downgradient well, SW-108.
- **Area 3 near wells A-2, A-3, A-5, and MW-2-2 in the eastern plume**: VOC increases in these wells since November 2006 indicate that VOCs are present in groundwater upgradient or between injection wells along the fault plane. Additional nutrient injections into these wells, including well A-6, are recommended to treat remaining VOCs in the groundwater in this plume.

Increases in levels of PCE or TCE were observed in wells A-2, A-3, A-4, A-5, B-1, B-2, BW-108, BW-202, DP-2-1, MW-2-2, MW-3D, SW-108, and SW-3. These are areas of the site where increases of ORP were also observed in September 2007. These increases in ORP and VOC concentration indicate that targeted nutrient injection in this area would be useful in helping further reduce the remaining VOC concentrations near these wells.

Wells DP-2-1, MW-3D, A-4, and A-7 have already been included as nutrient injection wells in the injection program. Analytical data suggests that injection activities have been successful in reducing overall VOC concentrations in these and the downgradient wells. However, increasing concentrations in DP-2-1, MW-3D, and SW-3 indicate that VOC-affected groundwater remains in this area. To mitigate long-term VOC migration, minimize the potential for VOC rebound and maintain conditions conducive to reductive dechlorination, targeted nutrient injection is recommended for this area.

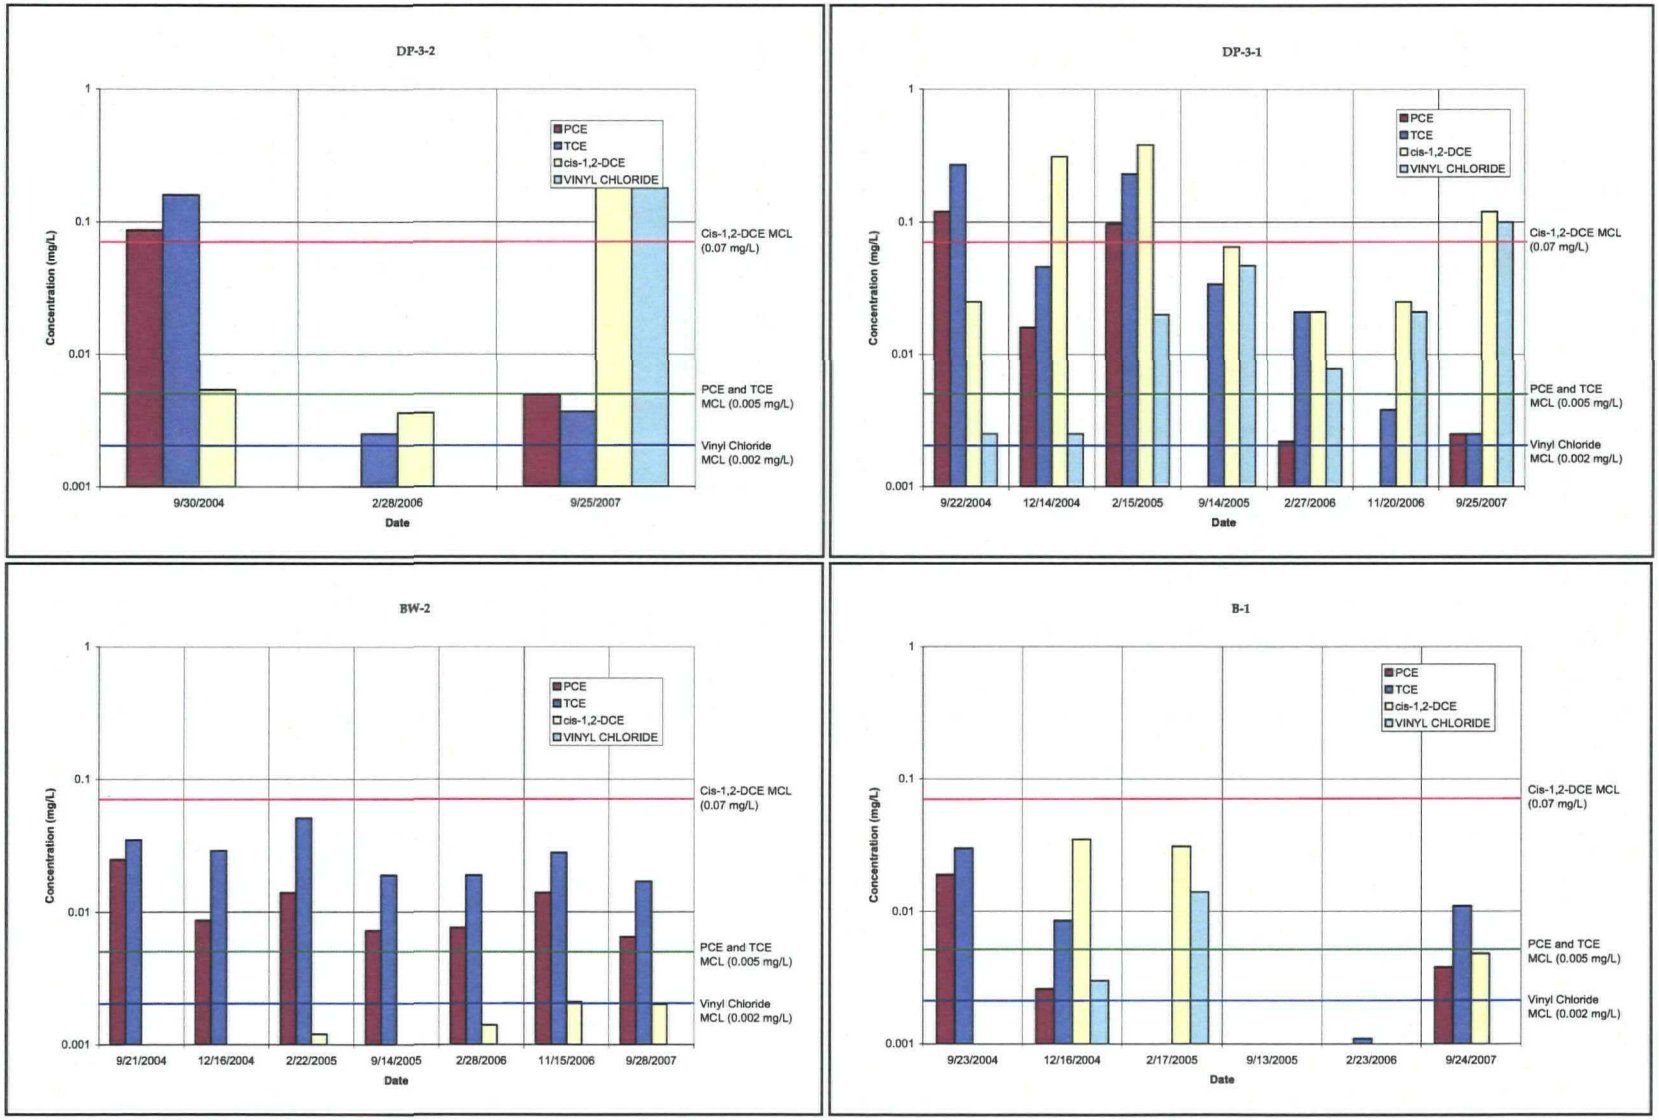
Figure 4a
Time versus Concentration in Southern-Trending Plume Wells
(DP-3-2, DP-3-1, BW-2, and B-1)

- **Area 1 near wells B-1 and B-2 in the southern-trending plume:** B-1 and B-2 were last included in the injection program in the winter of 2005. The September 2007 groundwater monitoring event shows evidence of observed increases in VOC concentrations. Targeted nutrient injection in B-1 and B-2 is recommended to treat the observed parent VOCs as well as observed daughter products, including 1,1,2-trichloroethane (1,1,2-TCA) and 1,2-dichloroethane (1,2-DCA), in the groundwater of this plume.

Increases in ORP were observed in one area of the site, near bedrock well BW-2 and former recovery wells B-1, and B-2. This is an area of the site where relative increases of VOCs were also observed in September 2007. These

Wells DP-3-1 and DP-3-2 have been included as injection wells in the nutrient injection program. Analytical data suggests that nutrient injections have been successful in reducing overall VOC concentrations in these and downgradient wells. However, as discussed in the previous sections, as a result of the observed increase in ORP and VOC concentrations in well B-2, targeted nutrient injection is recommended in this area as a remedial measure to further mitigate observed VOC levels and reduce the risk for VOC migration in a direction towards the MLW-1 well nest.

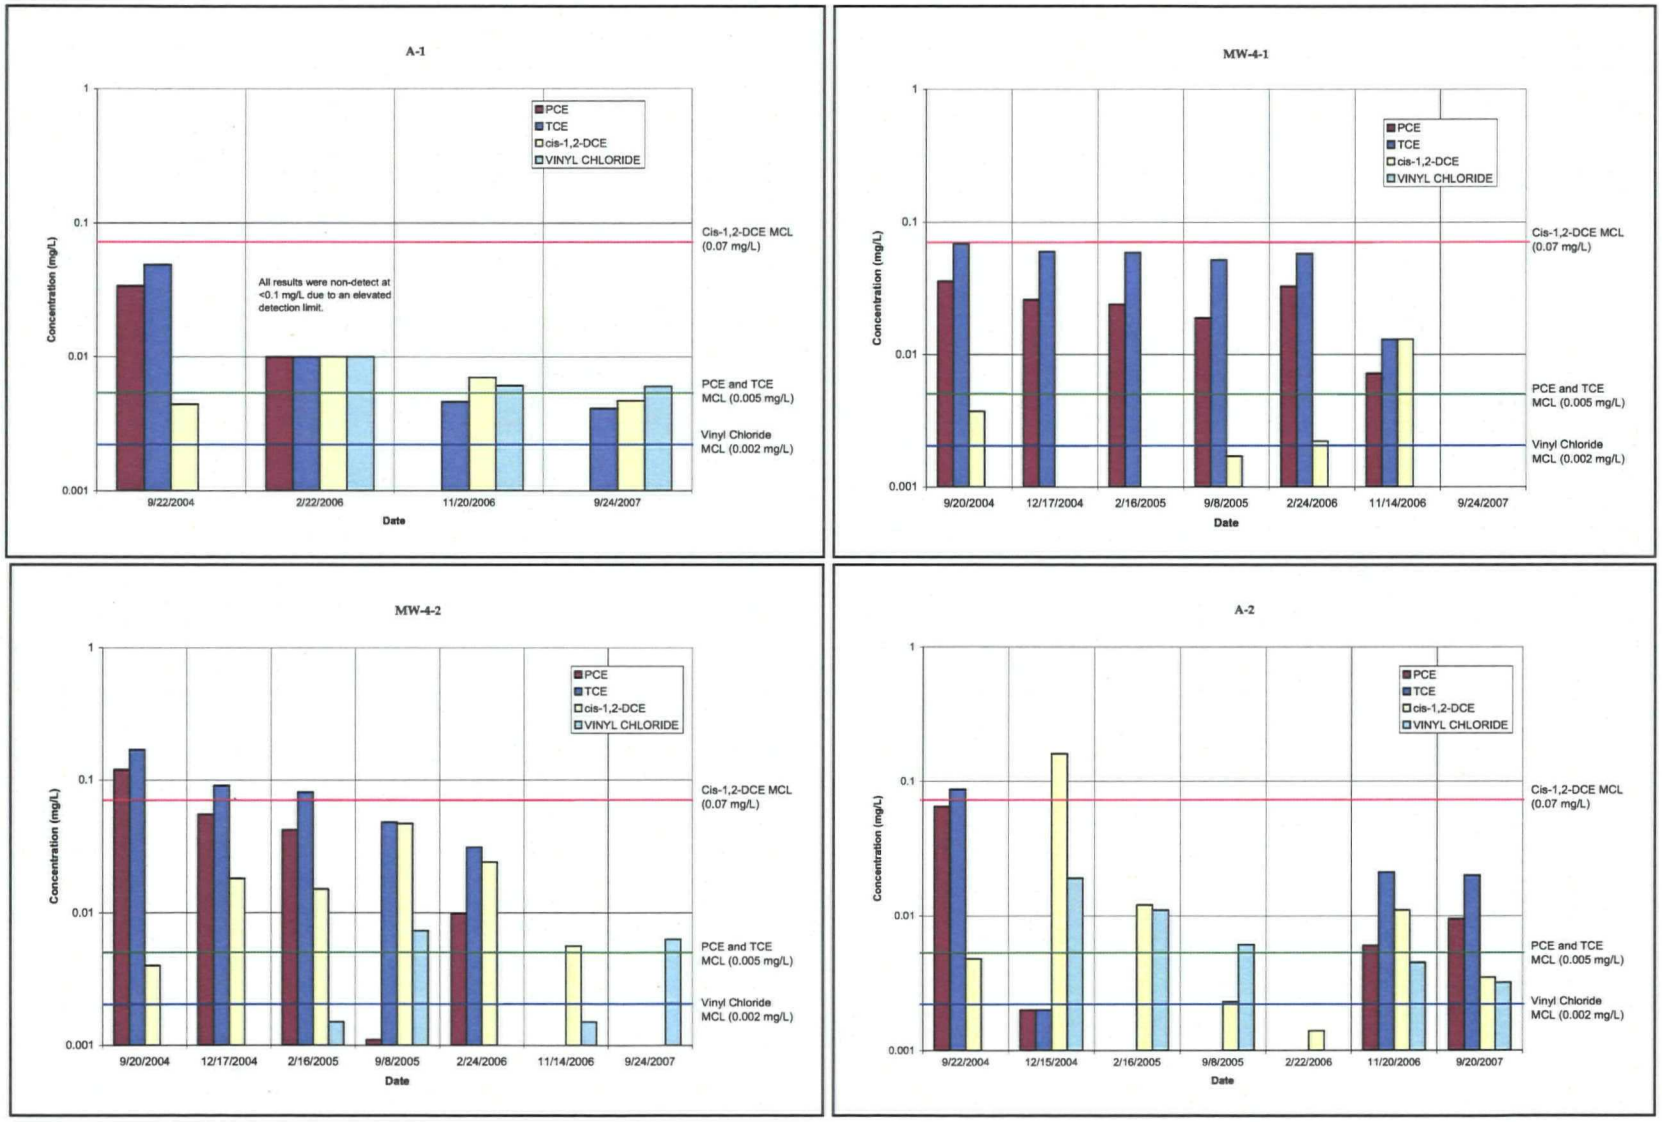
Figure 5a
Time versus Concentration in Eastern Plume Wells
(A-1, MW-4-1, MW-4-2, and A-2)

Continued decreases in PCE and TCE concentrations were also observed in monitoring wells MW-2-1, MW-4-1, and MW-4-2. Declines in VOC concentrations were not observed in these wells until the November 2006 monitoring event. This apparent delay in concentration decline is likely due to the low permeability formation surrounding these wells. When these wells were added to July/August 2006 injection program, lactate injections were difficult to conduct because the formation either would not accept water or the injection rate was too slow to be practical. Baseline levels of PCE and TCE in these wells ranged from 0.014 mg/L to 0.12 mg/L for PCE and 0.023 mg/L to 0.17 mg/L for TCE. Results of the September 2007 monitoring event indicate

Decreases in *cis*-1,2-DCE and VC concentrations were observed in wells A-2, A-3, A-4, MW-2-1, MW-2-2, MW-4-1. Each of these wells are located parallel to the fault plane on the eastern portion of the site. Field indicators in all of these wells indicate that reducing conditions remain persistent in these wells. Furthermore, parent compounds PCE and TCE are non-detect in wells MW-2-1, MW-4-1, and MW-4-2, indicating that the nutrient injection activities have been successful in reducing VOC concentrations in the past. However, concentrations of PCE and TCE in wells A-2, A-3, A-4, and MW-2-2 remain greater than the MCL. These results indicate that targeted nutrient injection in this area would be useful in helping further reduce the remaining VOC concentrations near these wells.

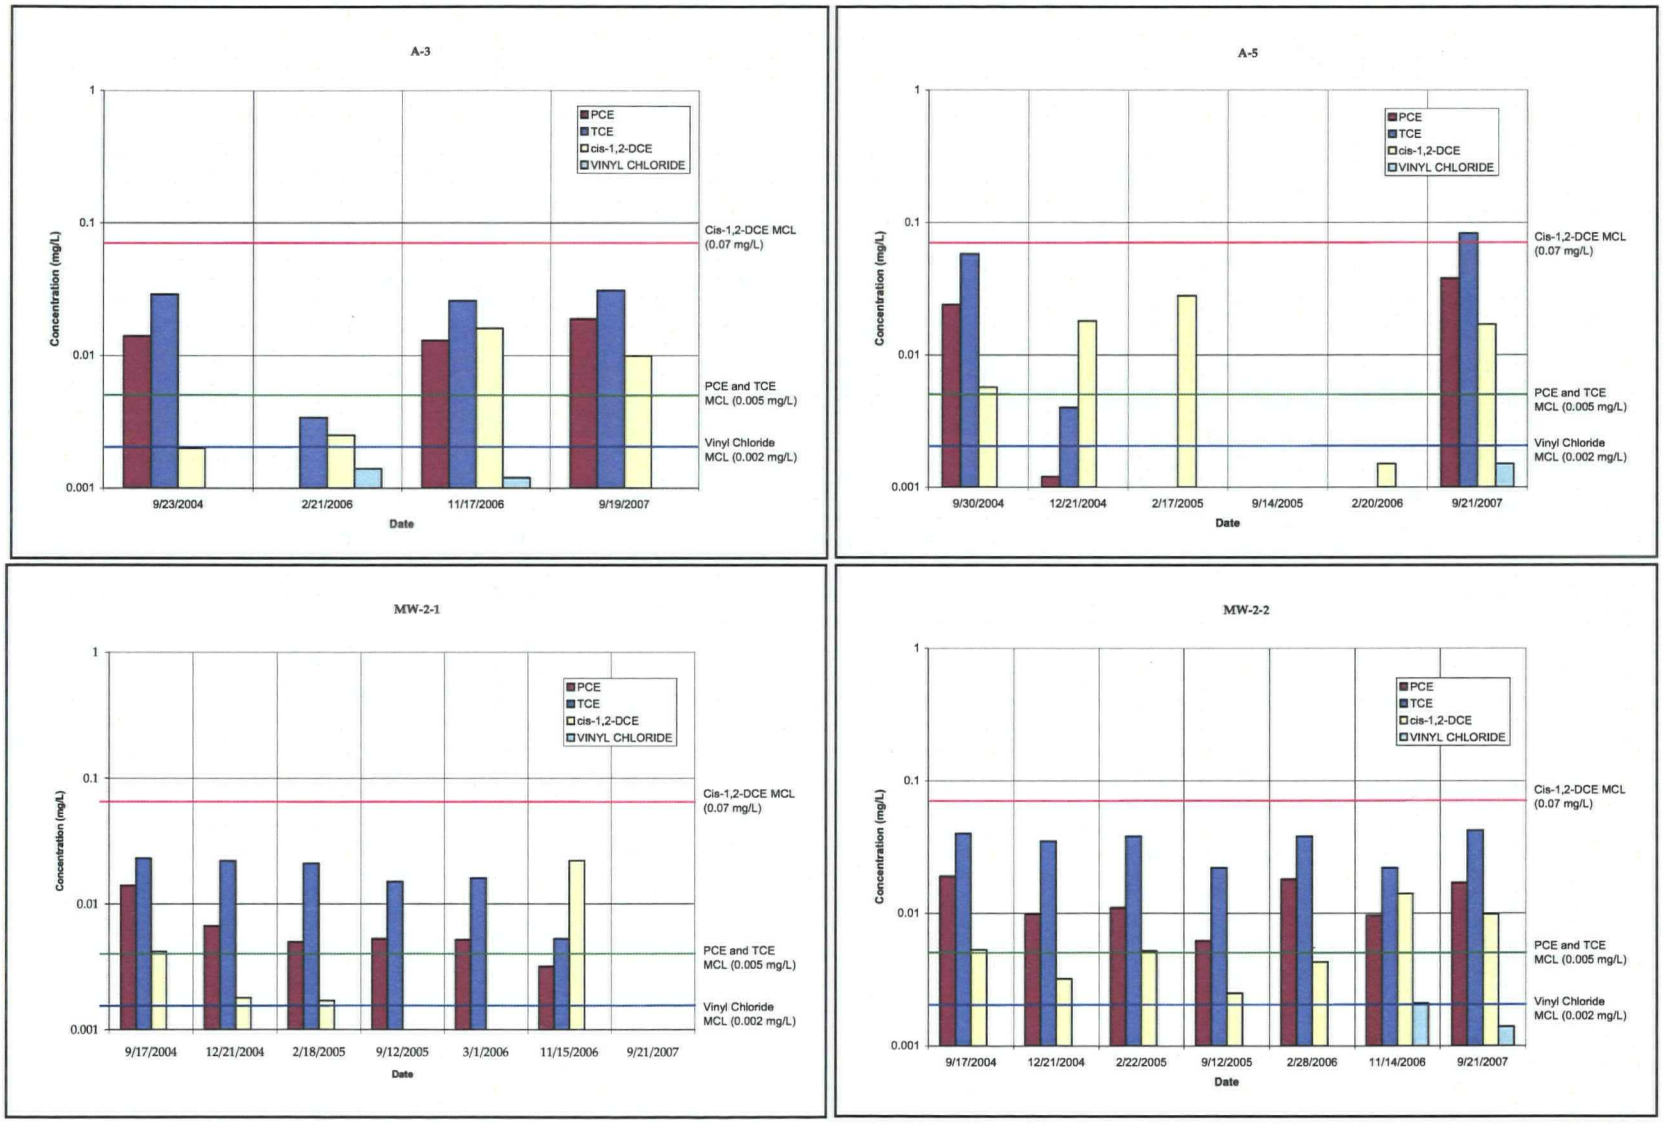
Figure 5b
Time versus Concentration in Eastern Plume Wells
(A-3, A-5, MW-2-1, and MW-2-2)

Nutrient injection activities have been successful in reducing VOC concentrations since baseline conditions were collected in wells A-1, A-2, and A-6. However, increases in VOC have also been observed in this area. Site data suggests that the injected lactate-based suspensions have migrated into the aquifer creating reducing conditions along and downgradient of the fault plane. ORP is negative in most of the wells in the area. Analytical results from the MLW-3 wells indicate that levels of PCE and TCE have declined to below MCLs and *cis*-1,2-DCE has been consistently detected since the onset of nutrient injection. Furthermore, VC has not been detected in the MLW-3 indicating that it attenuates in the aquifer outside the injection area. These data suggest to RMT that the extent of the eastern plume is stable and shrinking in direct response to the nutrient injection activities. The observed increases in the levels of VOCs in wells A-3, A-4, and A-5 indicate that some VOCs remain in groundwater parallel to the fault plane. Based on these observations, targeted nutrient injection in wells A-3, A-5, and A-6 are recommended as a beneficial response measure.

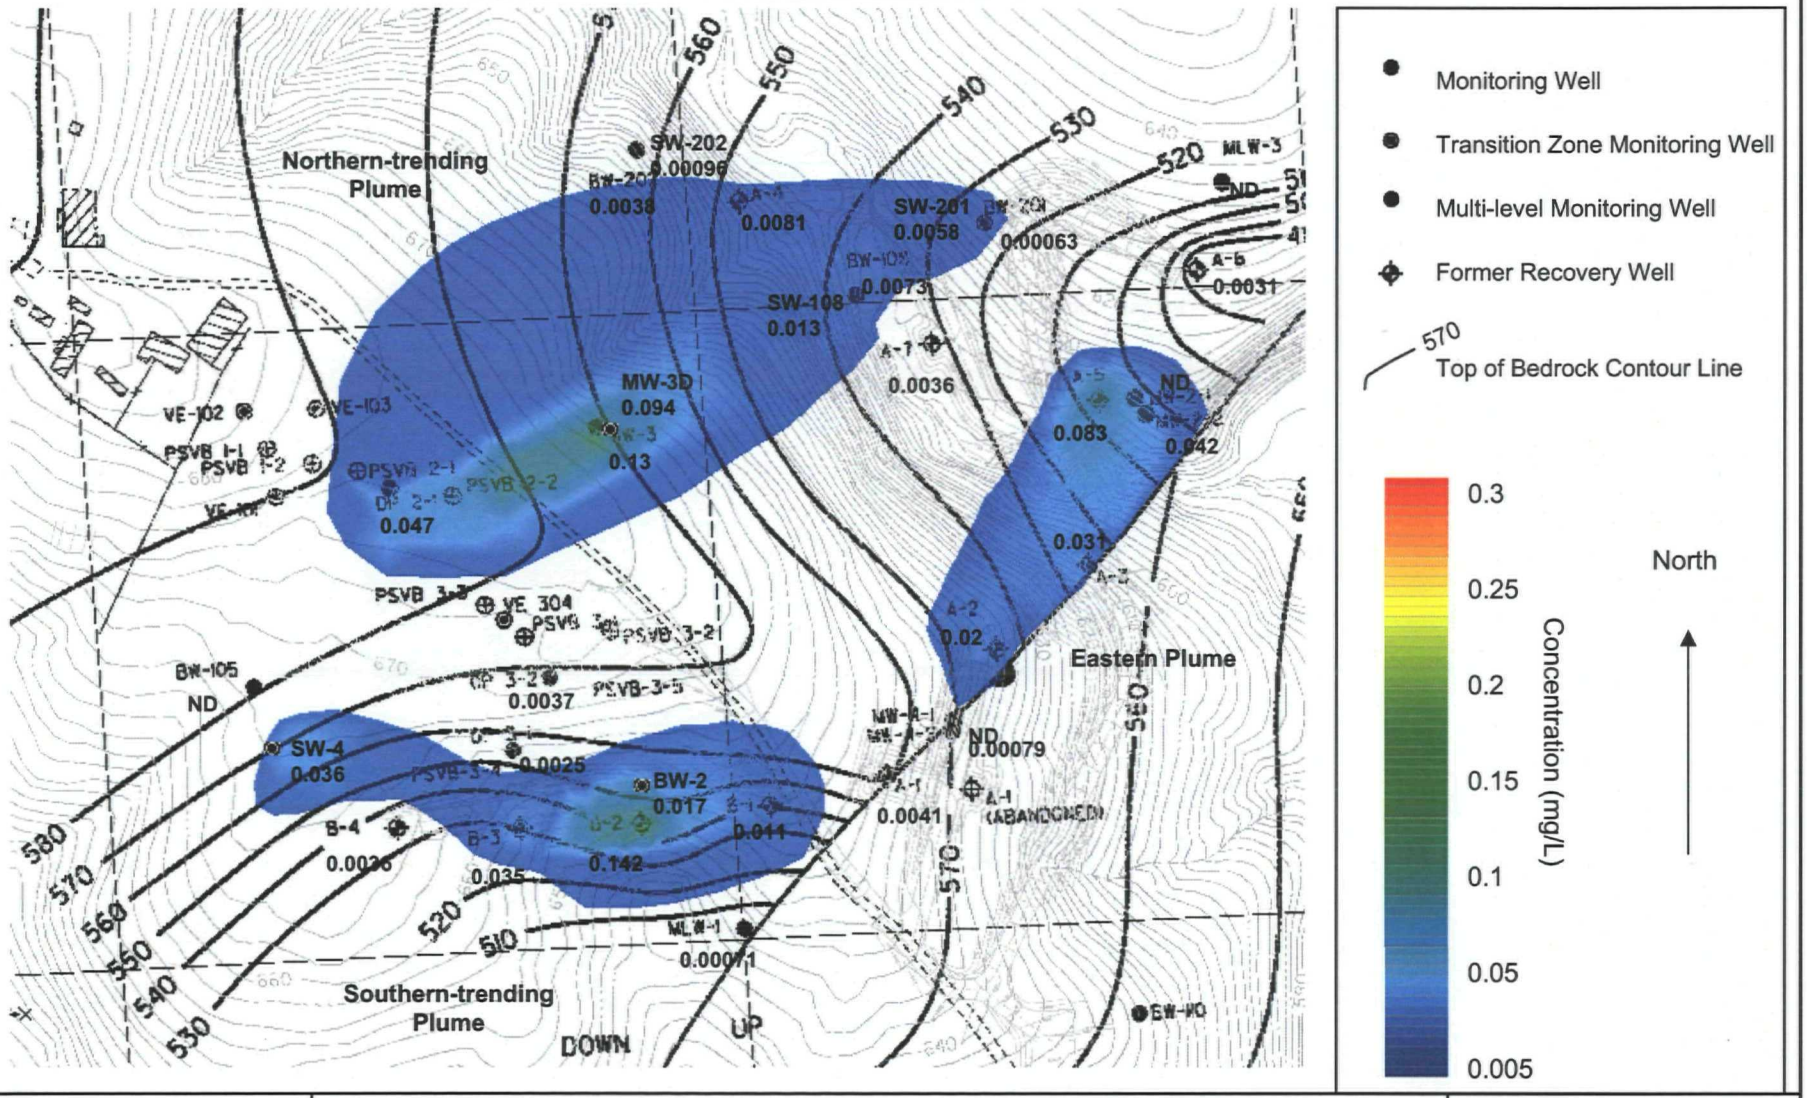
Results from the September 2007 site-wide monitoring event indicate that there are three areas of the site where aquifer conditions indicate that the aquifer is beginning to show signs of reverting to more aerobic conditions (see Figures 10 through 13):

RMT	**Figure 11** **Distribution of Trichloroethene in Groundwater** **September 2007**	Drawn By: CLC
		Approved By:
		Project No.
	Medley Farm NPL Site **Gaffney, South Carolina**	File No.
		Date: January 2008

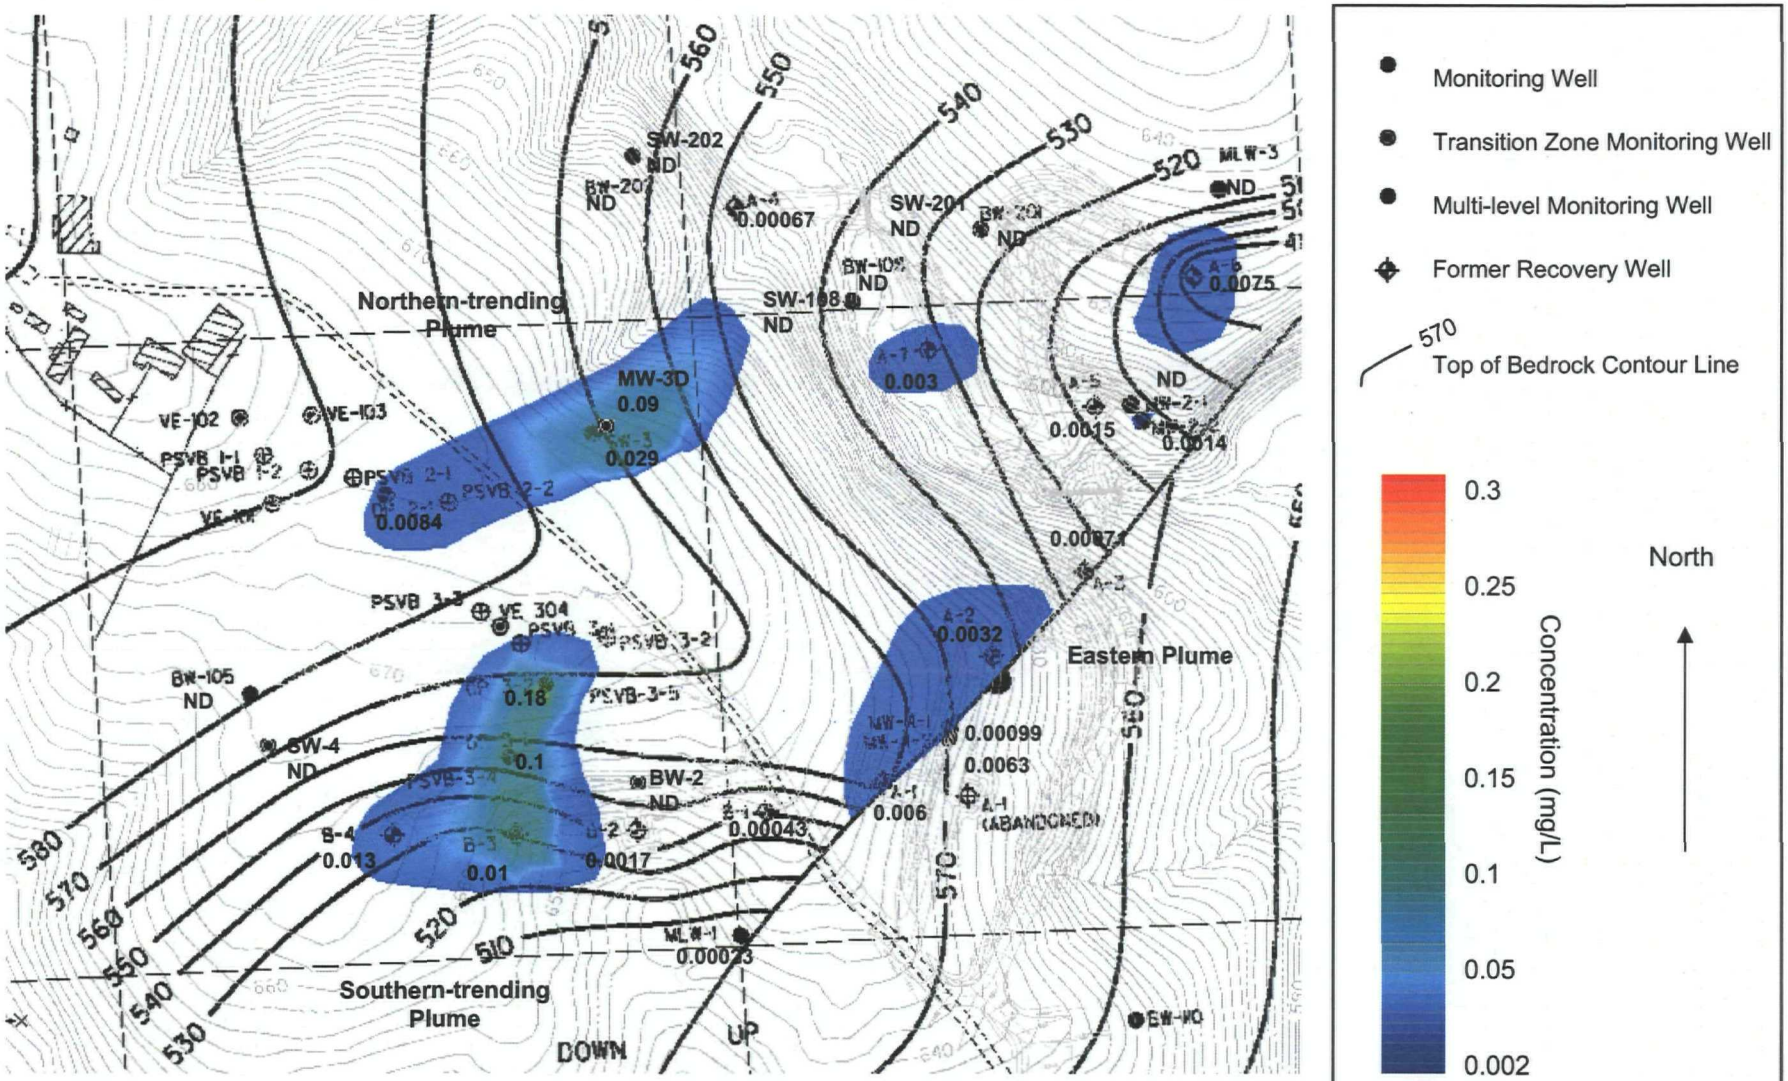
RMT	**Figure 13** **Distribution of Vinyl Chloride in Groundwater** **September 2007**	Drawn By: CLC
		Approved By:
	Medley Farm NPL Site **Gaffney, South Carolina**	Project No.
		File No.
		Date: January 2008
