UNITED STATES ENVIRONMENTAL PROTECTION AGENCY
REGION 4
ATLANTA FEDERAL CENTER
61 FORSYTH STREET
ATLANTA, GEORGIA 30303-8960

Re: Lee's Lane Landfill Superfund Site, Louisville, Jefferson County, Kentucky

The EPA issued its fifth Five Year Review Report for the Site on September 25, 2013. In the Report, the Agency was unable to conclude that the remedy remains protective of human health and the environment. The Report identifies a number of technical issues that must be addressed before the EPA can make a protectiveness determination. For example, the landfill gas collection system at the Site does not appear to be working properly, and data gaps exist concerning soil and groundwater contamination at the Site. More information about these issues is available in the enclosed copy of the Report.

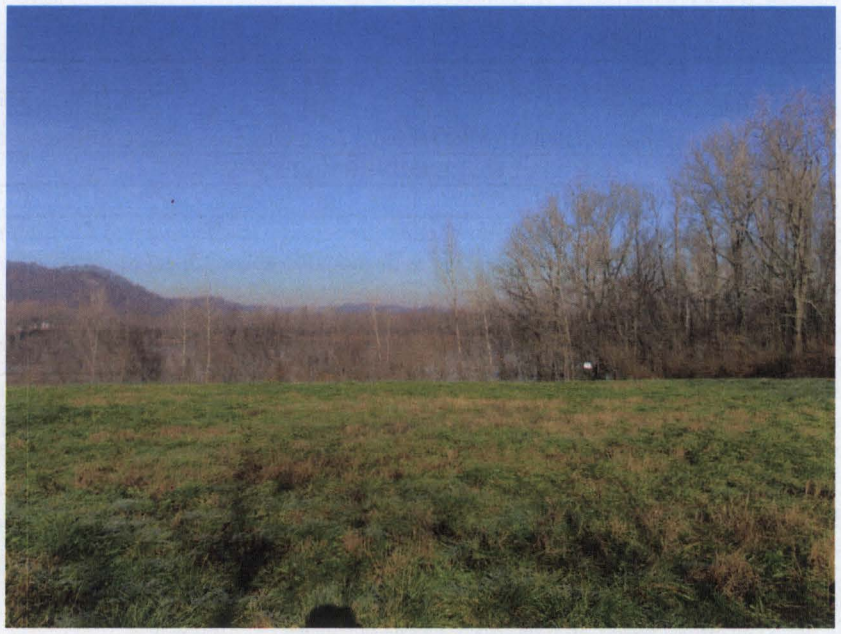
Looking across the cap toward the Ohio River.

Rip rap between the cap and the Ohio River.

Signage on the northern edge of the cap, with a trail on the right side of the sign.

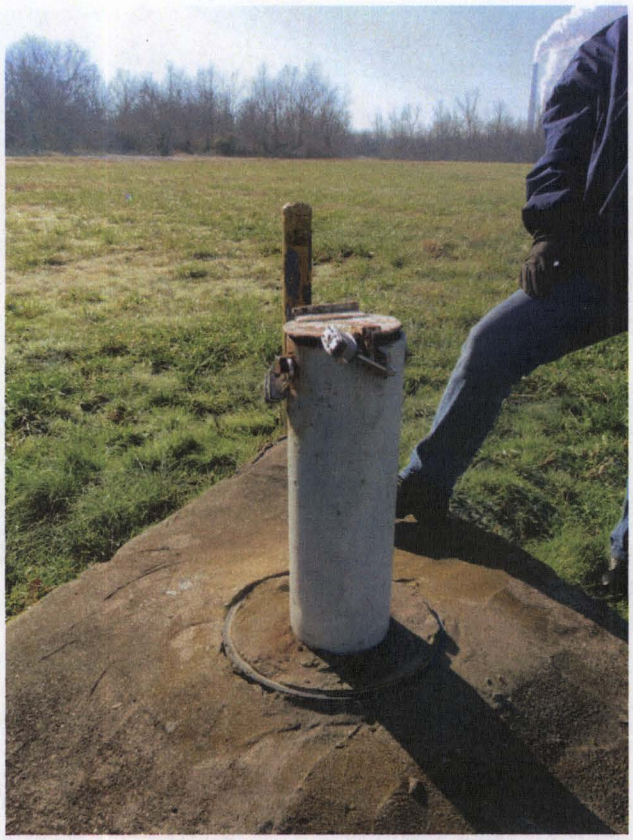
Ground water monitoring well near the cap along Ohio River. The well is securely locked.

Sign identifying the Site.

Clearly marked four wheeling trail near sign and ground water monitoring well.

Debris near the location of the old Quarry in the southern portion of the Site.

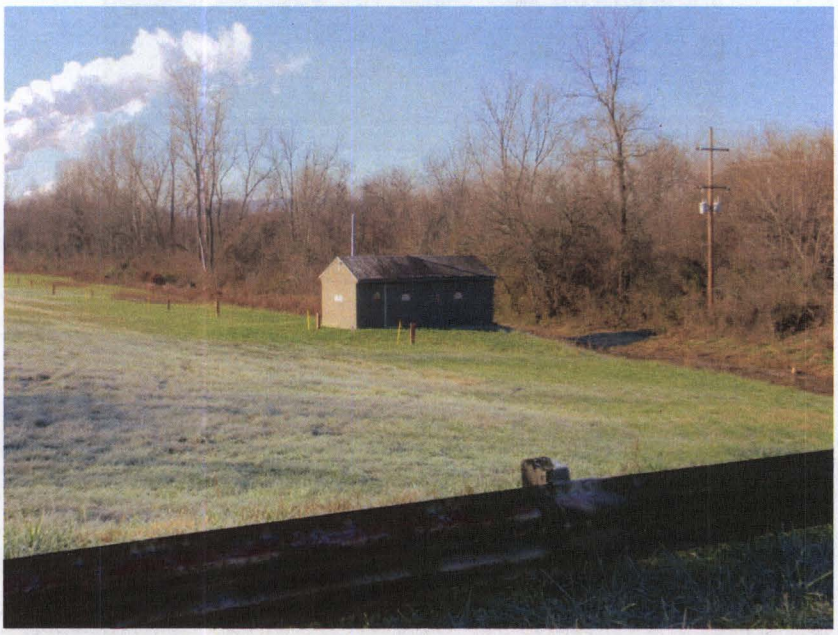
Wells along the gas extraction system and the blower house for the gas extraction system.

Signs clearly marking the gas extraction system.
