20 November 2000
42.25527.0001

17 November 2000

SUMMARY REPORT OF SOIL REMEDIATION AT HATHAWAY/JALK FEE LEASE PROPERTY LOCATED AT 10607 NORWALK BOULEVARD, SANTA FE SPRINGS, CALIFORNIA

Project No. 42.25527.0001

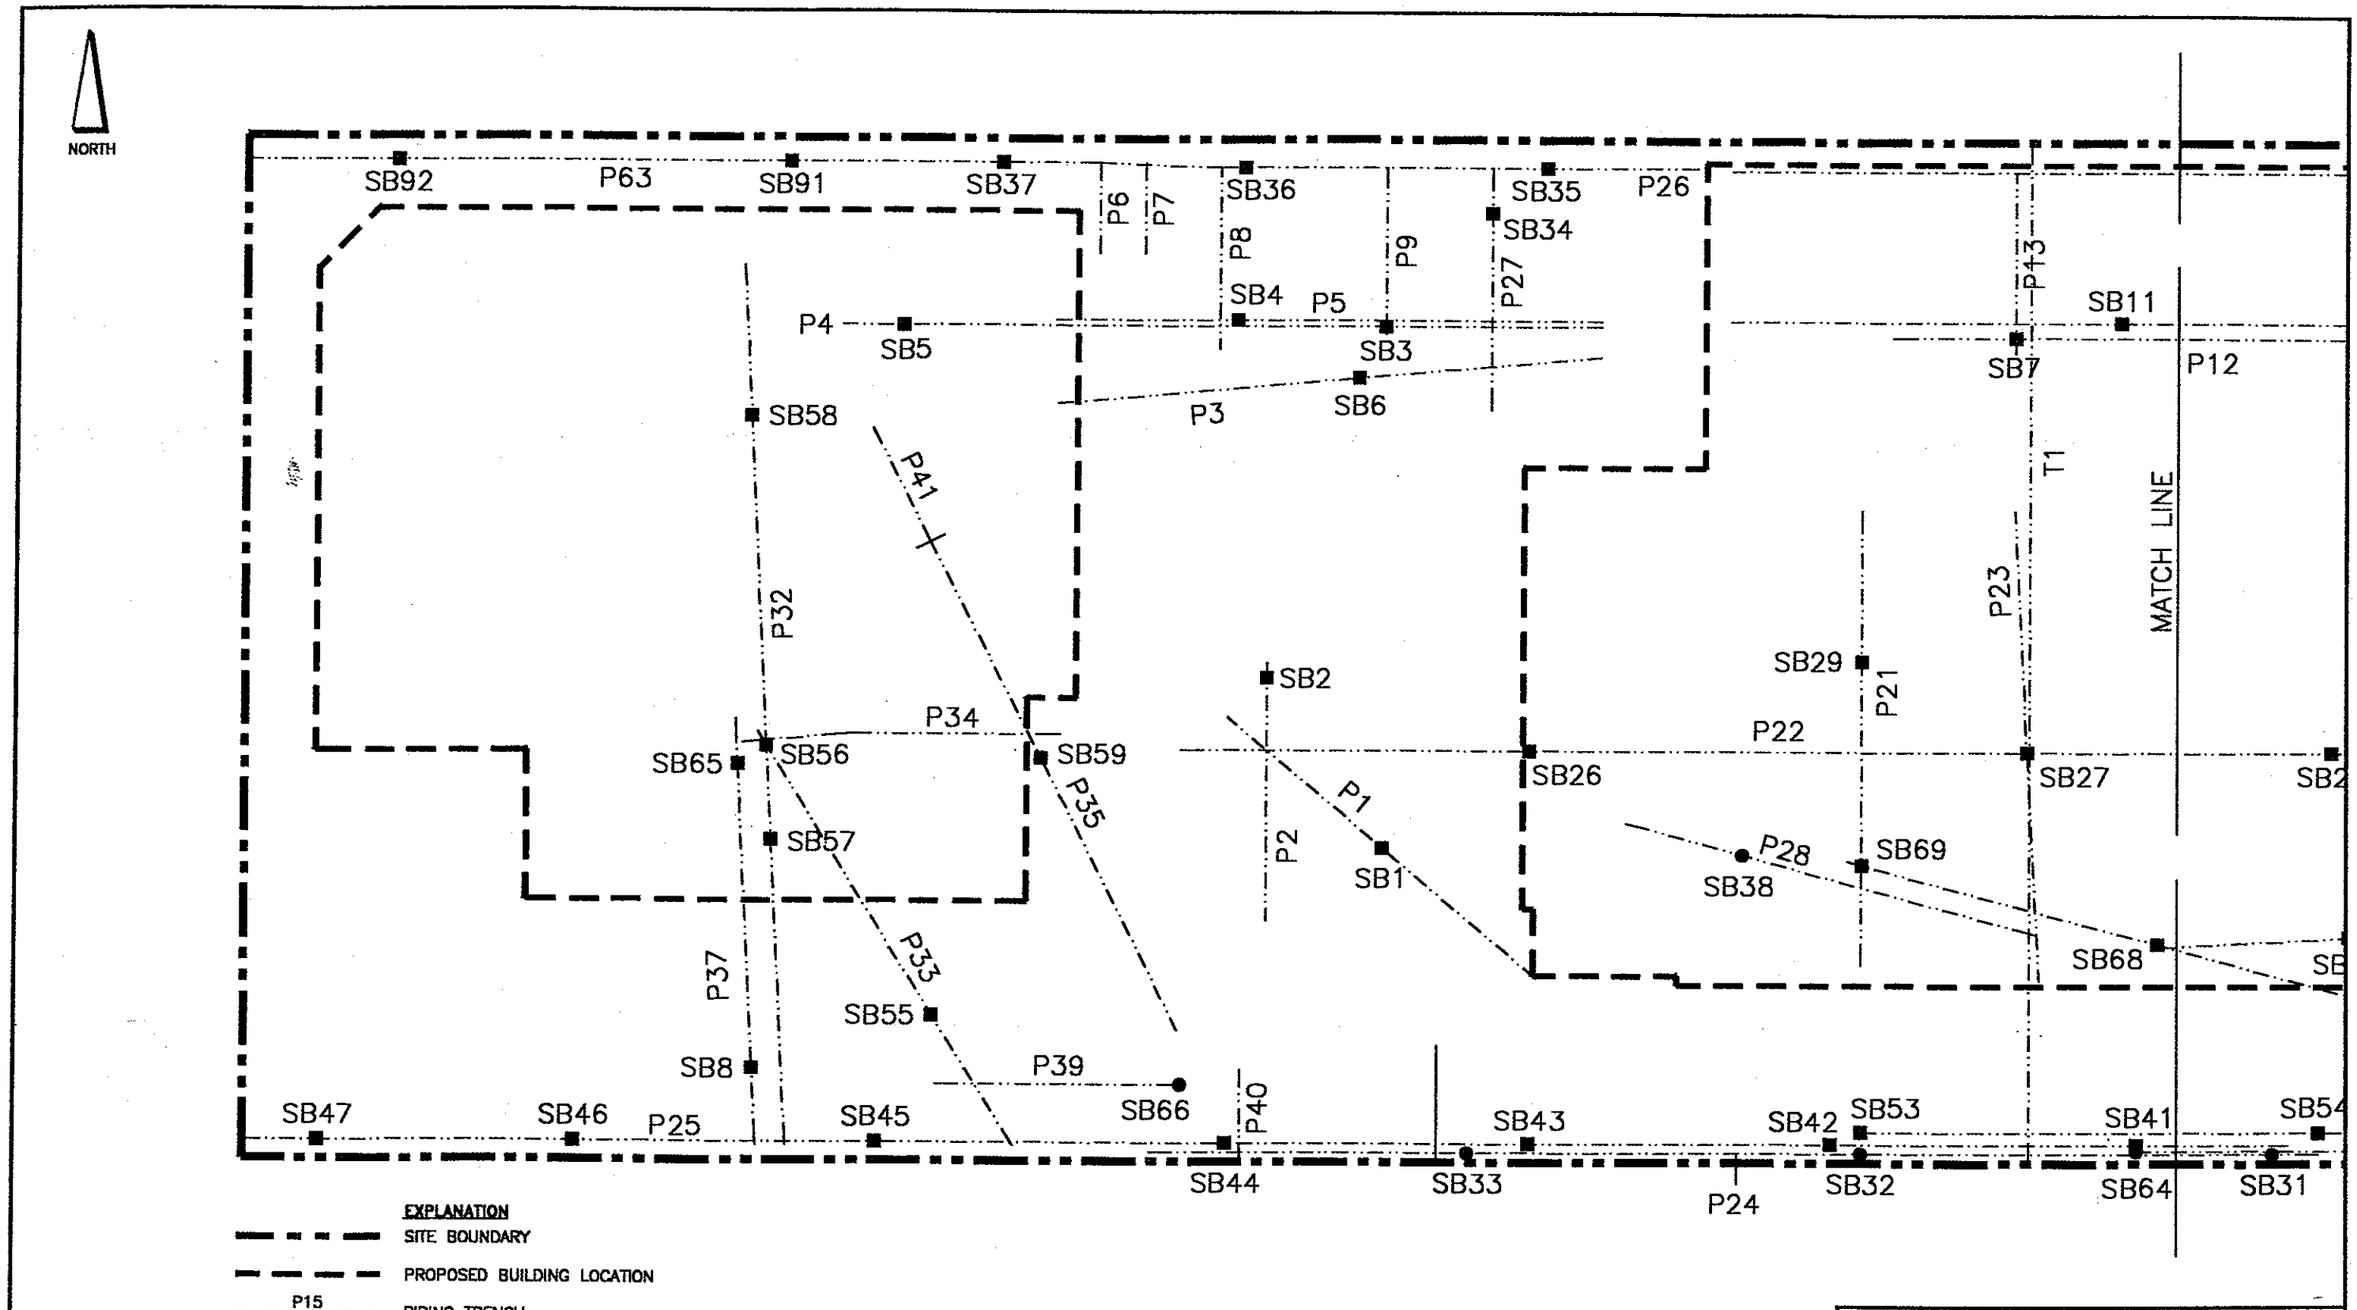
PROJECT NUMBER 42.25527.0001 | FIGURE 2A

A photoionization detector (PID) was used to evaluate soil conditions in the field. Observed petroleum-impacted areas in the trench excavations were recorded on site drawings (see Figures 2A, 2B, 3 and 5B) and photo-documented. A hand auger sampler was used to collect confirmation soil samples from the bottom and walls of the trench and/or excavation. The soil samples were labeled with the date, sample number, and project number. The collected soil samples were delivered to a California-certified environmental laboratory with a request for 48-hours turn-around time on analyses. Soil sampling procedures are described in Appendix B.

Throughout the site 63 trenches (P1 through P63) were excavated to depths ranging from 2 to 4 feet bgs. A total of 93 soil samples (SB1 through SB92 and A2-B) were collected from the 63 trench excavations. Areas with observed petroleum hydrocarbon staining were further excavated until no staining was observed. Confirmation soil samples were then collected for laboratory analysis. See Figures 2A and 2B for trench and soil sample locations. Nine impacted areas (M1 through M9) were found during monitoring of Mobil Oil Company piping excavation and removal. The soil in 8 of the 9 petroleum

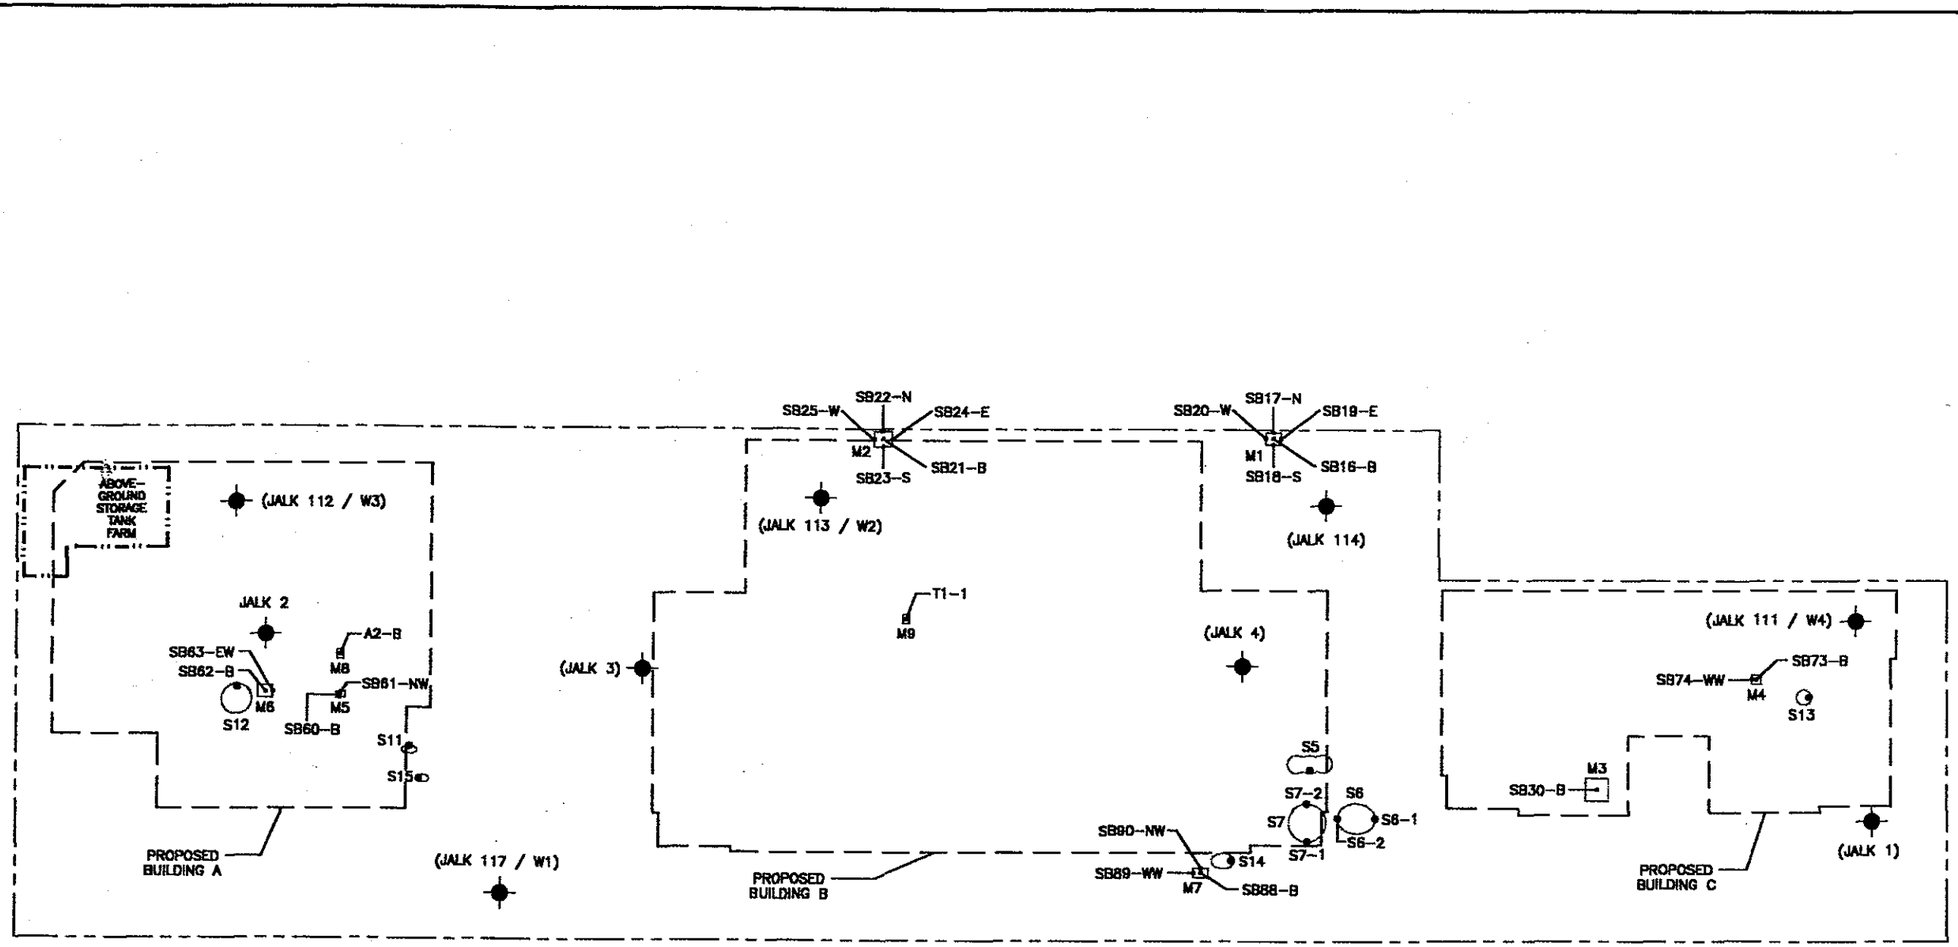
PROJECT NUMBER 42.25527.0001 | FIGURE 3

hydrocarbon impacted areas was initially excavated to depths ranging from 6 to 12 feet bgs. The soil was then sampled by ATC. Stained soil in area M9 was not sampled. Following the excavation work in these nine areas, Mobil Oil Company then took over the responsibility for further characterization (and remediation as needed) of these nine areas and the six areas in the vicinity of samples SB36 and SB37 (trench P26), SB39 (trench P20), SB40 (trench P15), SB49 (trench P29), and SB77 (trench P44).

Eight soil stockpiles (S5, S6, S7, S11, S12, S13, S14 and S15) were generated from areas M1 through M8 and are scheduled to be disposed of off-site by Mobile Oil Company. Seven soil stockpiles (S1, through S4, and S8 through S10) contain soil that was generated from the oil well abandonment activities. Three of the stockpiles (S2, S4, and S9) contain petroleum hydrocarbon impacted soil and are pending disposal by Hathaway. Four soil stockpiles (S16, S17, S18 and S19) were generated from the former tank farm excavation. Two (S16 and S18) are to be disposed of off-site by Hathaway and stockpile S19 is to be disposed of off-site by Mobil Oil Company. Soil stockpiles with petroleum hydrocarbon concentrations below the SFSFD-approved clean-up standards have been used for on-site backfill. These were stockpiles S1, S3, S8, S10 and S17. They were reworked with subsurface soils on the south side of the site, in the proposed parking lot areas. See Figures 3, 4 and/or 5B for excavation, soil stockpile, soil sample, and reworked soil placement locations.

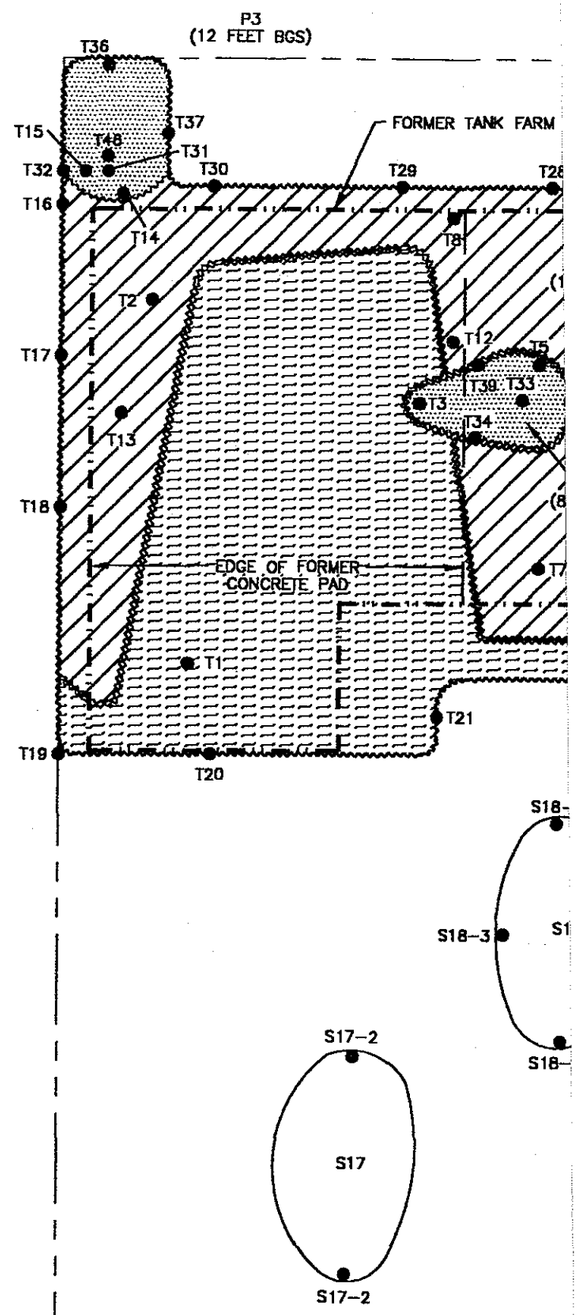
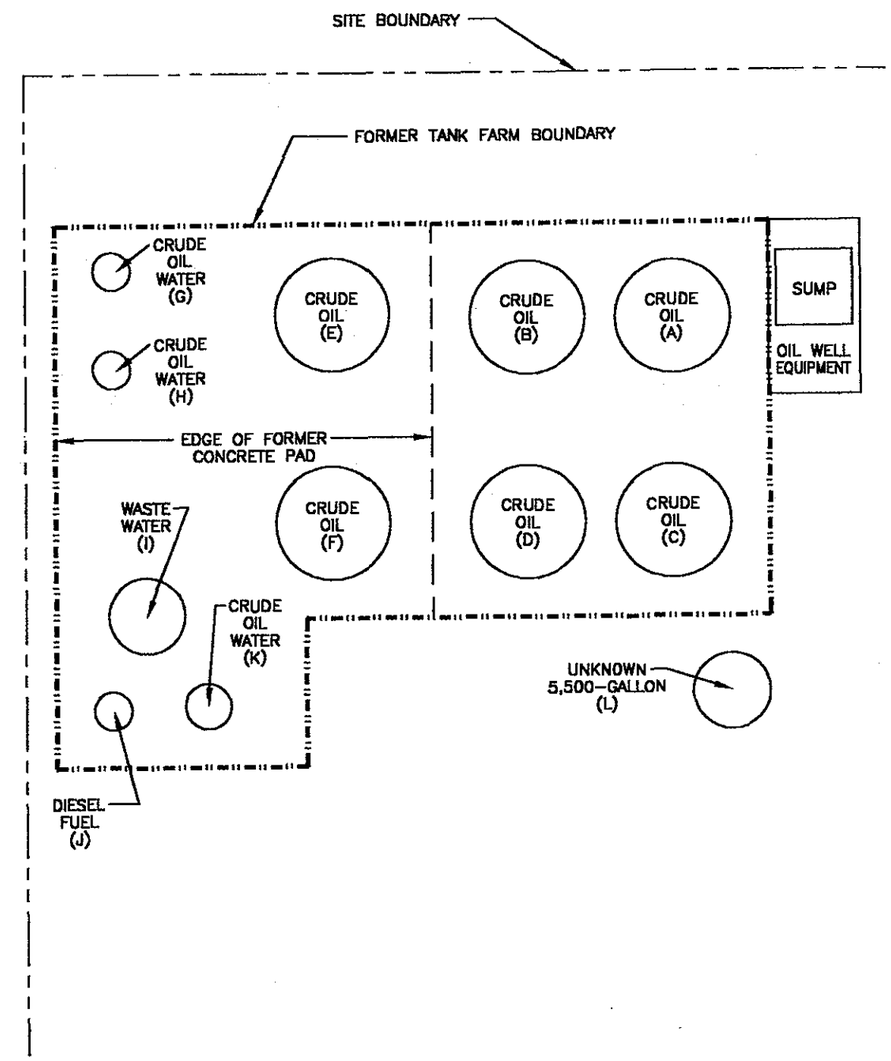
ASTs, and the former surface runoff and the crude oil sumps. Three petroleum-impacted areas (P1, P2 and P3) within the tank farm excavation were observed and further excavated to depths ranging from 8 to 12 feet bgs. The average depth in the remaining tank farm excavation was approximately 4 feet bgs. A total of approximately 1,840 cubic yards (estimated to be approximately 2,400 tons) of impacted soil were excavated from the former tank farm area pending off-site disposal by others under contract to Hathaway. Post-excavation confirmation soil samples were collected from the tank farm area. See Figures 5A and 5B for soil sample locations.

During excavation and abandonment of the crude oil sump, staining indicative of petroleum-impacted soil was observed in the former tank farm excavation, southwest of the crude oil sump. The stained soil appeared to be from piping which was removed along with the ASTs. The petroleum-impacted soil was excavated from this area (P1) to an approximate depth of 10 feet bgs. Confirmation soil samples (T9, T25, T35, and T40 through T45) were collected from the base and walls of the P1 excavation. Based on the laboratory results, no petroleum hydrocarbons exceeded the SFSFD-approved clean-up standards in the analyzed confirmation soil samples collected from area P1.

Surface stains were also observed in soils beneath the northwest corner of the former tank farm. It was reported to ATC by a representative of Hathaway that the impacted soil in this area was due to a crude oil spill by Mobil Oil Company. Soil samples T15 and T31 were collected from this area (P3). Elevated concentration of TPH-cc were reported in these soil samples. Impacted soils in excavation P3 were subsequently excavated to an approximate depth of 12 bgs. Confirmation soil samples (T32, T36, T37, and T46) were then collected from the bottom and walls of the area P3 excavation. Based on the
