REMOVAL ACTION - MOLINE STREET PCB SITE
AURORA, COLORADO

Subject: Moline Street PCB Site – Double Tee Wall Foundation Test Pad

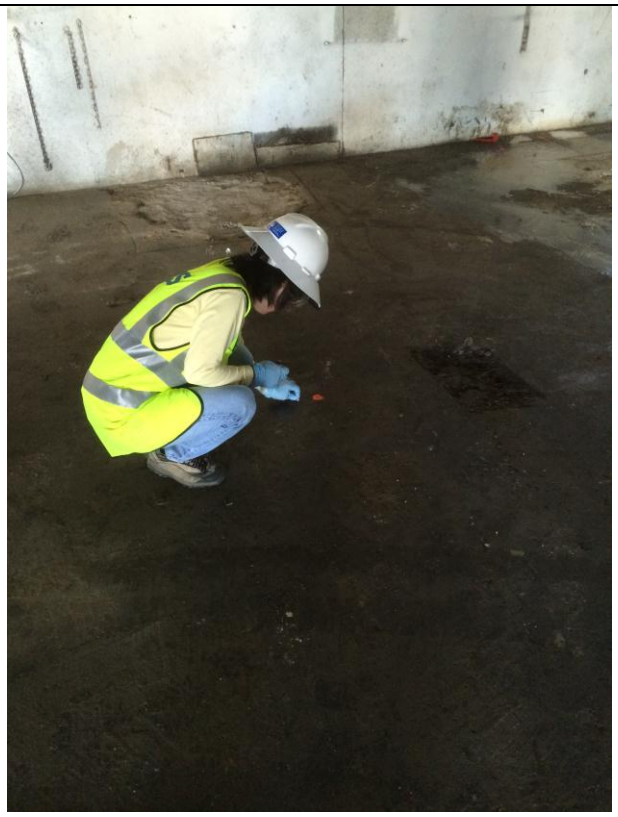
9. Floor wipe sampling.

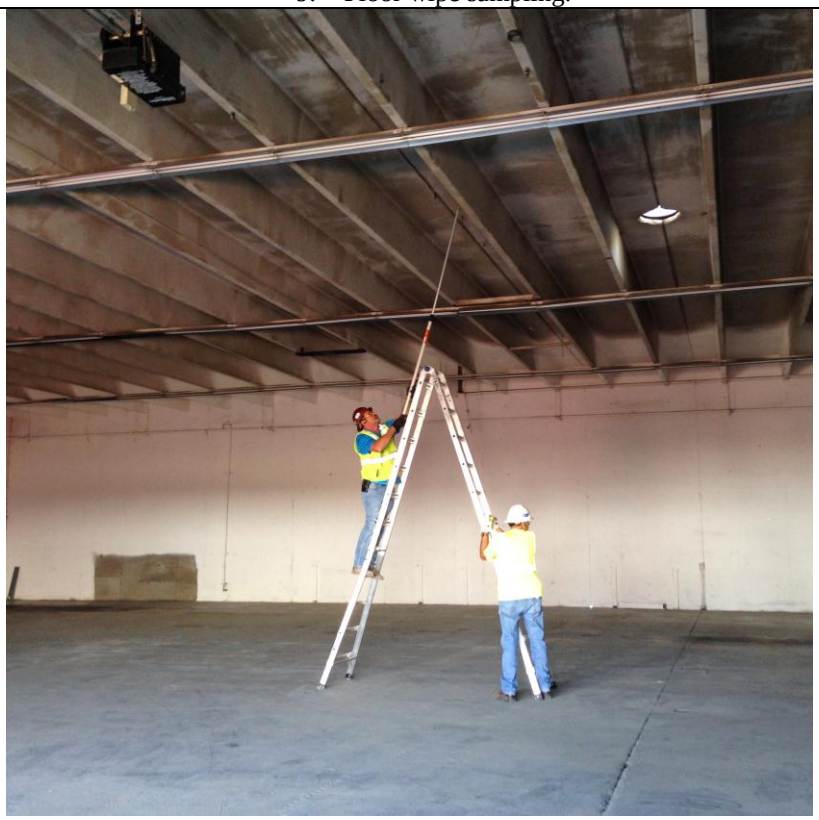
10. Ceiling wipe sampling.

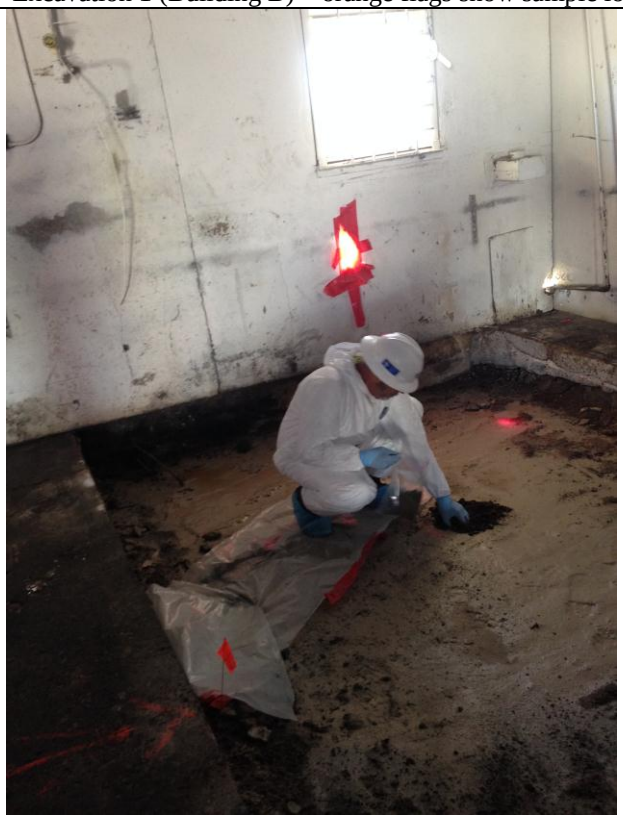
12. Excavation 2 (Building D) sampling – orange flags show sample locations.

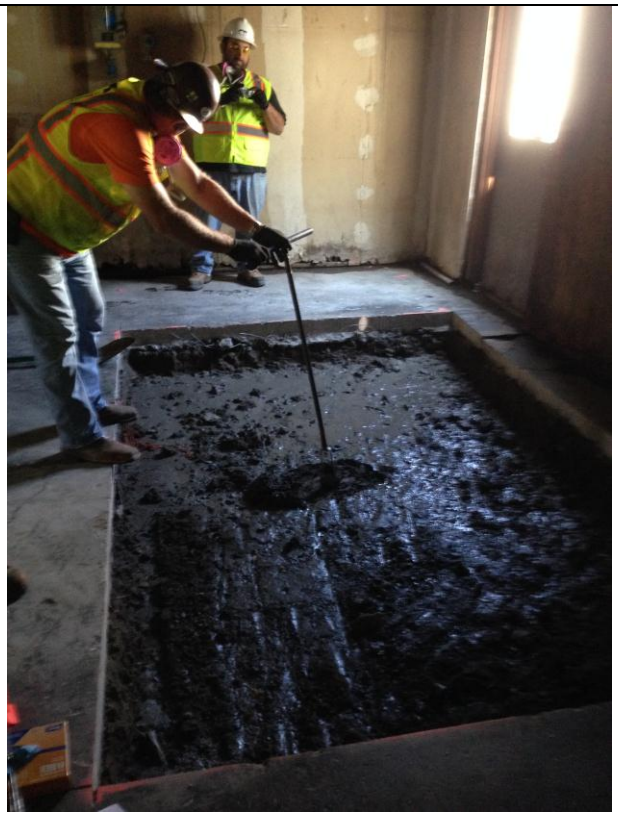
13. Excavation 3 (Building F) sampling.

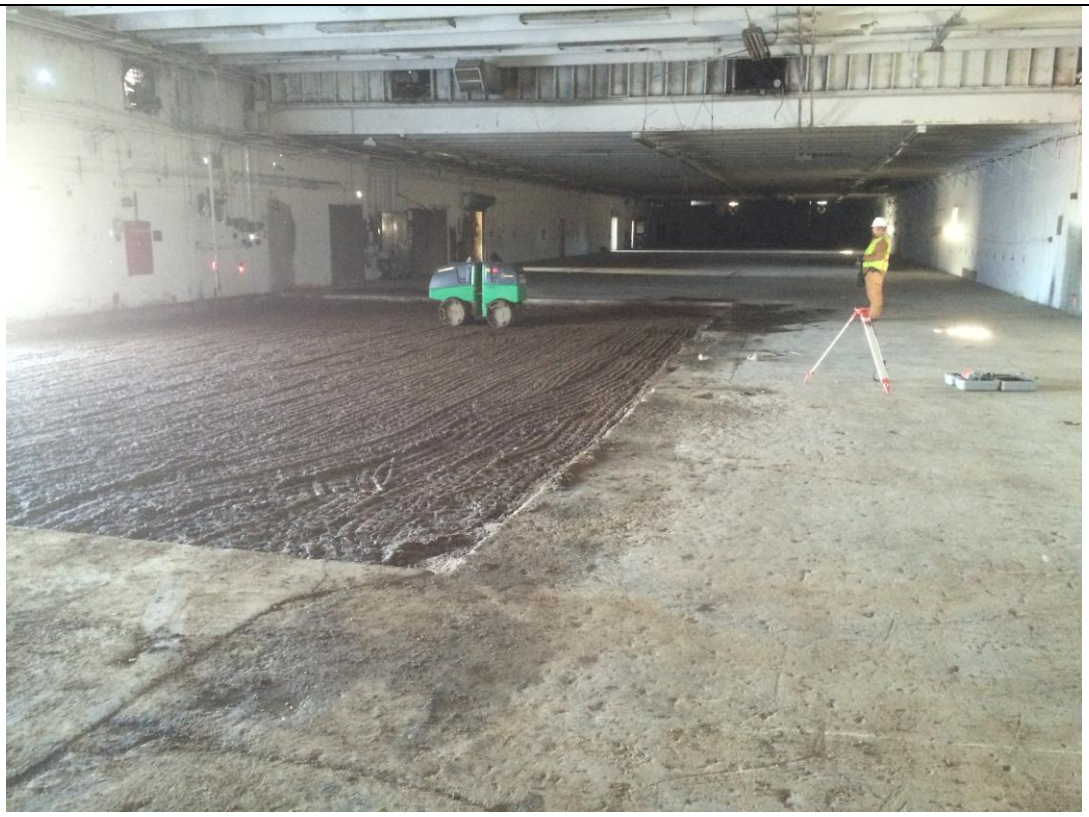
21. Compacting backfill material – Excavation 7 (Building D)

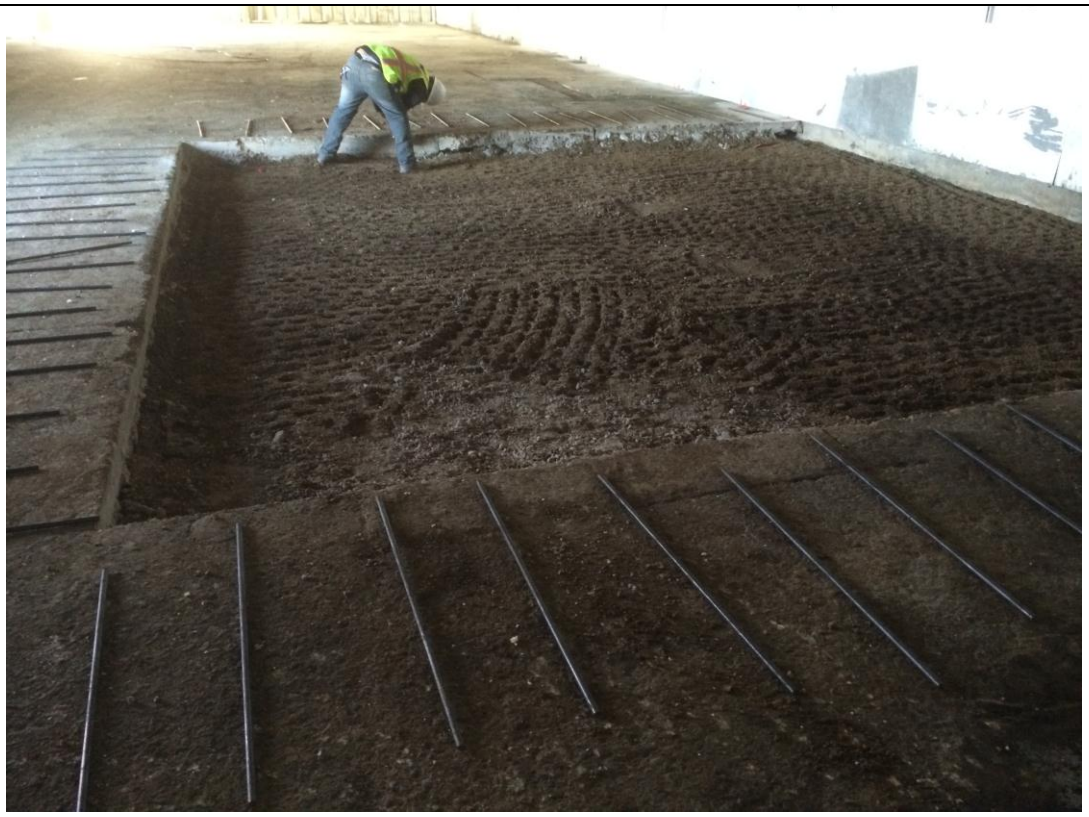
23. Compacted backfill material – Excavation 1 (Building B).

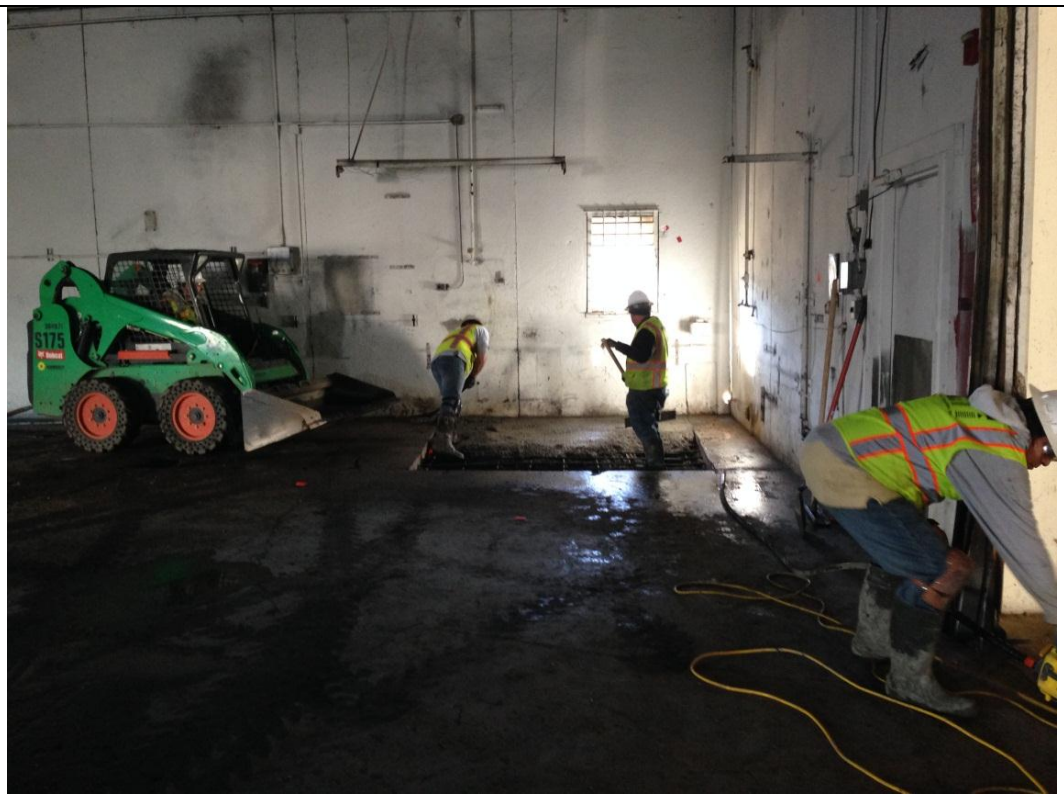
29. Placing concrete in SW corner of Building D (Excavation 2). Note use of skid steer to deliver concrete to slab location.

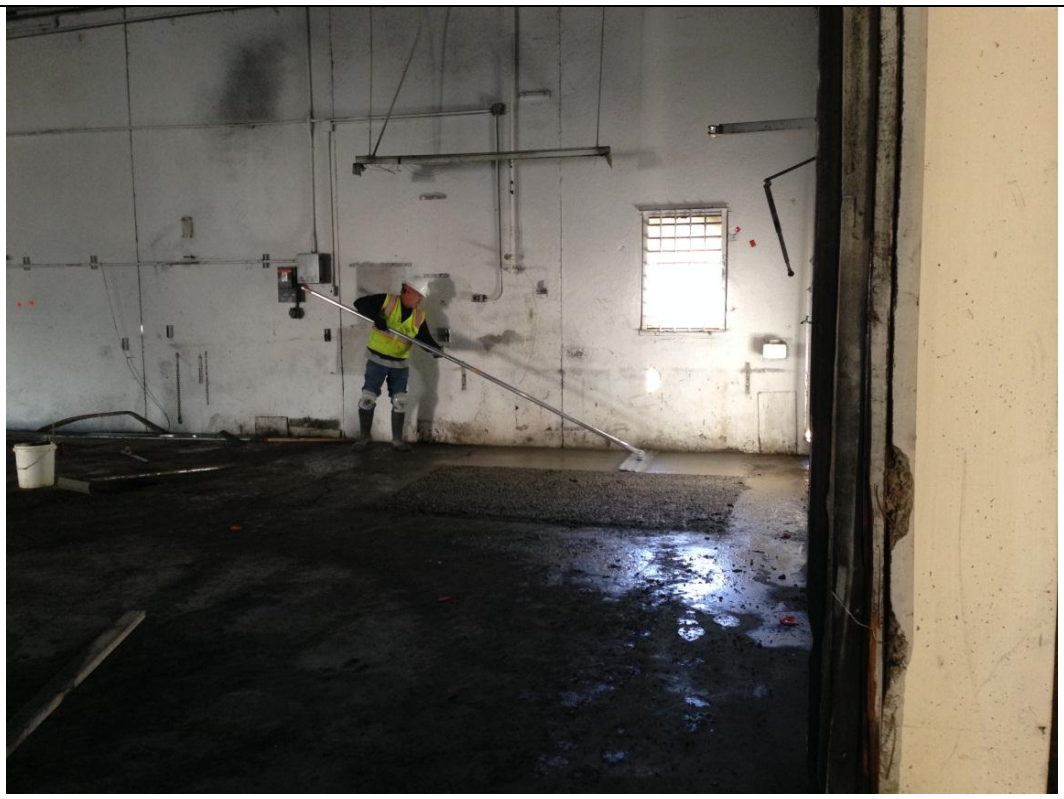
30. Finishing concrete in SW corner of Building D (Excavation 2).

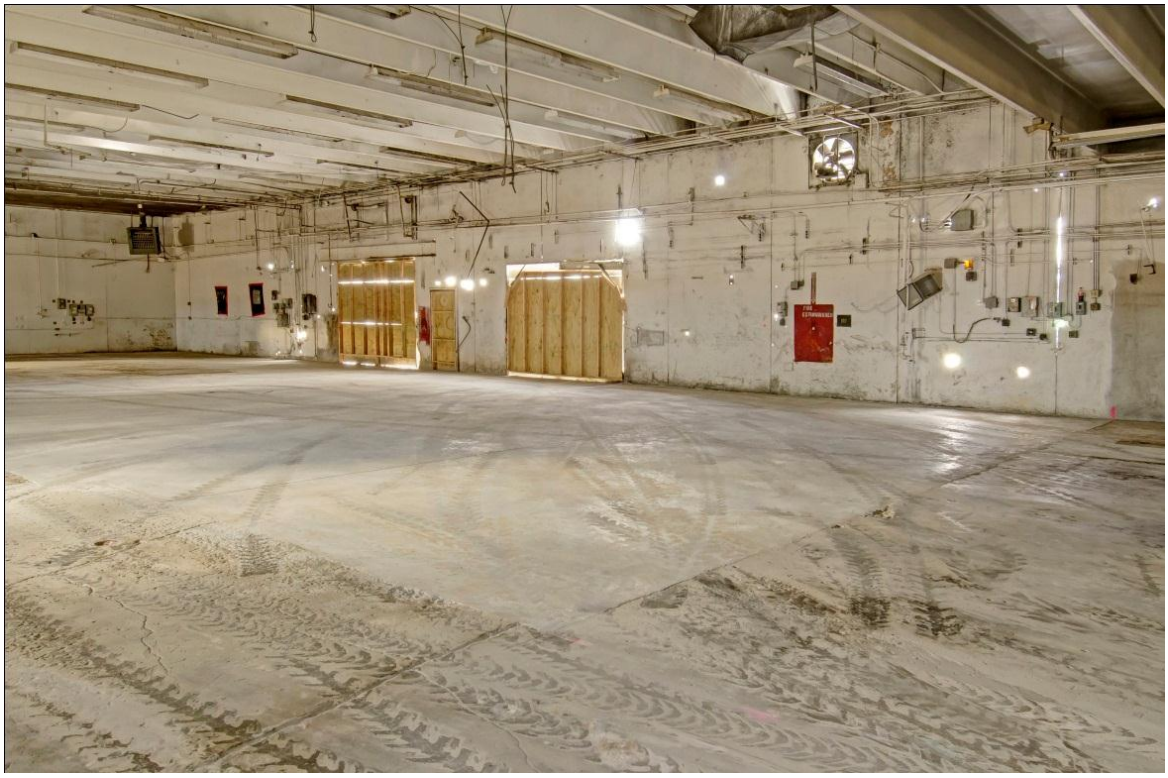
36. Post construction photo of Northern Slab in Building D (Excavation 7) - 11/20/14.

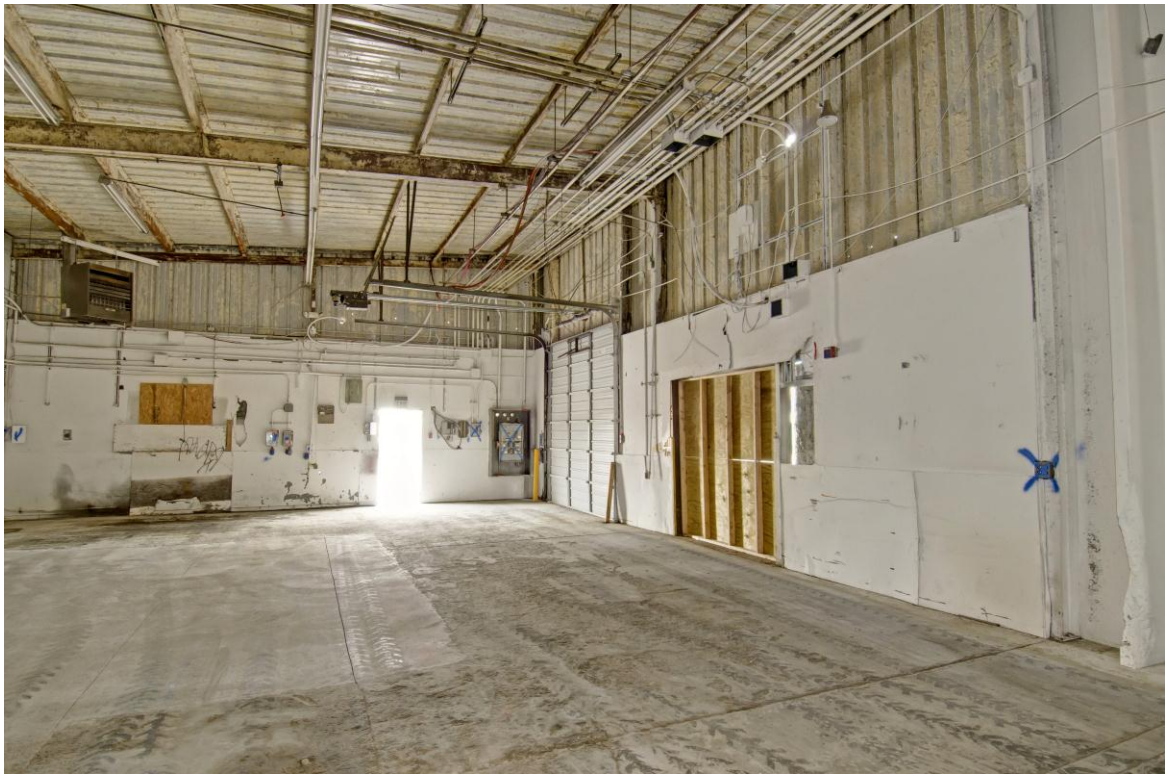
37. Building B post removal looking north - 11/20/14.

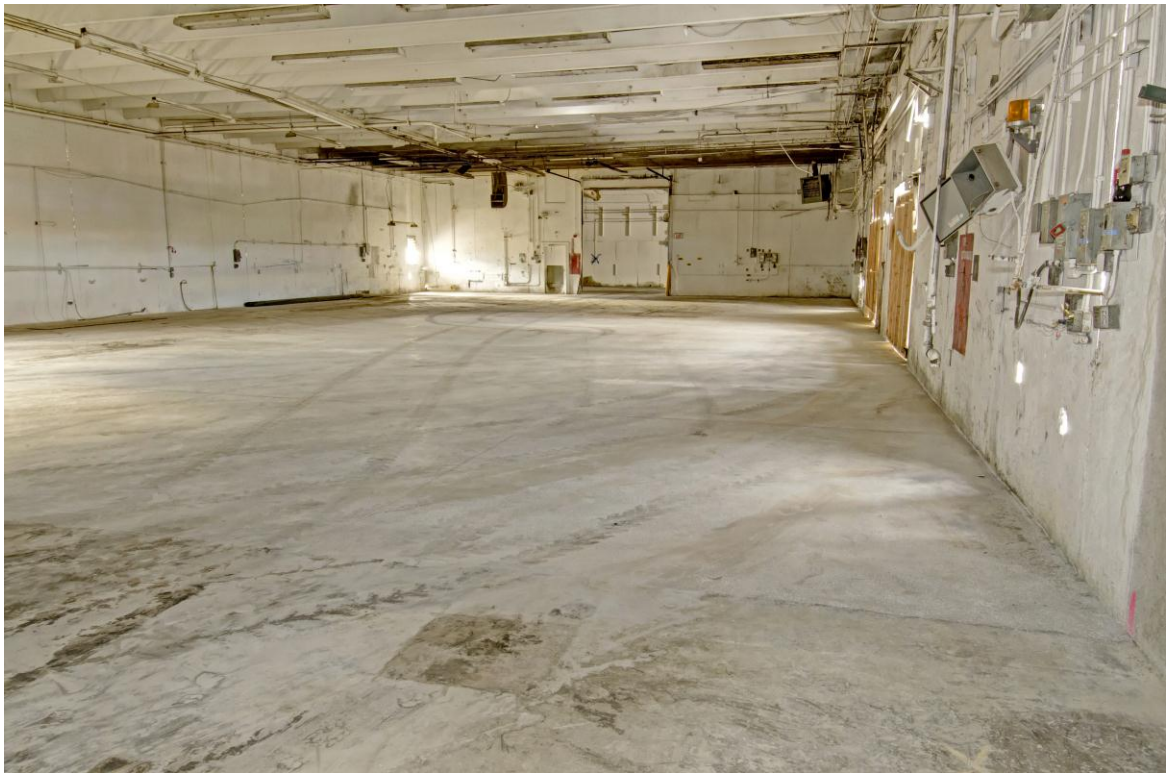
38. Building D post removal looking west - 11/20/14.

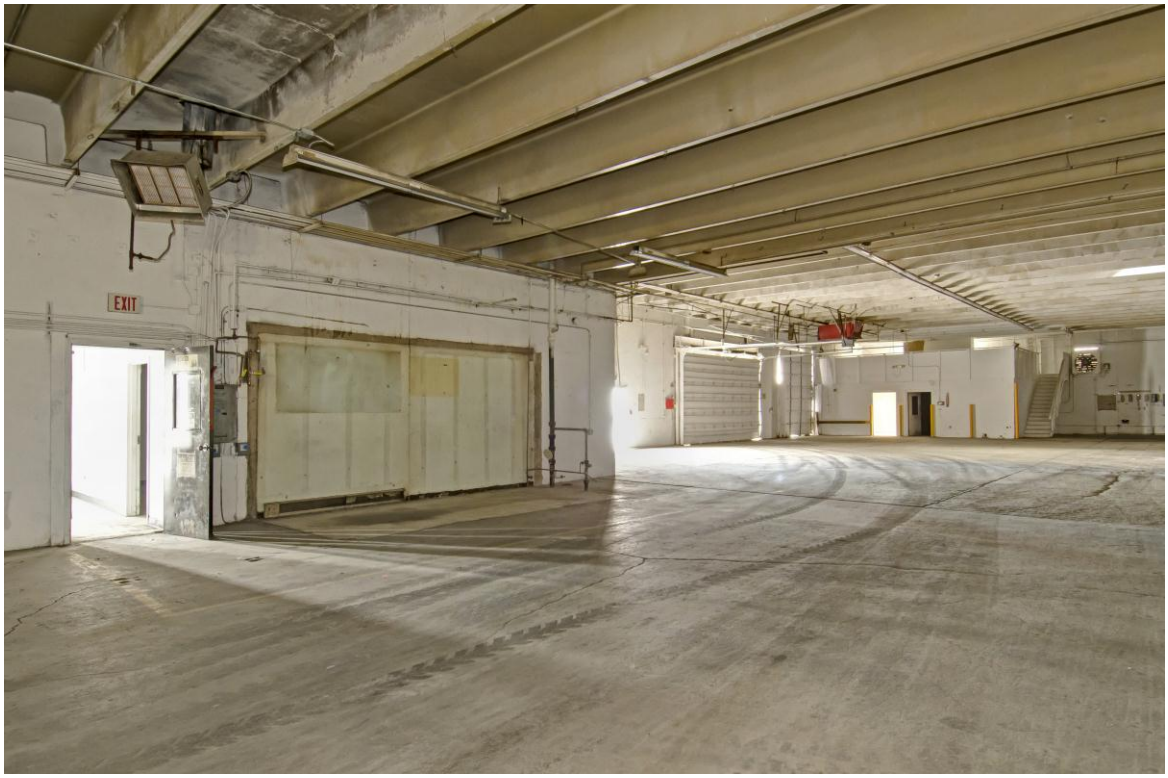
43. Building H post removal looking east - 11/20/14.
