POTENTIAL HAZARDOUS WASTE SITE
SITE INSPECTION REPORT

REGION	SITE NUMBER (to be assigned by HQ)
6	TX 11568

I. SITE IDENTIFICATION TXD000017756

Polymer chemical manufacturing plant with an onsite drum burial area.

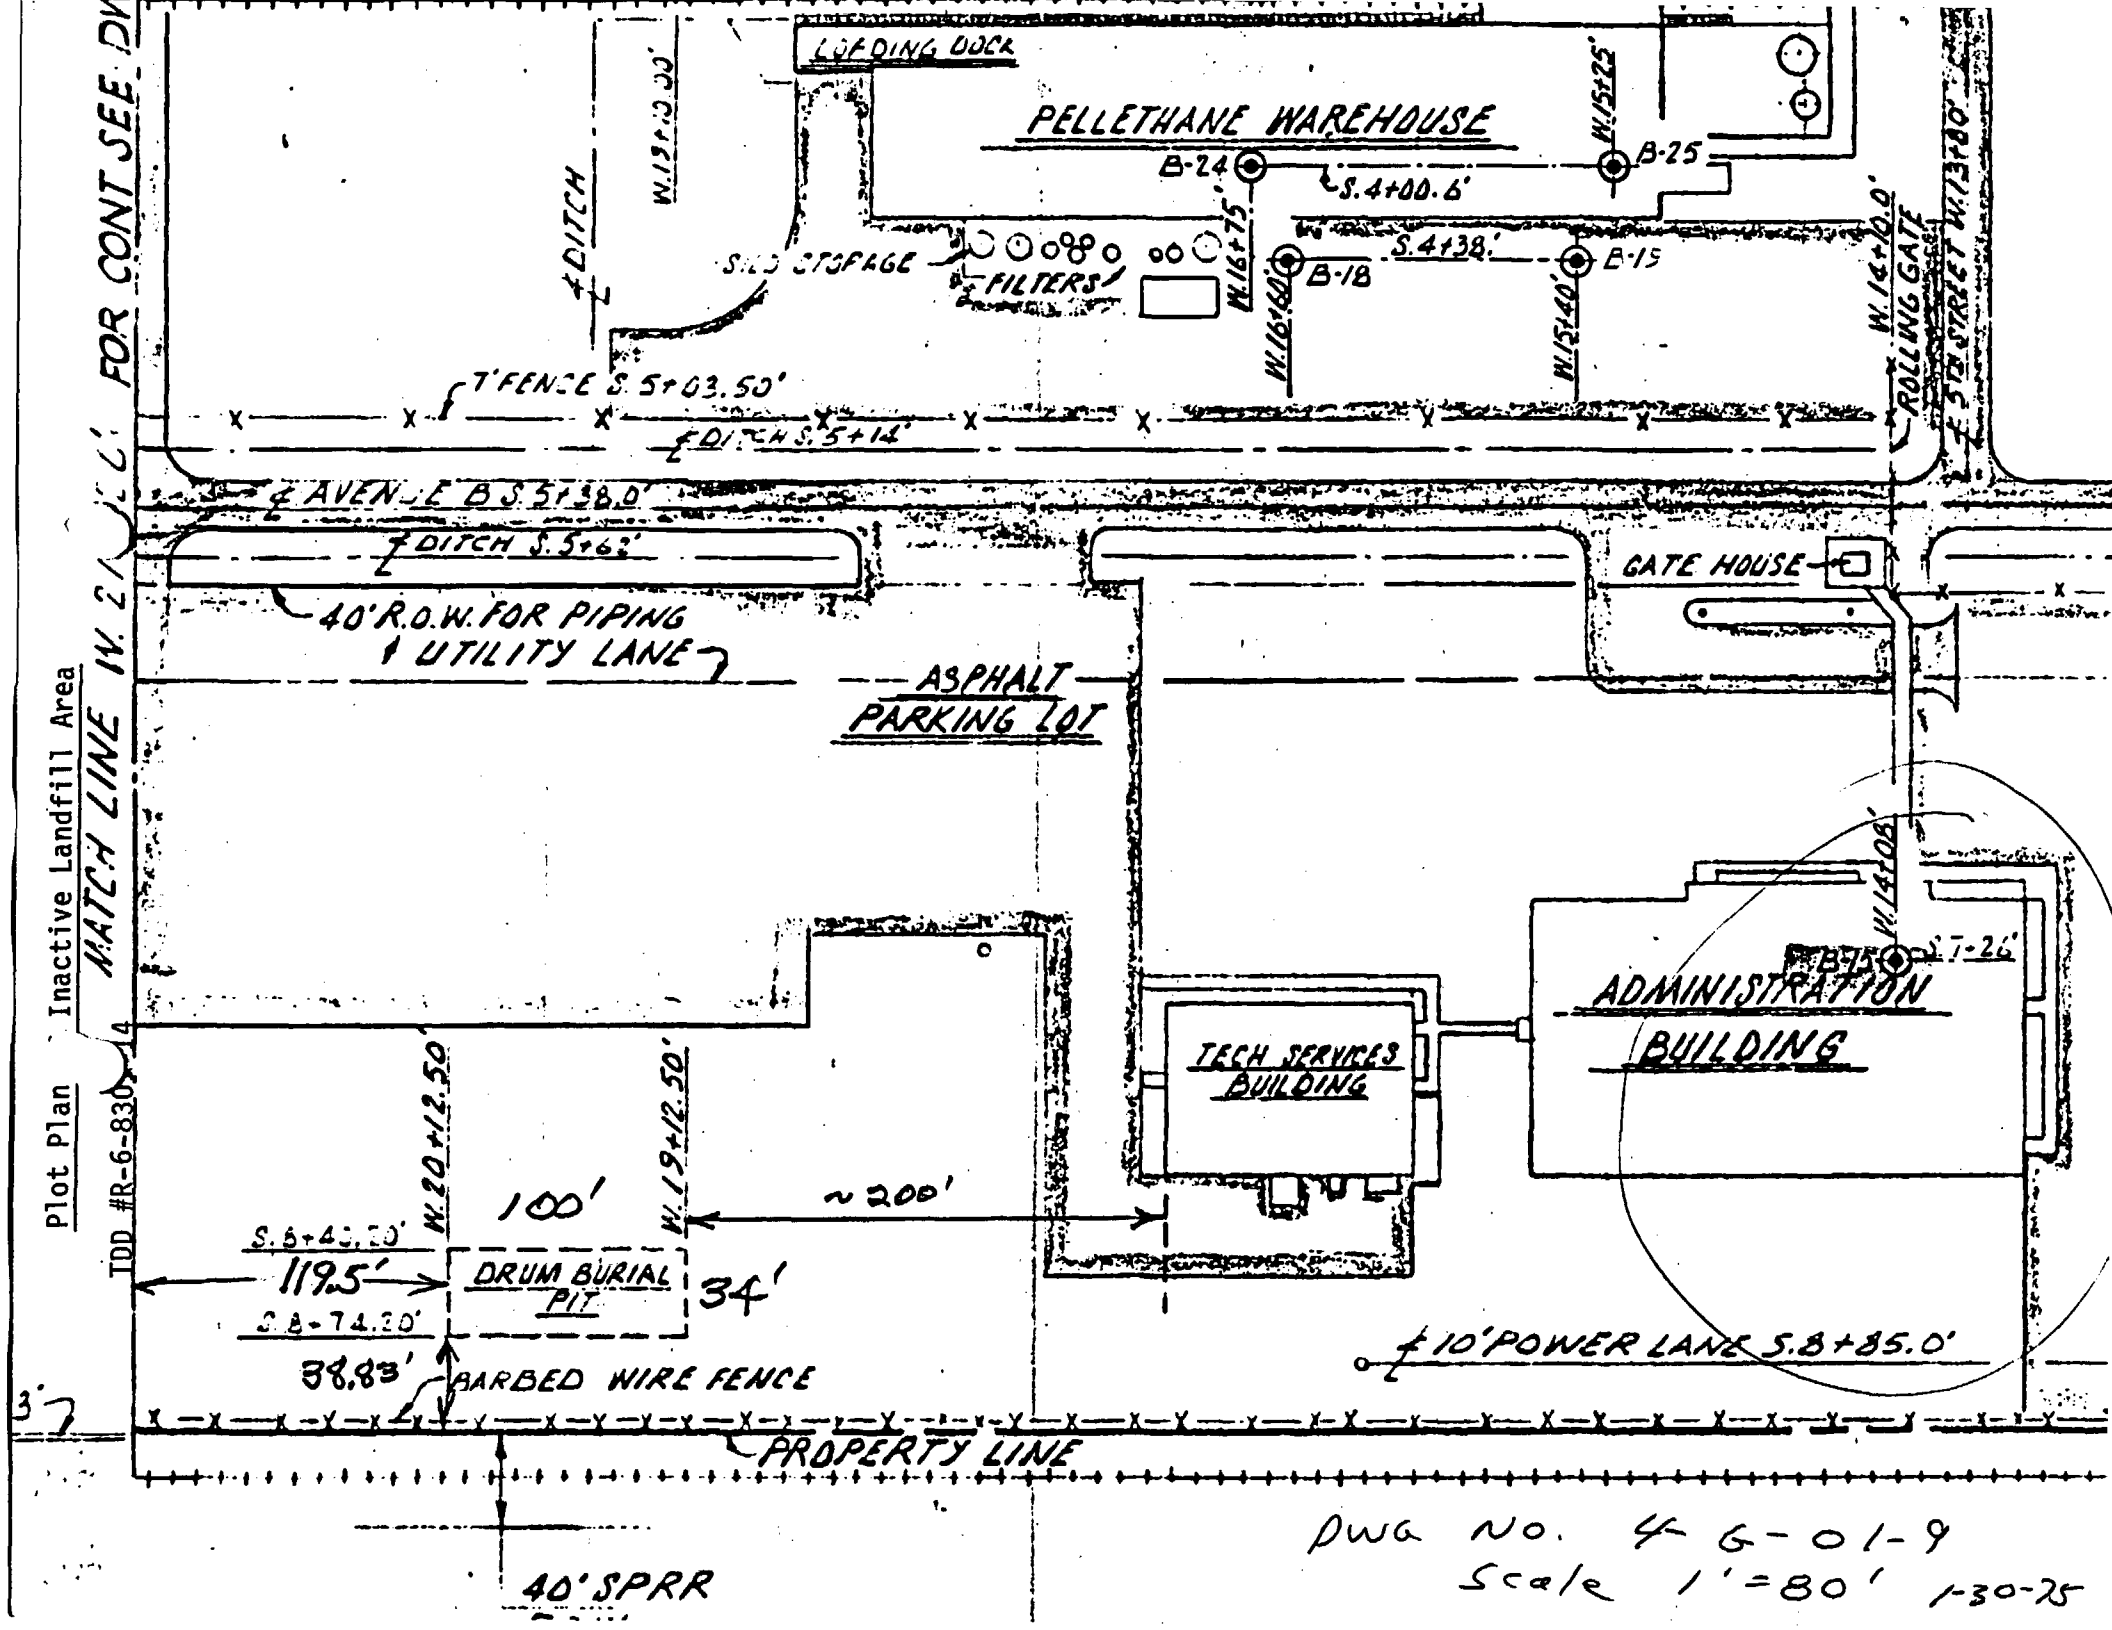
☒ U. OTHER (specify): Prior to and including 1964, approximately 5,000 drums of Butyl isocyanate residue and polymeric isocyanate were generated by the Upjohn company. Less than 1700 drums were buried on-site and the remaining 3300 drums were hauled off-site by local trash companies. A release was signed by the Upjohn company and Jack Arsenault was listed as one of the local trash hauling firms. Each drum was approximately half full and the solvents were distilled off, some plant trash was mixed with the Isocyanates. During construction of the present clarifier ponds these drums had to be relocated to their present site location. Four to six feet of soil was placed over the drums and clay was noted on the bottom and walls of the burial pit. It is believed that the drums are stacked two deep in most places, however, the number of drums placed in the hole is based solely on dimensional calculations. During the interview the Upjohn Company expressed the need to modify their present groundwater monitoring program for the plant to include the drum burial area.

It is therefore recommended that a groundwater monitoring system be established for the burial site and that the Upjohn company should be permitted to initiate the drilling program. If, within a reasonable time, no such groundwater program is established, a surface sampling and drilling program should be conducted to determine the extent and nature of material which may be leaving the burial site.
