CLOSURE REPORT

PCB Decontamination Activities

MIT Lincoln Laboratory

FA Building

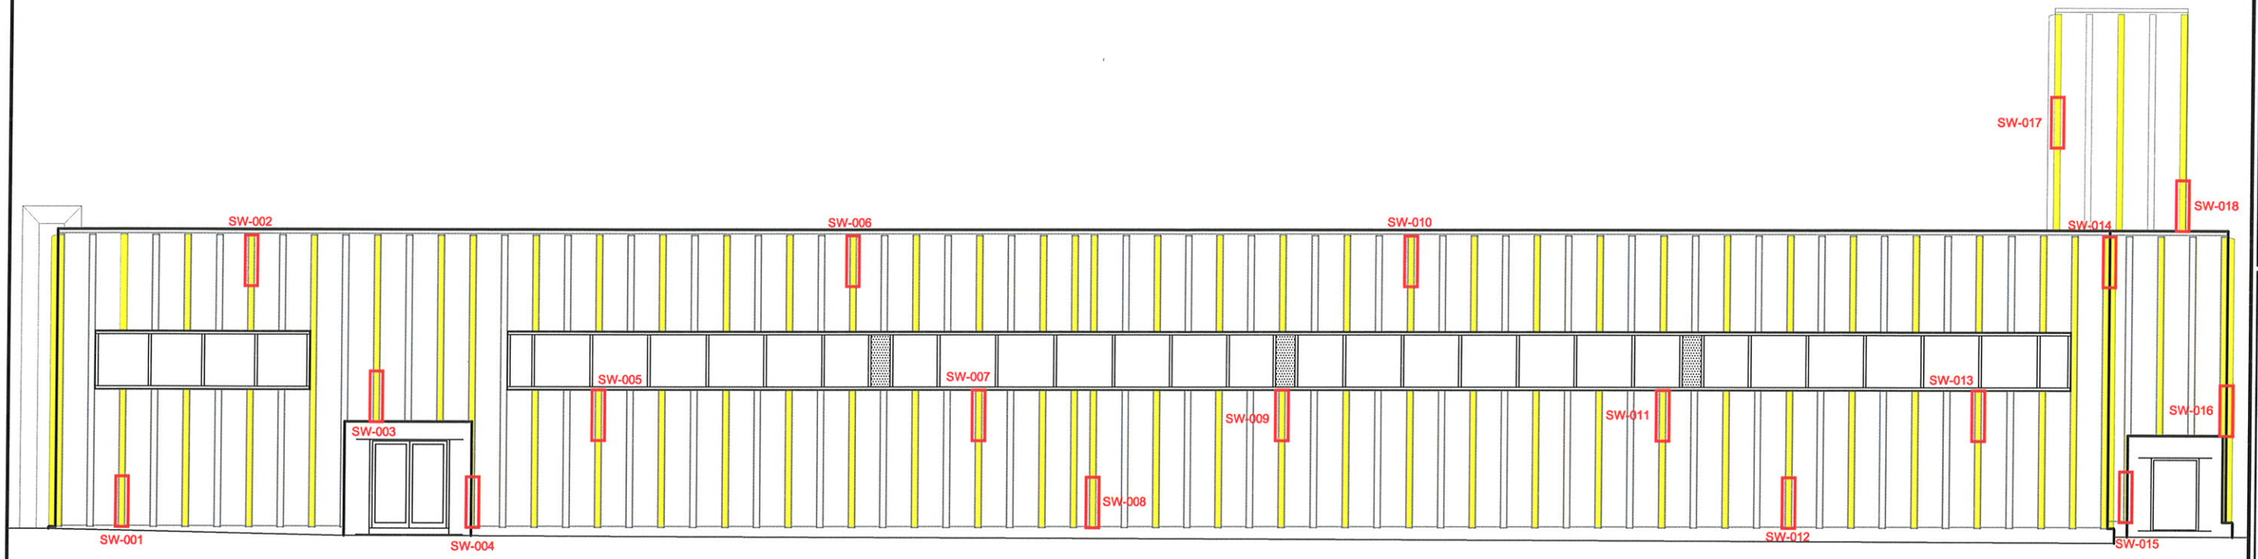
FIGURE 1

SOUTH WALL

1. PLAN ADAPTED FROM "FA BUILDING REMODEL" PREPARED BY BECHTEL FRANK ERICKSON ARCHITECTS, INC. DATED 1/24/07. DRAWING NO. D-482932-13
2. ALL VISIBLE CAULKING HAS BEEN REMOVED FROM THOSE JOINTS CONTAINING CAULKING, EXCEPT AS NOTED.

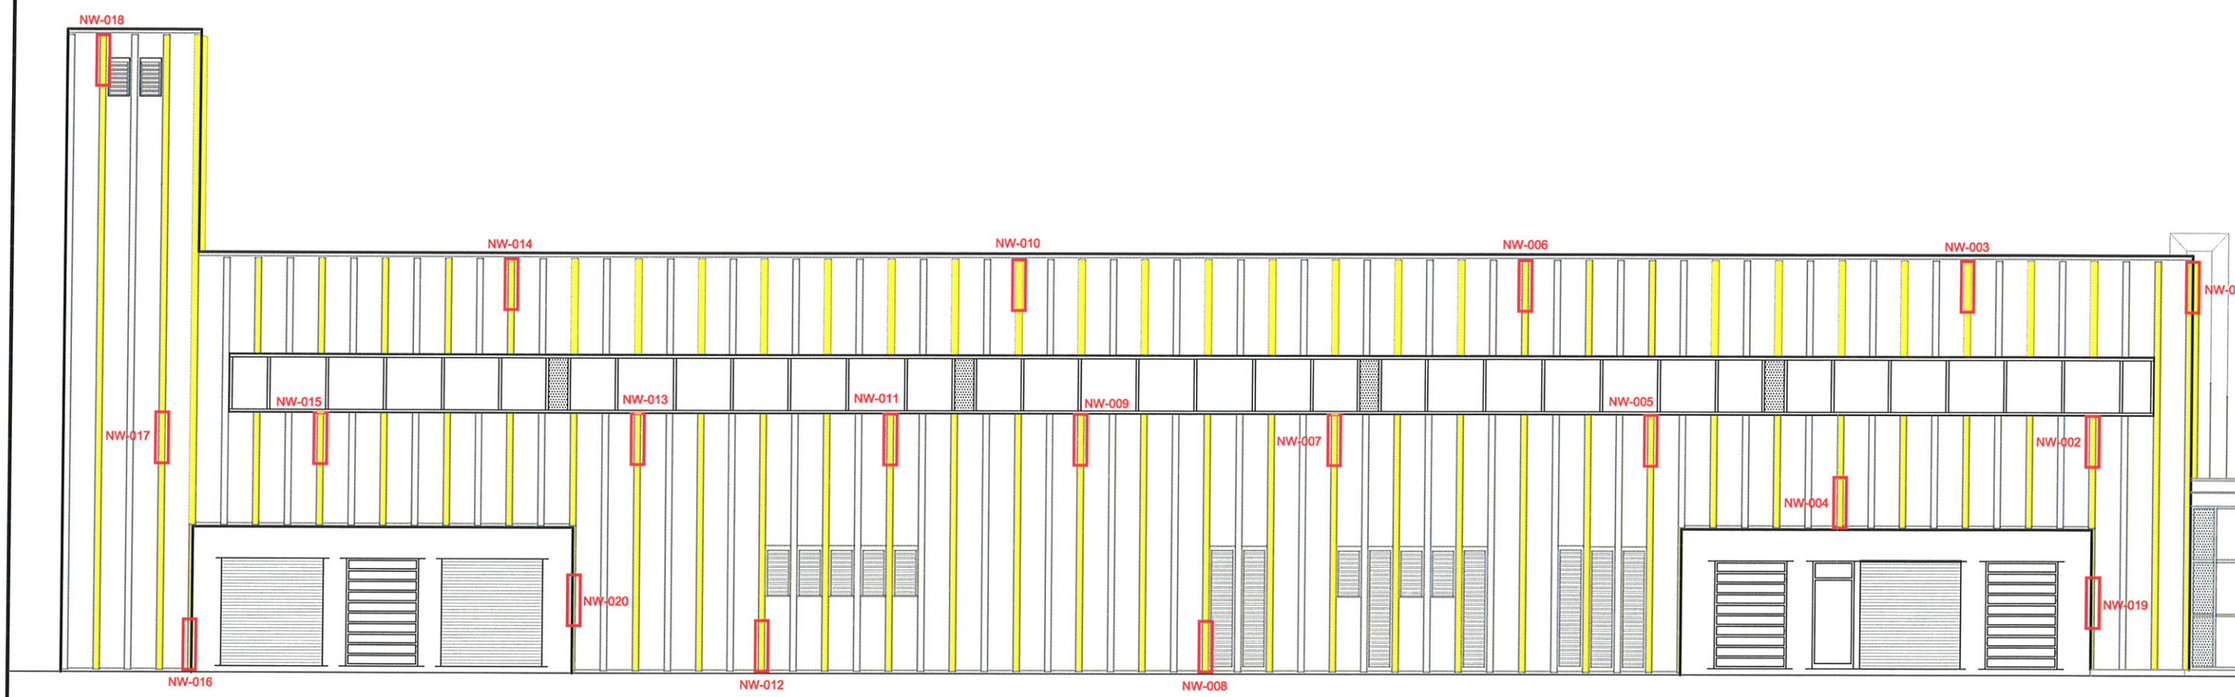
FIGURE 2

NORTH WALL

1. PLAN ADAPTED FROM "FA BUILDING REMODEL" PREPARED BY BECHTEL FRANK ERICKSON ARCHITECTS, INC. DATED 1/24/07. DRAWING NO. D-482932-13
2. ALL VISIBLE CAULKING HAS BEEN REMOVED FROM THOSE JOINTS CONTAINING CAULKING, EXCEPT AS NOTED.

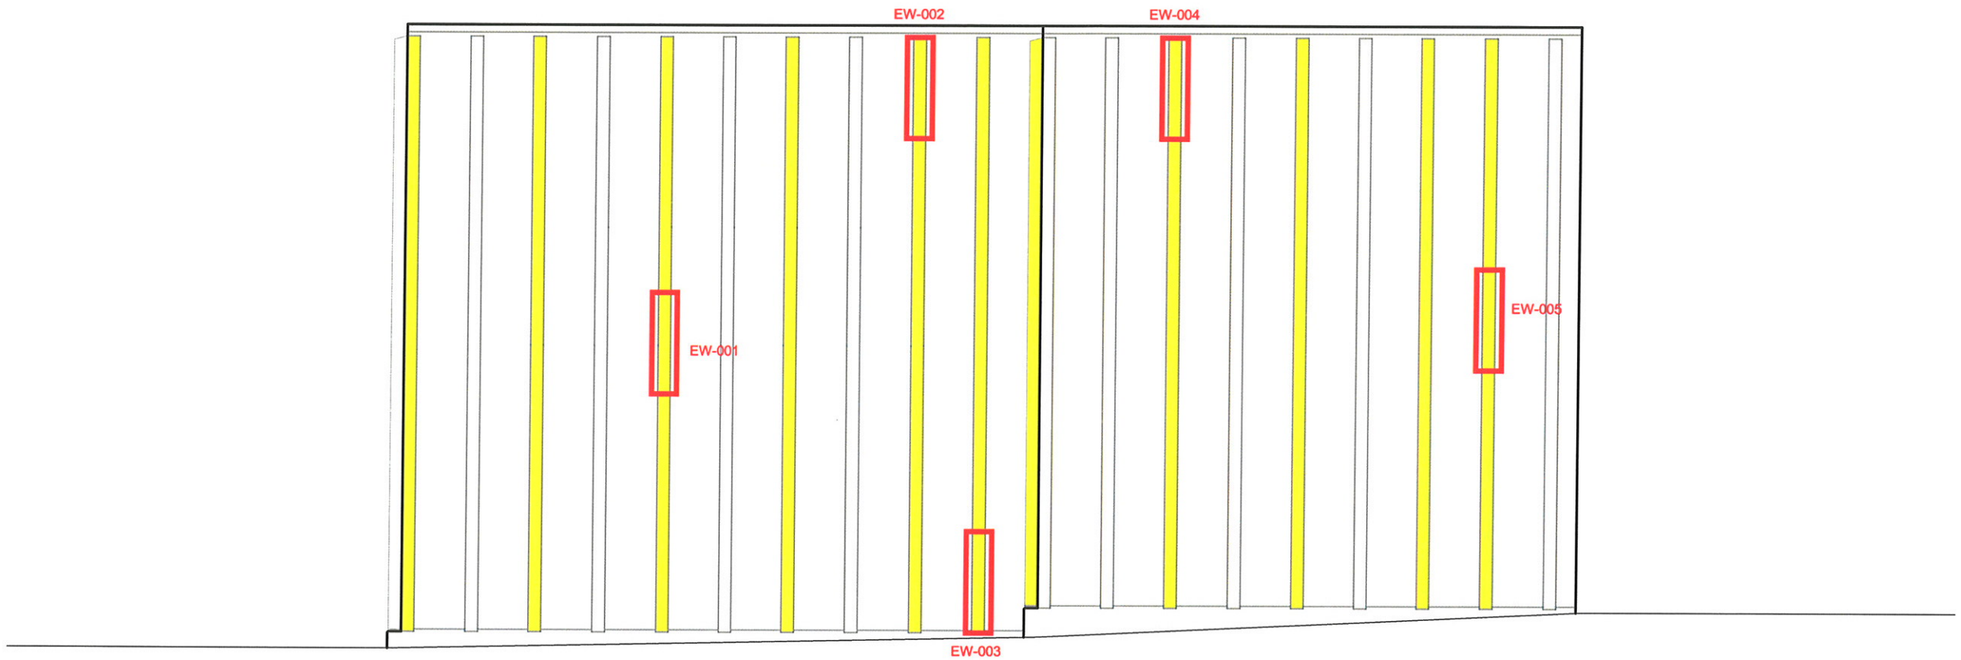
FIGURE 4

EAST WALL

1. PLAN ADAPTED FROM "FA BUILDING REMODEL" PREPARED BY BECHTEL FRANK ERICKSON ARCHITECTS, INC. DATED 1/24/07. DRAWING NO. D-482932-13
2. ALL VISIBLE CAULKING HAS BEEN REMOVED FROM THOSE JOINTS CONTAINING CAULKING, EXCEPT AS NOTED.
