Re: Final Completion Report
Former Stewart Commons Dining Hall
University of Maine, Orono, Maine

Final Completion Report

PCB Remediation

Former Stewart Commons Dining Hall

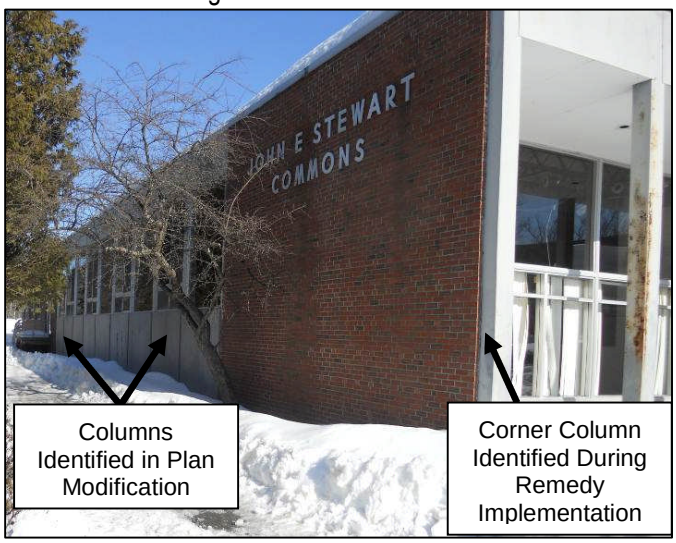
- *Southeast and Southwest Building Corners*: the southeast and southwest corners of the building each feature a structural metal column observed to be identical to the structural metal columns present along the east and west façades of the building as identified in Section 2.1.2 of the Plan Modification. A single bead of caulking was observed along the length of the joint measuring 15 linear feet (l.f.) between the metal column and the adjacent brick wall at each corner, where the caulking was observed to be the same that was present at other metal column to brick wall joints (i.e., previous sample UMSC-CBK-005, reported with PCBs at 135,000 ppm). The same joint configuration was also observed at two shorter heights of brick wall near the same building corners, which each measured 6 l.f. in length. The entire 42 l.f. of this caulking (2 joints x 15 l.f. plus 2 joints x 6 l.f.) was removed for off-site disposal as PCB waste ≥ 50 ppm by the same methods as other PCB ≥ 50 ppm caulking at the building. The adjacent bricks and metal columns were managed as described in Sections 2.2.6 and 2.3.3 of this Report, respectively.

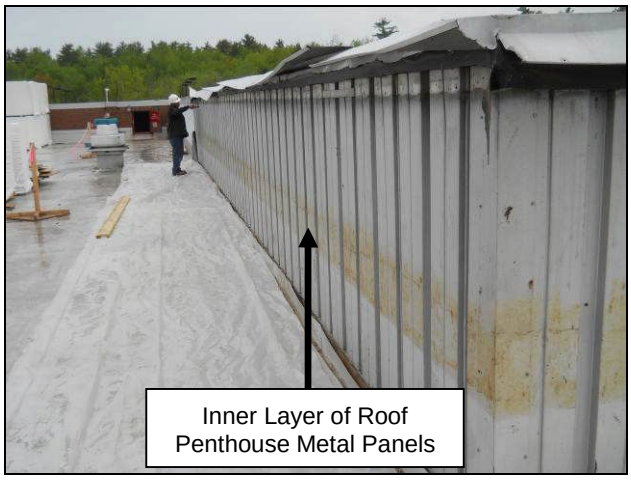
- *Roof Penthouse*: the roof penthouse structure depicted in the photos below was scheduled for demolition as part of the building renovation project. No caulking or sealants were identified in association with the metal panel joints that were visible on the outer structure at the time of initial building characterization and the development of the PCB Remediation Plan (see photo below, at left). However, after removing the outer layer of metal wall panels, an inner layer of metal wall panels were found to contain a bead of caulking at the vertical seams between each overlapping panel edge (see photo below, at right). A sample of this caulking was tested and found to contain PCBs at 407,000 ppm (similar in appearance and concentration to caulking found at east and west façade window frame to metal column joints). The total quantity of this roof penthouse caulking was approximately 340 l.f. (5-foot joints x 68 seams). The caulking, which was found in direct contact with only the inner layer of metal panels, was removed collectively with the metal panels for off-site disposal as PCB waste ≥ 50 ppm.

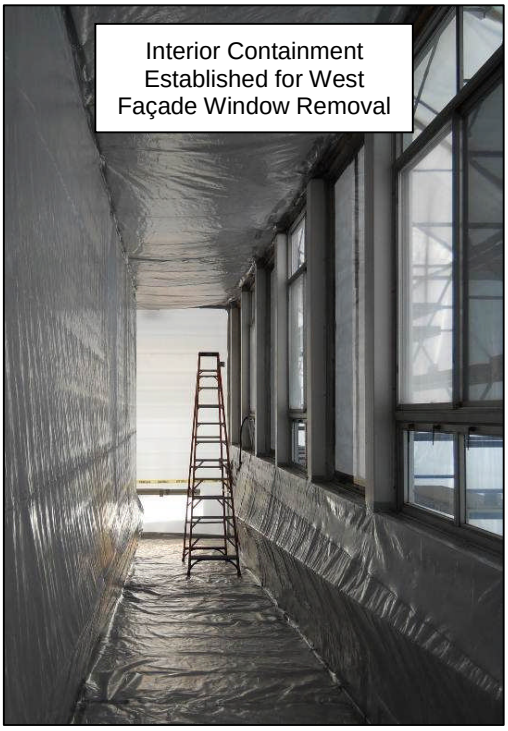
East and west façade windows adjacent to exterior caulking identified with PCBs ≥ 50 ppm as described in the Notification were removed for off-site disposal as PCB waste ≥ 50 ppm. The windows were removed using hand tools within a containment area as shown in the photo at right.

After gross caulking removal, the windows were the first building components to be removed on the east and west façades due to the sequence of work required in order to decontaminate the metal columns and granite panels located adjacent to these windows.

No verification samples were collected in association with the east and west façade windows, as the windows were removed in their entirety (remnant caulking, metal frames, and glass panes). Adjacent metal columns and granite panels were subsequently decontaminated as described in Section 2.3 of this Report.

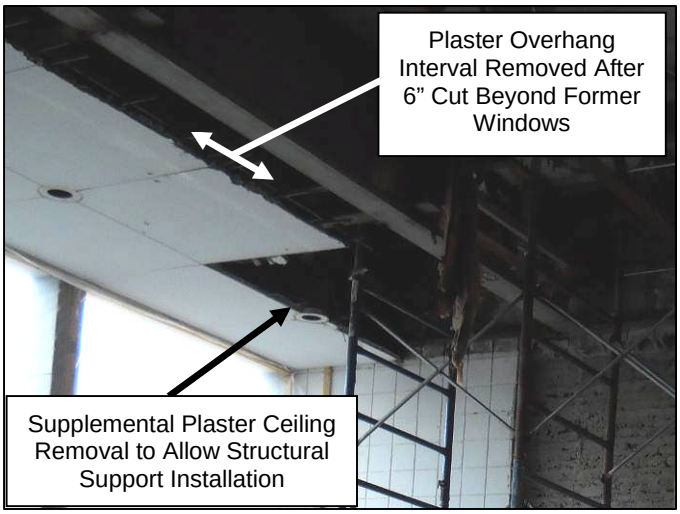
The plaster ceiling removal work was performed within the same interior and exterior containments established to remove the concrete block walls. After gross caulking removal, the plaster ceiling materials were sawcut at the cut line and removed by hand using chisels and pry bars. The debris was either loaded by hand into polyethylene bags prior to removal from the work area, or was transferred directly by truck to lined roll-off containers staged adjacent to the remediation work areas.

Plaster ceiling materials confirmed to contain PCBs ≤ 1 ppm was managed as general demolition debris (non-PCB waste) in accordance with the architect's renovation plans. Plaster ceiling materials containing PCBs > 1 ppm (within the cut-line) was managed with the caulking and direct contact window components for off-site disposal as PCB waste ≥ 50 ppm. A photo depicting the plaster ceiling cut adjacent to the southwest lobby window is provided above.

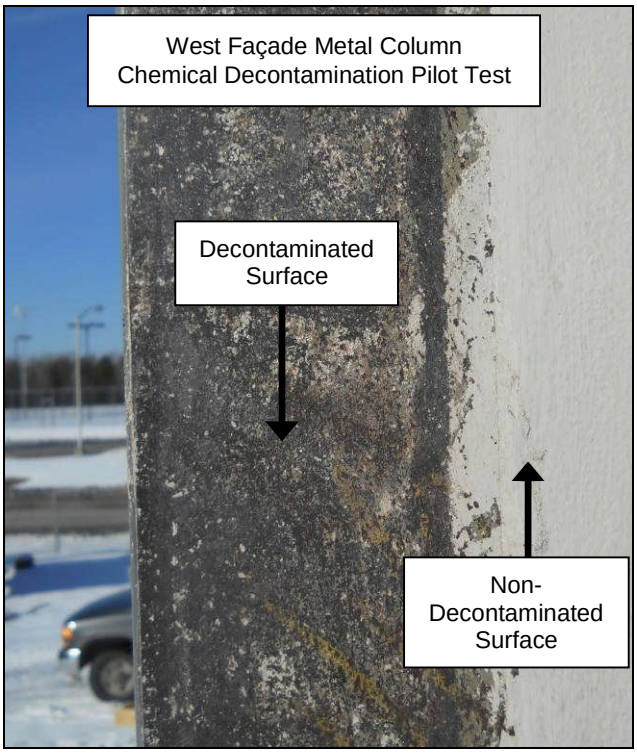
- One chemical decontamination pilot test was performed by applying a paint stripper followed by a mastic remover to scrape the paint from the surface of the metal column prior to cleaning with CAPSUR® by the triple wash / rinse / vacuum method (upper portion of column 1). See photo below at left.

The result of the chemical decontamination pilot test as demonstrated by a verification surface wipe sample collected from the upper portion of column 1 was reported as non-detect for PCBs (< 0.5 µg/100cm^2). Based on the demonstrated reduction in PCB concentrations on the surface of the metal column at this location, which had been reported with PCBs at 1,900 µg/100cm^2 prior to the chemical decontamination, this method was retained as a feasible option for the decontamination of additional metal columns.

Given the option of chemical or physical decontamination, the chemical decontamination method was preferred because it would not require the reestablishment of a containment area on the west façade (whereas sandblasting would necessitate a containment). However, due to the heavily corroded and pitted nature of the lower portion of the metal columns where they were formerly in contact with the granite panels, it was determined that sandblasting would be the more effective method for the lower portion of the columns. As a result, a containment was reestablished around the lower portion of the columns in order to perform sandblasting, and the upper portions of the columns were accessed by ladder and decontaminated by the chemical method described above.

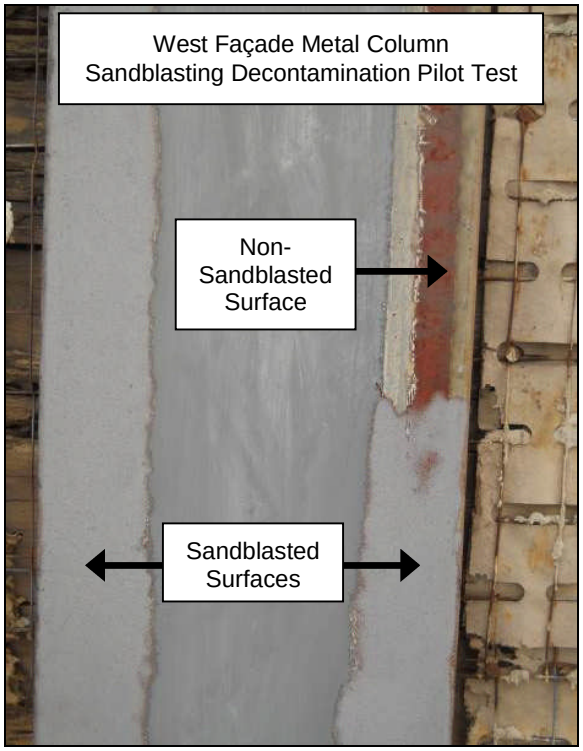
- Three physical decontamination pilot tests were performed by sandblasting on the lower portion of the columns formerly adjacent to the granite panels; after sandblasting, the surface of the metal columns were either wiped down with CAPSUR® (column 9), wiped down with water (column 8), or not wiped down at all (column 10). See photo below at right.

The results of the physical decontamination pilot test as demonstrated by verification surface wipe samples collected from the lower portions of columns 8, 9, and 10 were reported as non-detect for PCBs (< 0.5 µg/100cm^2) from column 8 (surface wiped with water after sandblasting), with PCBs at 2.1 µg/100cm^2 on column 9 (surface wiped with CAPSUR® after sandblasting), and with PCBs at 10 µg/100cm^2 on column 10 (surface not wiped down after sandblasting). Based on the achievement of the unrestricted use cleanup level at each of these locations, the sandblasting followed by surficial wipe down approach was retained as a feasible option for the decontamination of additional metal columns.

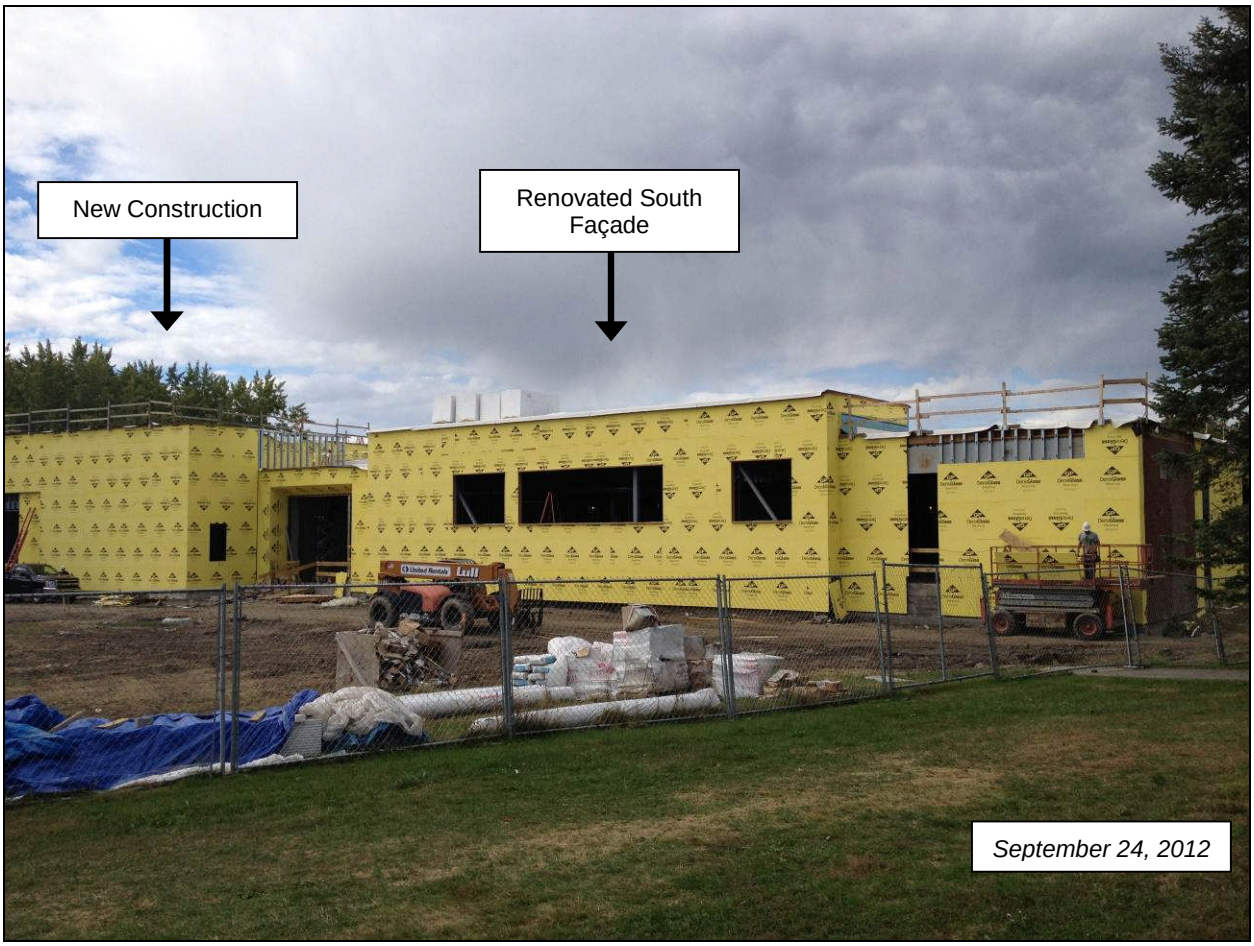
After completing the remediation activities and verifying that the cleanup levels had been met, building renovation and restoration activities continued according to the architect's plans for the overall site renovation project. As of the date of this report, restoration activities are still ongoing as shown in the photo below.

New Construction
Renovated South Façade
September 24, 2012

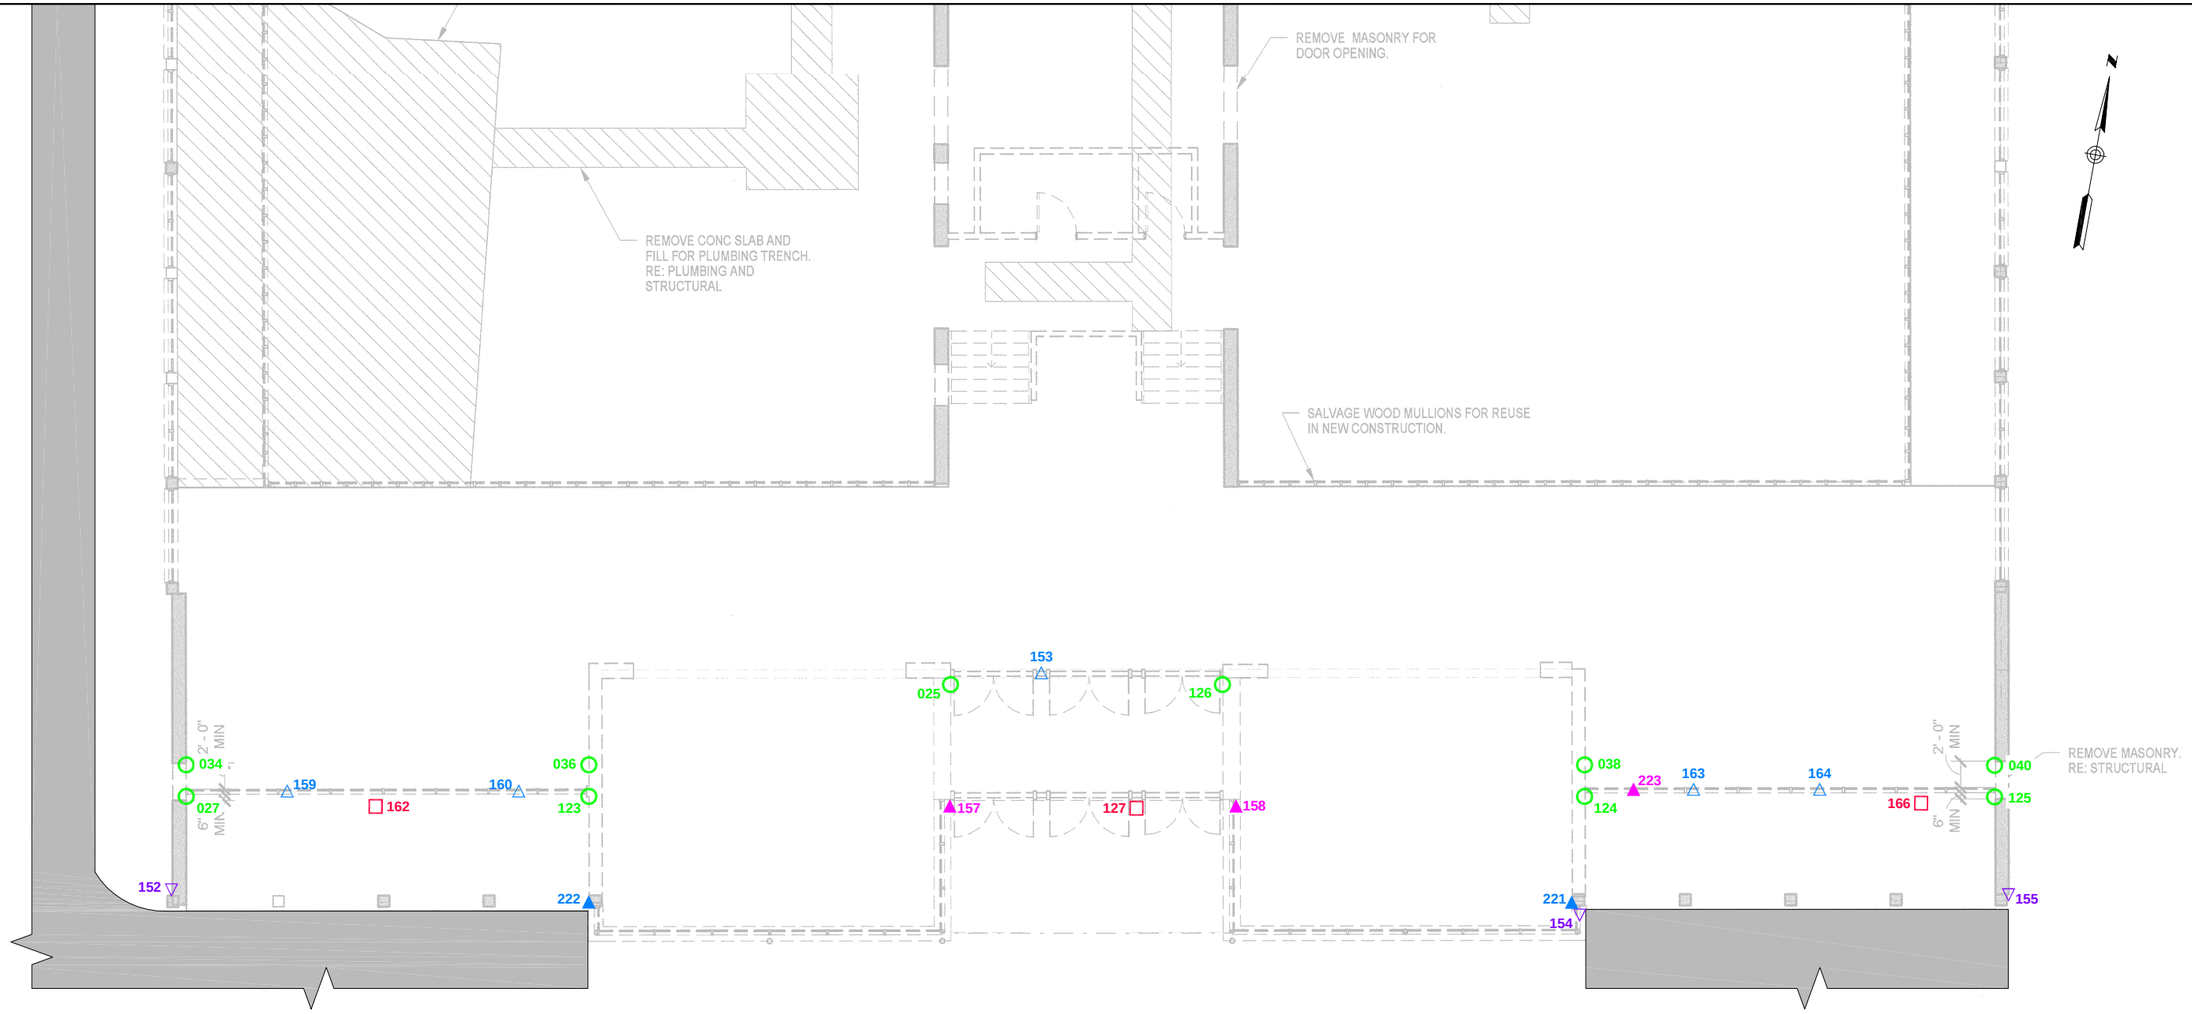
FIGURE 2-2

Drawings depicting the sample locations described in this section are provided as Figure 2-1 (South Façade Plan View and Sample Locations) and Figure 2-2 (East and West Façade Elevations and Sample Locations). Tables presenting the verification data are referenced in each section below.

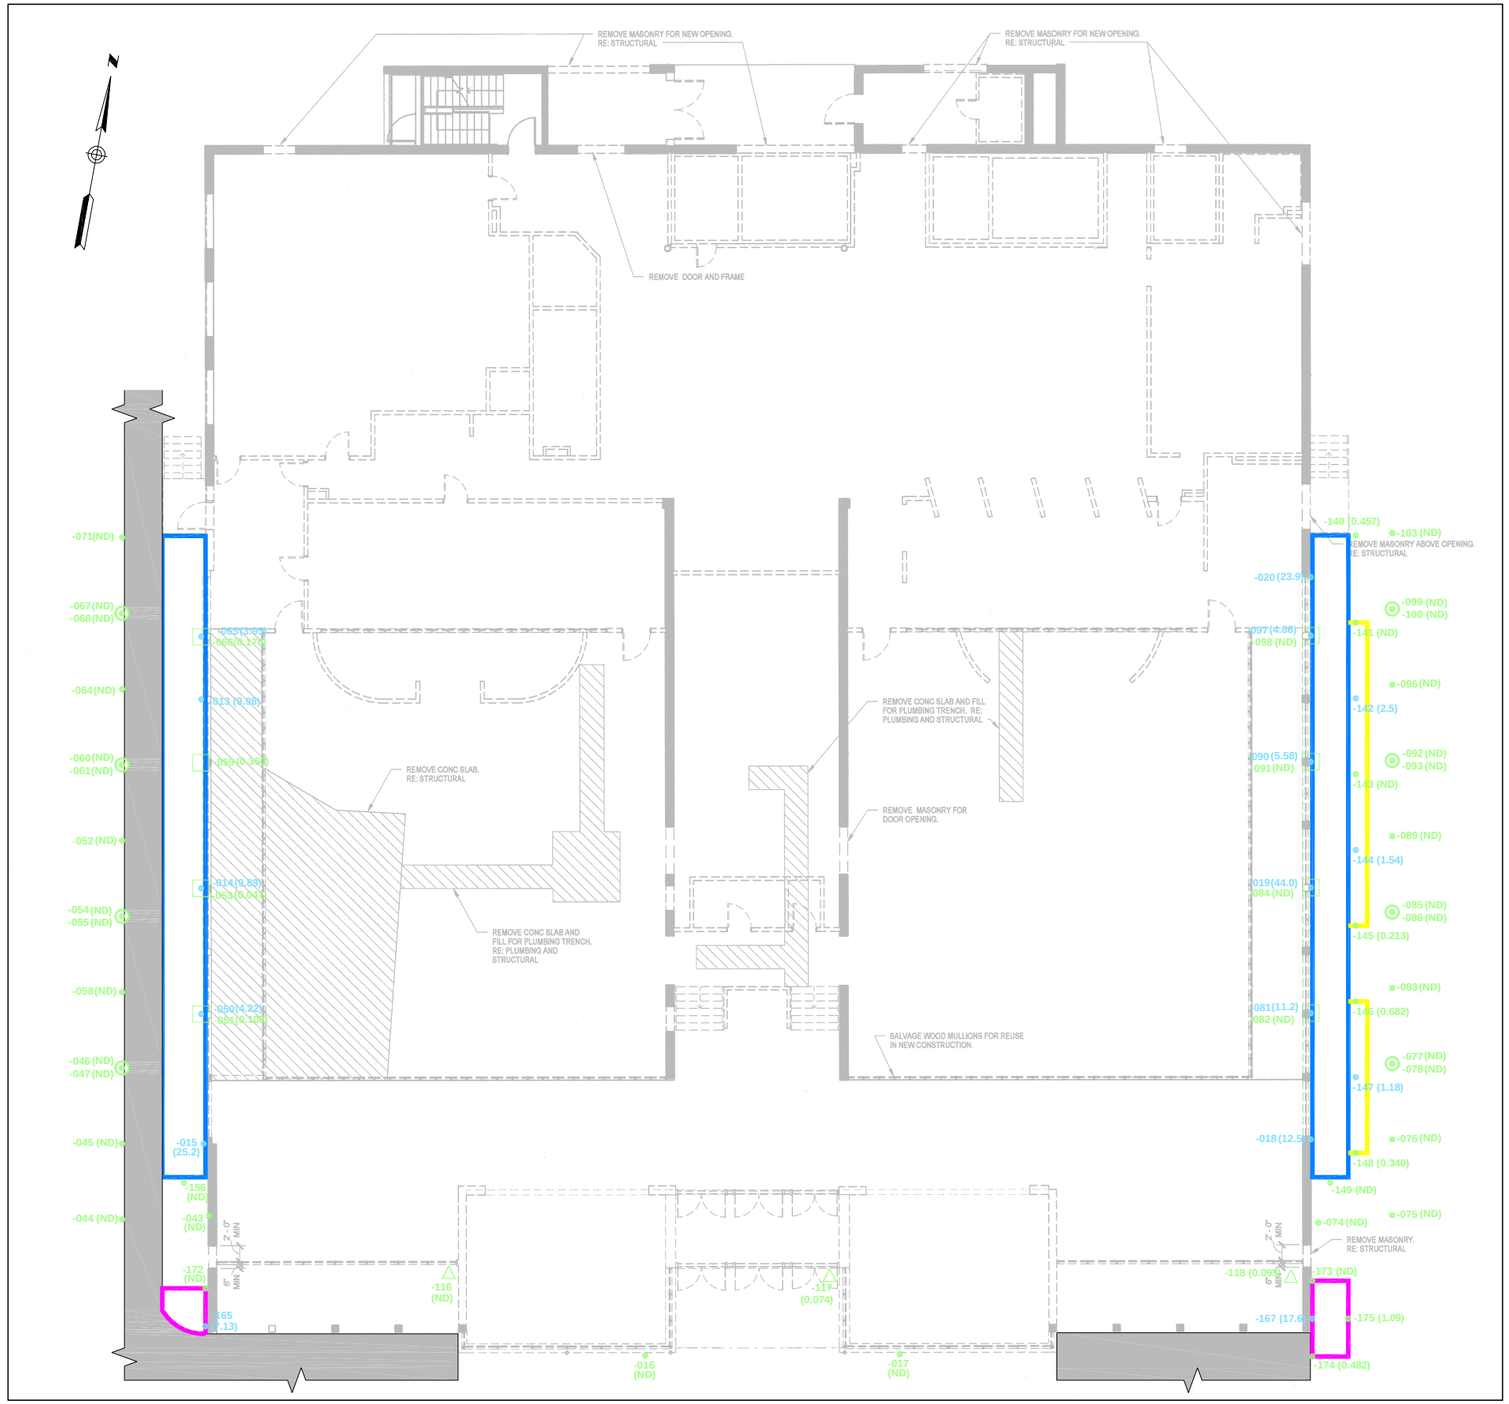
FIGURE 3-1

As requested by EPA during their review of the Plan Modification, additional surface soil samples (0-3 inches in depth) were collected to verify the lateral extent of the excavation areas proposed in the Plan Modification. Samples were collected along the eastern perimeter of the proposed excavation on the eastern side of the building at a distance of 7.5 feet from the building to characterize those soils midway between the proposed limit of excavation (at 5 feet from the building) and the existing row of characterization samples (at 10 feet from the building). In addition, one sample was collected at the southern extent of both the eastern and western excavation areas. Additional samples were not collected from the northern perimeter of the excavation areas since these areas terminated at concrete foundations to exterior staircases. Similarly, additional perimeter samples were not collected adjacent to the western perimeter of the western excavation area given the presence of an asphalt walkway with existing samples immediately adjacent to the asphalt. Each of the characterization sample locations are depicted on Figure 3-1.

The results of the supplemental soil characterization sampling requested by EPA confirmed the southern limits of excavation on both the east and west sides of the building; both samples were reported as non-detect for PCBs, and no changes were made to the proposed limits of excavation. The results of the additional samples collected along the eastern proposed limit of excavation on the east side of the building were reported with PCBs below the 1 ppm cleanup level in 6 out of 9 samples (results ranging from non-detect up to 0.682 ppm), and with PCBs above the 1 ppm cleanup level in the remaining 3 samples (results reported at 1.18, 1.54, and 2.50 ppm). Based on these results, the proposed limits of excavation were modified along the eastern elevation to remove the soils containing PCBs > 1 ppm as depicted on Figure 3-1. The results of these samples are presented on Table 3-1.

As described in Section 2.2.1 of this Report, two exterior building joints containing PCB ≥ 50 ppm caulking at the southeast and southwest corners of the building were encountered when remedy implementation was underway in February 2012. Because the vertical joints terminated at the unpaved ground surface adjacent to each building corner in a fashion similar to other locations along the east and west façades where PCBs had been characterized in adjacent soils at concentrations > 1 ppm, samples were collected at the base of the southeast and southwest building corners to determine whether PCBs were present. Samples were collected from unpaved surfaces on a 5-foot grid spacing at the locations depicted on Figure 3-1.

The results of the samples collected at the "worst-case" locations at the base of the caulked joints were reported with PCBs at 7.13 ppm (southwest corner) and at 17.6 ppm (southeast corner). The lateral extent of contamination was delineated by the next row of samples collected a distance of 5 feet from the worst-case locations, as samples collected at this distance were reported with PCBs ≤ 1 ppm. Based on these results, the proposed limits of excavation were modified at each of these corners to remove the soils containing PCBs > 1 ppm as depicted on Figure 3-1. These results are summarized on Table 3-1.

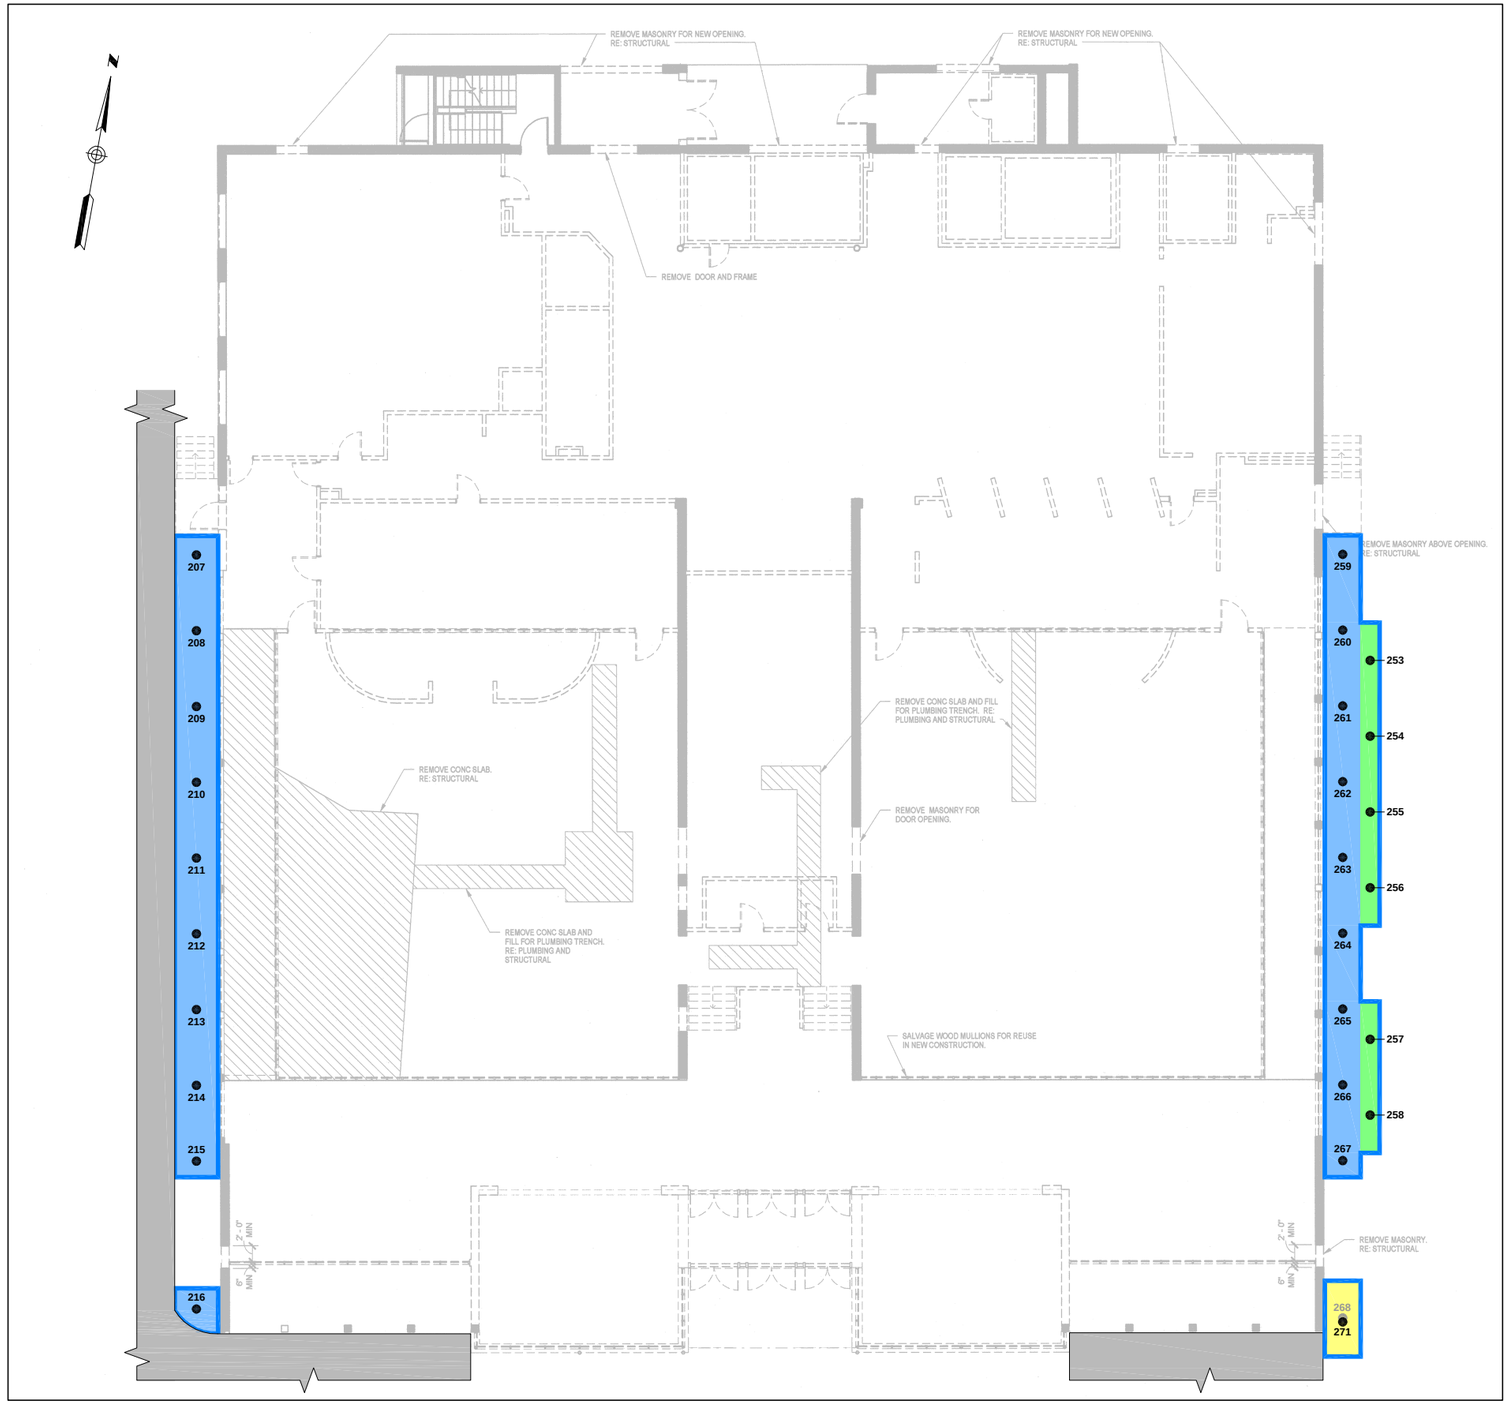
Drawings depicting the sample locations described in this section are provided as Figure 3-1 (Pre-Excavation Data and Proposed Limits of Excavation) and Figure 3-2 (Post-Excavation Data and Final Limits of Excavation). Tables presenting the laboratory analytical data are included as Table 3-1 (Supplemental Soil Characterization Data) and Table 3-2 (Soil Verification Data Summary).
