ENVIRONMENTAL ASSESSMENT OF POLYCHLORINATED BIPHENYLS (PCBs) NEAR NEW BEDFORD, MASSACHUSETTS MUNICIPAL LANDFILL

May 1978

ENVIRONMENTAL PROTECTION AGENCY
OFFICE OF TOXIC SUBSTANCES
WASHINGTON, D.C. 20460

Final Task Report
Research Request No. 4
Contract No. 68-01-3248

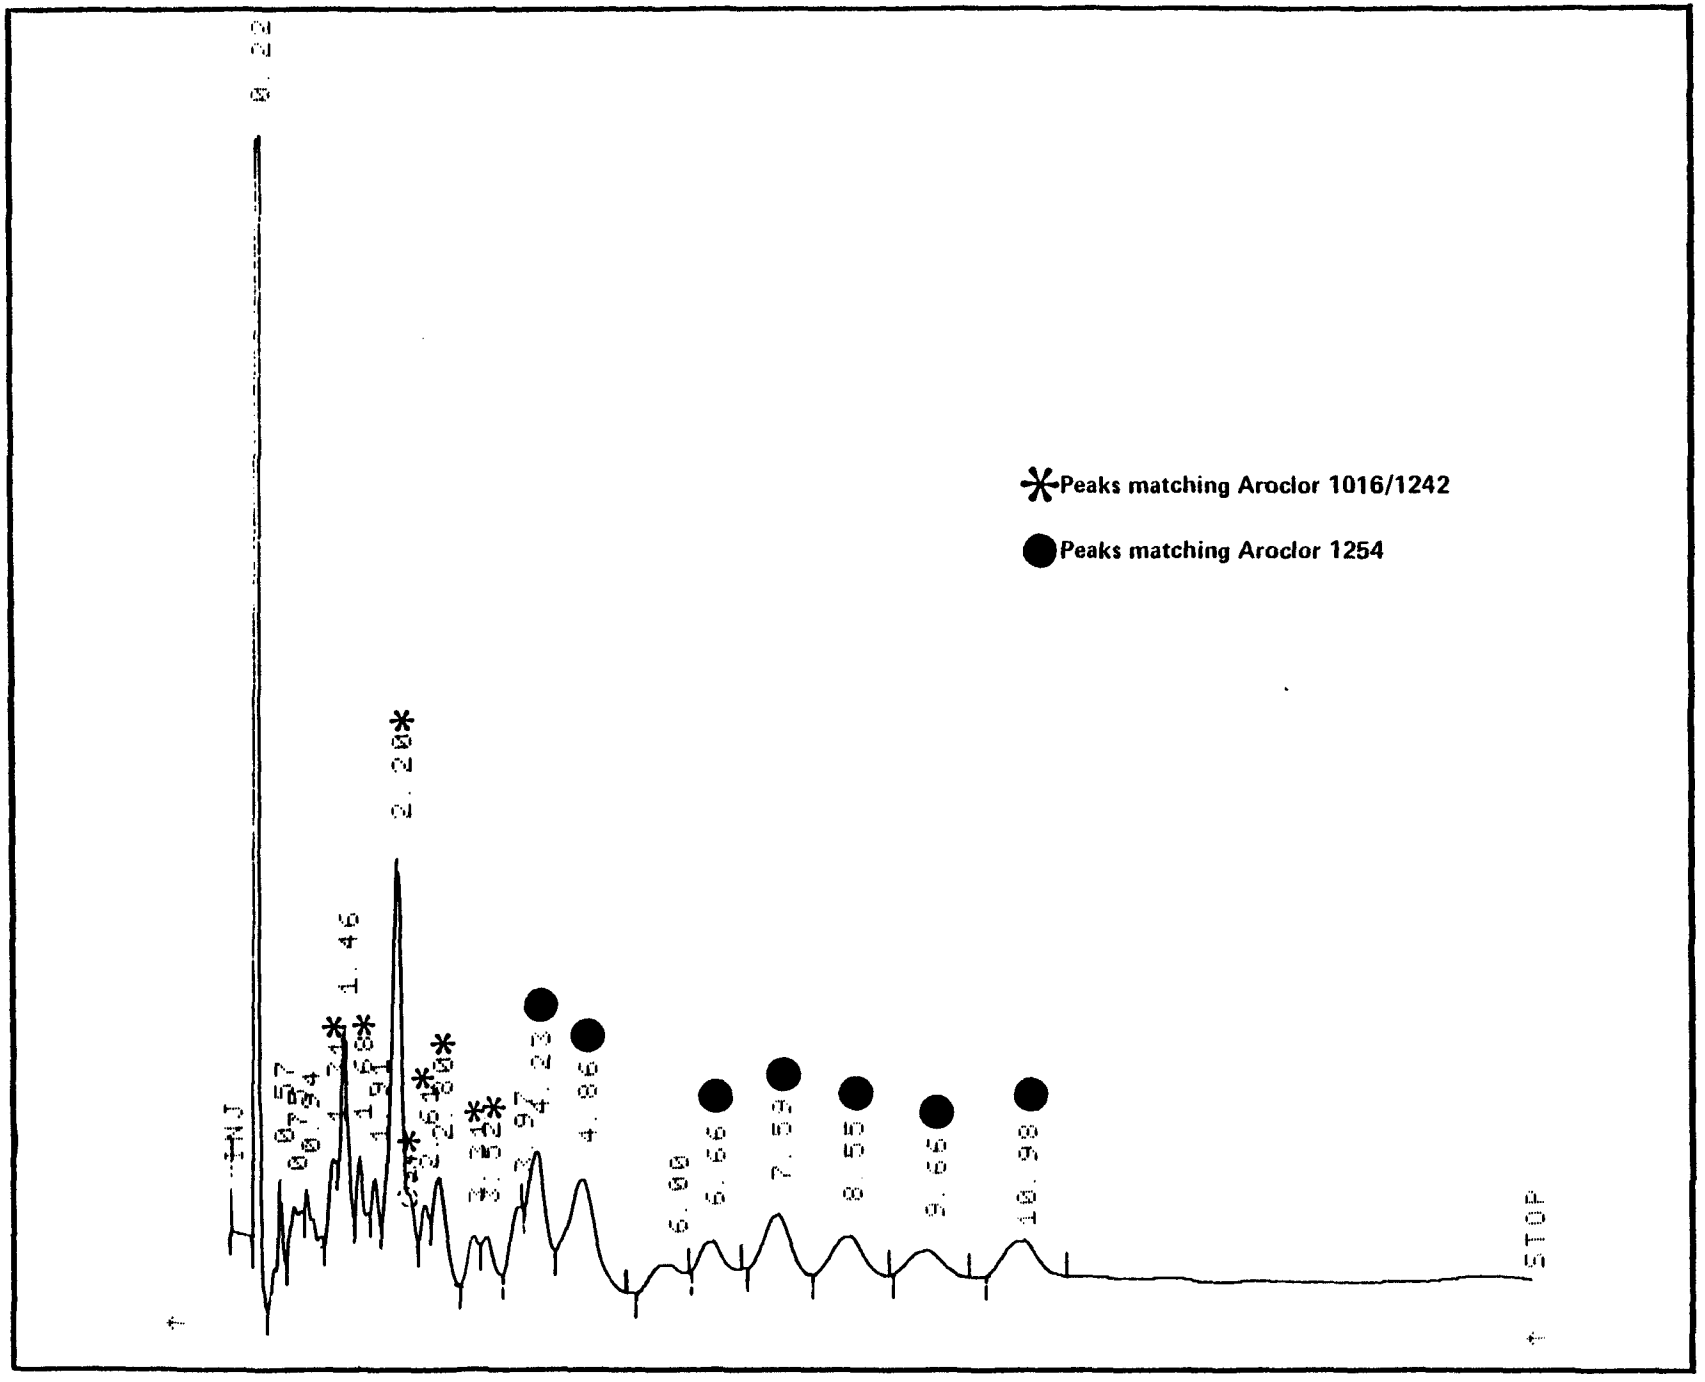
FIGURE 7

Figure 7 is a chromatogram of the water sample taken from Test Well 9. Figure 8 shows chromatograms of Aroclor 1016/1242, and Figure 9 a chromatogram of Aroclor 1254. It can be seen that the well water sample (Figure 7) contains all the major peaks of Aroclor 1254, except the two latest eluting, and many earlier peaks matching Aroclors 1016 and 1242. It is not possible when Aroclor 1254 is present to definitively identify the earlier pattern as either Aroclor 1016 or 1242, since the elution patterns for these two Aroclors differ only with respect to the last few eluting peaks which coincide with Aroclor 1254 peaks.

CHROMATOGRAM OF SHALLOW GROUNDWATER
SAMPLE FROM TEST WELL NO. 9

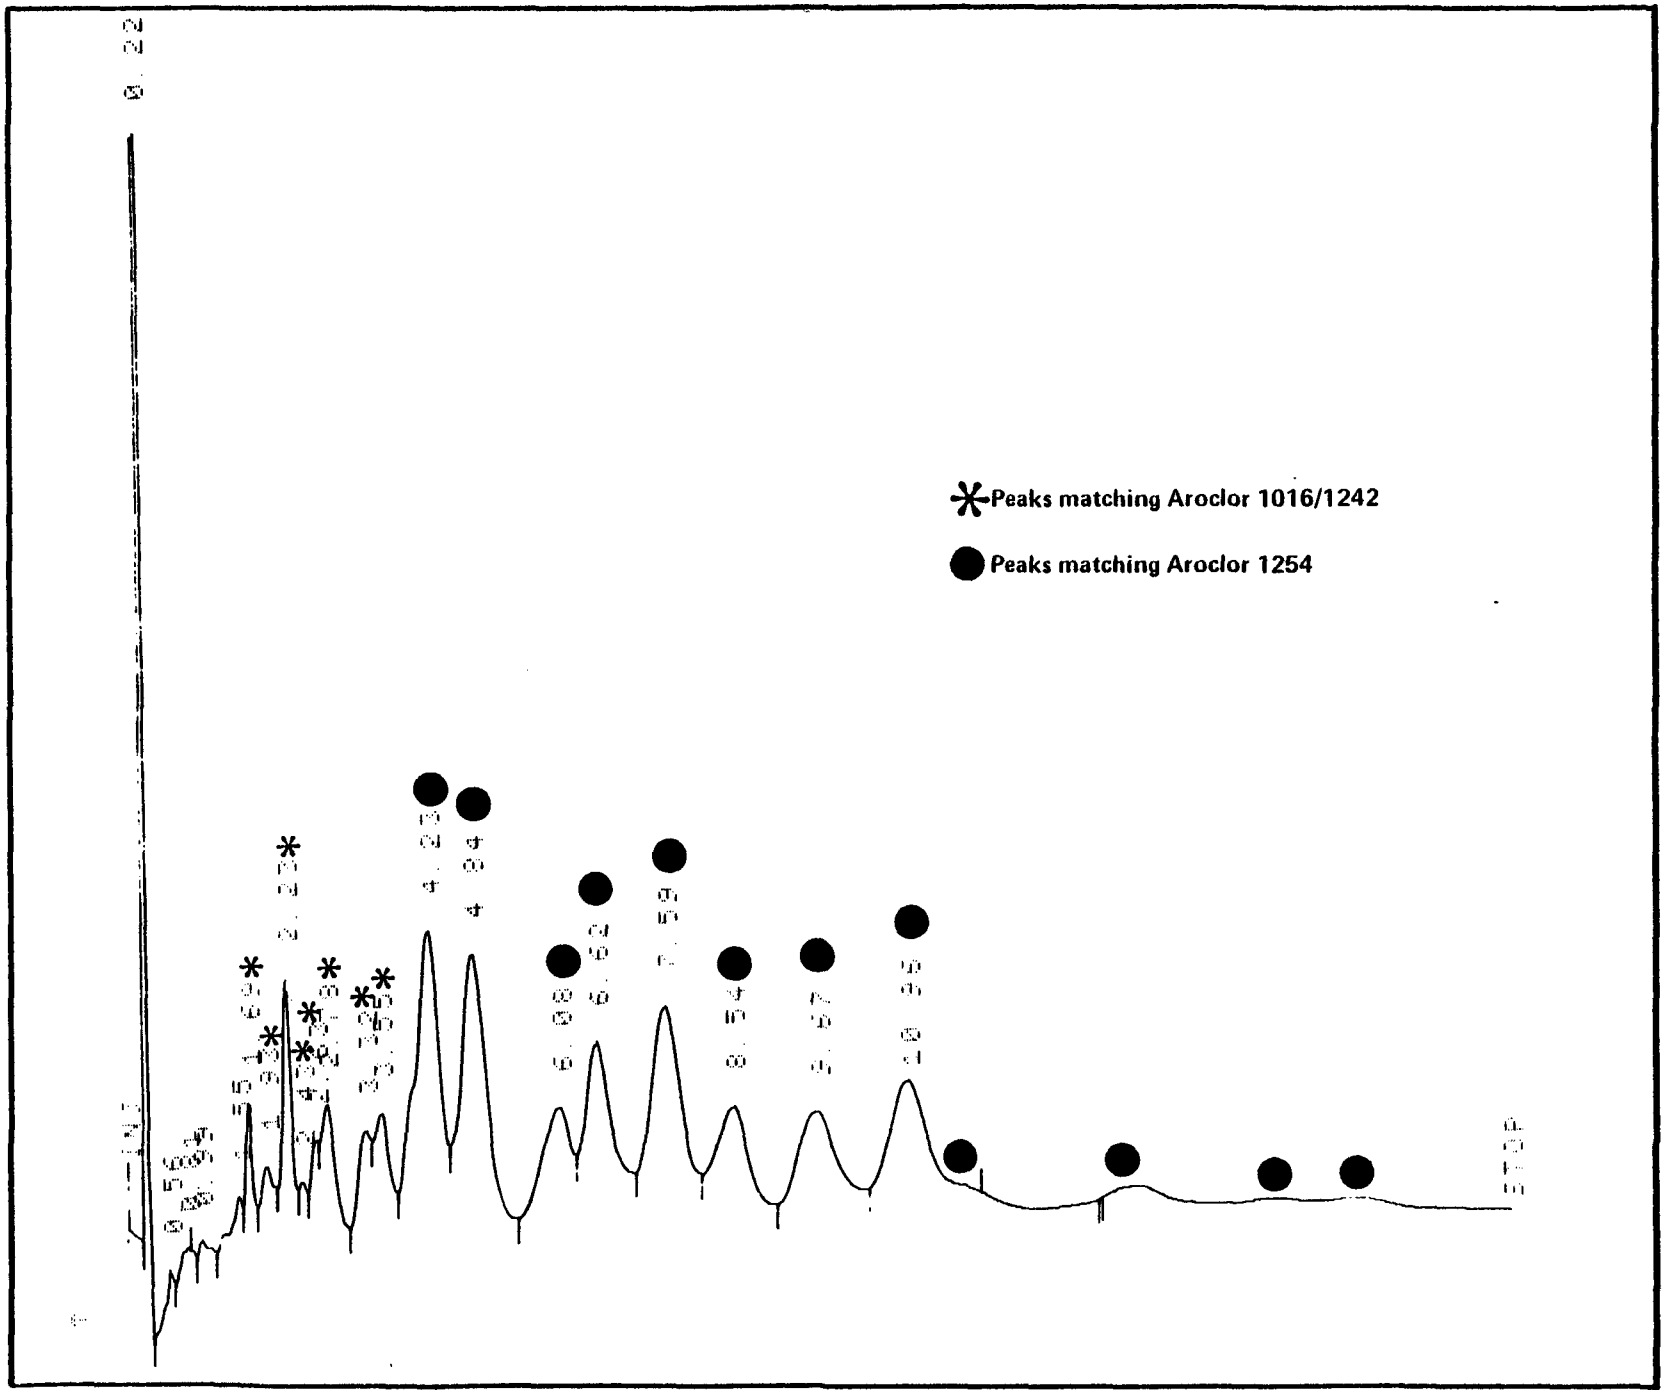
FIGURE 10

Soil core samples taken at Test Well 9 were analyzed in two sections. The results are shown in Table 6 along with a surface soil sample taken near Test Well 3. Figure 10 is the chromatogram of the 0- to 15-cm core at Test Well 9 showing that both Aroclor 1016/1242 and Aroclor 1254 are present.

CHROMATOGRAM OF SOIL CORE (0-15 cm)
TAKEN AT TEST WELL NO. 9

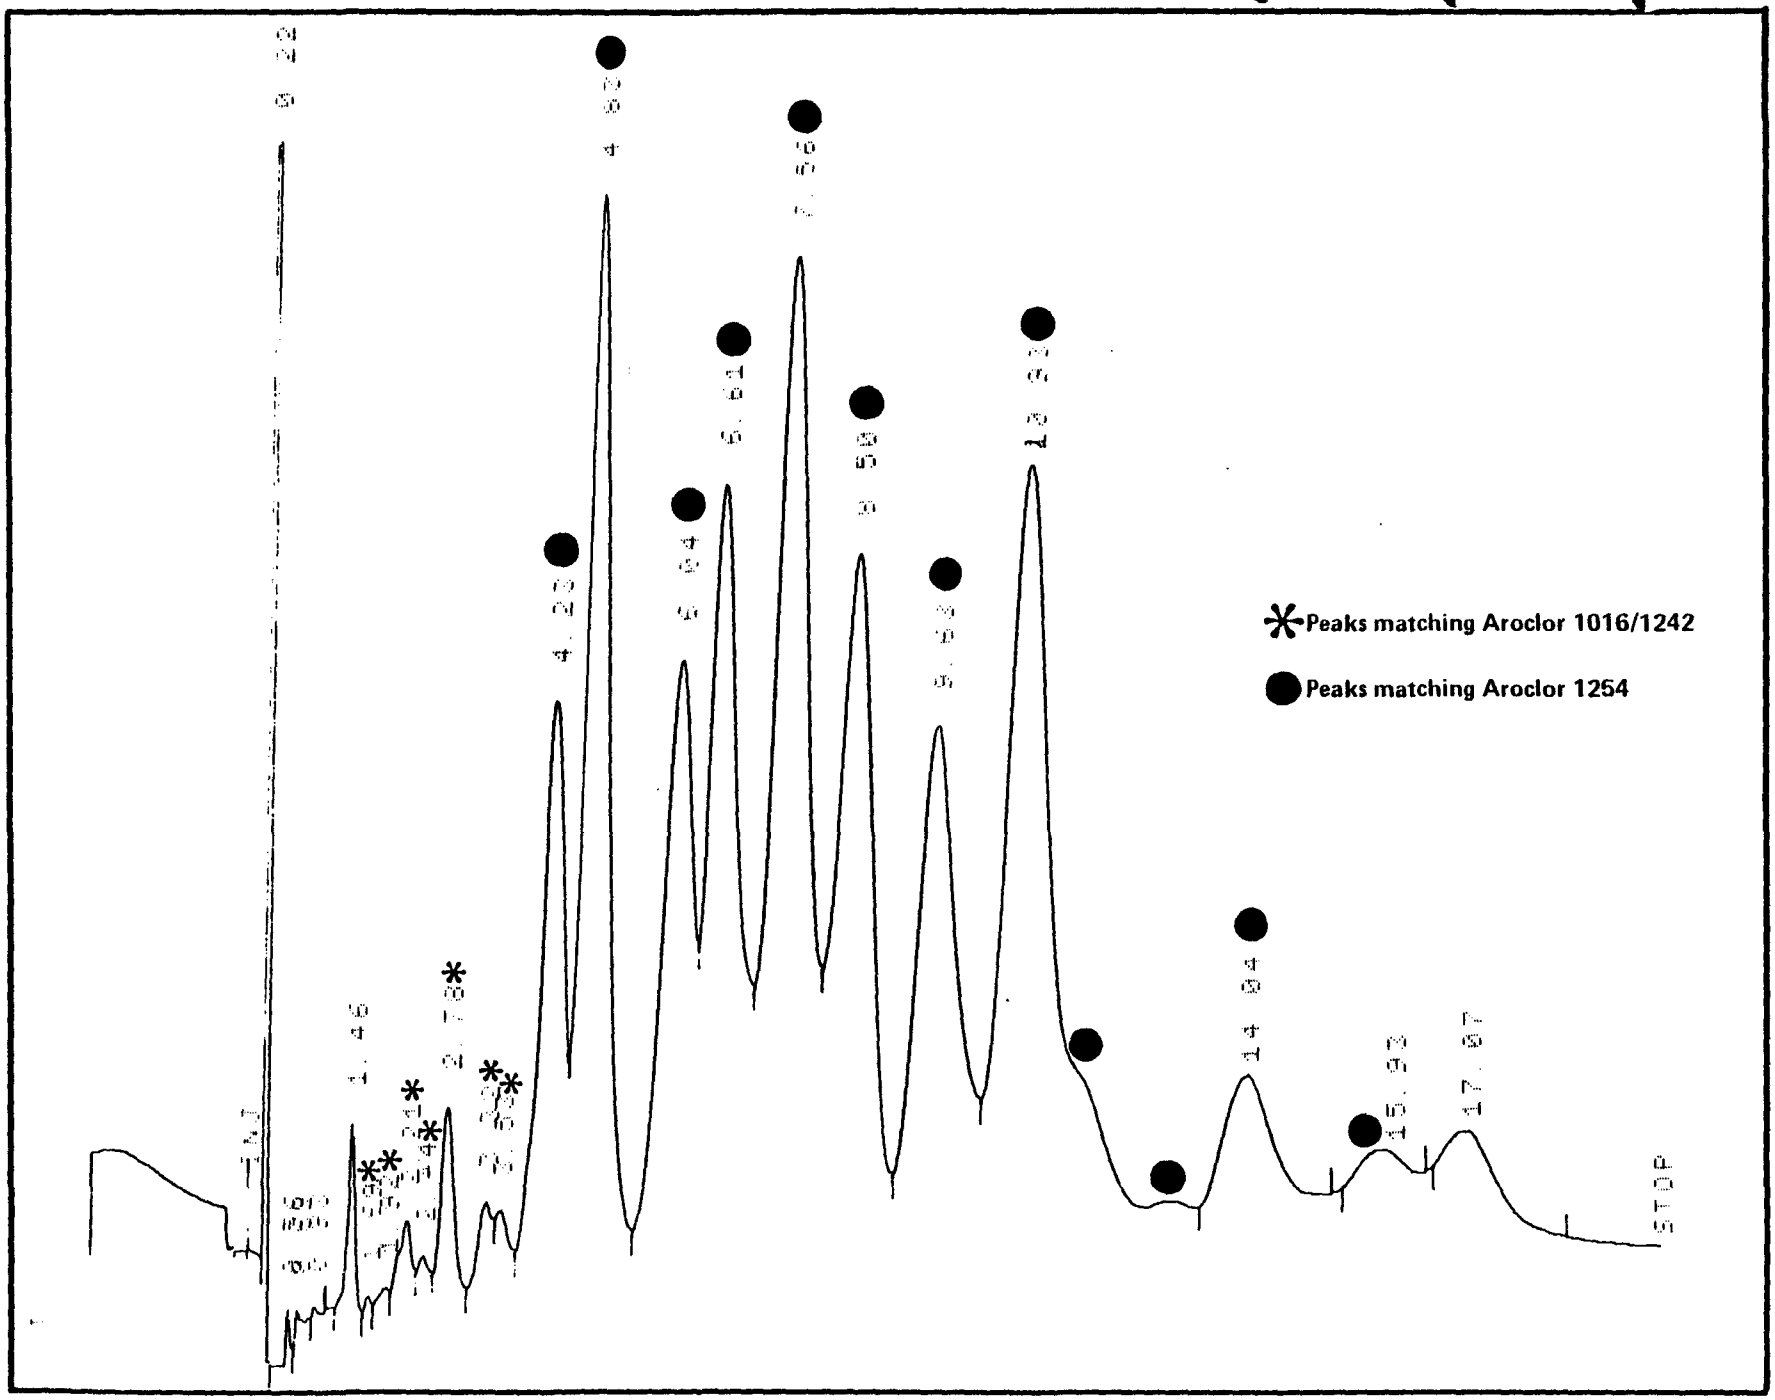
FIGURE 11

Figure 11 is the chromatogram of the extract from the bottom sediment sample taken from the stream behind Lums. This chromatogram shows a total of 288 ppb PCB, 98 percent of which is Aroclor 1254.

CHROMATOGRAM OF EXTRACT FROM SEDIMENT SAMPLE
TAKEN FROM BEHIND LUMS

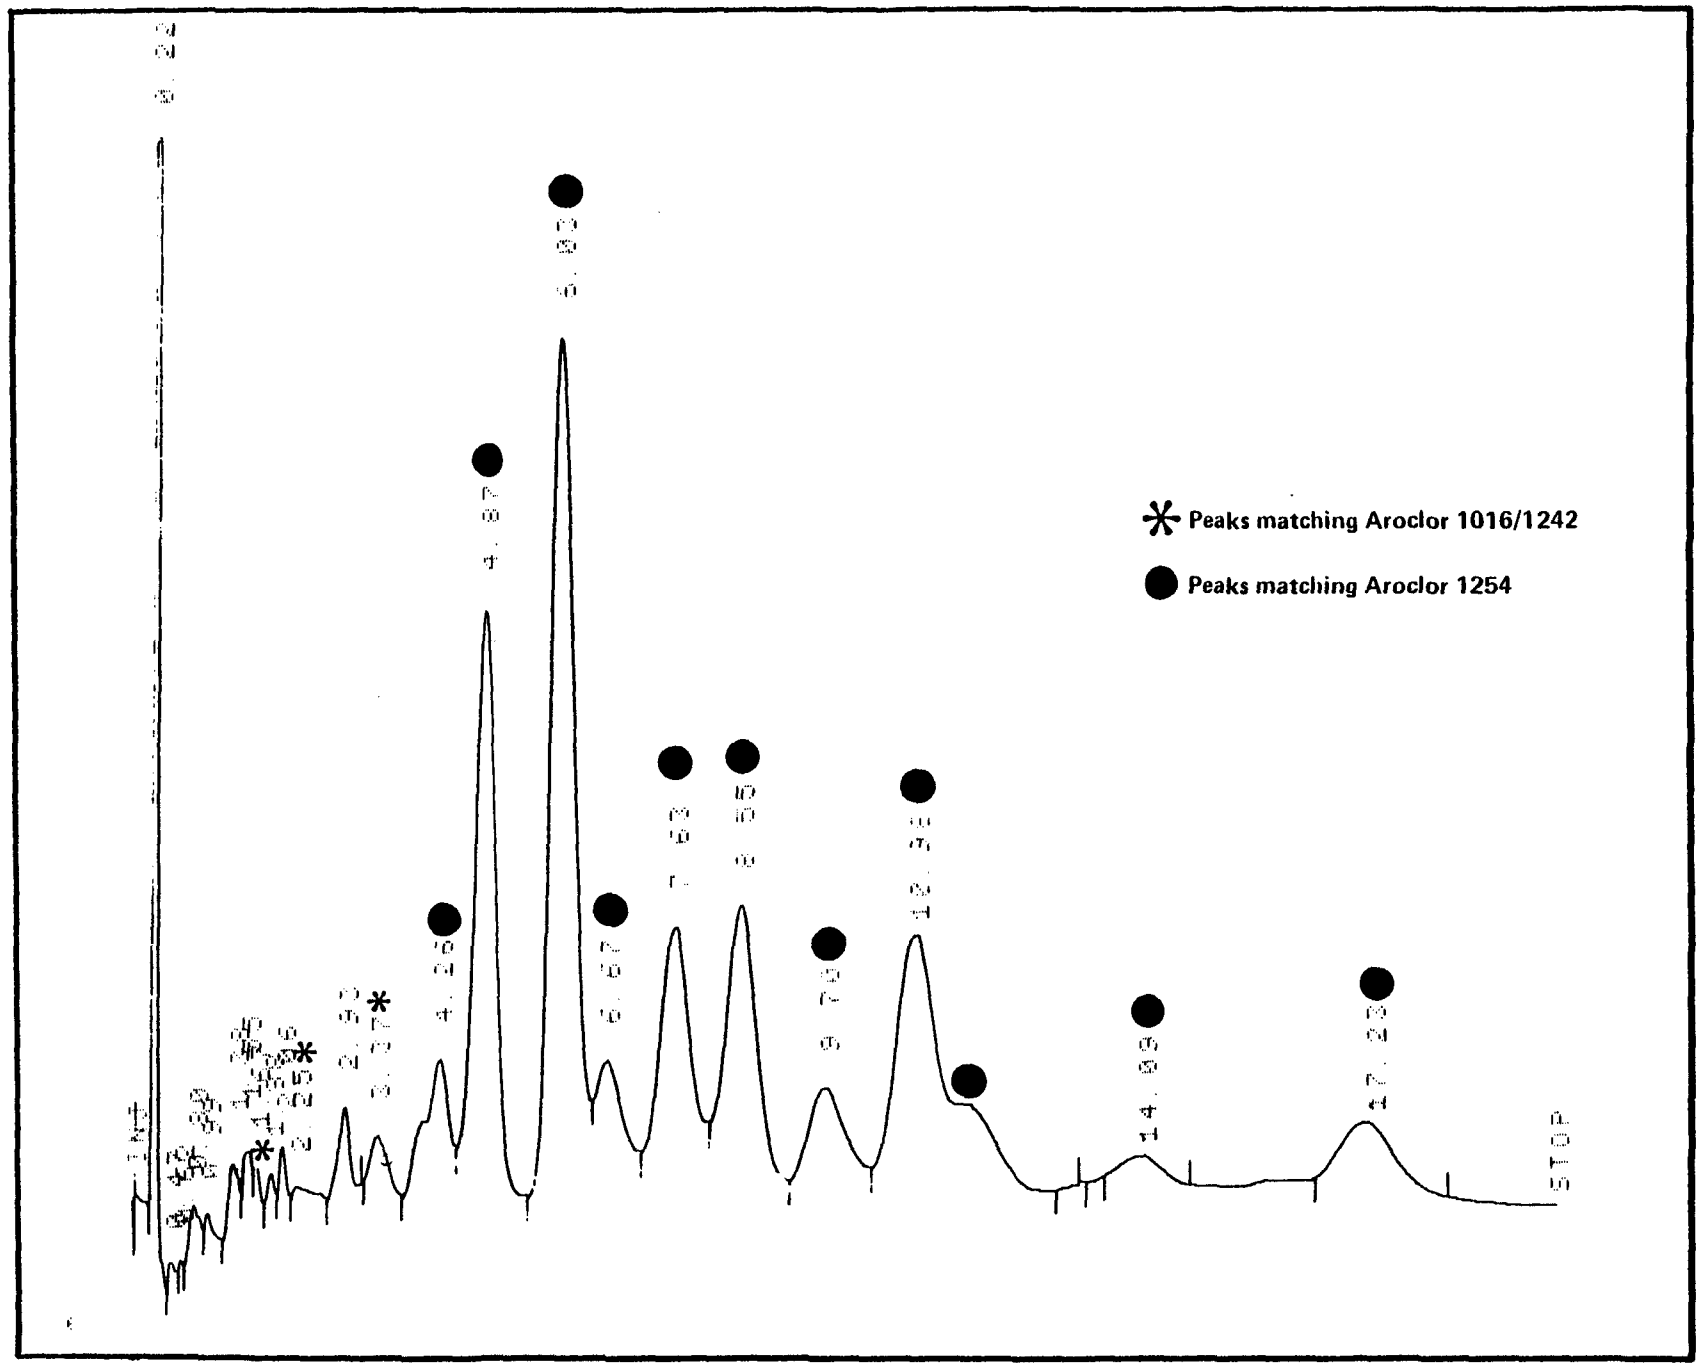
FIGURE 12

The fish samples contained only traces of Aroclor 1016/1242, but larger quantities of Aroclor 1254 (average 345 ppb). Figure 12 shows the chromatogram of the fish sample taken at Sample Station 8. It should be recalled that PCB was not detected in either the water or bottom sediment at this location.

CHROMATOGRAM OF FISH SAMPLE EXTRACT
FROM SAMPLE STATION NO. 8

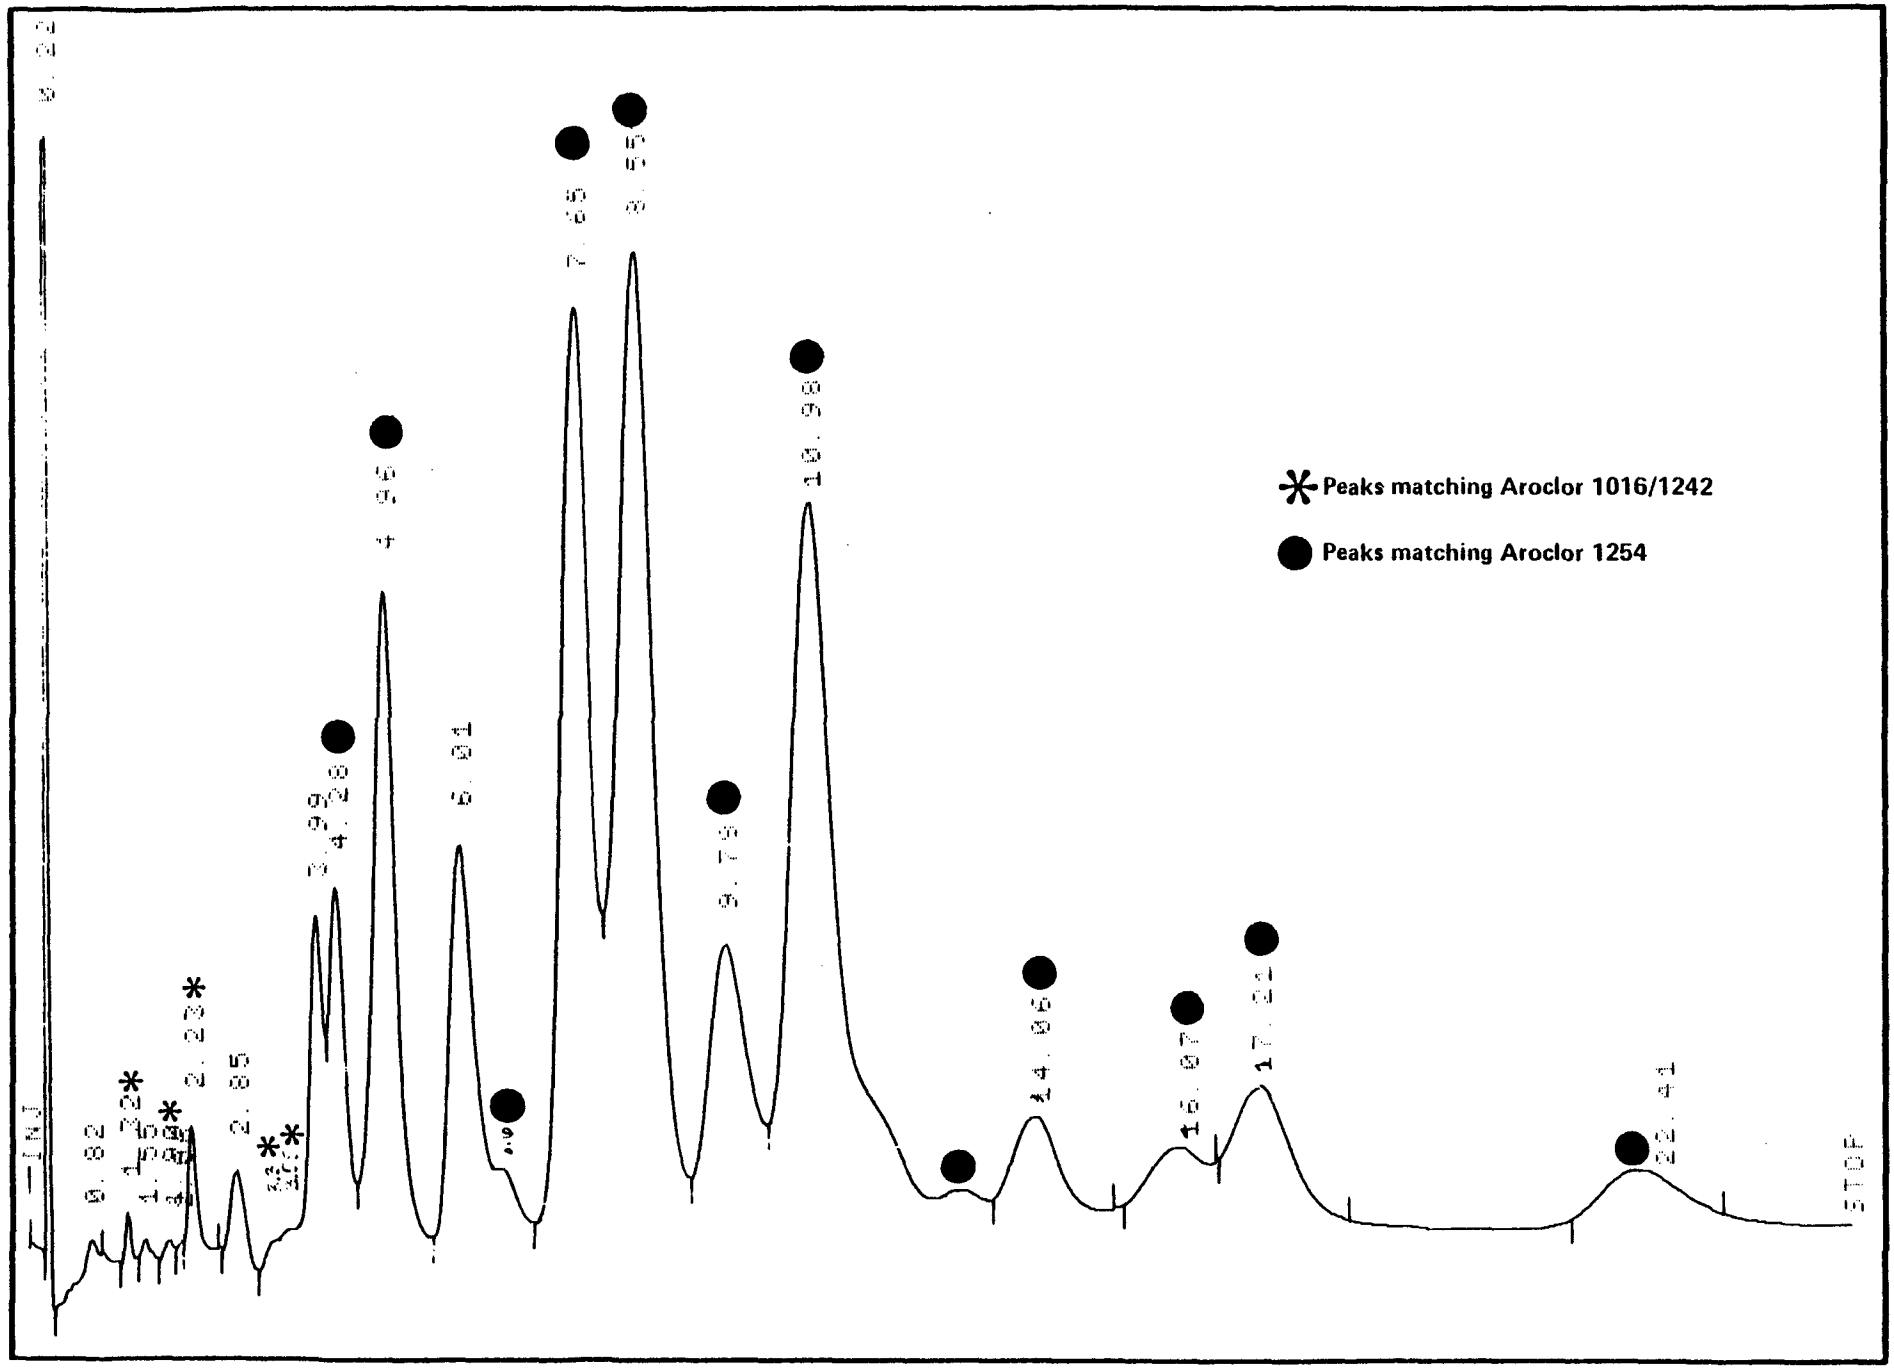
FIGURE 13

The herring gull eggs contained substantial quantities (4.6 ppm) of Aroclor 1254, and lesser quantities (0.076 ppm) of Aroclor 1016/1242. Figure 13 is a chromatogram of the egg extract. The field mice contained an average of 16 ppb of Aroclor 1254, while Aroclor 1016/1242 was not detected in these organisms.

CHROMATOGRAM OF EXTRACT
FROM HERRING GULL EGGS

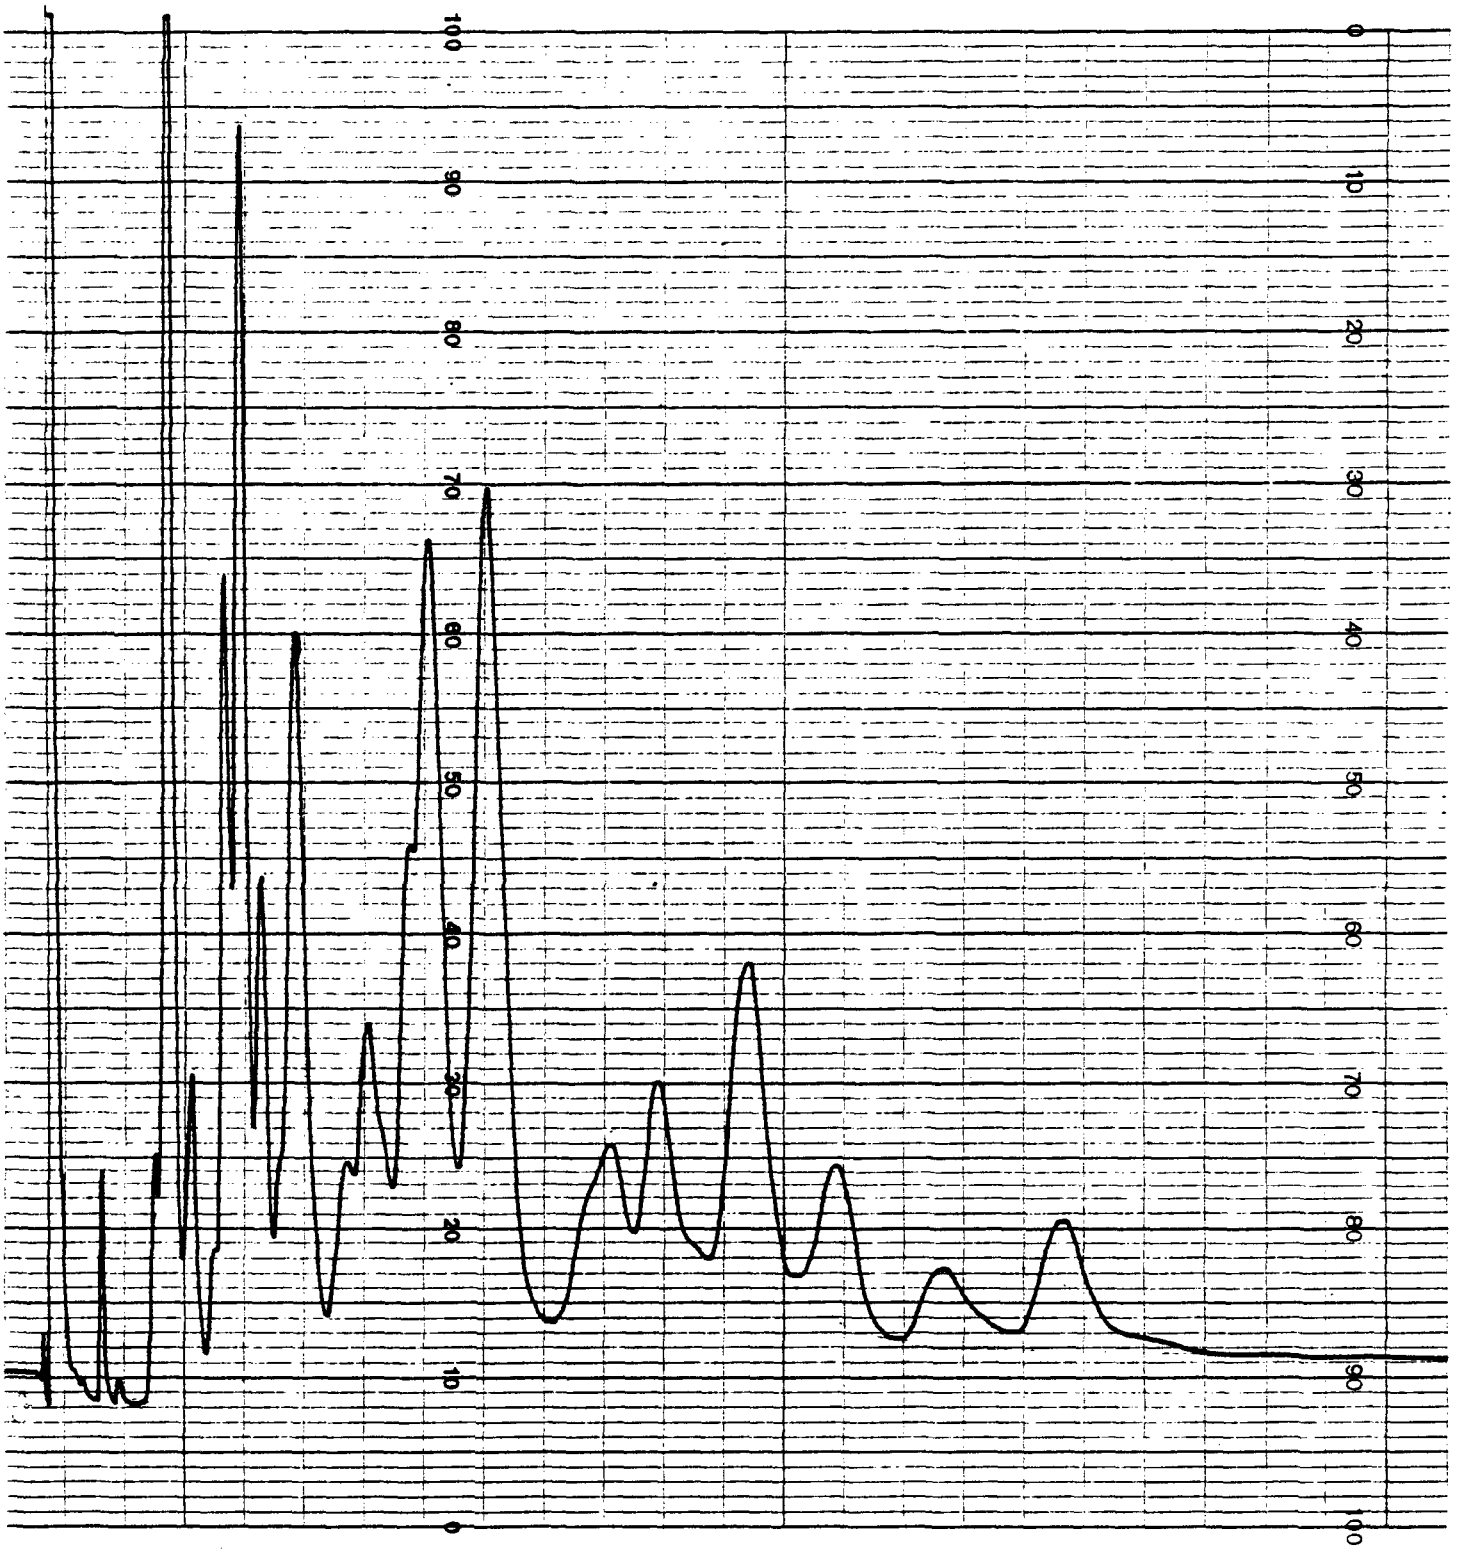
FIGURE 14

CHROMATOGRAM OF ONE-HOUR AMBIENT AIR SAMPLE
TAKEN AT THE LANDFILL SITE

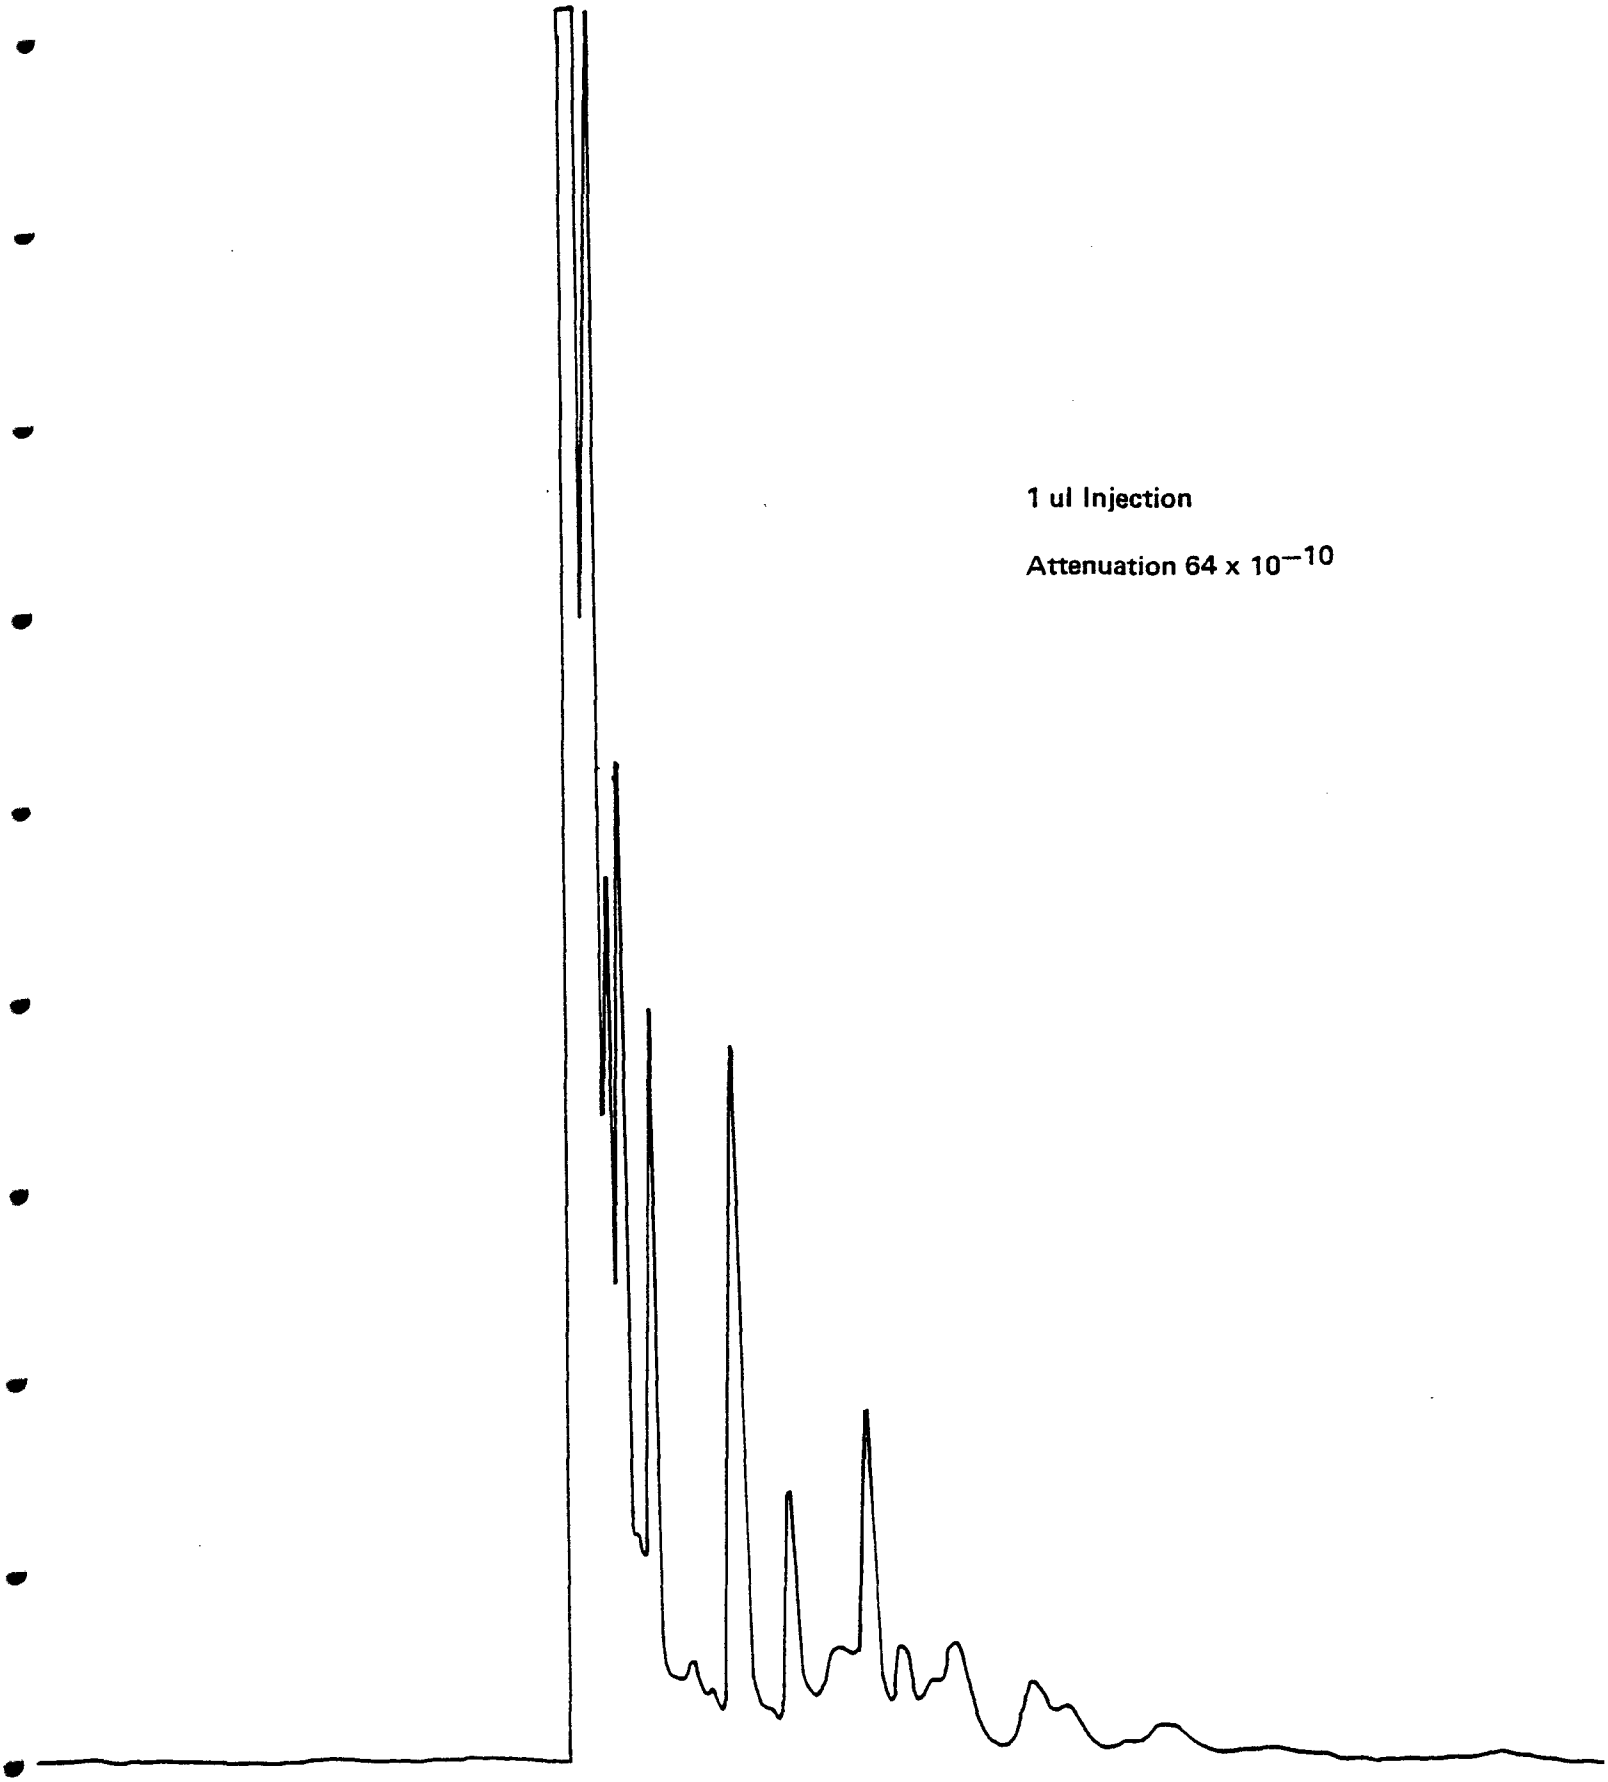
FIGURE 16

CHROMATOGRAM OF AIR SAMPLE
TAKEN UPWIND OF AEROVOX CORPORATION

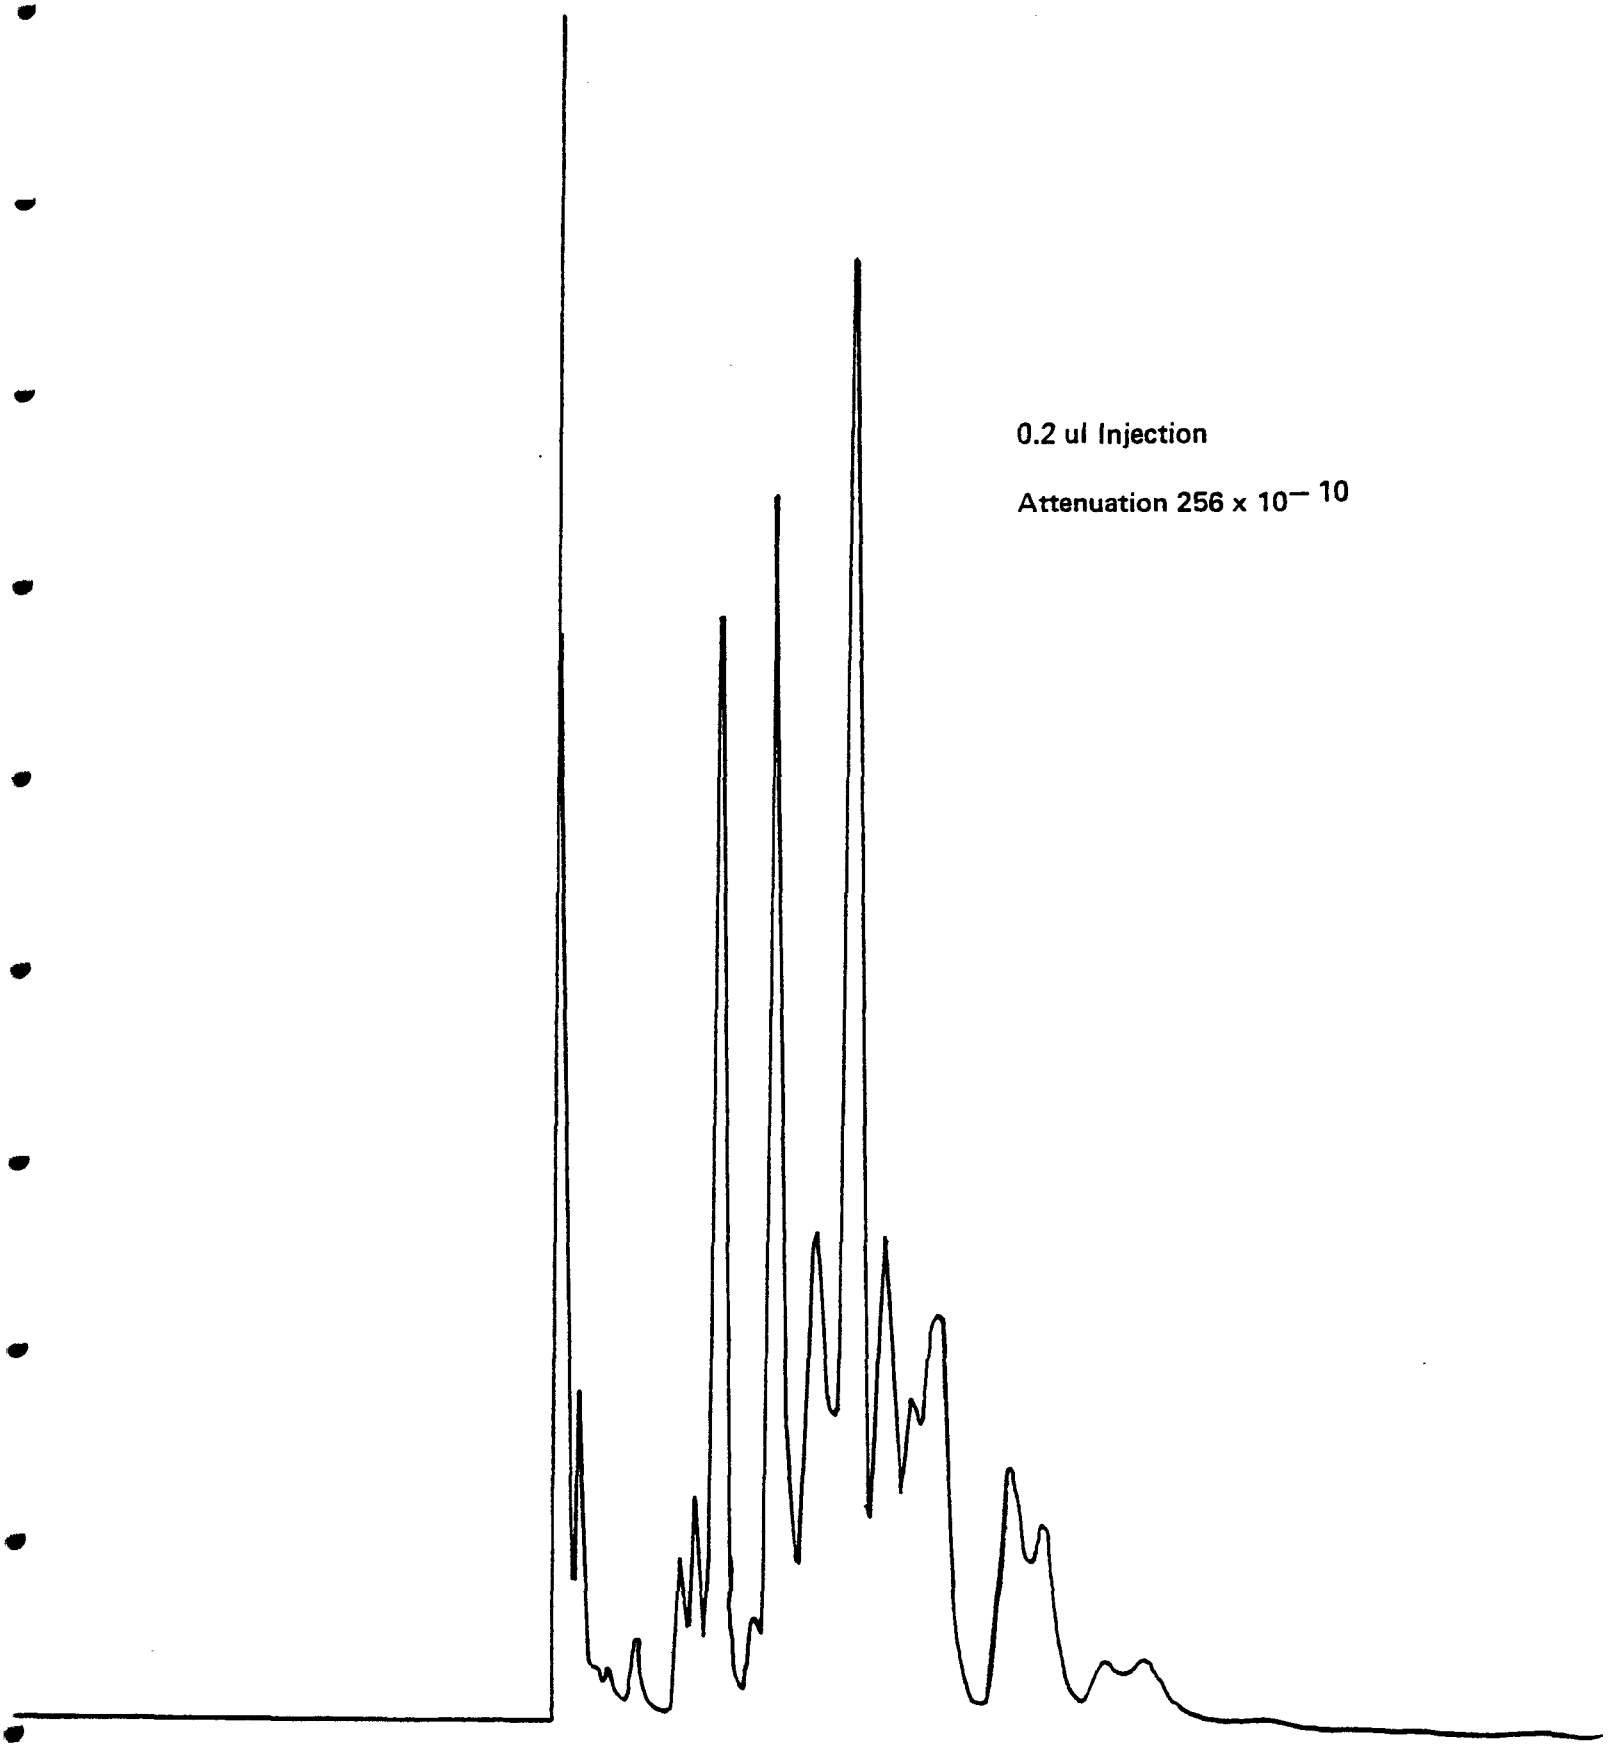
FIGURE 17

CHROMATOGRAM OF AIR SAMPLE
TAKEN DOWNWIND OF AEROVOX CORPORATION

10. Results of the air samples taken in January, 1978, indicate that the municipal sewage sludge incinerator is a low-level PCB emitter, while Aerovox Corporation appears to substantially increase downwind ambient levels of PCB. Cornell-Dubilier Electronics Corporation had no detectable emissions at the time of sampling.
