MONITORING WELL INSTALLATION AND GROUND WATER INVESTIGATION

August 2001 (Rev. 1: February 2002)

Former Sylvania Electric Products, Incorporated Facility
Cantiague, Rock Road
Hicksville, New York

GTE OPERATIONS SUPPORT INCORPORATED

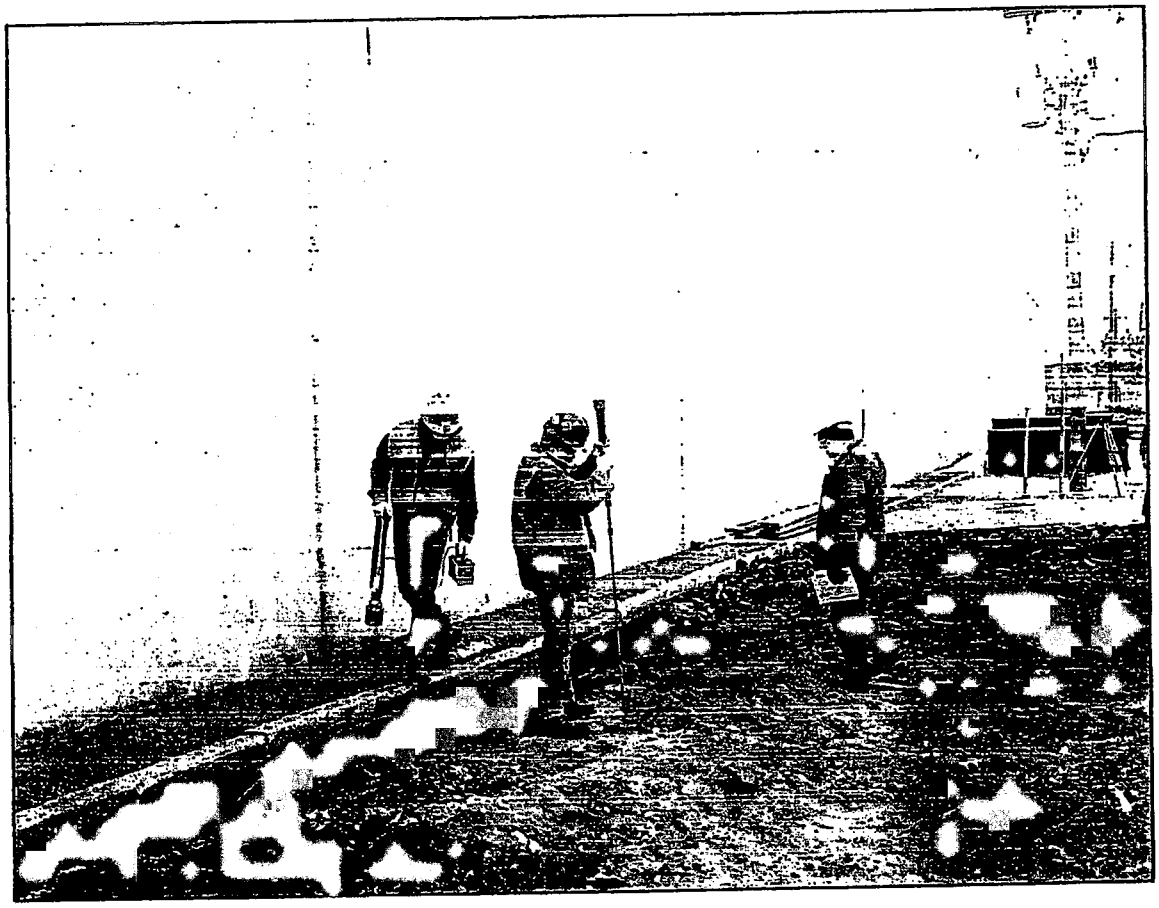
Photograph 2 - Removing the asphalt cover.

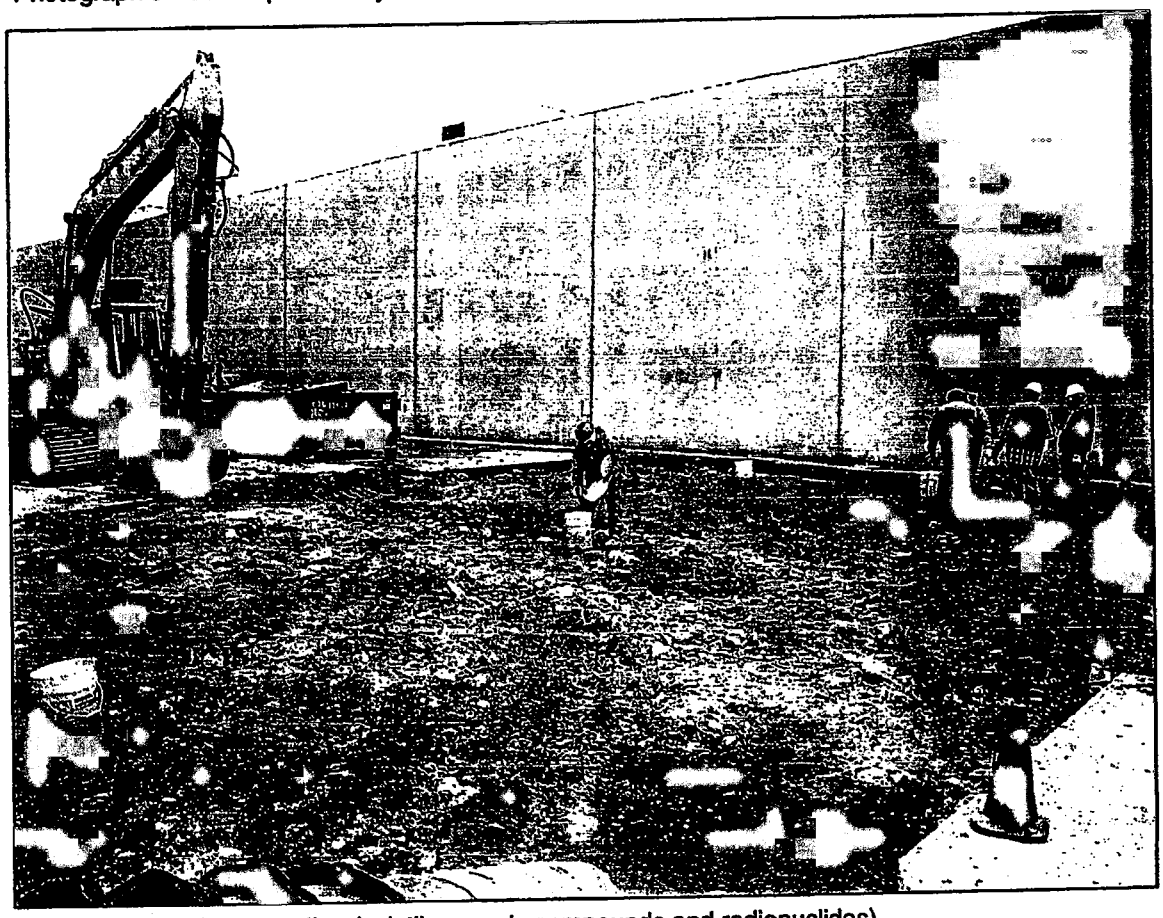
Photograph 3 - Soil Vapor Survey.

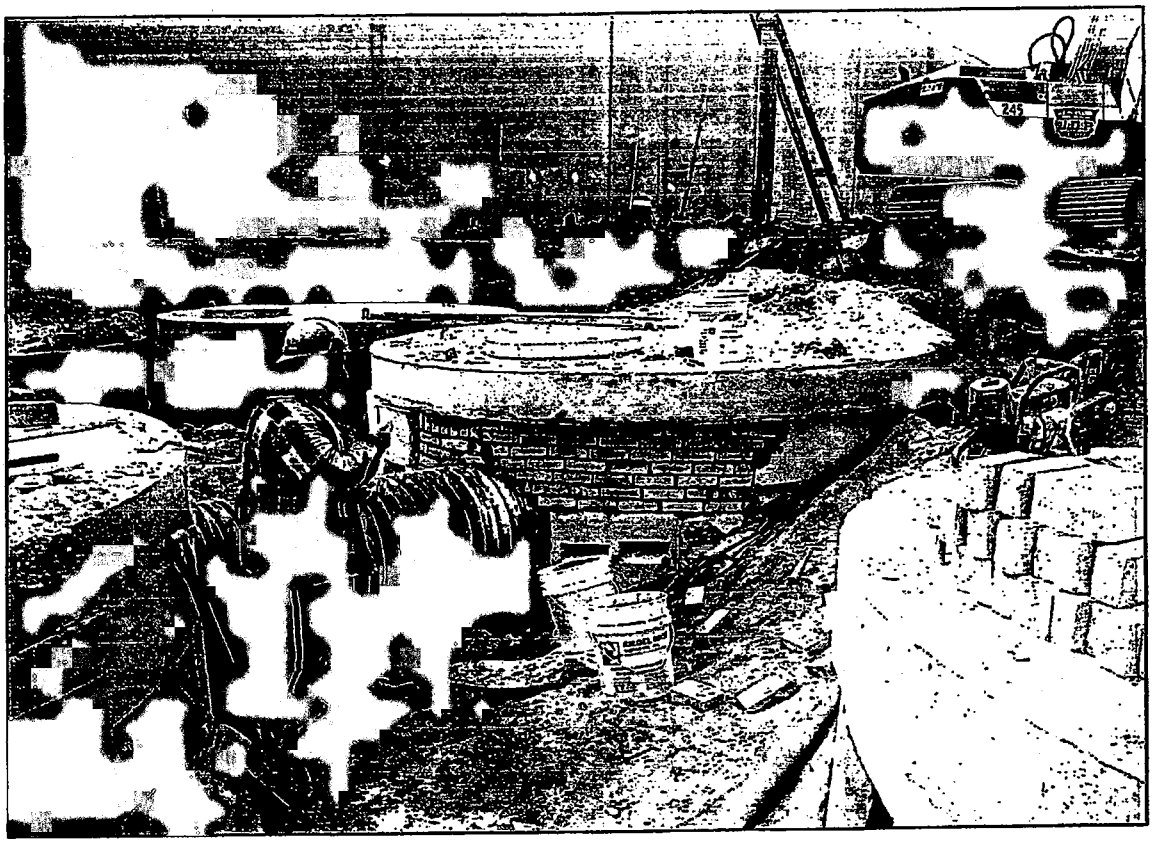
Photographs 6, 7, and 8 illustrate the Interim Drainage System on the south side of the 140 Property. The installation of the Interim Drainage System was competed on March 12, 2003. The area was repaved on March 17, 2003.

Photograph 6 - Leaching Pool

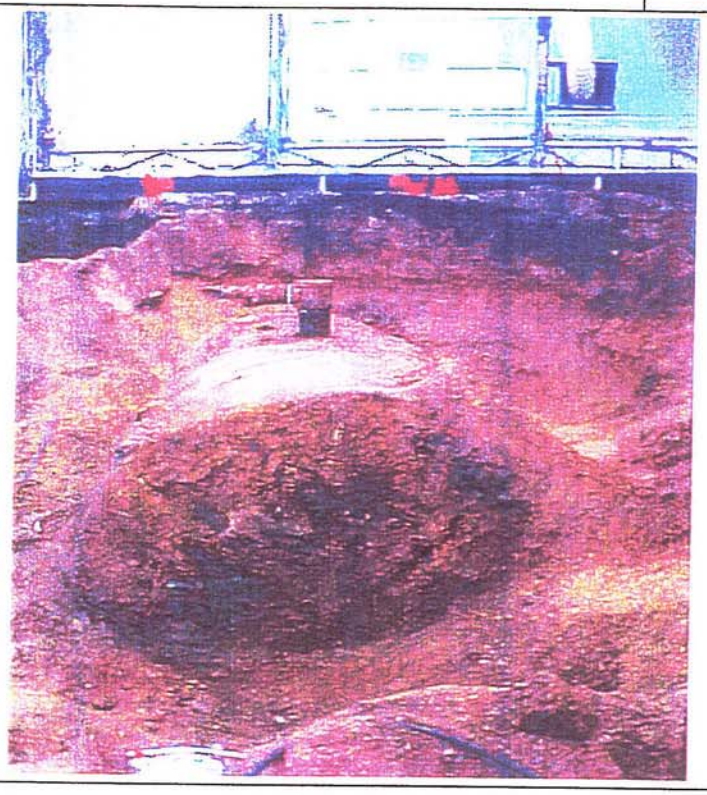
Photo No.	Date:
2	7-1-03

Partially uncovered tank located within enclosure of Cell 2.

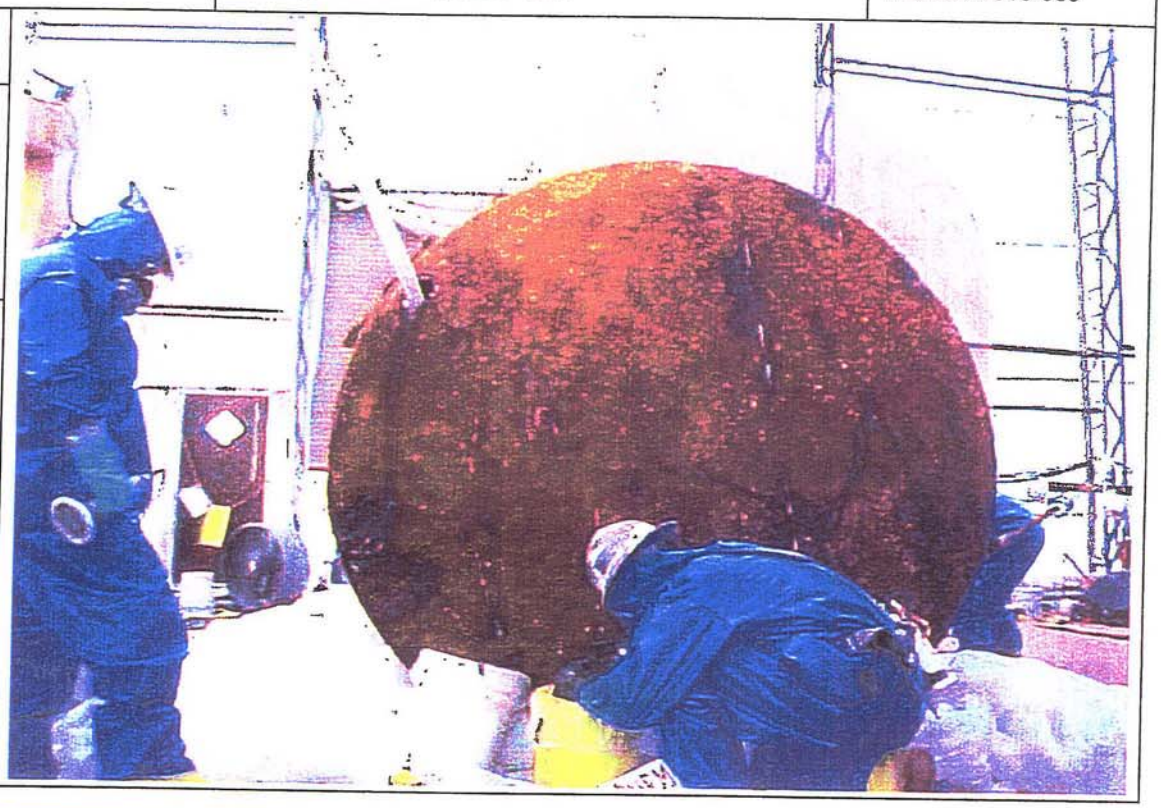
Photo No.	Date:
6	7-2-03

Survey of tank and sludge and liquid sampling.

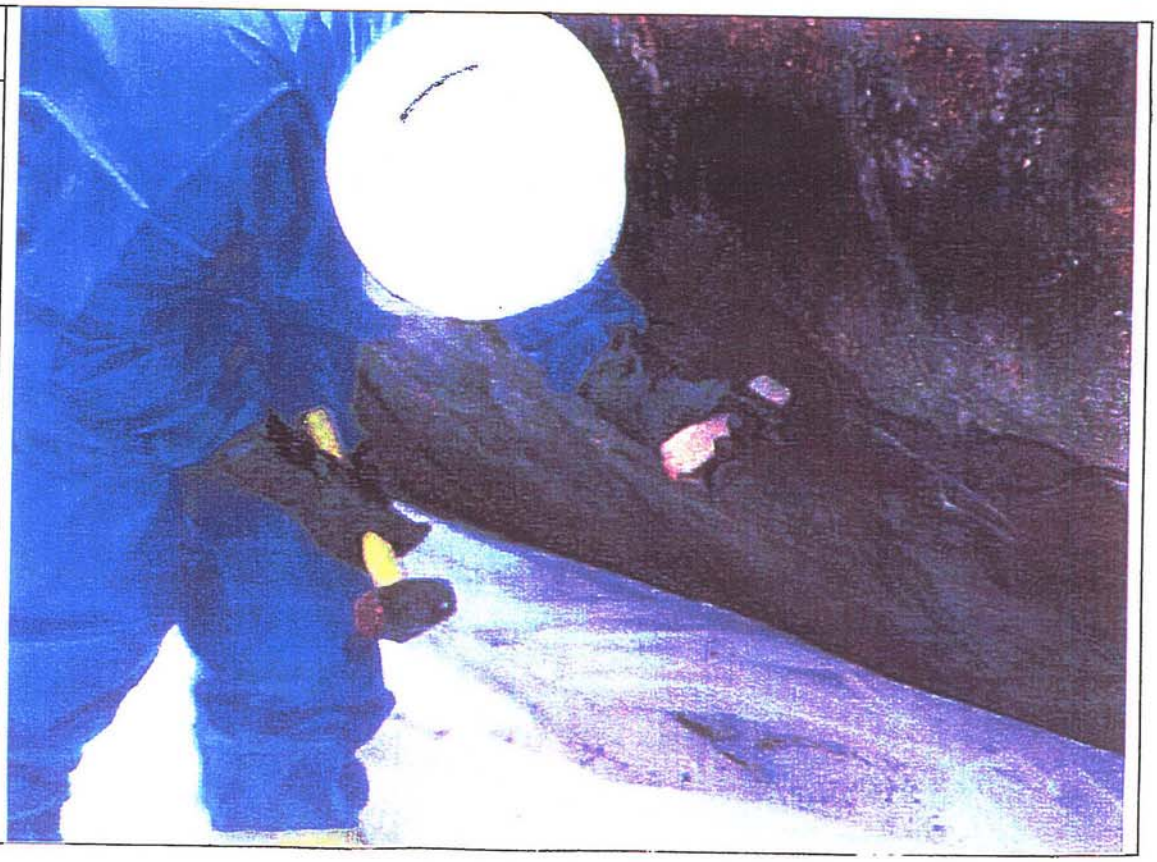
Opening being closed.

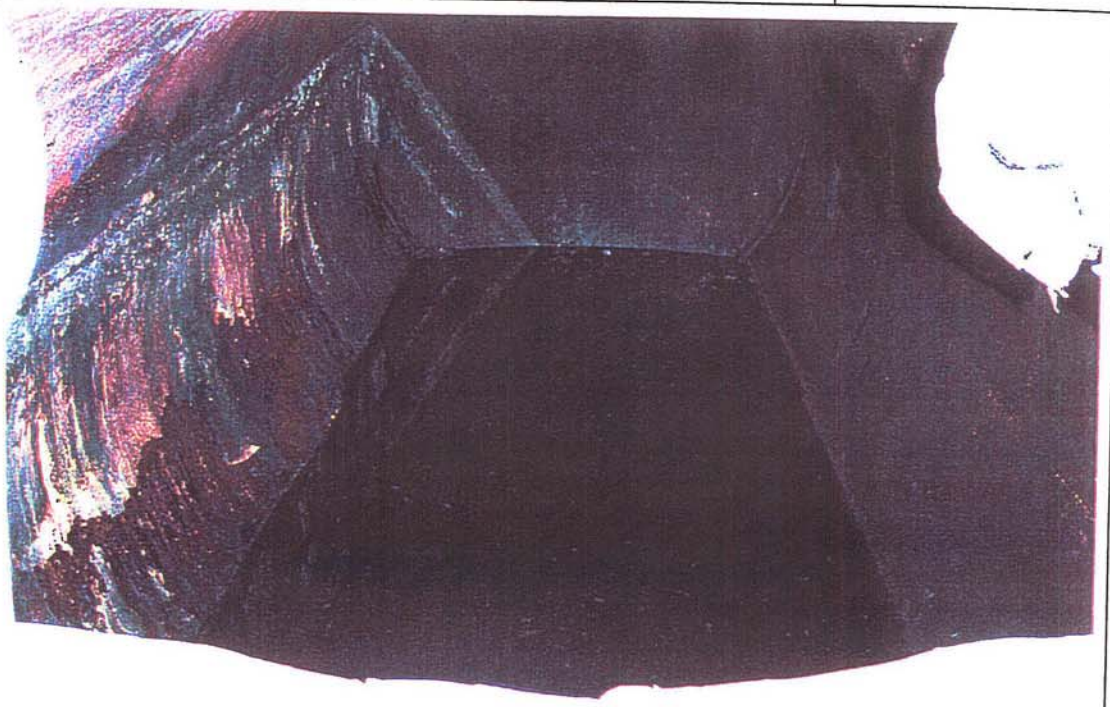
Photo No.	Date:
12	9-18-03

Residual material remaining in tank.

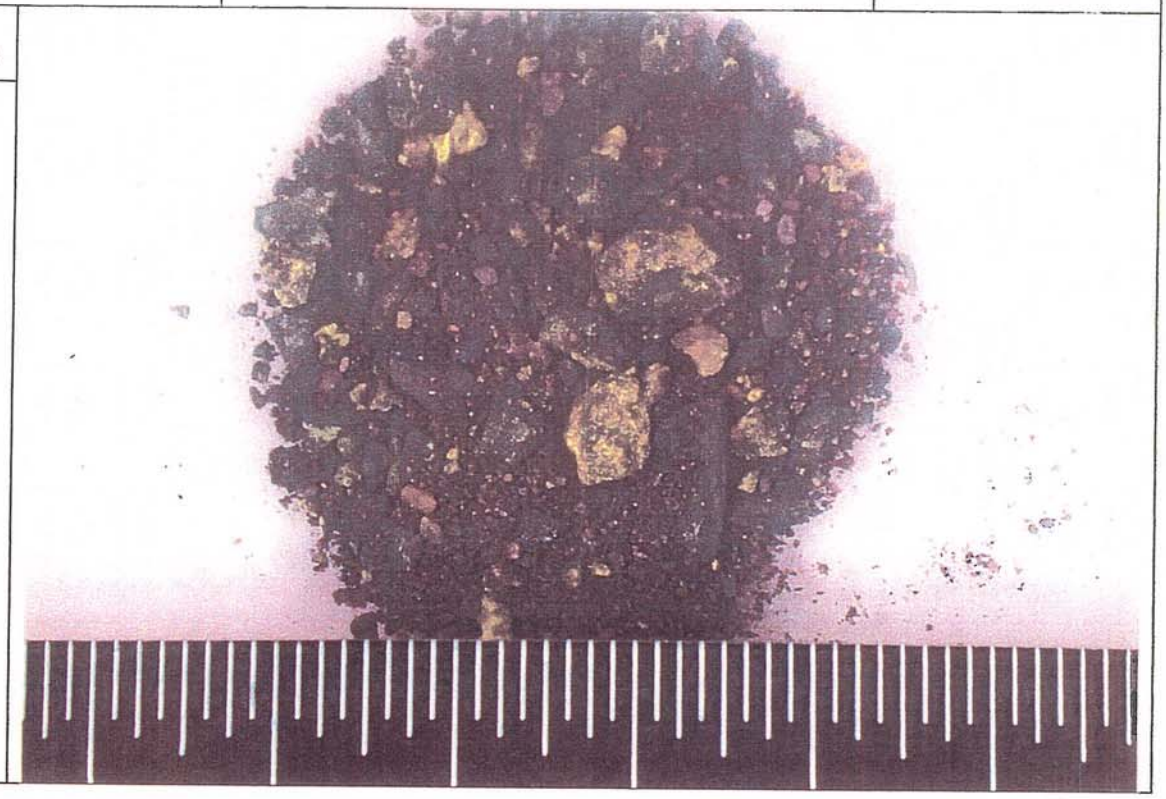
Photo No.	Date:
3	11/17/03

Description:
BWXT photo of representative sample from tube contents.
