The List of Documents:

Explosive Safety Board reports to LMD – April & June 2013

Enclosed is the report from the technical assistance visit you requested in your letter of March12, 2013 regarding the potential short- and long-term hazards associated with the M6 propellant that Explo Systems, Inc. (Explo) stores and processes for recycling and commercial sale at the Louisiana National Guard's (LANG) Camp Minden. The attached report provides recommendations LANG and the Louisiana State Police (LASP) may consider to improve the explosives safety posture at Camp Minden.

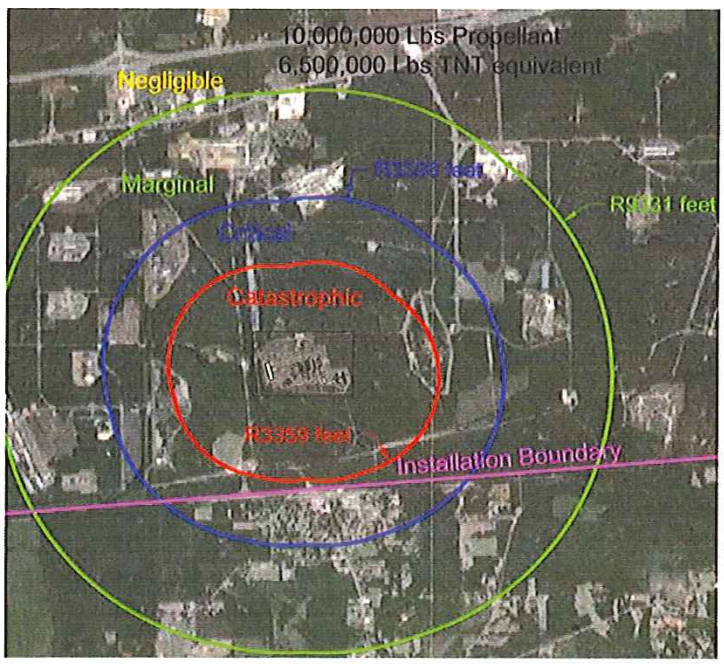
Figure 1 – Original Situation (November 2012)

Figure 1 shows the situation on the S-Line in November 2012. The ESQD situation depicted is for 6.5M lbs of TNT, which is the TNT equivalency of 10M lbs of M6 propellant. The team calculated the TNT equivalency by simply adding all the explosives material present on the S-Line at that time.

In its ESQD analysis of the S-Line's original situation, the team assumed that all 10M lbs of M6 propellant on the line in November 2012 would react with a prompt propagation as a Hazard Division (HD) 1.1 – a reaction of 6.5M lbs net explosives weight (NEW).

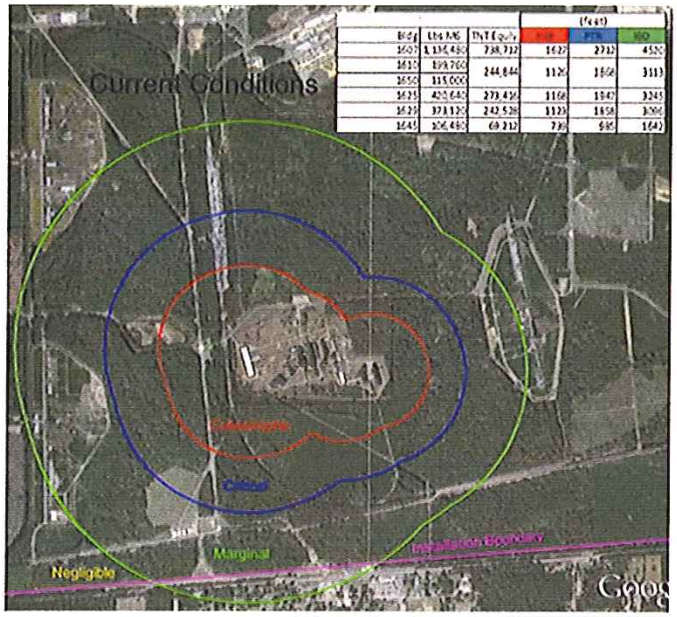
Figure 2 – Current Situation (Apr 13)

- There are three inter-magazine distance (IMD) violations on S-line.
  - The first is from building 1607 to building 1645. Considering both buildings only contain M6 propellant, it is not anticipated that propagation will occur between these buildings. Therefore, the IMD violation will be discounted.

- The second is from building 1607 to building 1610. Considering both buildings only contain M6 propellant, it is not anticipated that propagation will occur between these buildings. Therefore, the IMD violation will be discounted.

- The third is between buildings 1610 and 1650. Therefore, for the "Current Situation" analysis, buildings 1610 and 1650 will be referred to as the "group of 2," with the explosives totaled and treated as one explosives storage location. IMD is maintained between the "group of 2" and all other explosives storage buildings.

- The small wing on building 1607 that extends east towards building 1610 does not contain any explosives materials. Non-explosives materials are allowed.

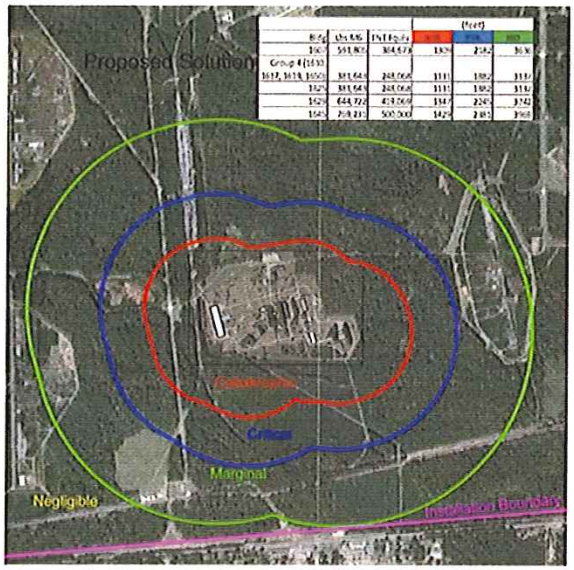
Figure 3 – Proposed Solution

- For the proposed solution, buildings 1610, 1617, 1619, and 1650 will be referred to as the "group of 4," with the explosives totaled and treated as one explosives storage location. IMD is maintained between the "group of 4" and all other explosives storage facilities. Grouping these four buildings as one explosives location maximizes the allowable explosives storage within S-line.

- The proposed solution meets DoD 6055.09-M's criteria, with respect to IMD, and provides an acceptable level of protection for the public.

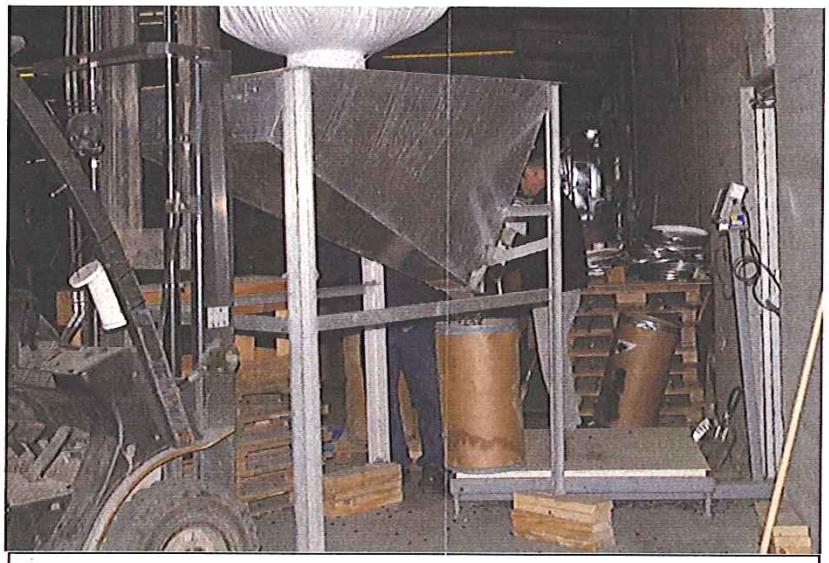
Propellant repackaging operations in building 1607

- **Observation**: The amount of propellant in storage in building 1607 creates ESQD violations.

Recommendation: Prohibit Explo from repackaging propellant in building 1607 and move the repackaging operation to another location that complies with DoD 6055.09-M. Limit building 1607's use to storage of M6 propellant.

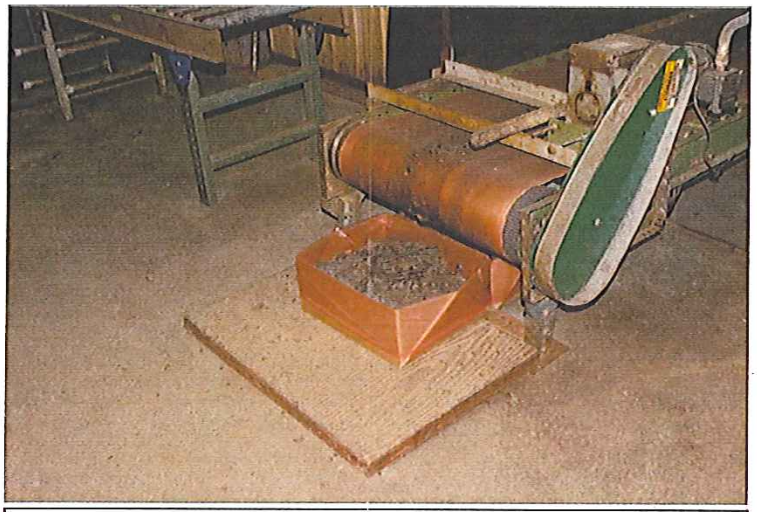
Tritonal Flaking Belt – Building 1619

Tritonal scraps located in Building 1619 generated from Tritonal flaking operation

DA Pam 385-64, paragraph 2-7.a.(4) – *At a minimum, hazardous waste material will be removed from AE and other operating facilities and taken to an approved disposal area or temporary collection point at the end of each shift. (b) Hazardous waste material should not be "stored" in the disposal area, but disposed of as soon as possible after arrival.*
