Site Name: Grow Group, Inc. Consumer Products Division

ENVIRONMENTAL PRIORITIES INITIATIVE PRELIMINARY ASSESSMENT

Purpose:	RCRA Preliminary Assessment
Site:	Grow Group, Inc. Consumer Products Division 2501 Malt Avenue Commerce, CA 90040 Los Angeles
Site EPA ID Number:	CAD085393080
TDD Number:	F9-9105-033
Program Account Number:	FCA1791RAA
FIT Investigators:	Janine Young and Yoon Toh, ICF Technology, Incorporated
Date of Inspection:	August 7, 1991
Report Prepared By:	Janine M. Young, ICF Technology, Incorporated
Report Date:	October 16, 1991
FIT Review/Concurrence:	10-17-91
Submitted To:	Rachel Loftin Site Assessment Manager, EPA Region IX

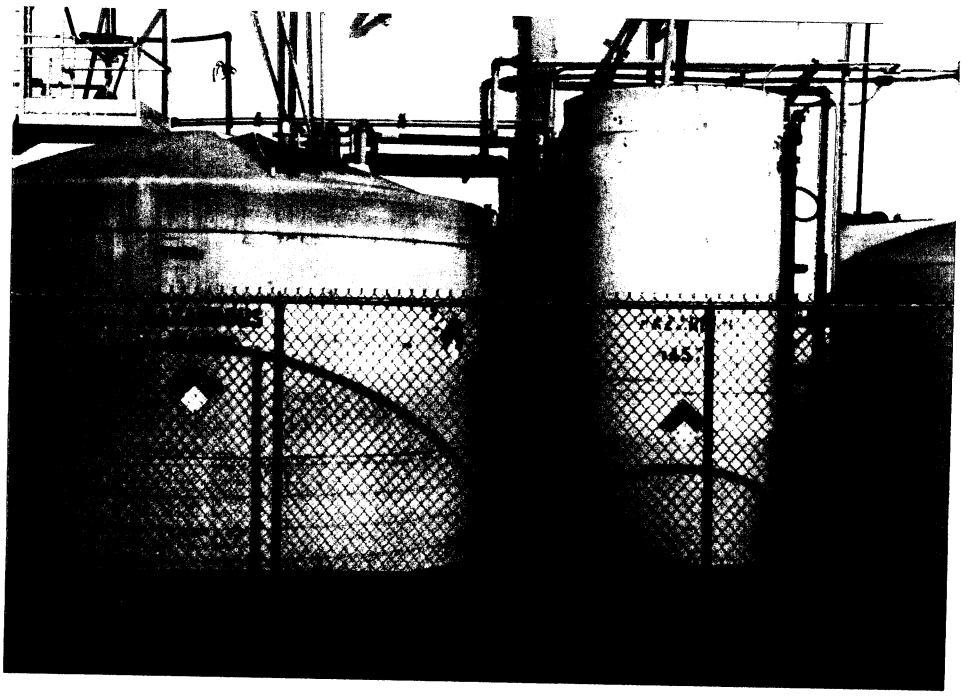
Photo 3: Current wastewater treatment system.

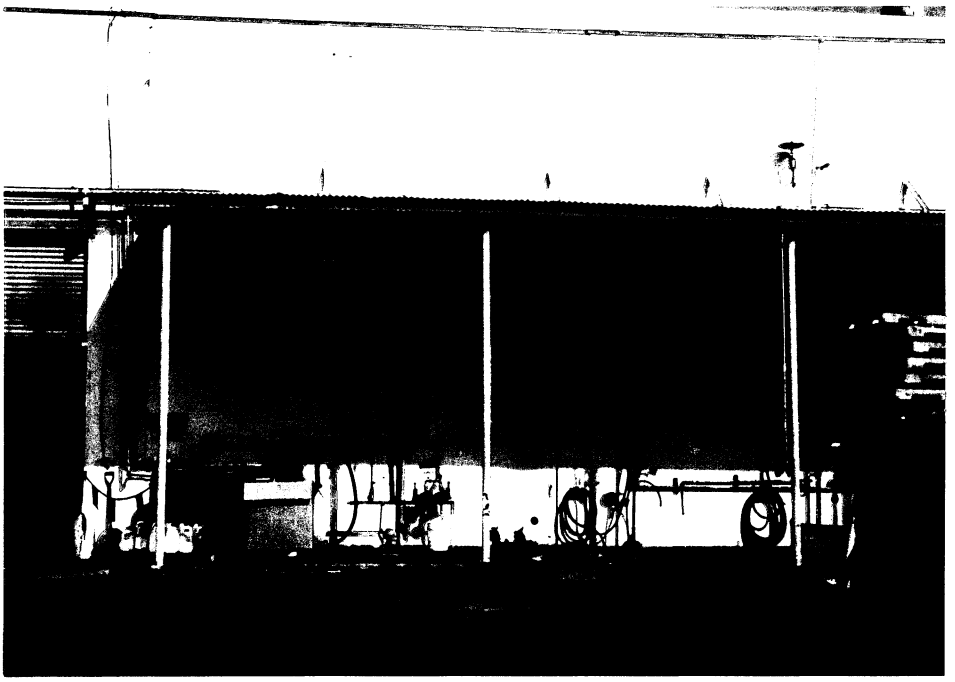
Photo 4: Former below-grade wastewater treatment system.

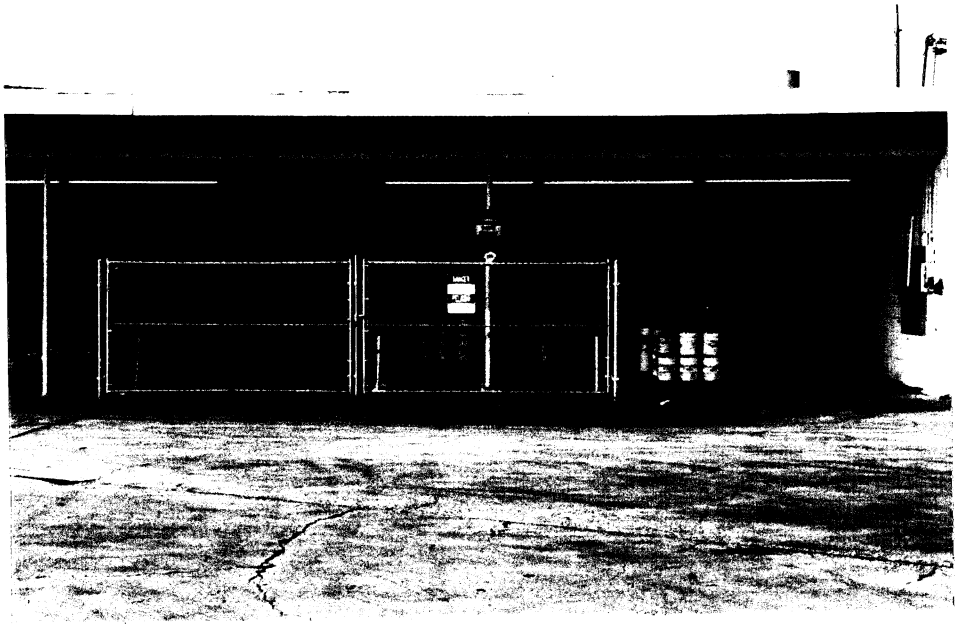
Photo 1: Current storage area for dry chemical wastes.

Photo 2: Current storage for drums of waste oil.

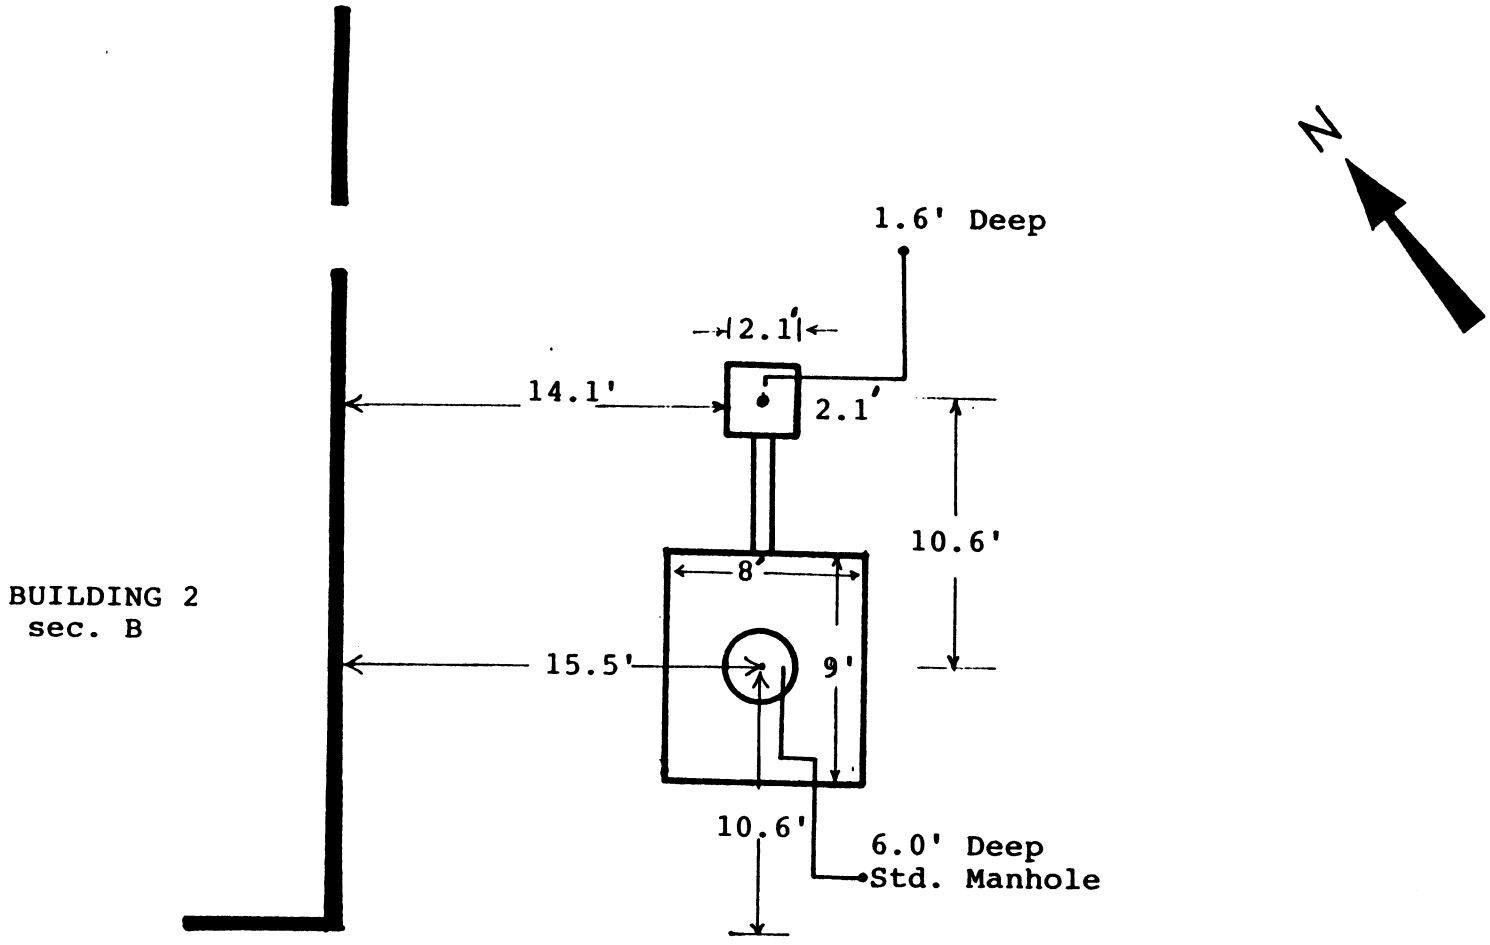
FIGURE 4
TRUCK WASH SUMP
GROW GROUP FACILITY

The truck wash sump lies under the pavement in the truck maintenance area. Figure 4 shows the location of this sump. The sump collects oily water from truck washing and any drippings from truck maintenance. The sump consists of two rectangular concrete cells approximately 10 feet apart and connected by pipe. One cell is approximately 2 feet square and 1.6 feet deep and covered by a 2-foot square cap. The other cell is 8 feet by 9 feet and 6 feet deep and covered by a 2-foot diameter manhole.

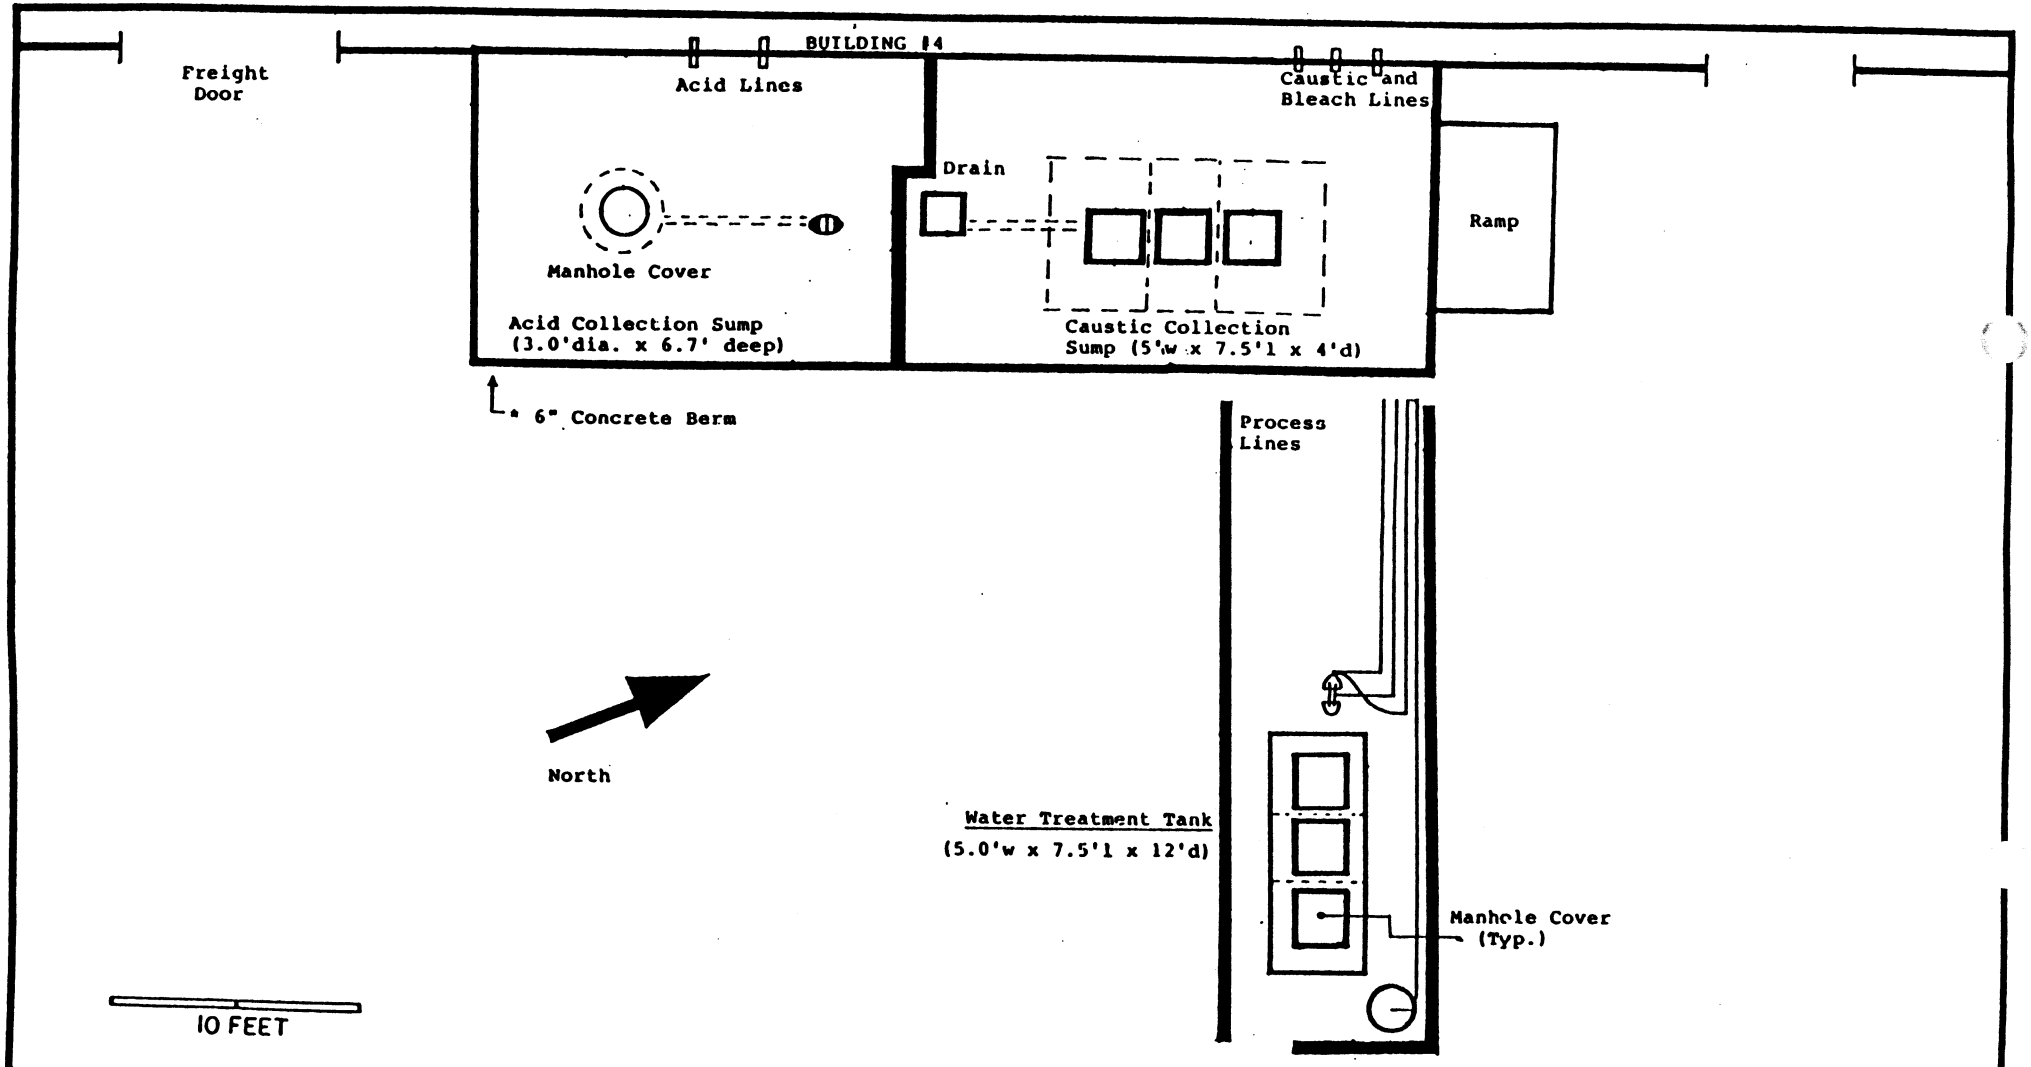
FIGURE 2
GROW GROUP FACILITY
Commerce, California

The caustic collection sump consists of three rectangular concrete chambers, as shown in Figure 2. The sump, approximately 7.5 feet by 5 feet and 4 feet deep, lies along the northeast side of building 4, the consumer packaging line. A 2-foot square manhole covers each cell. Tank trucks delivering caustic and bleach to the facility discharge at this point into pipe connections for transfer to the caustic and bleach storage tanks. A 6-inch concrete berm contains any spillage which may occur during caustic transfer. A floor drain allows the caustic to flow into the sump. The sump is periodically pumped out to the plant treatment system. There is no indication that the caustic sump has ever leaked.

Figure 2 also shows the former water treatment tank. The tank, which is approximately 7.6 feet by 5 feet and 12 feet deep, consists of three interconnected rectangular concrete cells. A 2-foot square manhole covers each cell. The floor drains from the caustic area of the consumer products packaging line empty into the first cell. The contents of the first cell are periodically pumped out to the plant treatment system. Effluent from the plant treatment system connects to a tee at the outlet of the third cell and discharges to the sewer.
