EPA FINAL REPORT

Purpose: Federal Facility PA Review

Site: Kaiser Eagle Mountain
Eagle Mountain, California
Riverside County

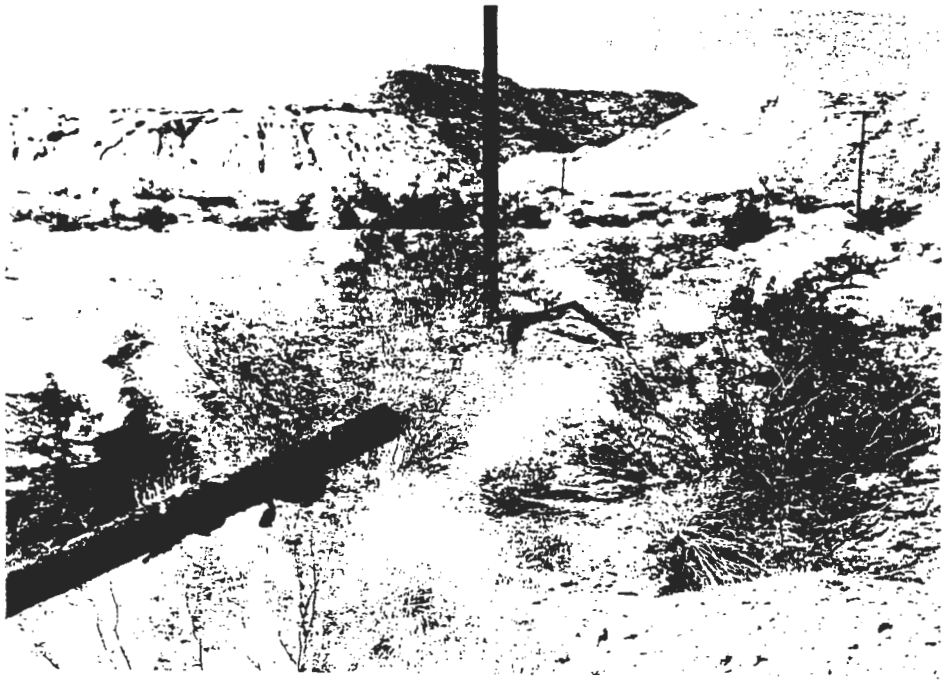
T. 3 S., R. 15 E., SEC. 31

BROKEN WATER PIPELINE

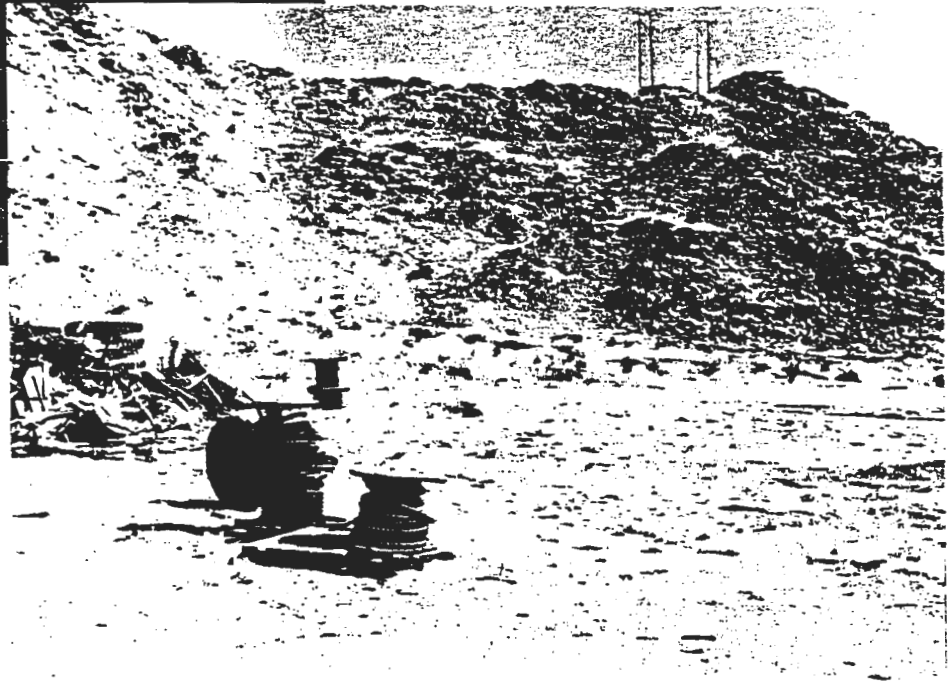
T. 4 S., R. 14 E., SEC. 11-12

BARRELS OF UNKNOWN MATERIAL, TIRES, RAILROAD SPUR

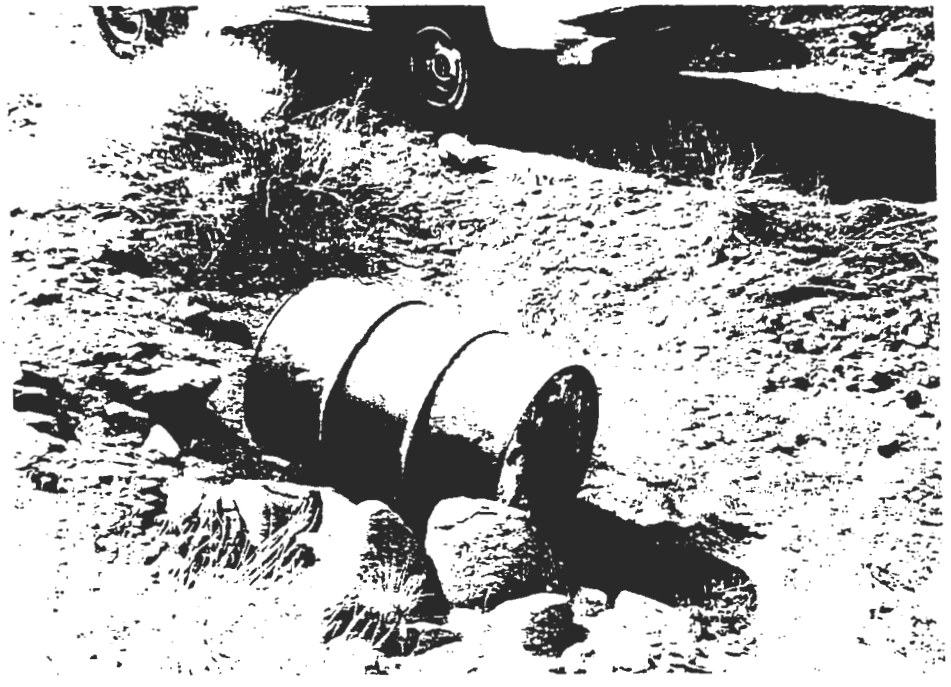
T. 4 S., R. 15 E., SEC. 6

EMPTY DRUM, NO MARKINGS

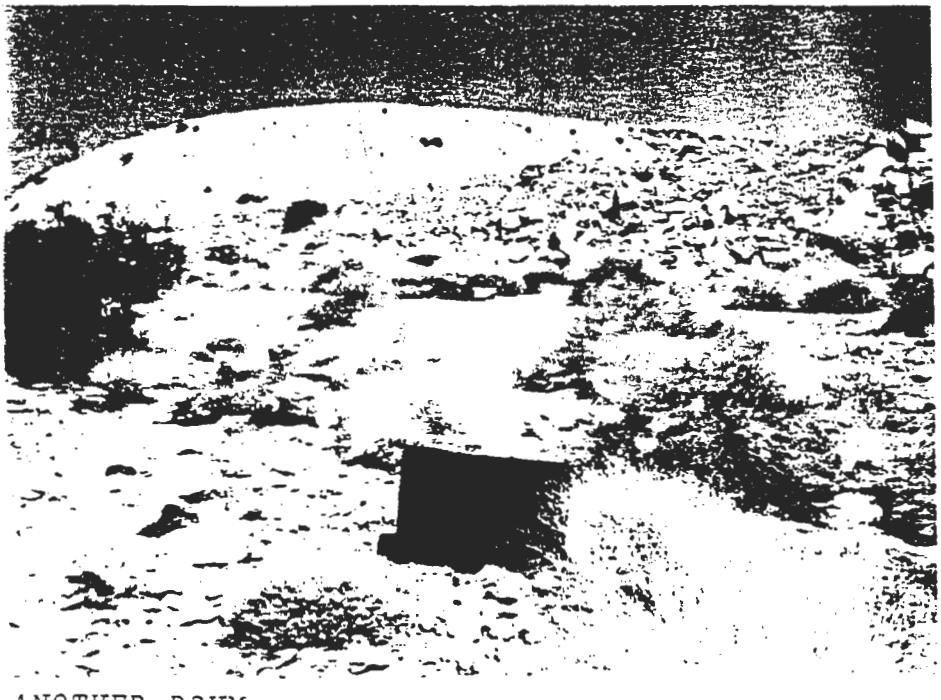
T. 4 S., R. 15 E., SEC. 6

ANOTHER DRUM

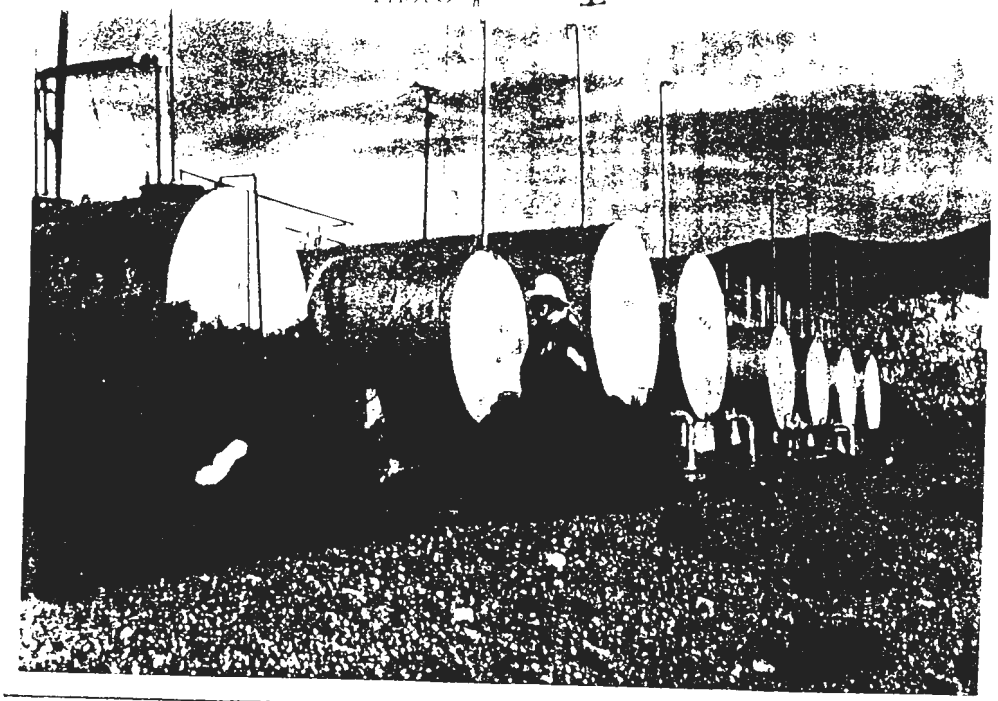
Photo # 1

[illegible] Eagle Mountain Mine, Central Pit Fueling Station [illegible] diesel and hydraulic fluid storage tanks. All tanks [illegible] Lowell Hall [illegible] the tanks. Picture shows [illegible] Rich [illegible]

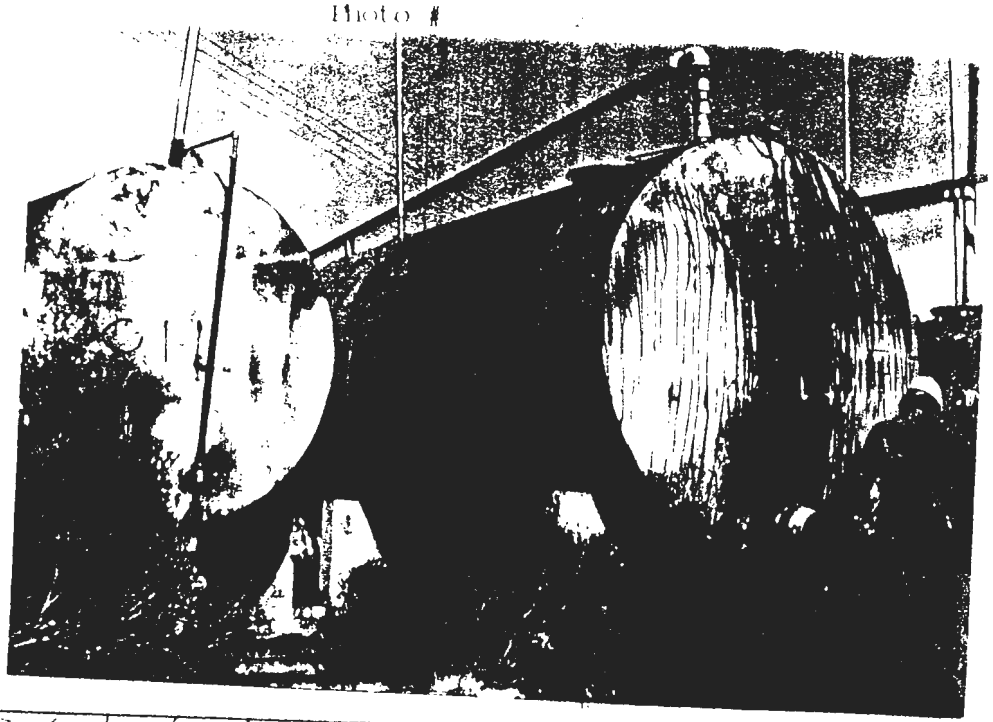
Photo #

[illegible] Eagle Mountain Mine, Central Pit Fueling Station [illegible]

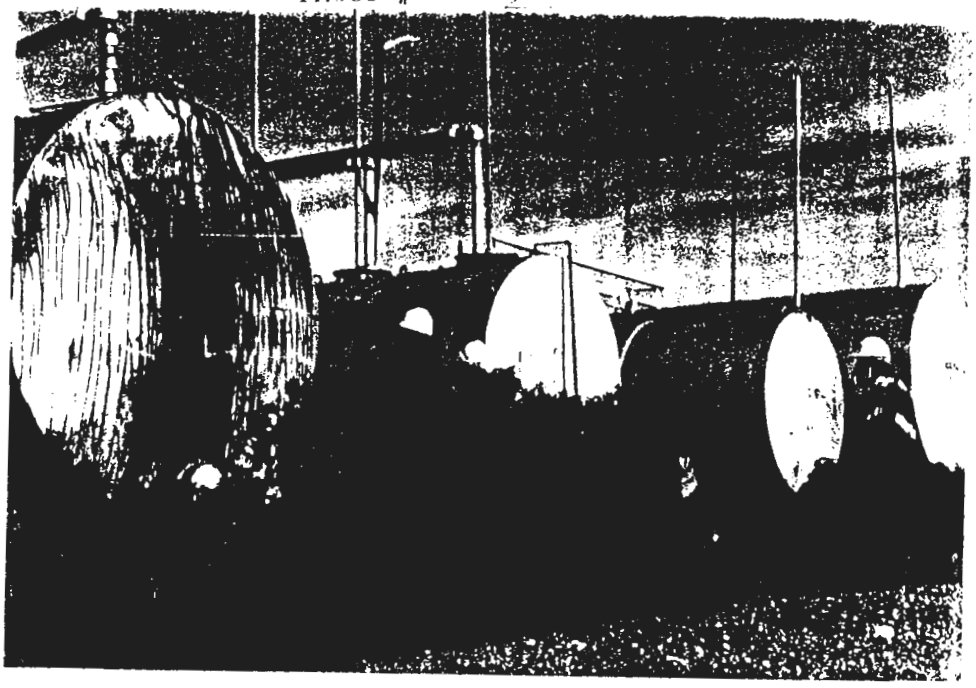
Photo # 3

Comments:
[illegible] Eagle Mountain Mine Central Pit Fueling Station [illegible] diesel and hydraulic fluid storage tanks.

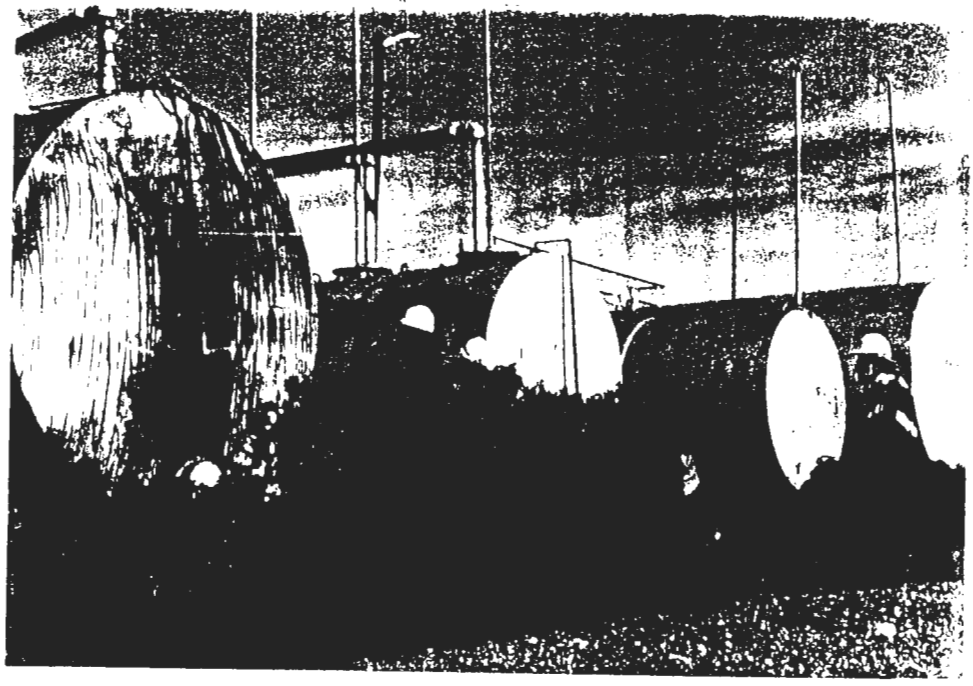
Photo # 5

Comments:
[illegible] Eagle Mountain Mine Central Pit Fueling Station [illegible] station in center.

[illegible] Eagle Mountain [illegible] Central Pit Fueling Station [illegible] [illegible] and [illegible] [illegible] storage tanks.

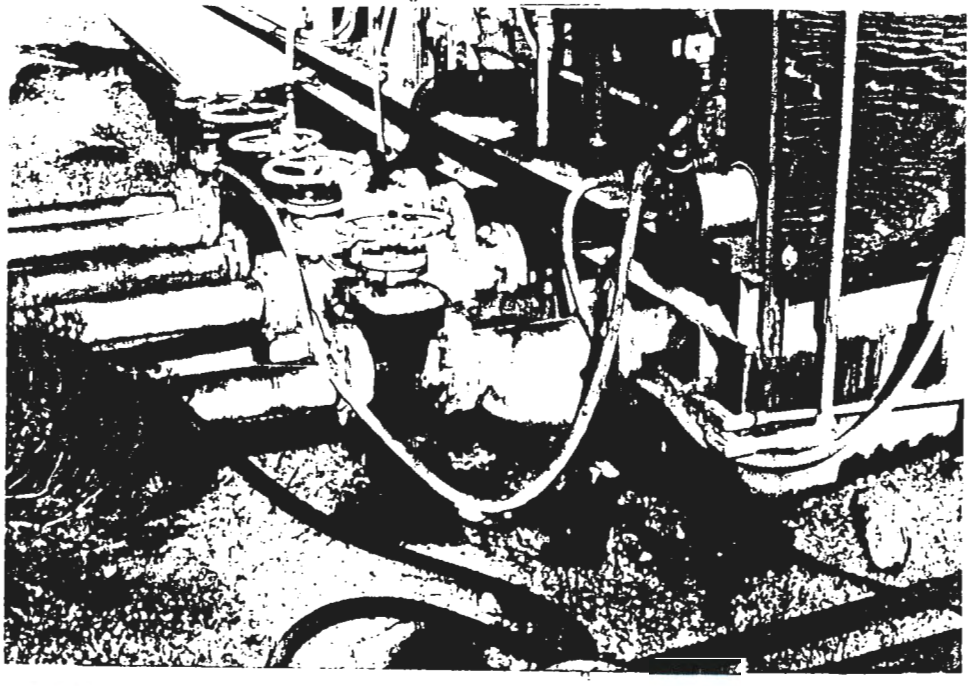
Photo # 6

Comments:
2/10/94 Eagle Mountain Mine Central Pit Fueling Station - Service Station. Soil contamination from parking valves and connections. Petrol, solvent, hydraulic fluid.
Photographer: Rich Hubbell
