November 9, 1995

SUBJECT: REPORT OF SOIL INVESTIGATION AND REMOVAL
MCDONNELL DOUGLAS CORPORATION
DOUGLAS AIRCRAFT COMPANY BUILDING NO. 61
TORRANCE, CALIFORNIA
ESE PROJECT NO. 6495203

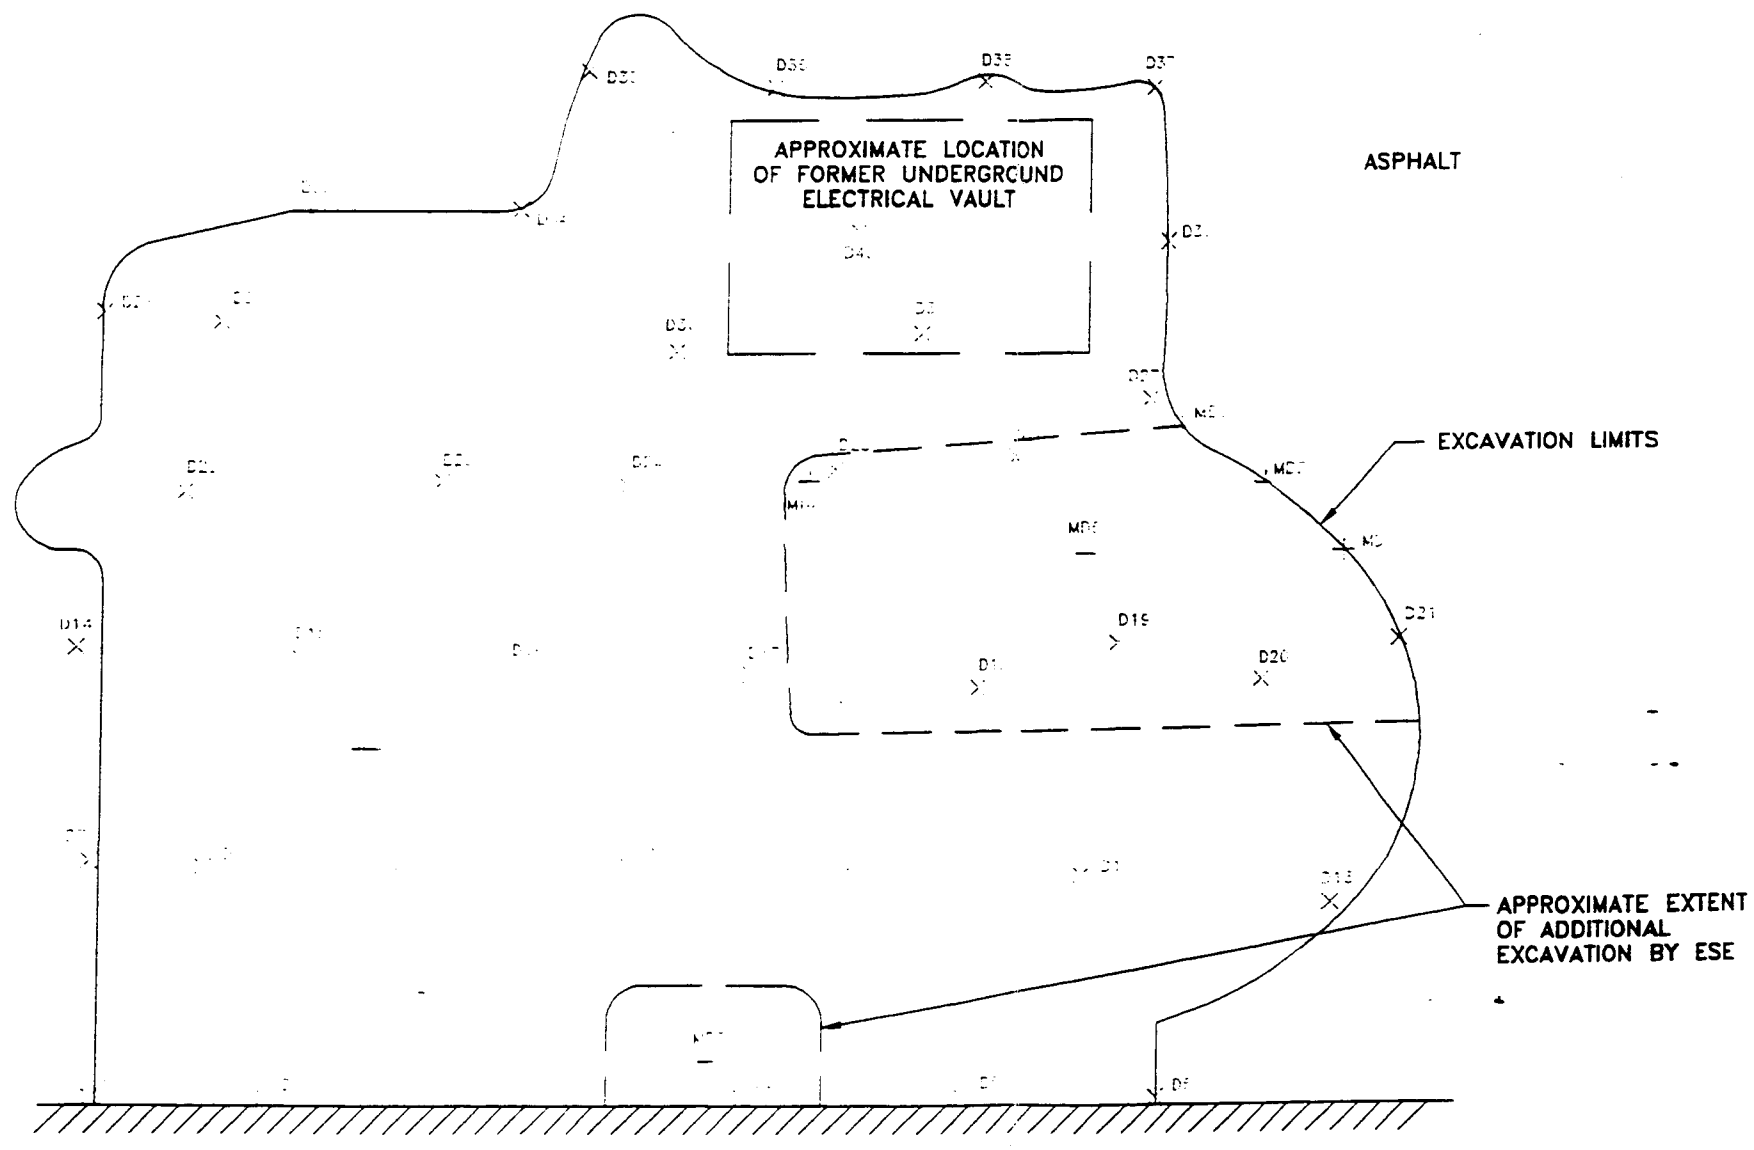
# INITIAL GRID SAMPLING LOCATION MAP

On July 18, 1995, ESE personnel collected soil samples from the vault excavation floor using the 37-point grid pattern. Samples were also collected from the excavation sidewalls. The sampling locations are shown on Figure 3. Analytical results for the soil samples are shown in Table 1. Copies of the laboratory reports and chain-of-custody documents are in Appendix B.

Detectable PCB concentrations in three composite samples were above the established cleanup level: D1 through D10, D11 through D20, and D25-1 through D31-15. Therefore, the samples were analyzed individually and PCB concentrations were found to be above the cleanup level in Samples D4, D18, D19, D25-1, D27-1 and D27-5. Aroclor-1260 was the only PCB identified.

On August 24, 1995, Jerry's Backhoe Service of Paramount, California, under the supervision of ESE personnel, excavated approximately 15 yards of soil containing PCBs. This soil was placed into roll-off bins and the disposal was coordinated by IT Corporation. Upon removal of the affected soil, ESE collected Samples MD-1 through MD-6 to verify that PCB concentrations in the remaining soil were below the cleanup level (Figure 3). The samples were analyzed using USEPA Method 8080. The analytical results are shown in Table 2. Copies of the laboratory report and chain-of-custody document are in Appendix B. PCBs were not detected in the verification samples.

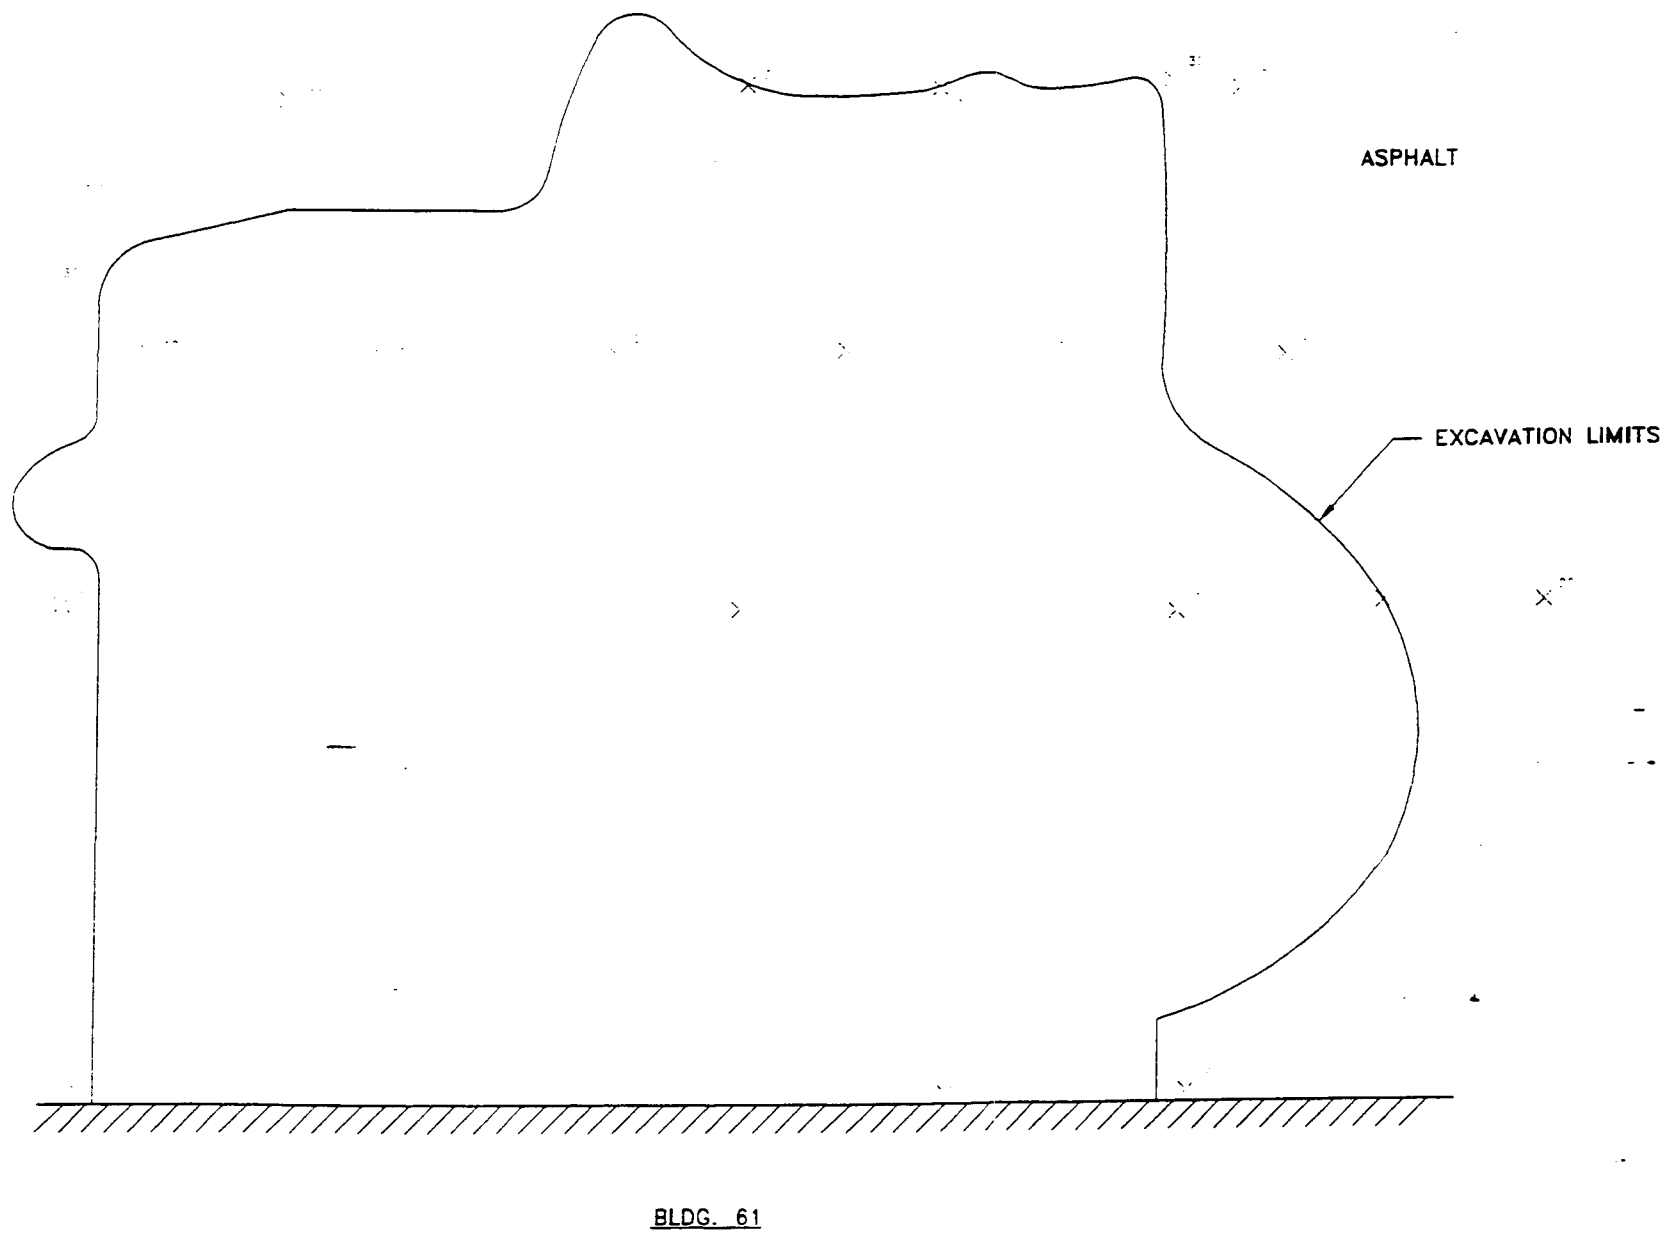
# SUBSEQUENT GRID SAMPLING LOCATION MAP

On September 6, 1995, ESE personnel performed additional grid sampling at the request of DAC. The sampling locations are shown on Figure 4. The analytical results are shown in Table 3. Copies of the laboratory reports and chain-of-custody documents are in Appendix C. The results show that soil remaining in the investigated area does not contain PCB concentrations above the 10 mg/kg cleanup goal.
