May 4, 2000

Letter Report
Groundwater Sampling and Well Destruction, Well TMW-17
Boeing C-6 Facility
Los Angeles, California

SITE PHOTOGRAPHS

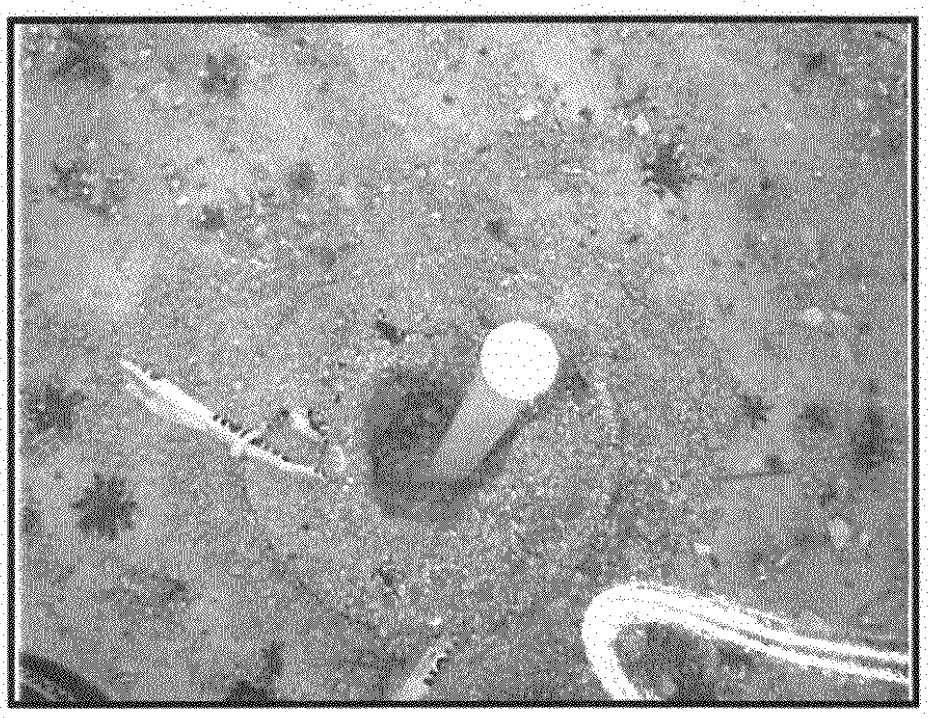
Well BL-1 showing approximately 4 inches of bentonite grout seal settlement.

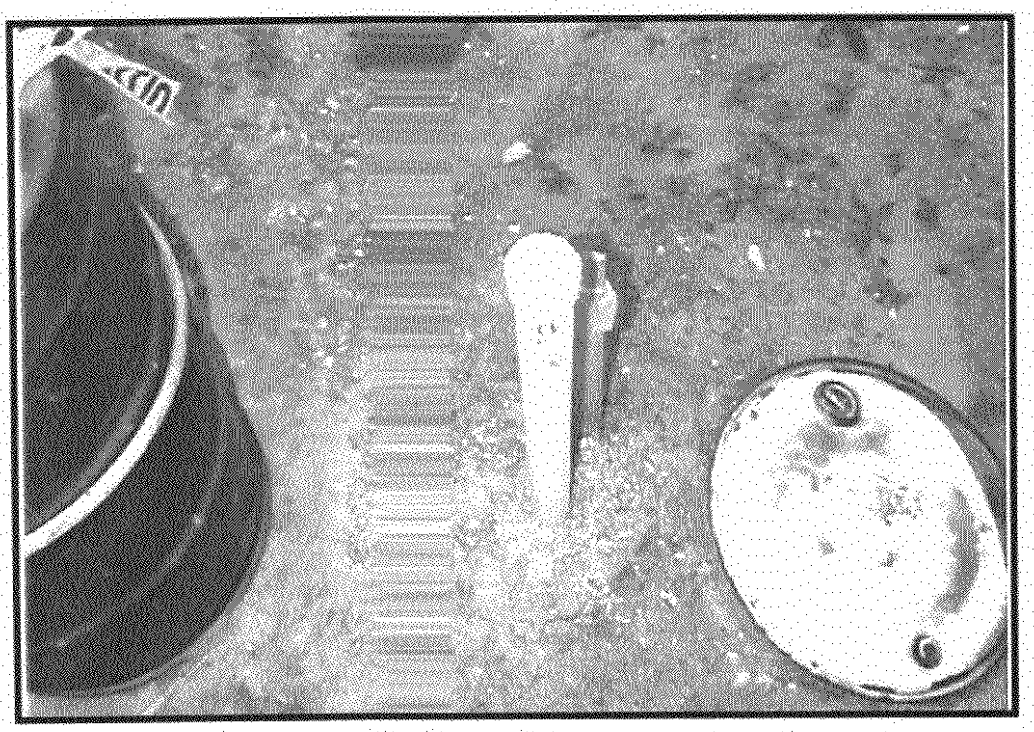
Well BL-3 w[redacted]th negligible grout settlement.

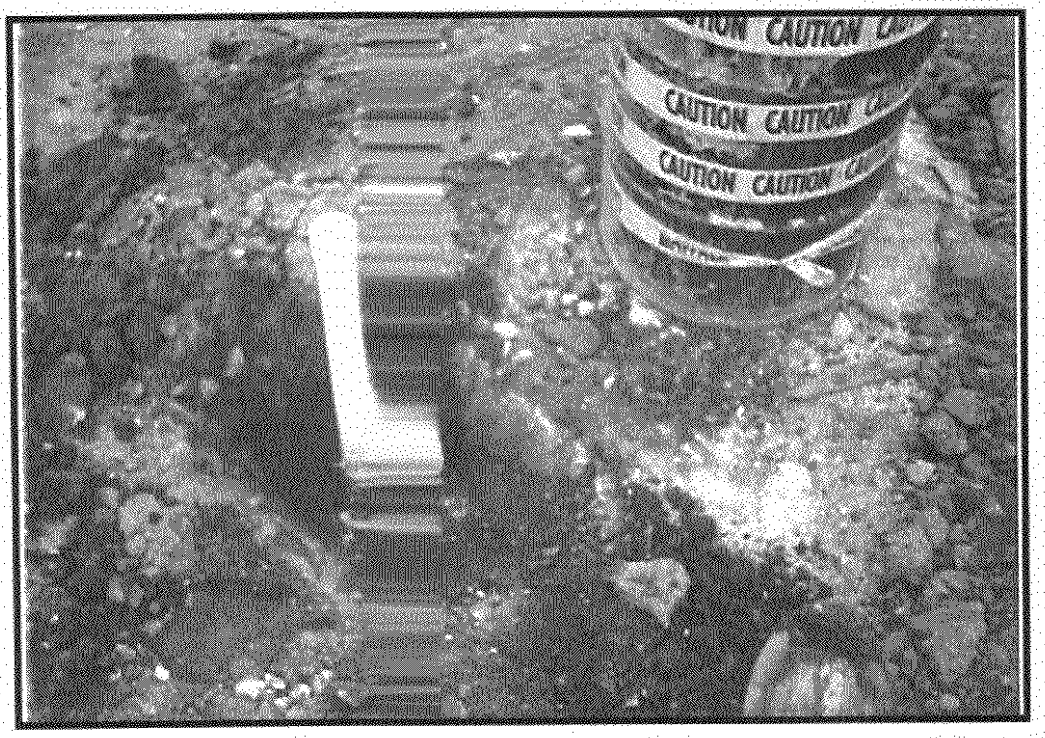
Well BL-4 with top of bentonite gr[redacted]ut found at 1 foot below surface beneath soil backfill.
