Environmental
Science &
Engineering, Inc.

November 9, 1995

SUBJECT: REPORT OF SOIL INVESTIGATION AND REMOVAL
MCDONNELL DOUGLAS CORPORATION
DOUGLAS AIRCRAFT COMPANY BUILDING NO. 61
TORRANCE, CALIFORNIA
ESE PROJECT NO. 6495203

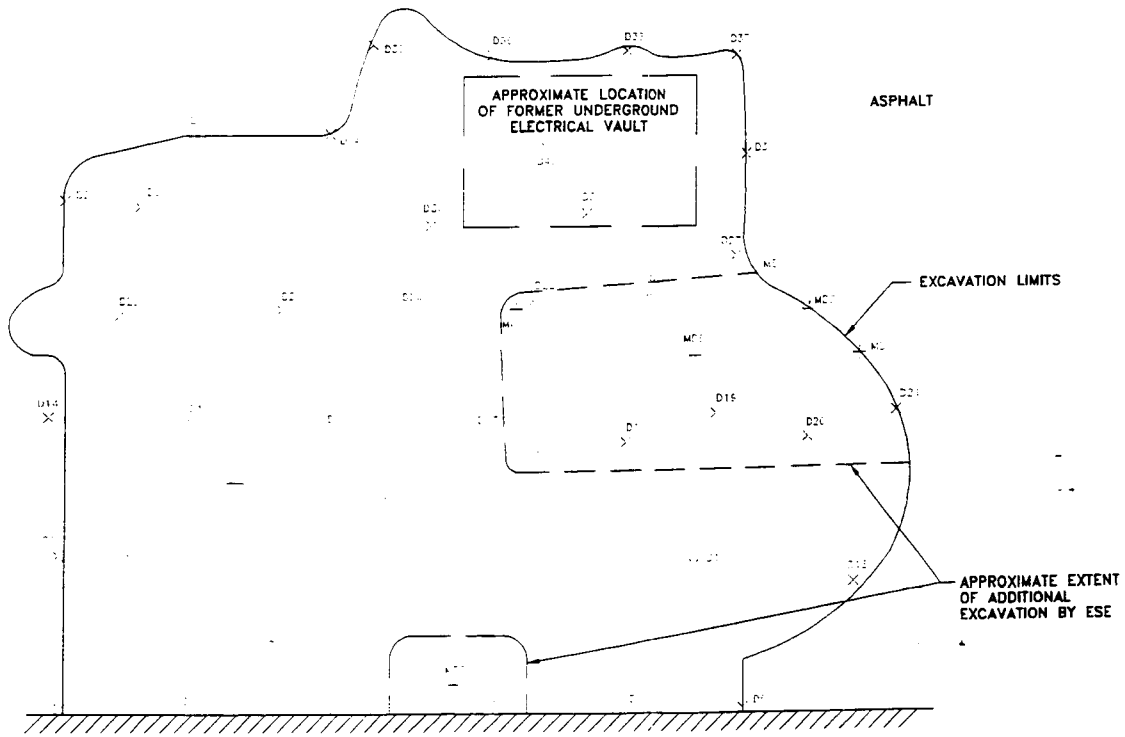
INITIAL GRID SAMPLING LOCATION MAP

On July 18, 1995, ESE personnel collected soil samples from the vault excavation floor using the 37-point grid pattern. Samples were also collected from the excavation sidewalls. The sampling locations are shown on Figure 3. Analytical results for the soil samples are shown in Table 1. Copies of the laboratory reports and chain-of-custody documents are in Appendix B.

Detectable PCB concentrations in three composite samples were above the established cleanup level: D1 through D10, D11 through D20, and D25-1 through D31-15. Therefore, the samples were analyzed individually and PCB concentrations were found to be above the cleanup level in Samples D4, D18, D19, D25-1, D27-1 and D27-5. Aroclor-1260 was the only PCB identified.

On August 24, 1995, Jerry's Backhoe Service of Paramount, California, under the supervision of ESE personnel, excavated approximately 15 yards of soil containing PCBs. This soil was placed into roll-off bins and the disposal was coordinated by IT Corporation. Upon removal of the affected soil, ESE collected Samples MD-1 through MD-6 to verify that PCB concentrations in the remaining soil were below the cleanup level (Figure 3). The samples were analyzed using USEPA Method 8080. The analytical results are shown in Table 2. Copies of the laboratory report and chain-of-custody document are in Appendix B. PCBs were not detected in the verification samples.

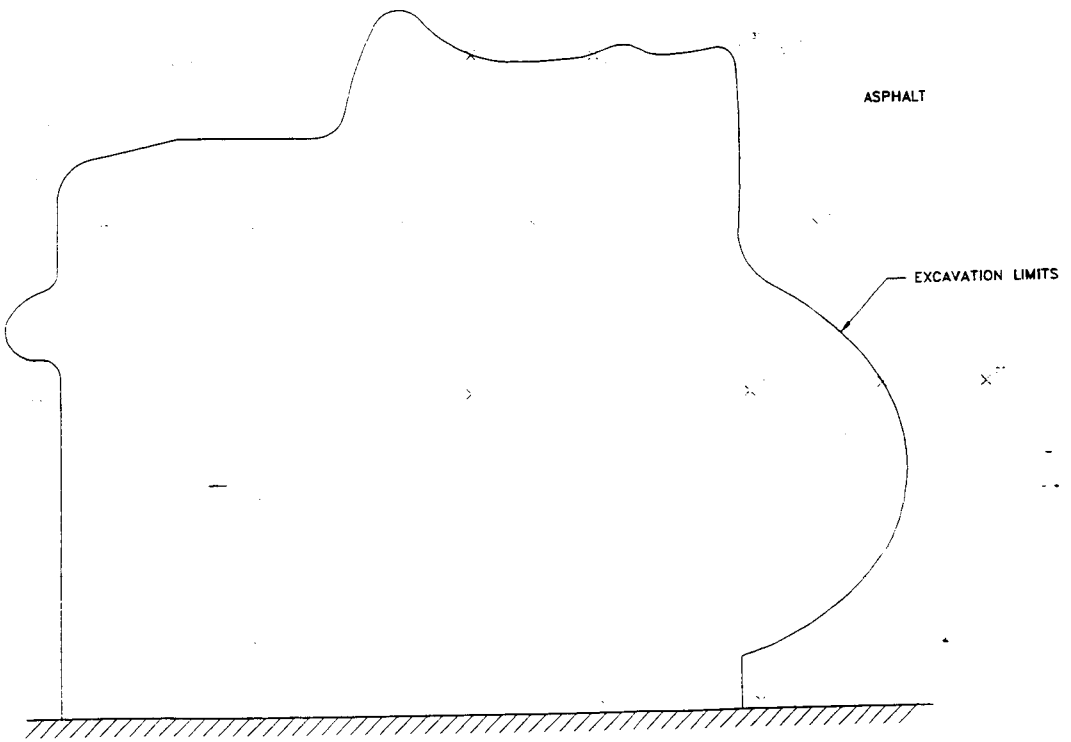
SUBSEQUENT GRID SAMPLING LOCATION MAP

On September 6, 1995, ESE personnel performed additional grid sampling at the request of DAC. The sampling locations are shown on Figure 4. The analytical results are shown in Table 3. Copies of the laboratory reports and chain-of-custody documents are in Appendix C. The results show that soil remaining in the investigated area does not contain PCB concentrations above the 10 mg/kg cleanup goal.
