Environmental
Science &
Engineering, Inc.
A CILCORP Company

November 9, 1995

SUBJECT: REPORT OF SOIL INVESTIGATION AND REMOVAL
MCDONNELL DOUGLAS CORPORATION
DOUGLAS AIRCRAFT COMPANY BUILDING NO. 61
TORRANCE, CALIFORNIA
ESE PROJECT NO. 6495203

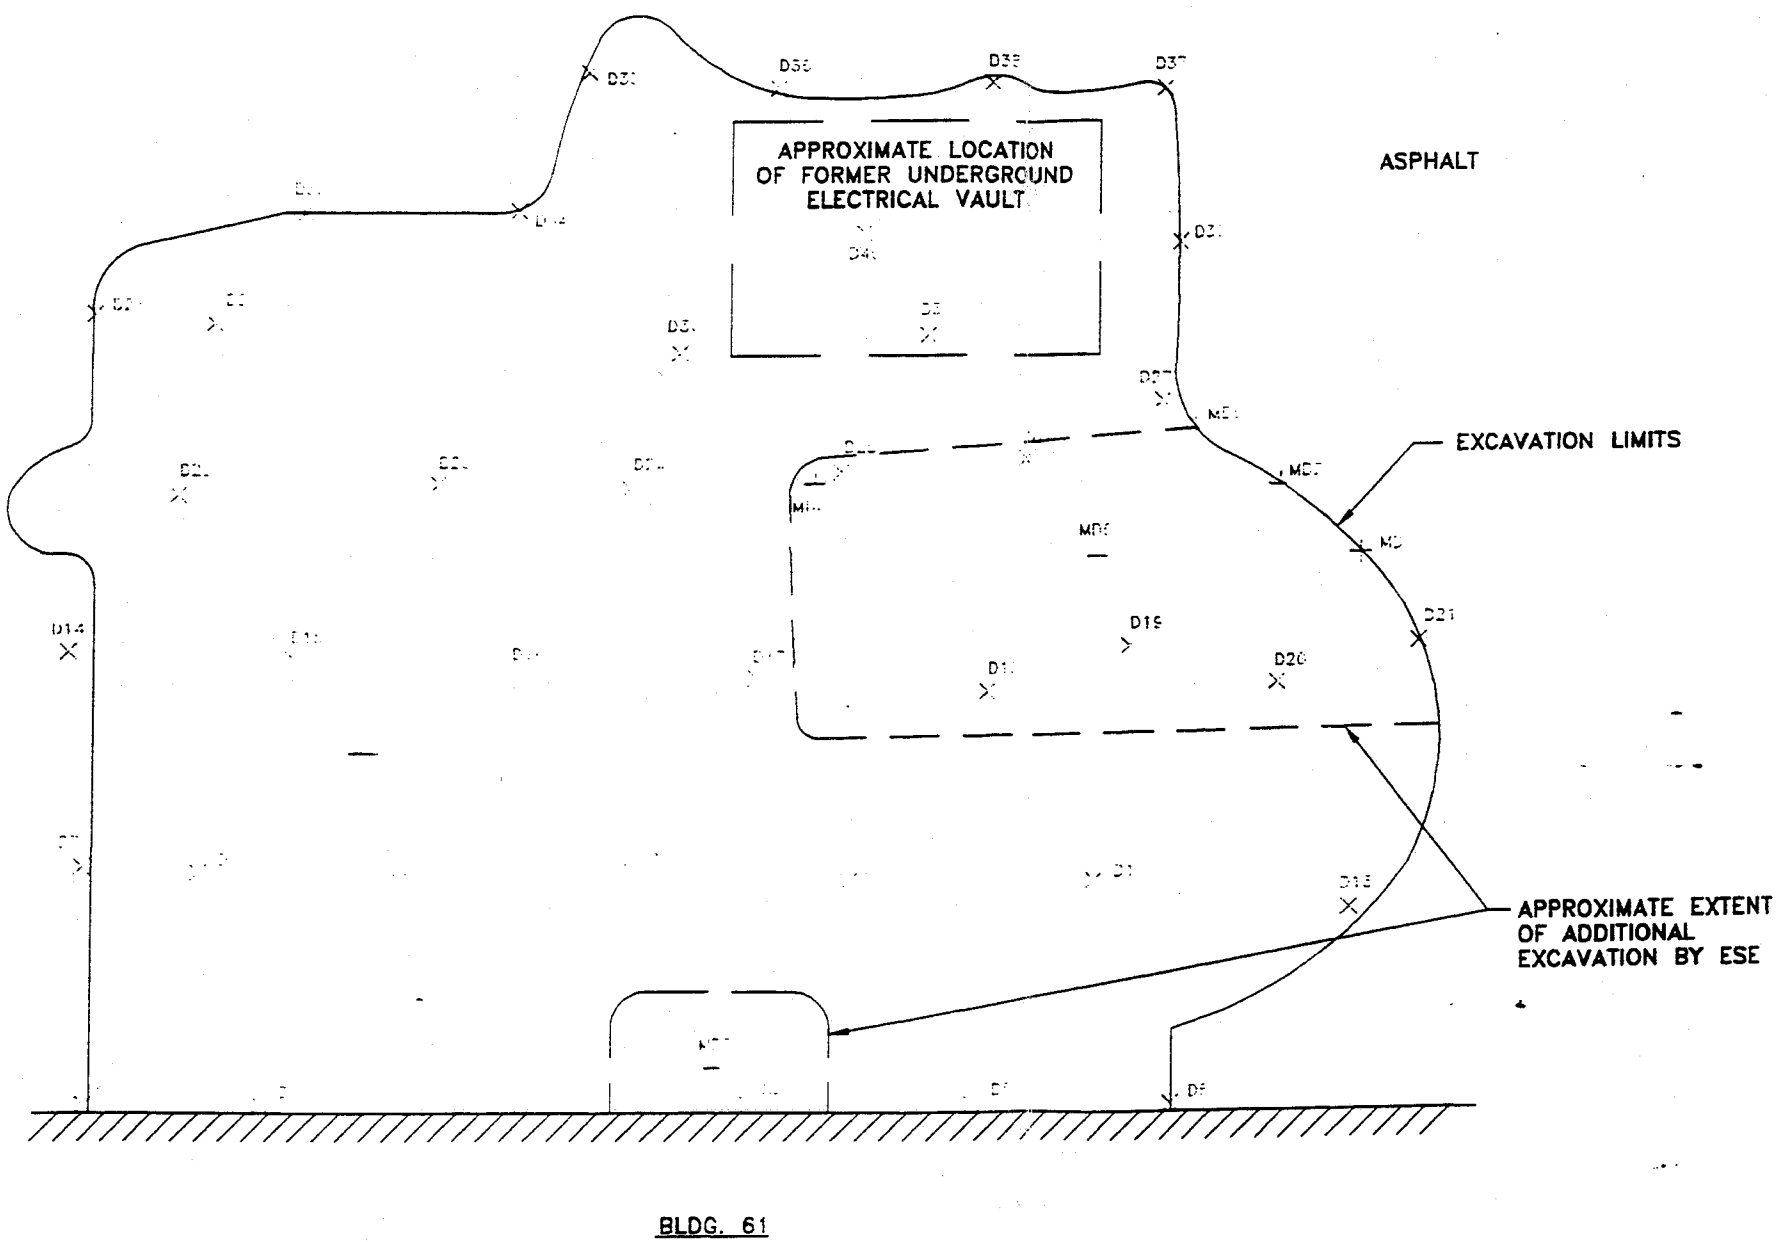
INITIAL GRID SAMPLING LOCATION MAP

On July 18, 1995, ESE personnel collected soil samples from the vault excavation floor using the 37-point grid pattern. Samples were also collected from the excavation sidewalls. The sampling locations are shown on Figure 3. Analytical results for the soil samples are shown in Table 1. Copies of the laboratory reports and chain-of-custody documents are in Appendix B.

Detectable PCB concentrations in three composite samples were above the established cleanup level: D1 through D10, D11 through D20, and D25-1 through D31-15. Therefore, the samples were analyzed individually and PCB concentrations were found to be above the cleanup level in Samples D4, D18, D19, D25-1, D27-1 and D27-5. Aroclor-1260 was the only PCB identified.

On August 24, 1995, Jerry's Backhoe Service of Paramount, California, under the supervision of ESE personnel, excavated approximately 15 yards of soil containing PCBs. This soil was placed into roll-off bins and the disposal was coordinated by IT Corporation. Upon removal of the affected soil, ESE collected Samples MD-1 through MD-6 to verify that PCB concentrations in the remaining soil were below the cleanup level (Figure 3). The samples were analyzed using USEPA Method 8080. The analytical results are shown in Table 2. Copies of the laboratory report and chain-of-custody document are in Appendix B. PCBs were not detected in the verification samples.

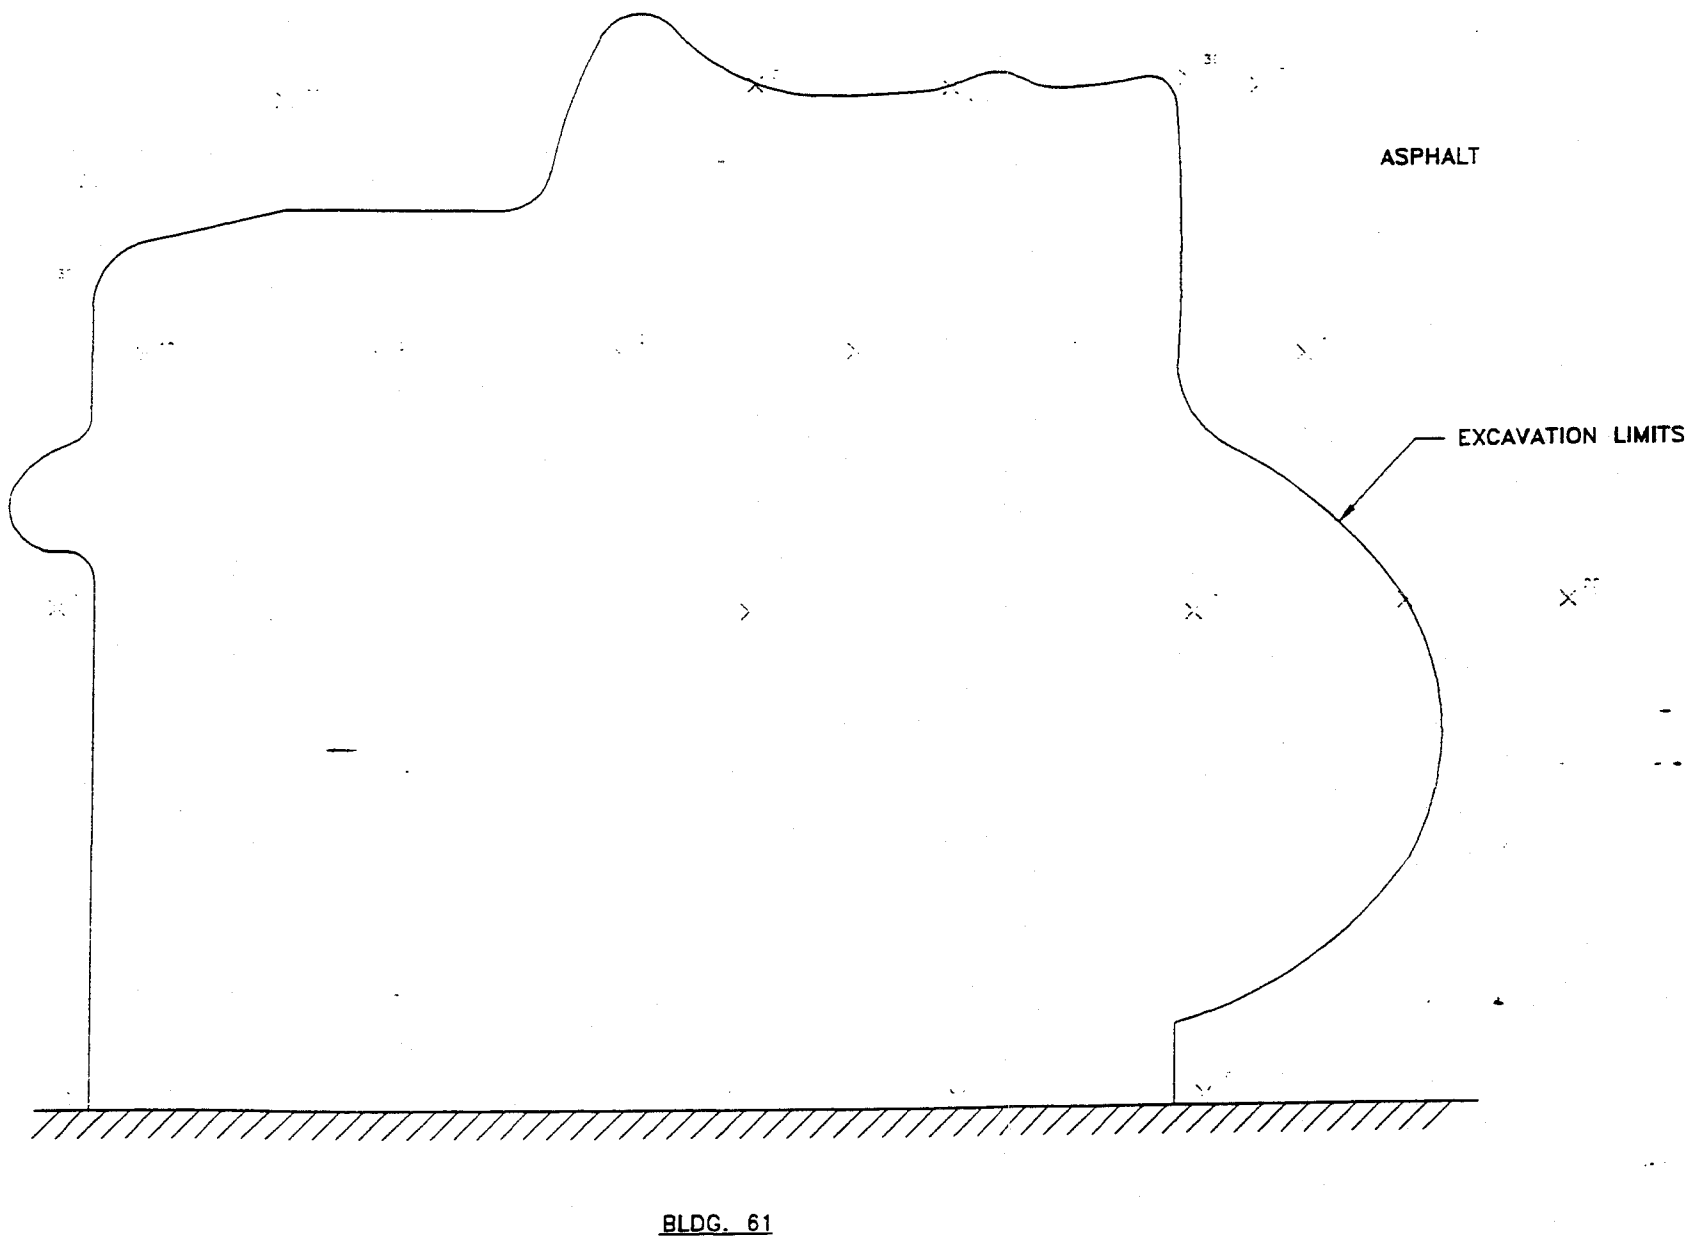
SUBSEQUENT GRID SAMPLING LOCATION MAP

On September 6, 1995, ESE personnel performed additional grid sampling at the request of DAC. The sampling locations are shown on Figure 4. The analytical results are shown in Table 3. Copies of the laboratory reports and chain-of-custody documents are in Appendix C. The results show that soil remaining in the investigated area does not contain PCB concentrations above the 10 mg/kg cleanup goal.
