TSCA PCB 6(e) Compliance Evaluation Inspection

Clean Harbors Environmental Services, Inc.
4105 Whitaker Avenue
Philadelphia, Pennsylvania 19124

Date of Inspection: May 7, 2003

Inspection category: Commercial Storage Facility

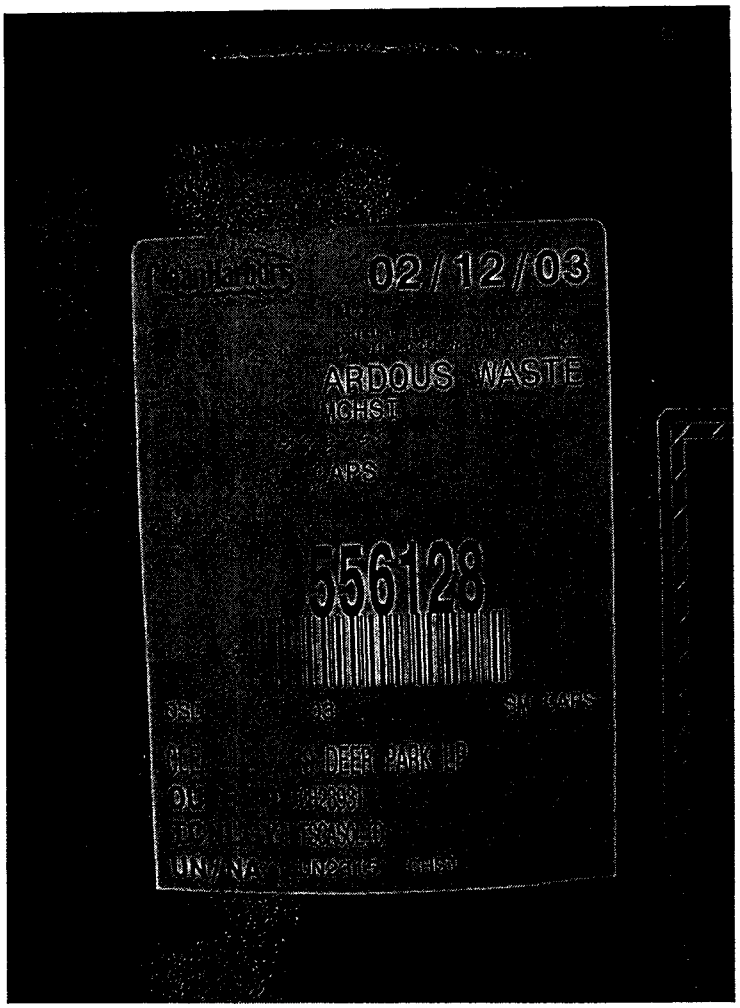
791
Clean Harbors Environmental Services, Inc.
4105 Whitaker Avenue
Philadelphia, Pennsylvania 19124
G. Houghton
May 7, 2003

Typical label used for all container in storage for disposal at Clean Harbors. The date in the upper right hand corner is the arrival dated in Philadelphia. The number over the barcode is the unique identifier number for this particular container. The 'OSD' out of service date is directly under the barcode.. Other information includes content information and disposal location.

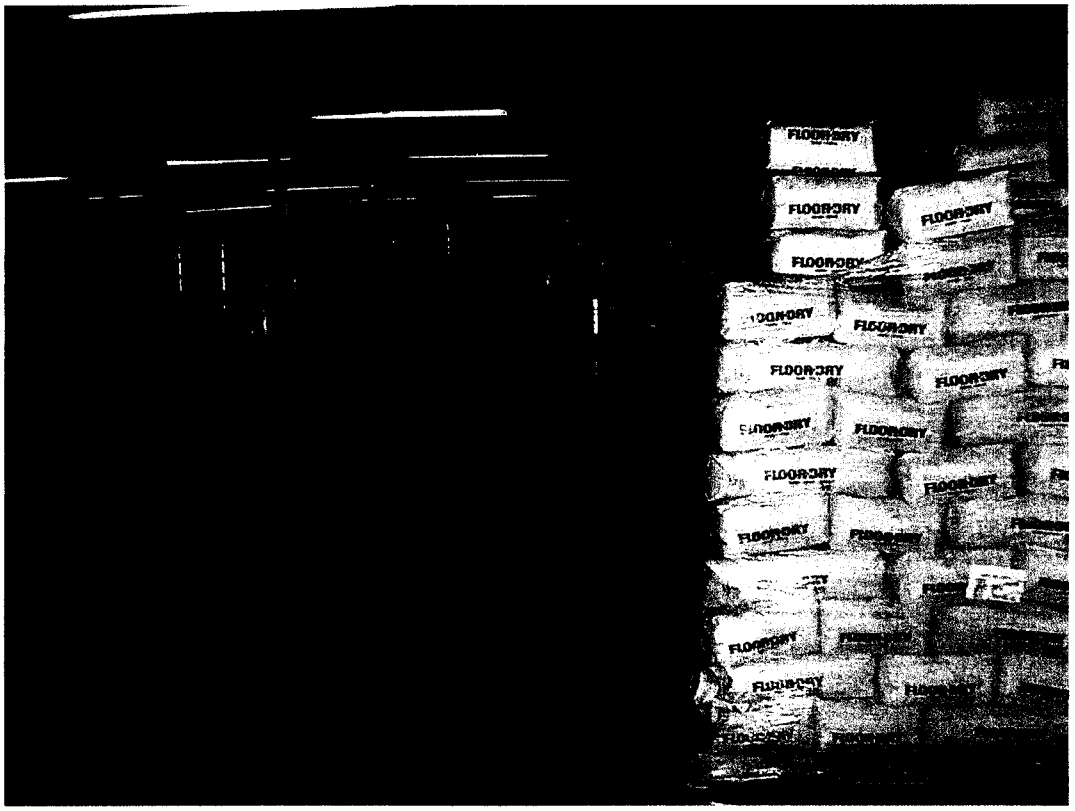
794
Clean Harbors Environmental Services, Inc.
4105 Whitaker Avenue
Philadelphia, Pennsylvania 19124
G. Houghton
May 7, 2003

Final frame of the three photo pan of the storage area. In the far background are non PCB items that will be disposed.

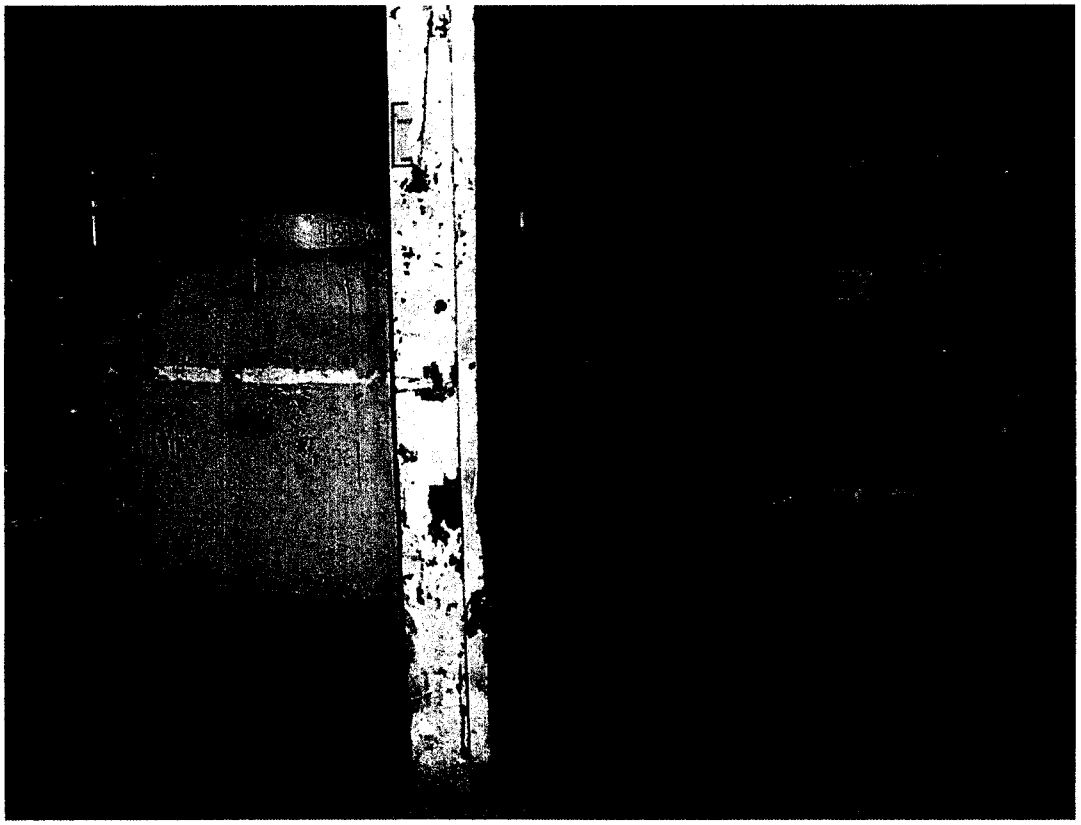
800
Clean Harbors Environmental Services, Inc.
4105 Whitaker Avenue
Philadelphia, Pennsylvania 19124
G. Houghton
May 7, 2003

Totes, each capable of holding 325 gallons of fluid. This fluid is transferred via hoses to tank trucks for transport to a destruction facility.

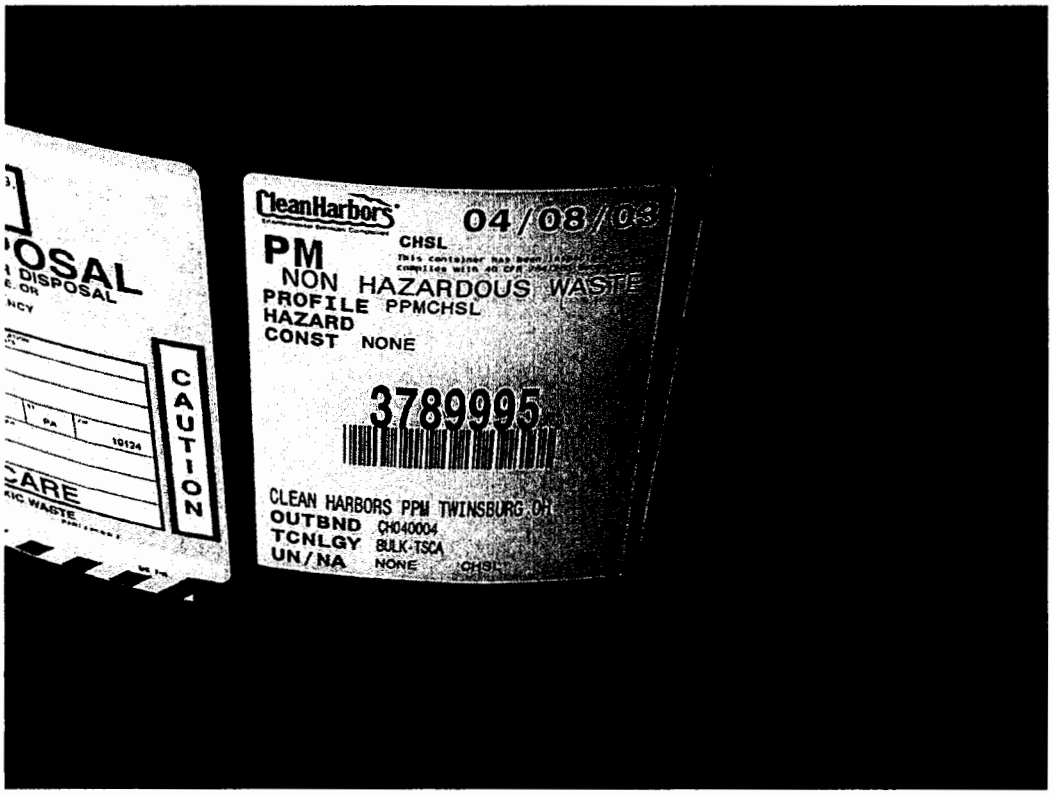
802
Clean Harbors Environmental Services, Inc.
4105 Whitaker Avenue
Philadelphia, Pennsylvania 19124
G. Houghton
May 7, 2003

This label has no out of service date. This omission was noted on only a few container in the storage area. The date is typically under the barcode.

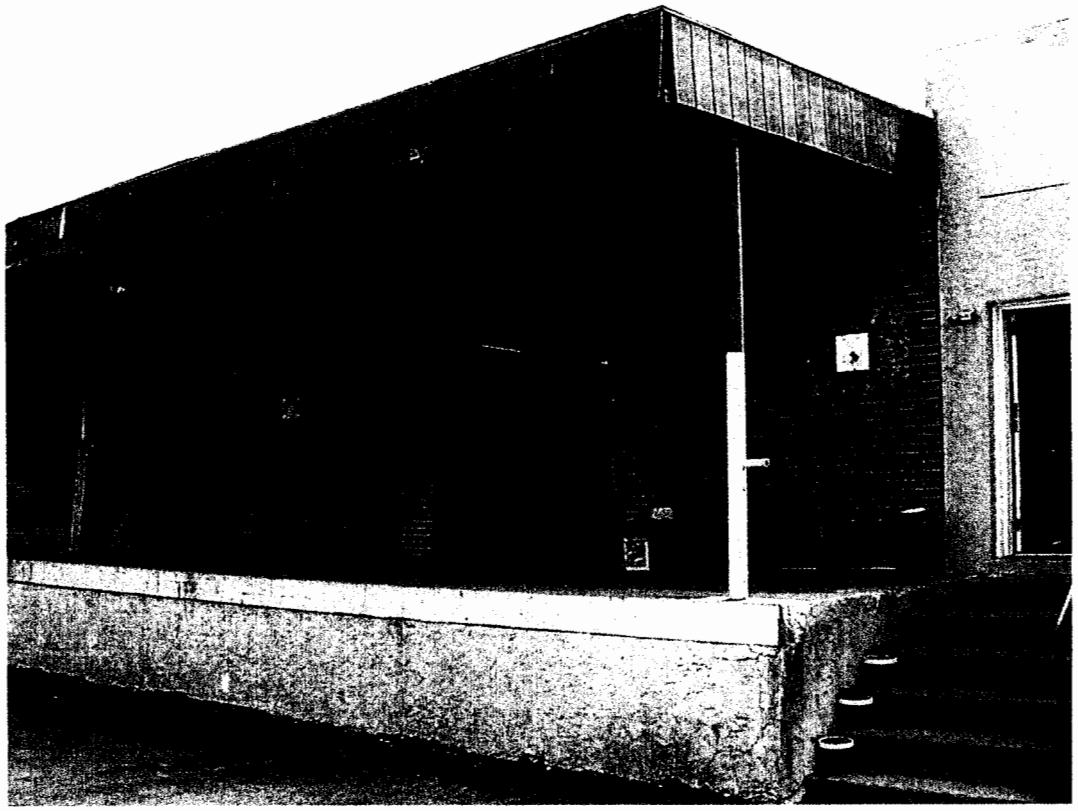
806
Clean Harbors Environmental Services, Inc.
4105 Whitaker Avenue
Philadelphia, Pennsylvania 19124
G. Houghton
May 7, 2003

Loading dock at Clean Harbors showing the entry to the active portion of the facility.

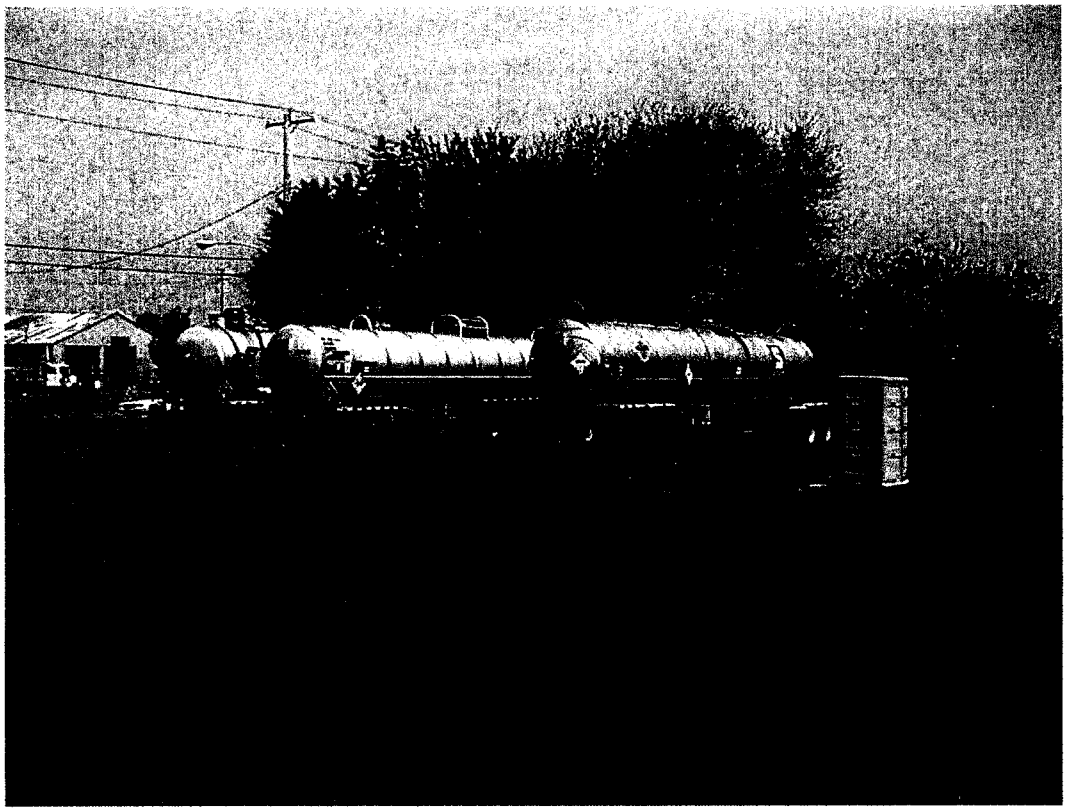
809
Clean Harbors Environmental Services, Inc.
4105 Whitaker Avenue
Philadelphia, Pennsylvania 19124
G. Houghton
May 7, 2003

Tank truck storage area in the front parking lot. Note the berm surrounding the parking area. The small shed on the right contains spill equipment. The tanker on the right had just completed its annual DOT inspection. The other two trailer are in service. The center trailer has a PCB label.

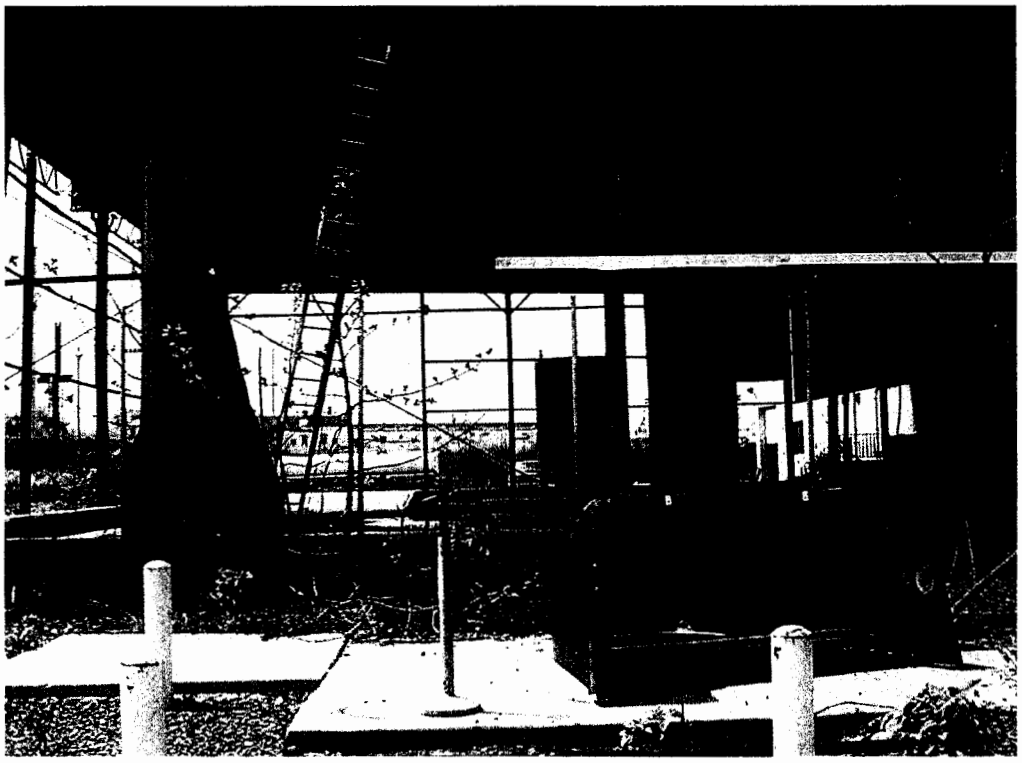
812
Clean Harbors Environmental Services, Inc.
4105 Whitaker Avenue
Philadelphia, Pennsylvania 19124
G. Houghton
May 7, 2003

Under this canopy was at one time a tank farm. This area was the subject of the last EPA inspection in 1999. The area was vacant, no activity was observed.
