MISSOULA COUNTY

BCC 2018-077
March 28, 2018

Re: Draft HHRA OU2 and OU3, BERA OU2 and OU3

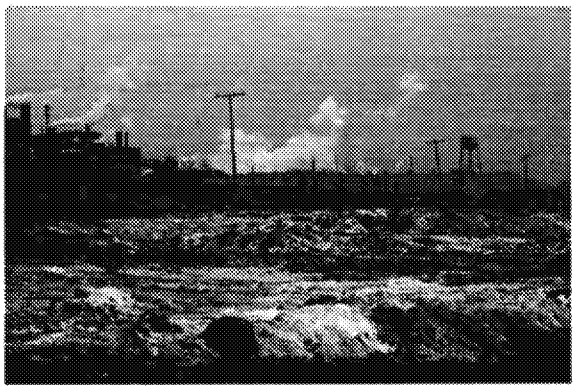
Photos from DEQ files and photos provided by past workers show that drums were buried in these dumps in 1978 and 1992. This has not yet been evaluated.

1978 photo showing buried drum

1992 photo from DEQ files, showing wastes, including drum, in the main dump

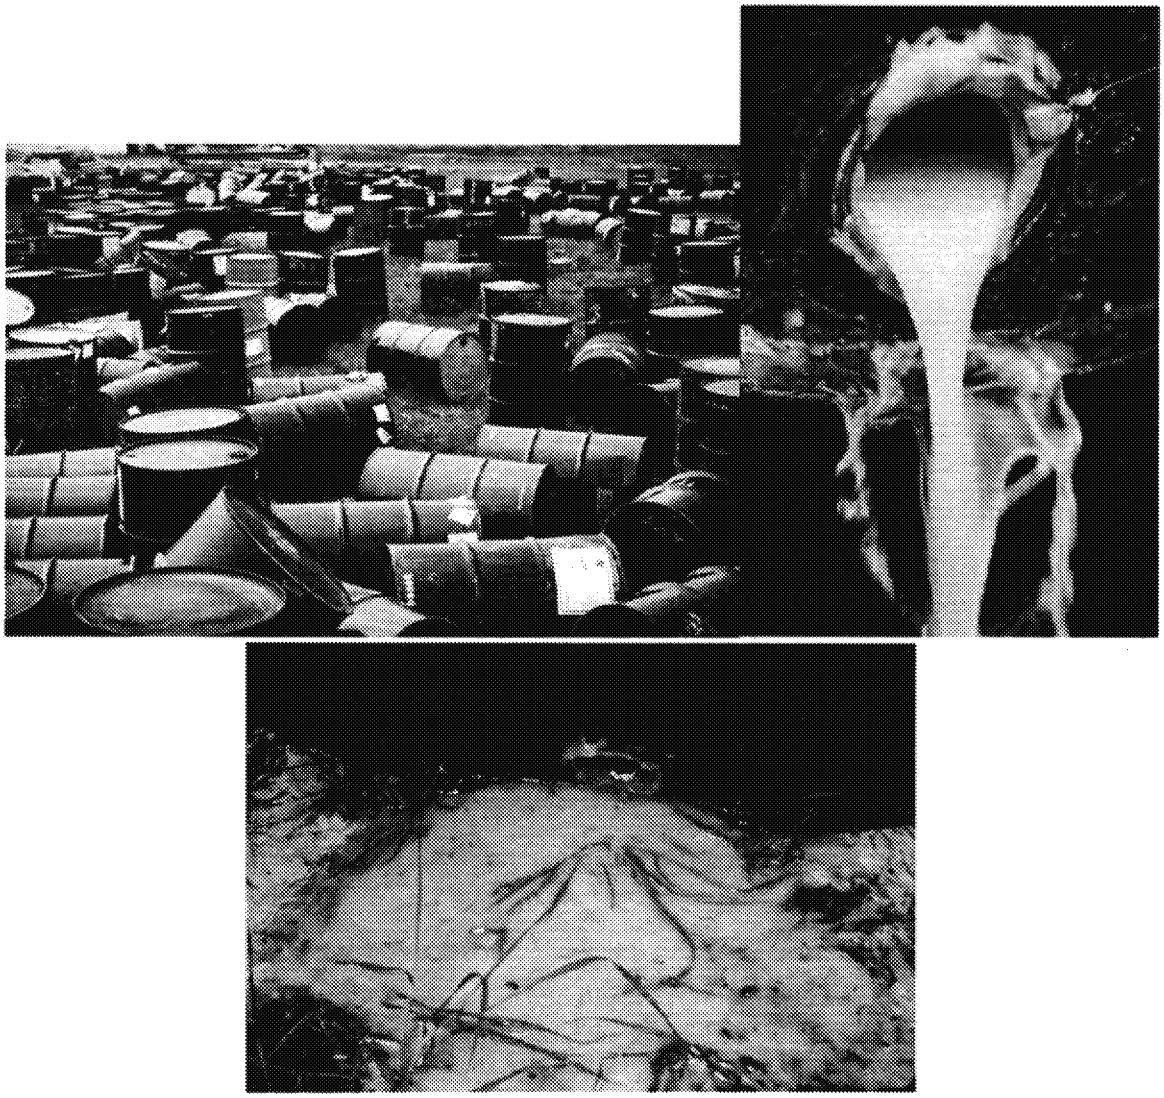
1978 photos, drums in boneyard (Tony Hoyt)

1978 photos – boneyard (Tony Hoyt)

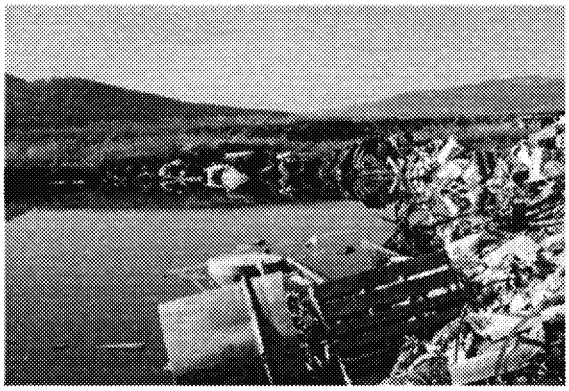
1992 DEQ file photo, showing waste buried in groundwater

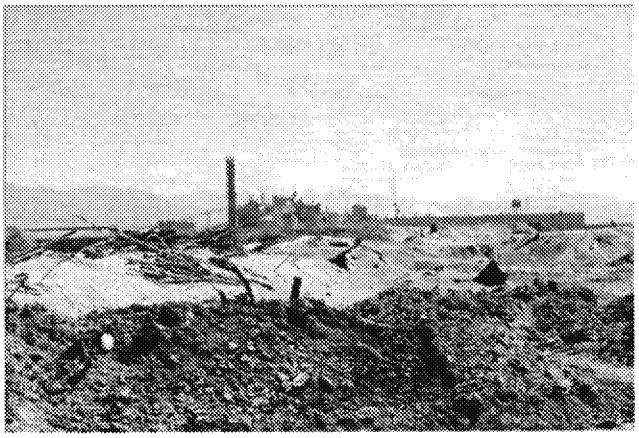
1992 DEQ file photo – note drums buried in ash dump

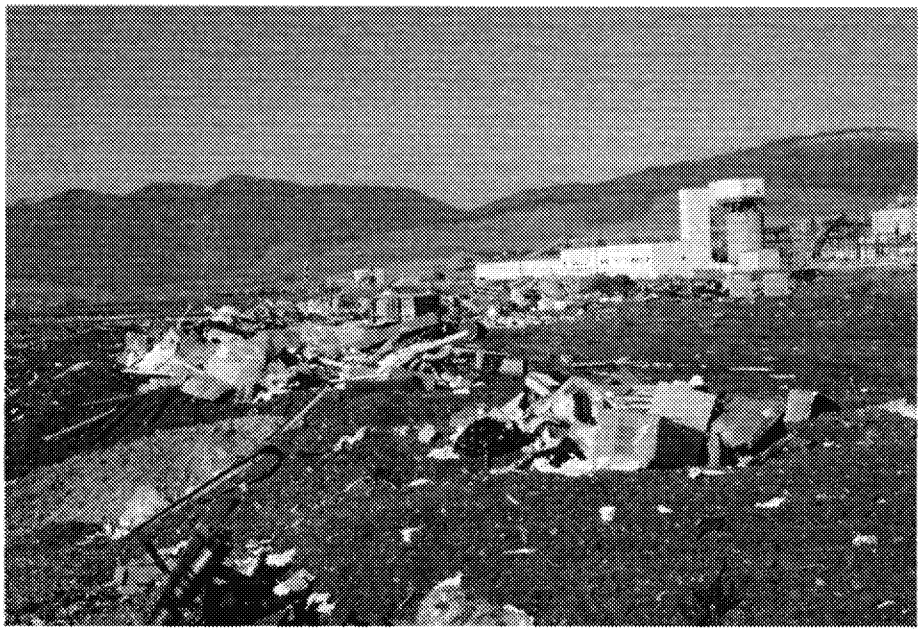
1992 DEQ file photo, note drums

A large flood has the potential to erode 53 years of accumulation of sludge, ash and industrial waste that has yet to be properly characterized. These photos are evidence of the materials that may be currently affecting groundwater and are certainly vulnerable to floods.
