Pretreatment Compliance Inspection

Summary Report

Discharger:	City of North Las Vegas NPDES Permit No. NV0023647
Location:	2580 Betty Lane; Las Vegas, NV 89156
Contacts:	Kirk Medina, Utilities Operations Manager Dave N. Commons, Water Reclamation Facility Administrator Perry Johnson, Water Reclamation Facility Operations Supervisor Robert Shipton, Senior Pretreatment Inspector Dominic Marvelli, Pretreatment Inspector Lloyd Schafer, Pretreatment Inspector
Inspection Dates:	September 29–30, 2014
Inspected By:	Kettie Holland, PG Environmental, LLC Danny O'Connell, PG Environmental, LLC Anthony D'Angelo, PG Environmental, LLC Jim Polek, EPA Region 9 Nikita Ligenfelter, Nevada Division of Environmental Protection

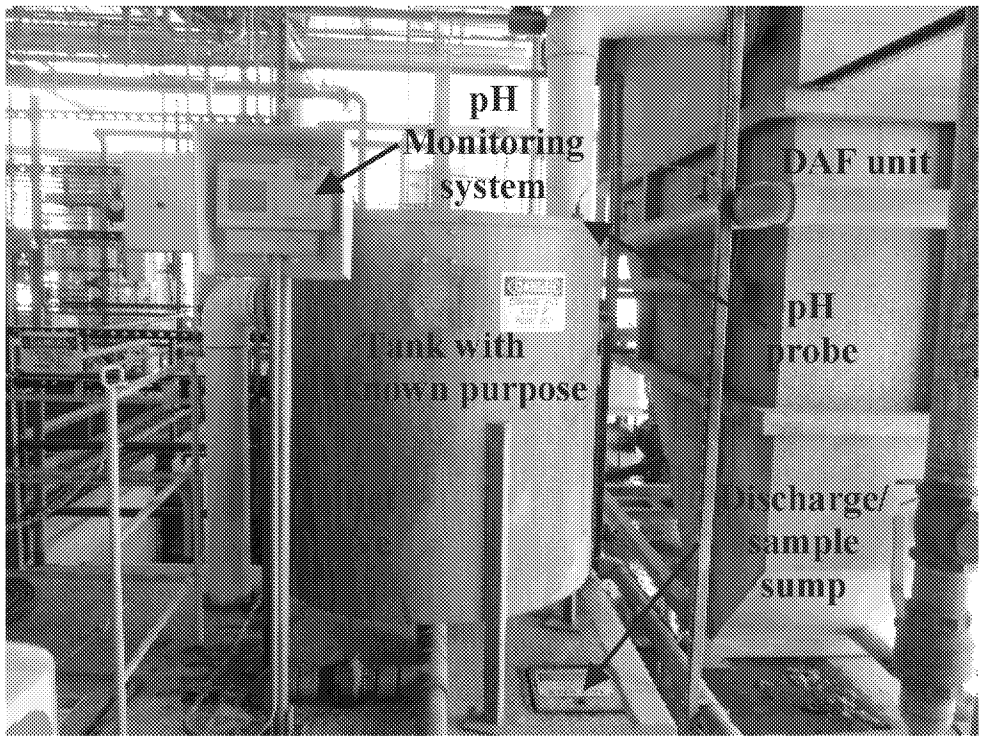
The facility does not perform continuous pH monitoring of its wastewater effluent. The EPA Inspection Team observed a pH probe and monitoring system near the unlabeled tank and discharge/sample sump; however, it was not working at the time of the inspection (refer to Photograph 1 of the CINTAS Corporation Photograph Log).

The Production Manager stated that the facility does not conduct continuous pH monitoring of the facility's discharge. The EPA Inspection Team observed a pH probe and a monitoring system control box; however, the system was inoperable at the time of the inspection (refer to Photograph 1 of the CINTAS Corporation Photograph Log). In addition, a tank with an unknown purpose was observed between the DAF unit and the facility's discharge/sample sump. The facility representatives were unaware of the purpose of the tank. Effluent from the DAF passed through the tank before entering the discharge/sample sump.

Photograph 1. View of the unlabeled tank, pH monitoring system, and pH probe located adjacent to the DAF unit and discharge/sample sump. The pH monitoring system was inoperable at the time of the inspection. Note the unknown tank's outlet pipe valve.

The EPA Inspection Team observed a large amount of foam at two locations: the effluent point from the DAF unit and within the discharge/sample sump (refer to Photographs 2 and 3 of the CINTAS Corporation Photograph Log). The facility's pretreatment operator present at the time of the inspection stated that foam is very common in both the DAF unit and within the discharge/sample sump due to the flocculent that is added to the wastewater upstream of the DAF unit. The facility does not conduct continuous pH monitoring; therefore, the EPA Inspection Team was unable to verify whether the foam accumulated was influencing the pH of the facility's discharge. It is recommended that the City conduct a followup inspection to determine the facility's need to reinstall the pH

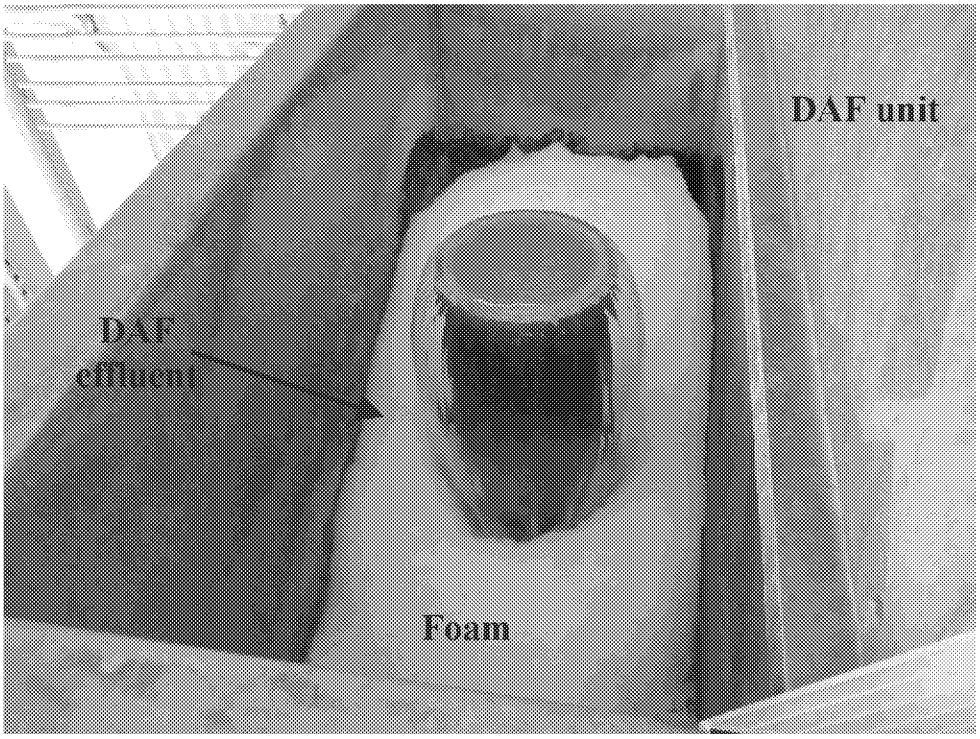
Photograph 2. View of foam accumulation at the DAF unit effluent discharge point. The facility's pretreatment system shift operator stated that foam was very common in here and in the discharge/sample sump due to the addition of flocculant to the wastewater, prior to the DAF unit.

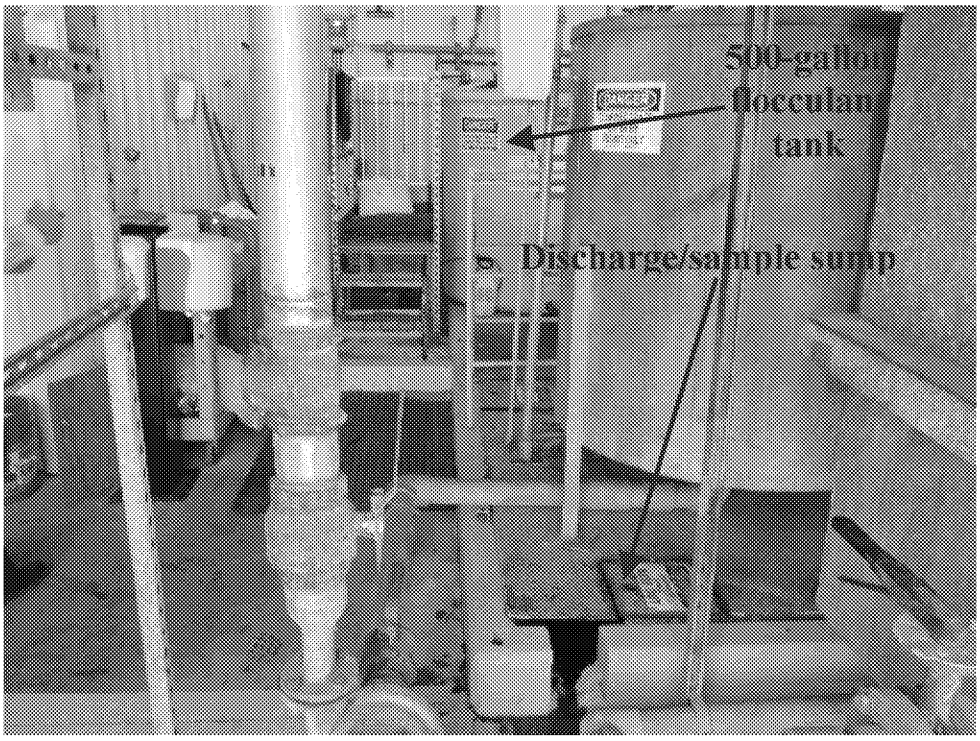
The EPA Inspection Team observed that the 500-gallon tank of flocculant was stored immediately up gradient of the facility's discharge/sample sump. The flocculant tank was single-walled and was not located in a secondary containment structure (refer to Photographs 4 and 5 of the CINTAS Corporation Photograph Log). In the event of a spill or leak, flocculant could potentially enter the discharge/sample sump and discharge directly to the City via the open discharge pipe. Part II, Monitoring and Reporting, Item L, Spill Containment Systems, of the facility's expired Class I Wastewater Control Permit states, "Secondary containment is required for all petroleum and chemical products in containers greater than five gallons." Therefore, the City is required to ensure that the facility store the 500-gallon tank of flocculant inside secondary containment in accordance with Part II, Item L of the permit. It is also recommended that the City conduct a follow-up inspection to ensure that chemicals are properly stored, and not within the direct vicinity of the facility's discharge/sample sump.

Photograph 4. View of the single-walled, 500-gallon flocculant tank stored immediately adjacent to the facility's discharge/sample sump. Note the tank was not in secondary containment.

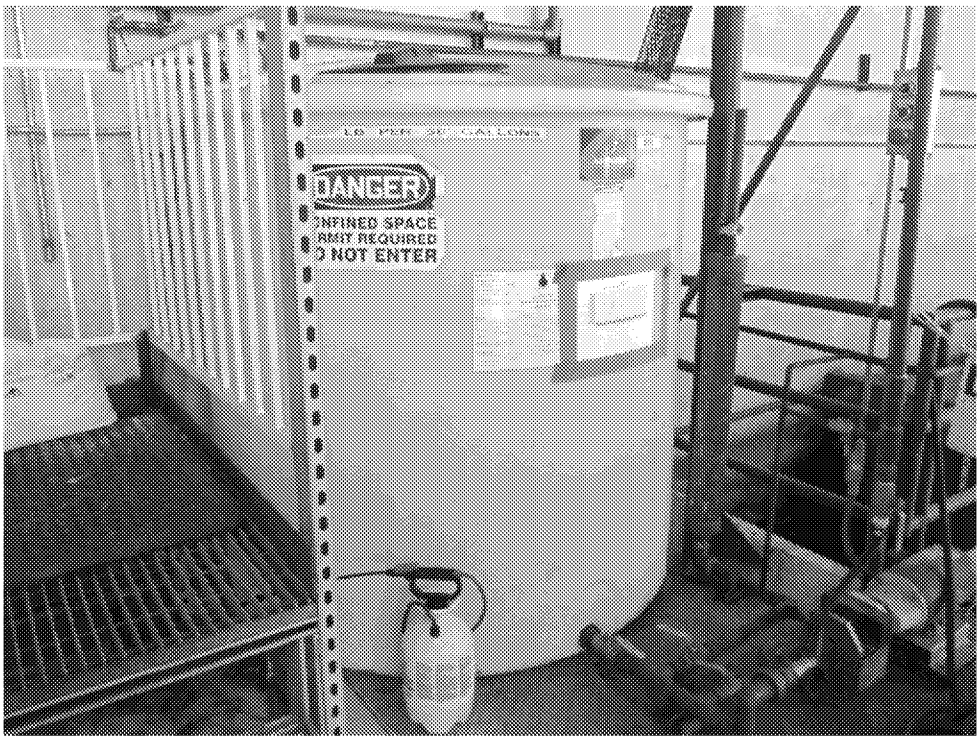
Photograph 5. Close-up view of the single-walled, 500-gallon flocculant tank, shown in Photograph 4, stored immediately adjacent to the facility's discharge/sample sump. Note the tank was not in secondary containment.

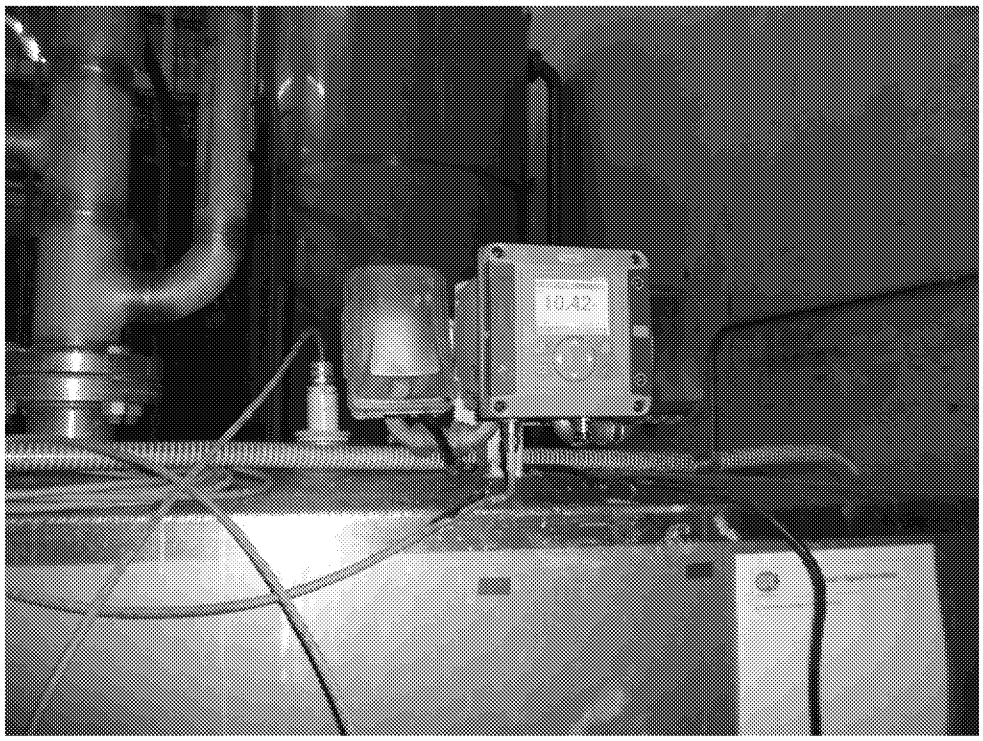
Photograph 1. Digital pH monitor for wastewater being discharged to the sanitary sewer. The meter was reading a pH of 10.42 standard units at this time of the inspection.

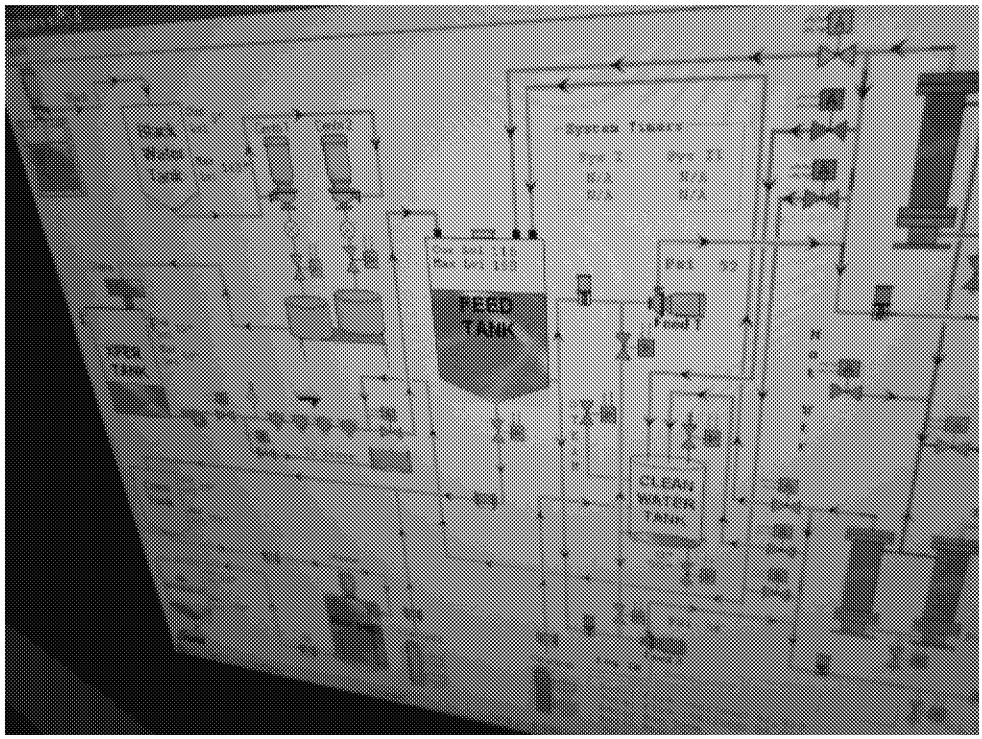
Photograph 4. View of the SCADA screen for the operation of the water treatment and reuse system.

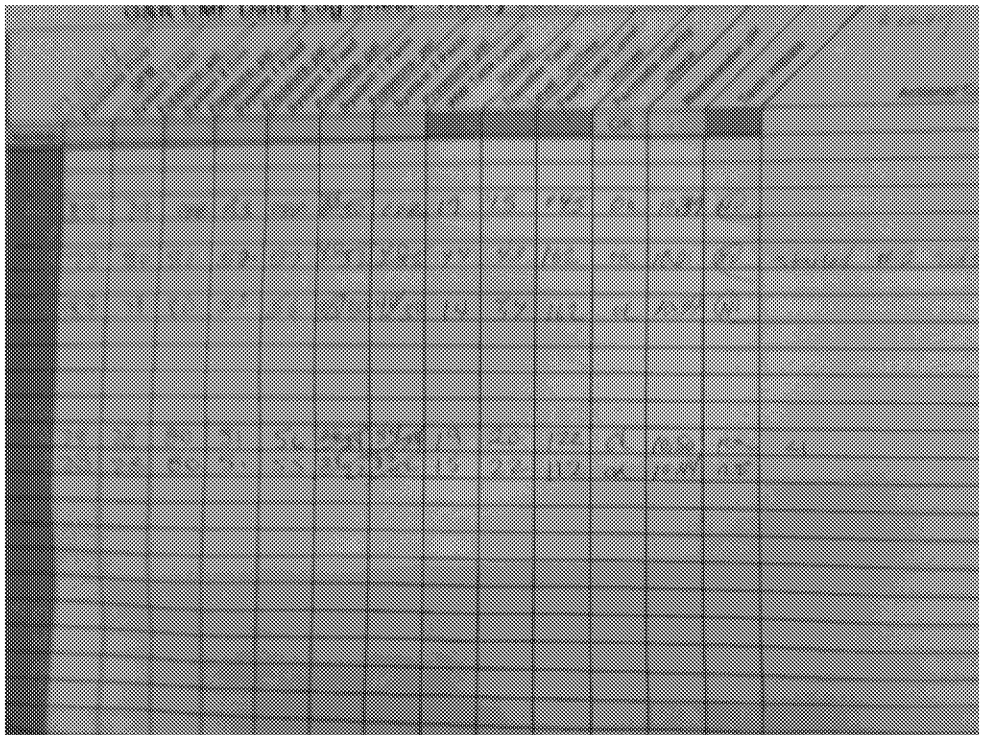
5. The facility had a daily log sheet which was used to record information pertaining to the water treatment and reuse system (refer to Photograph 6 of the attached G&K Services Photograph Log).

Photograph 6. View of wastewater treatment and reuse system's daily log sheet.

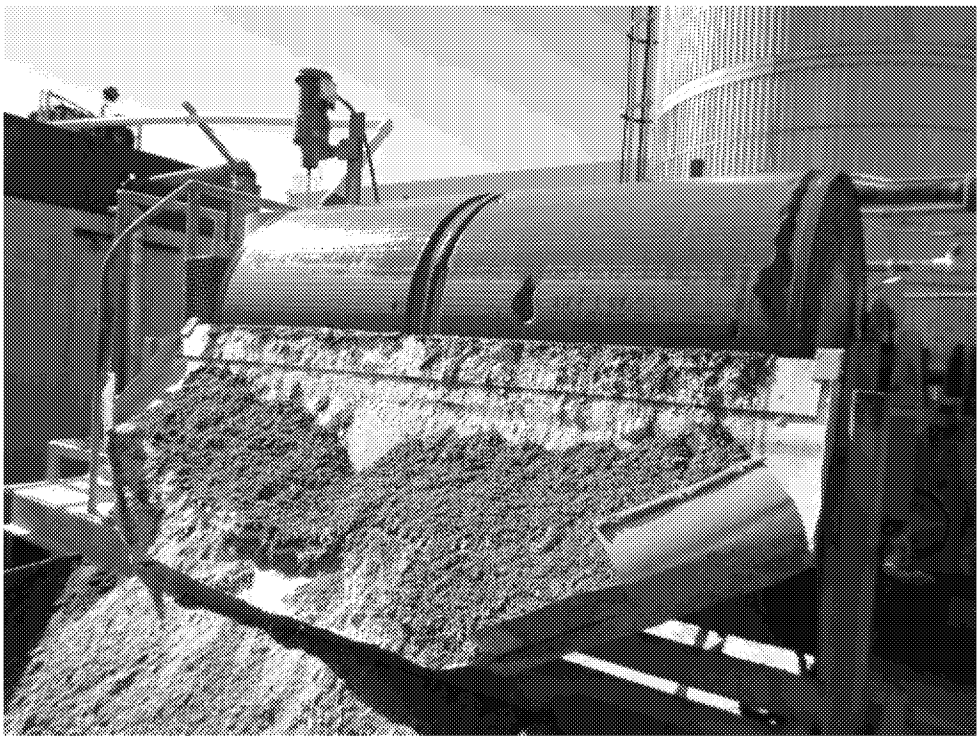
- Brown grease process area schematic—The schematic provided to the EPA Inspection Team (refer to Attachment 1.a of the Pipe Maintenance Services, Inc. Photograph Log) showed that the facility used a DAF unit for treatment, although the DAF unit had been replaced with the current ALAR system which was not depicted on the schematic diagram (refer to Photograph 1 of the Attached Pipe Maintenance Services, Inc. Photograph Log). The facility also used additional tanks (two-5,000 gallon finished brown oil) located adjacent to the grease separation and storage area, which were not shown on the schematic diagram. The EPA Inspection Team observed that a lime slurry was added to the brown grease process to aid in maintaining a consistent viscosity of the grease during the processing. However, this treatment step was not depicted on the facility schematic diagram provided to the EPA Inspection Team (refer to Photograph 2 of the Attached Pipe Maintenance Services, Inc. Photograph Log).

Photograph 1. View of the current ALAR filter unit that has replaced facility's DAF unit. The ALAR filter was not depicted on the schematic of the facility's brown grease processing area.

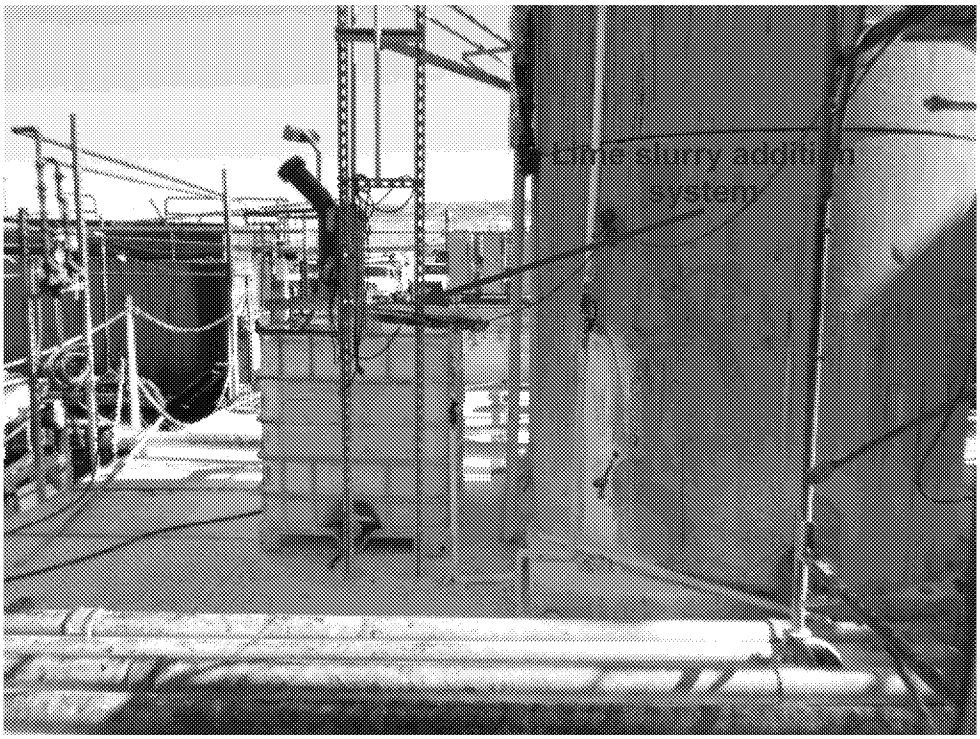
Photograph 2. View of lime slurry addition system, which was not depicted on the schematic diagram of the facility's brown grease processing area.

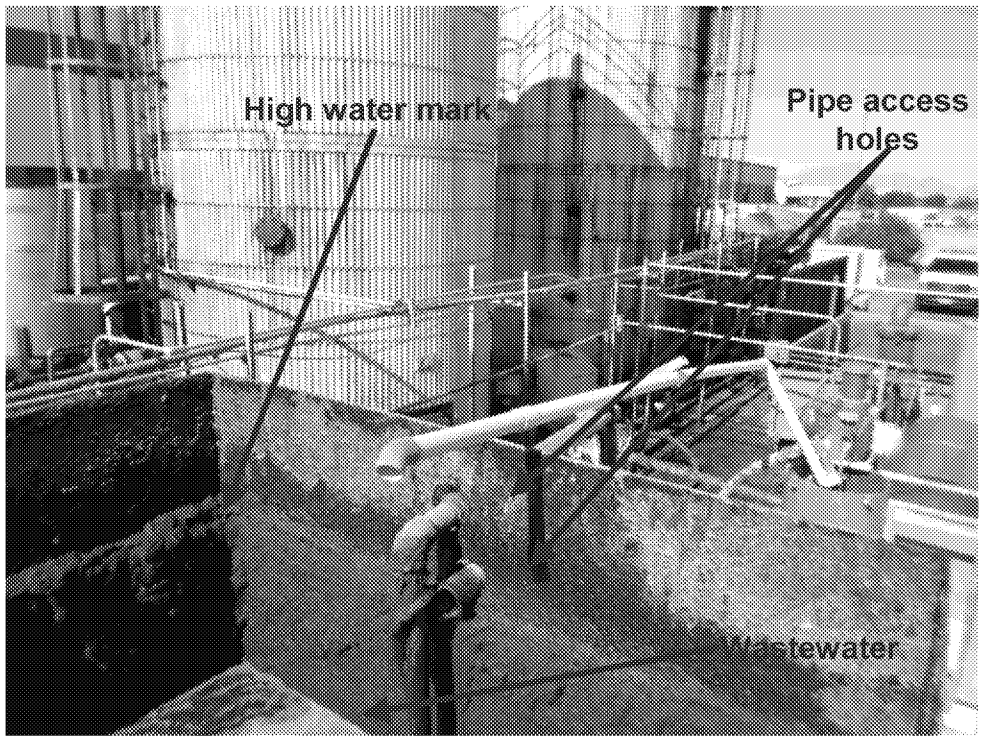
Photograph 3. View of grease interceptor wastewater level, influent pipe from the ALAR unit, and pipe access holes at the high water mark of the grease interceptor.

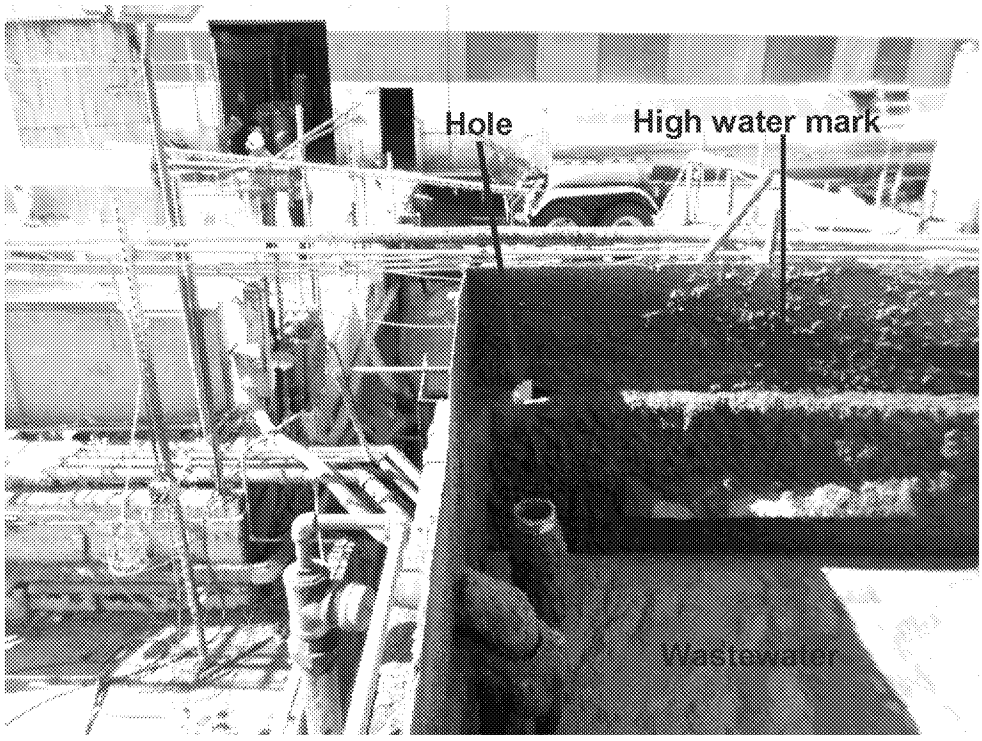
Photograph 4. View of grease interceptor wastewater level and a hole at the high water mark at the facility's grease interceptor.

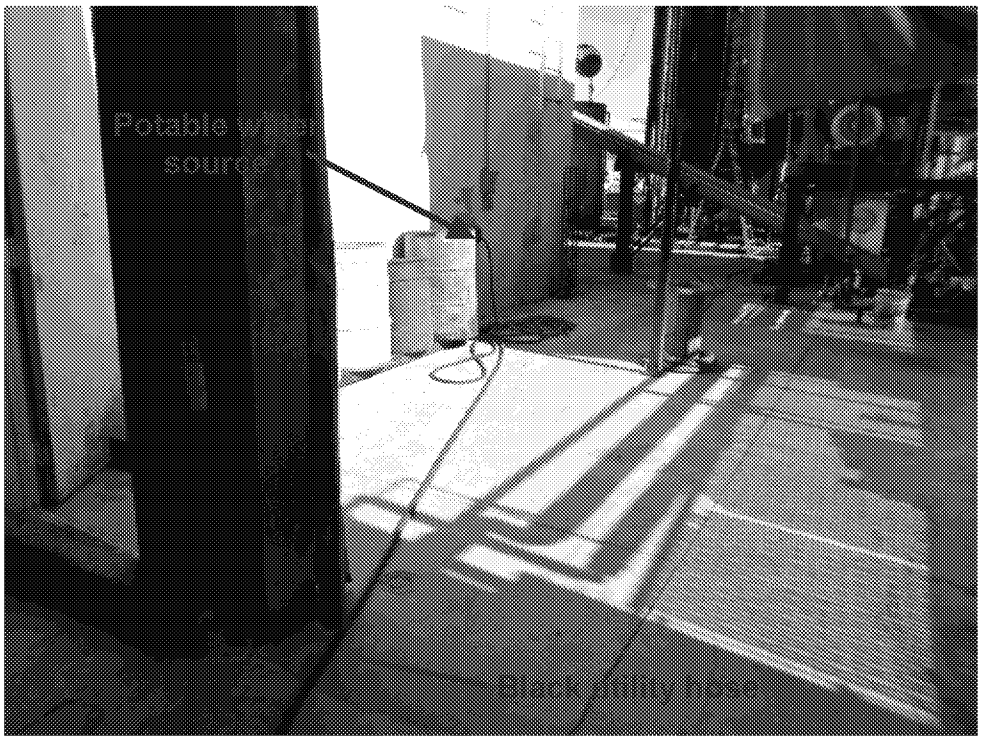
Photograph 5. View of the black utility hose connected to the portable water hose tap, leading into the boiler room.

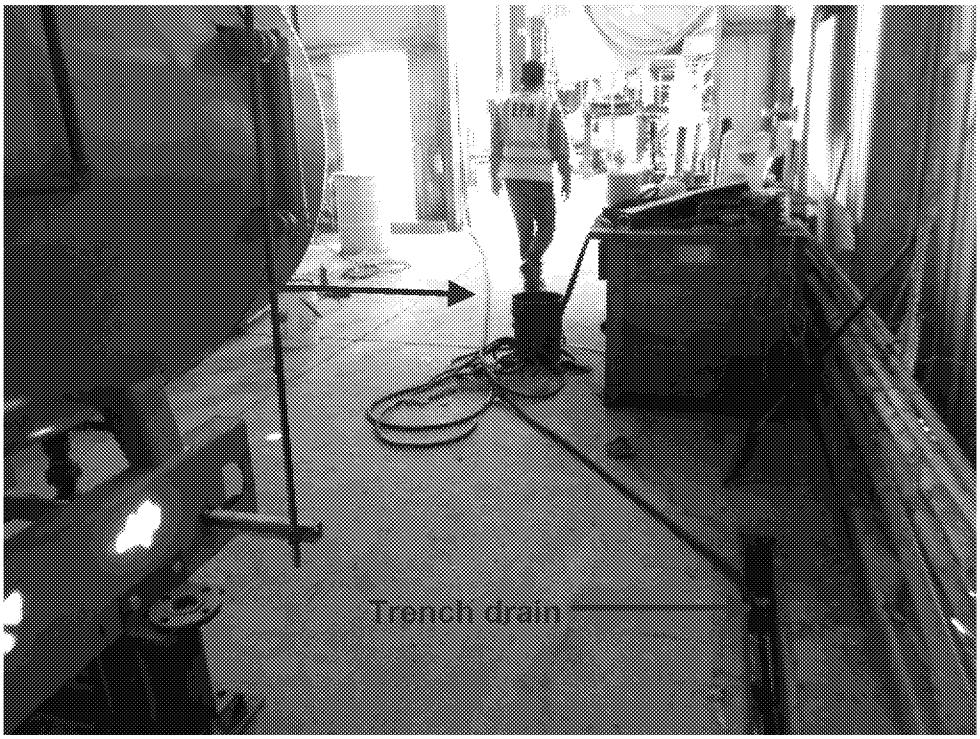
Photograph 6. View of the black utility hose running into the boiler room trench drain.

Photograph 7. Close-up view of the boiler room floor trench and drain. A black utility hose was found running in the floor trench, as depicted in Photograph 6, above.

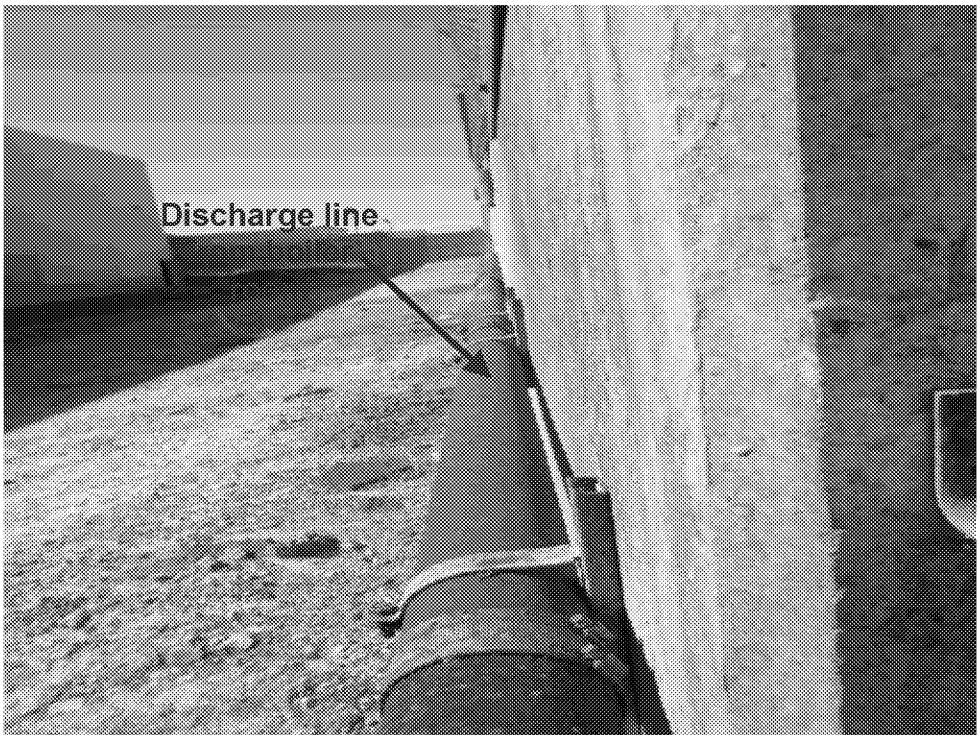
Photograph 8. View of the discharge line following the perimeter of the exterior edge of the property from the facility's boiler room.

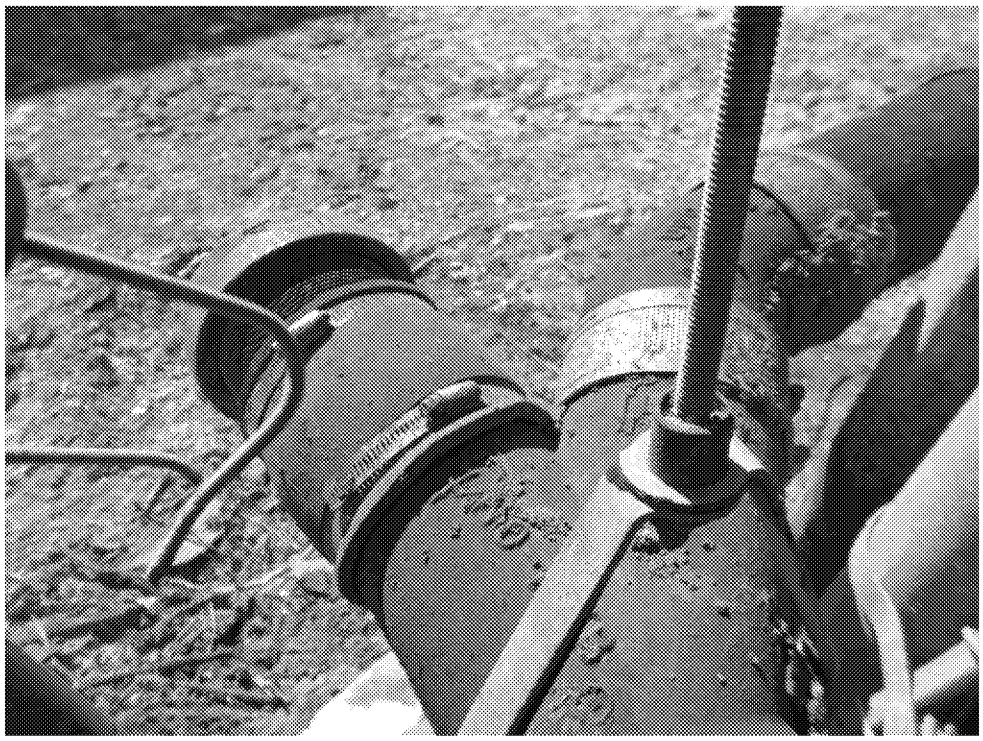
Photograph 9. View of the discharge line following the perimeter of the process area at the exterior edge of the property. It unclear why there was a "Y" connector at this location or if this location was used for pumping directly to the sewer.

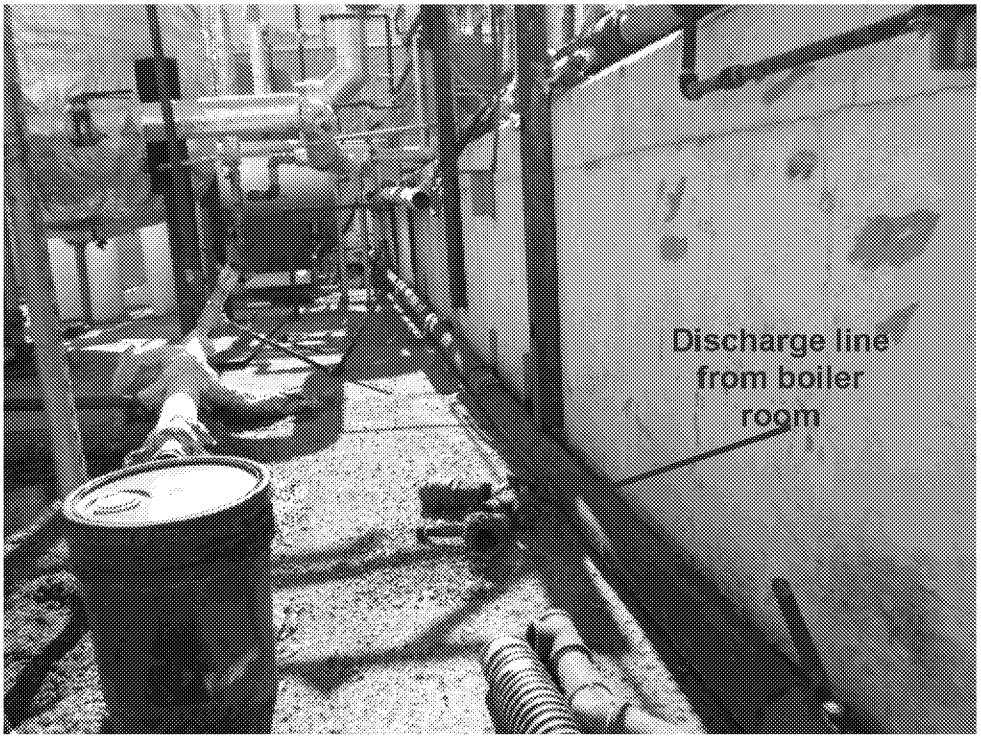
Photograph 10. View of the discharge line depicted in Photograph 8 following the perimeter of the process area.

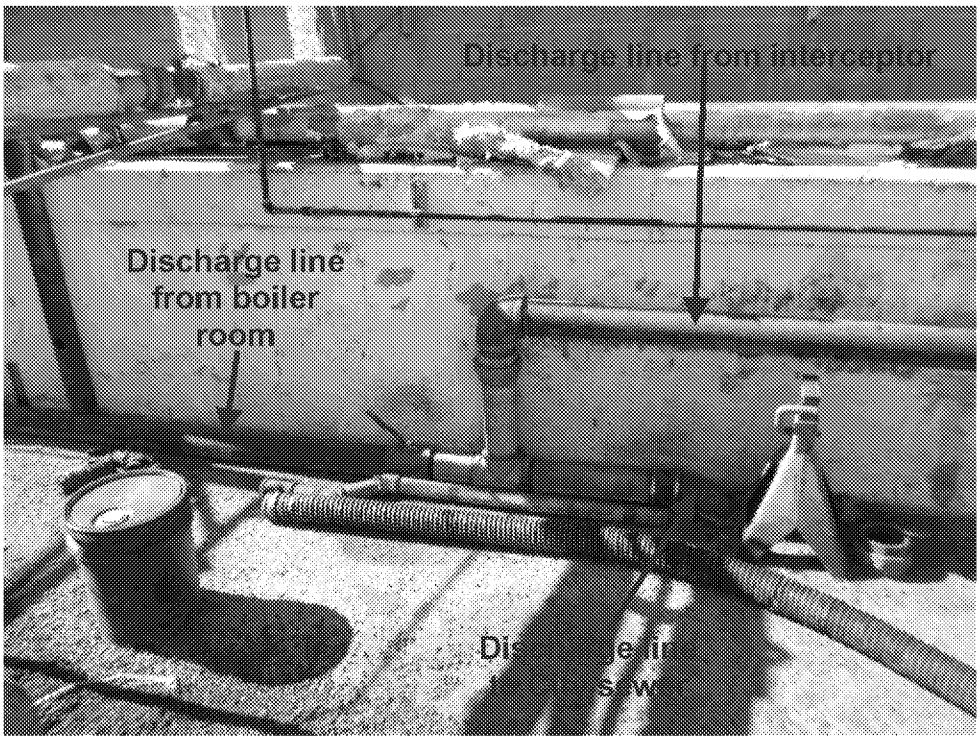
Photograph 11. View of the facility's process discharge lines to the City's sewer system.

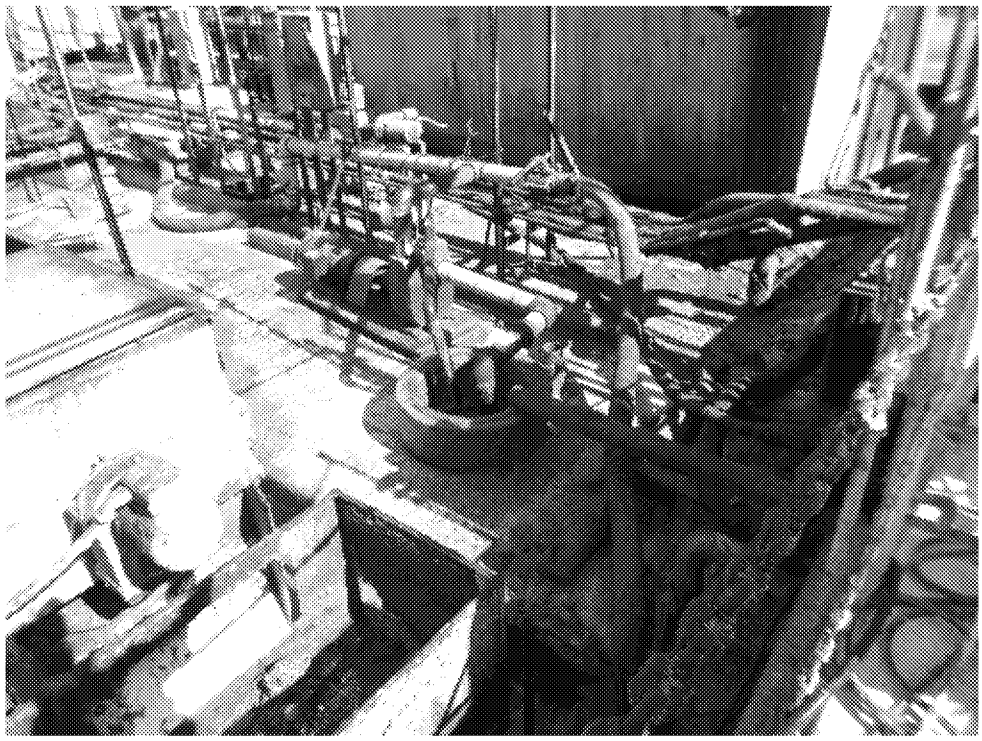
9. Condition/operation of process area (Describe): The brown grease processing area was located outside. The movement and management of grease and general debris associated with grease was a very elaborate process that observed many hoses and pipes (refer to Photographs 12 and 13 of the attached Pipe Maintenance Services, Inc. Photograph Log). The yellow grease (and cooking oils) processing area was housed within the warehouse structure. The yellow grease process was more basic and cleaner than the brown grease processing operation (refer to Photograph 14 of the attached Pipe Maintenance Services, Inc. Photograph Log).

liquids that made walking hazardous (refer to Photograph 13 of the attached Pipe Maintenance Services, Inc. Photograph Log). The yellow grease process area was located within the facility warehouse and was clean and organized at the time of the inspection (refer to Photograph 14 Pipe Maintenance Services, Inc. of the attached Photograph Log).
	Any unusual conditions or problems with general housekeeping in process area: Due to the nature of the facility's operations, it was hazardous to walk through some of the process areas due to the accumulation of grease. Apart from this hazard, no unusual conditions or problems were observed with the housekeeping of the process area during the time of the inspection.

Photograph 13. Example of the network of pipes and hoses used to transport grease throughout the process area at the facility.

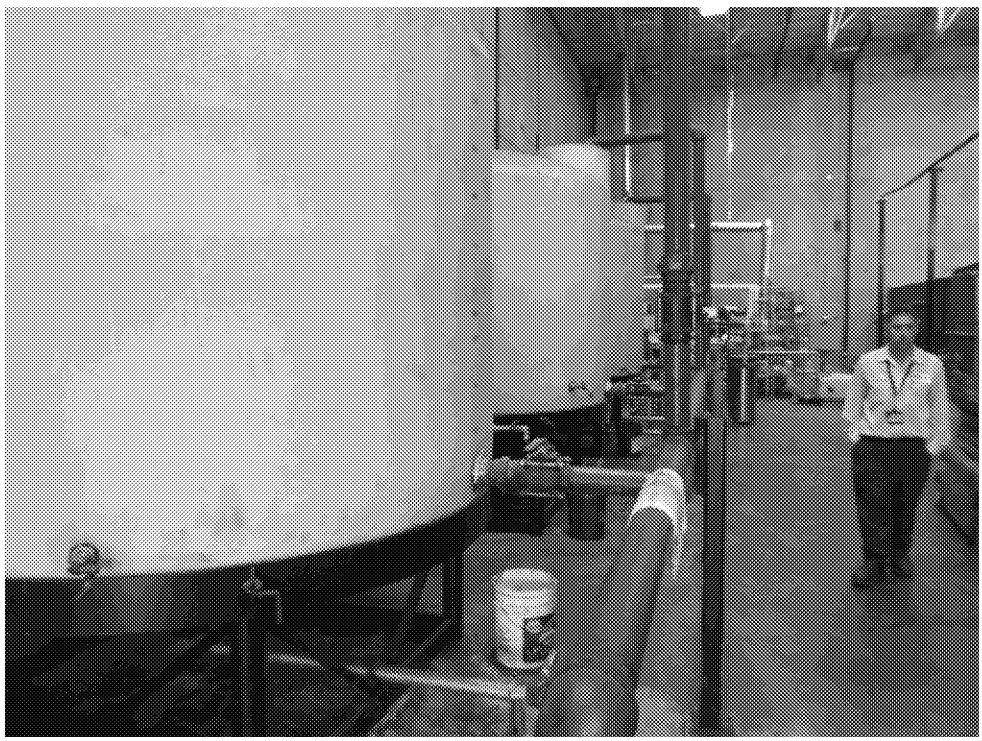
Photograph 14. View of the yellow grease process area, located within the warehouse.

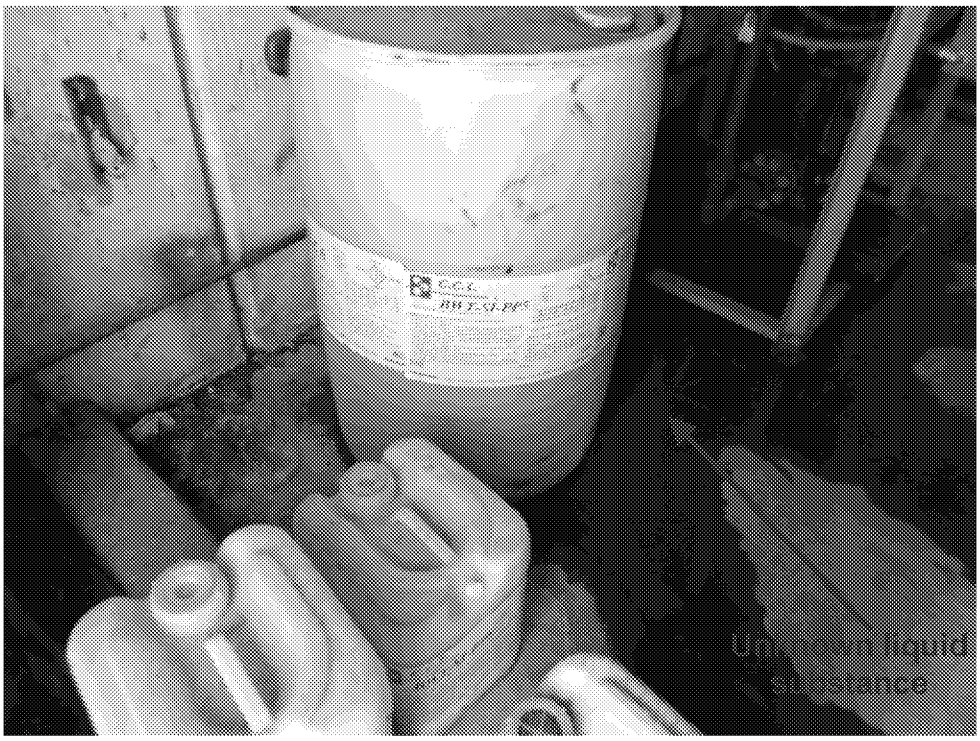
Photograph 15. View of the boiler chemicals stored without secondary containment. Although the liquid on the floor did not omit an odor, the source of the liquid was unknown.

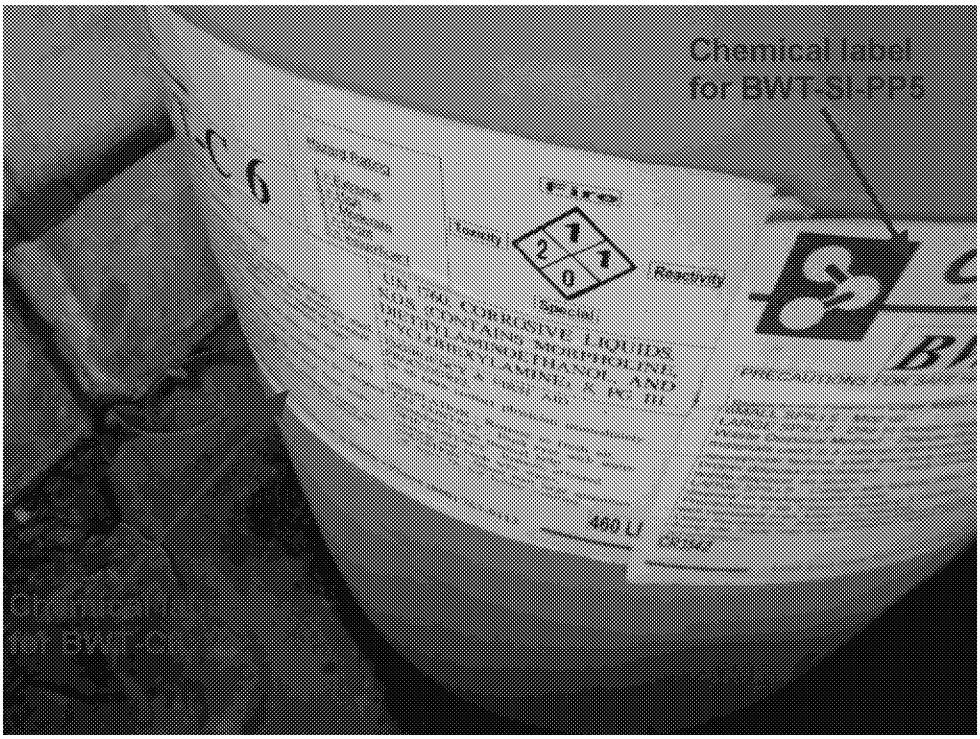
Photograph 16. View of the label on the 55-gallon drum in the boiler room. The drum appeared to have two chemical labels on its side wall: one for BWT-C6 and the other for BWT-SI-PP5. It was unclear to the EPA Inspection Team which chemical was housed in the drum.

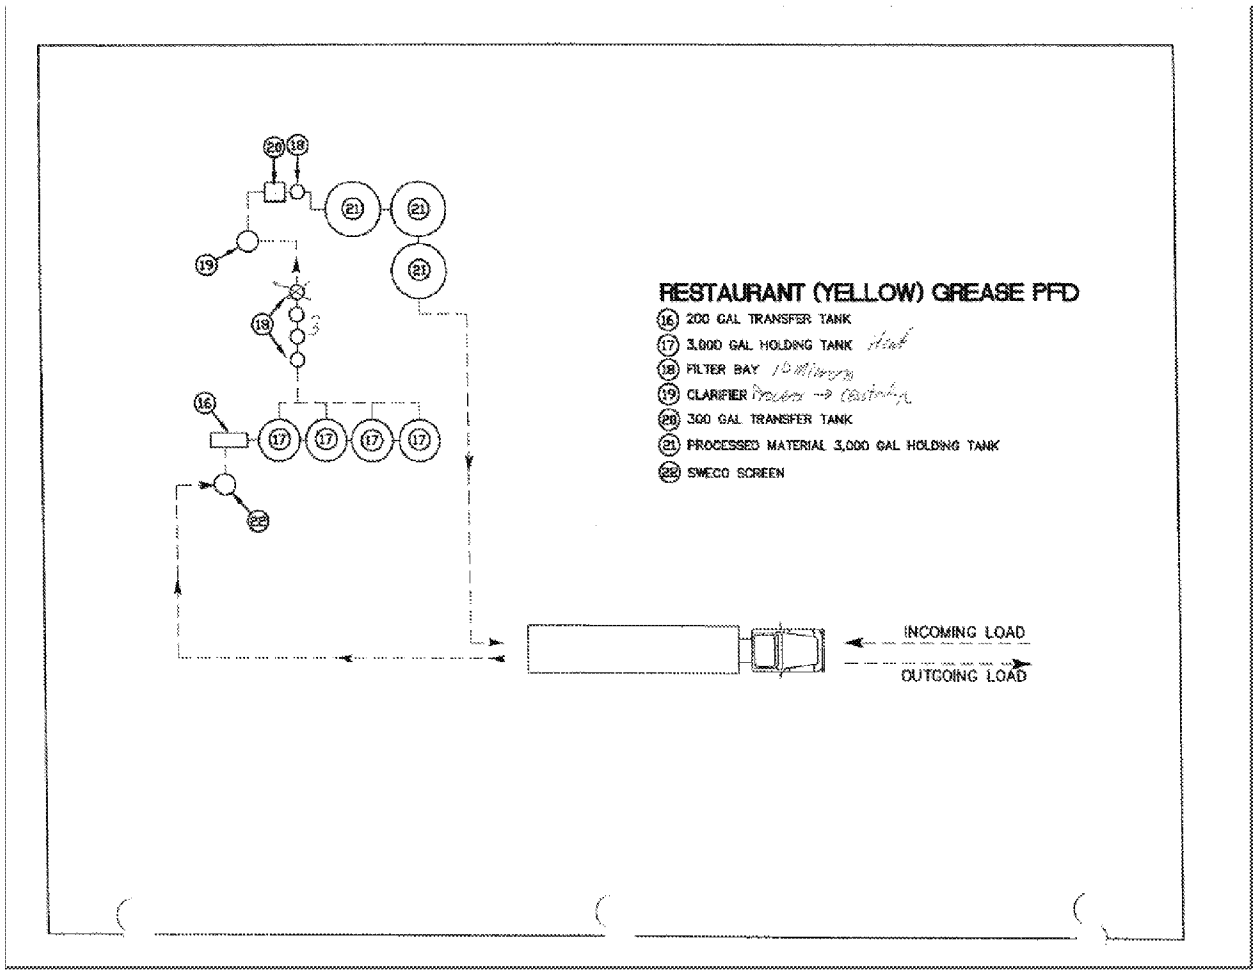
Attachment 1.b. Yellow Grease Process Area Schematic Diagram

- Yellow grease process area schematic—The facility schematic diagram shows four-10 micron filters in the yellow grease processing area, however, the EPA Inspection Team observed three-10 micron filters (refer to Attachment 1.b of the Pipe Maintenance Services, Inc. Photograph Log).
