DRAFT
Fourth Five-Year Review Report for the Rocky Flats Site Jefferson County, Colorado

July 2017

U.S. DEPARTMENT OF ENERGY | Legacy Management

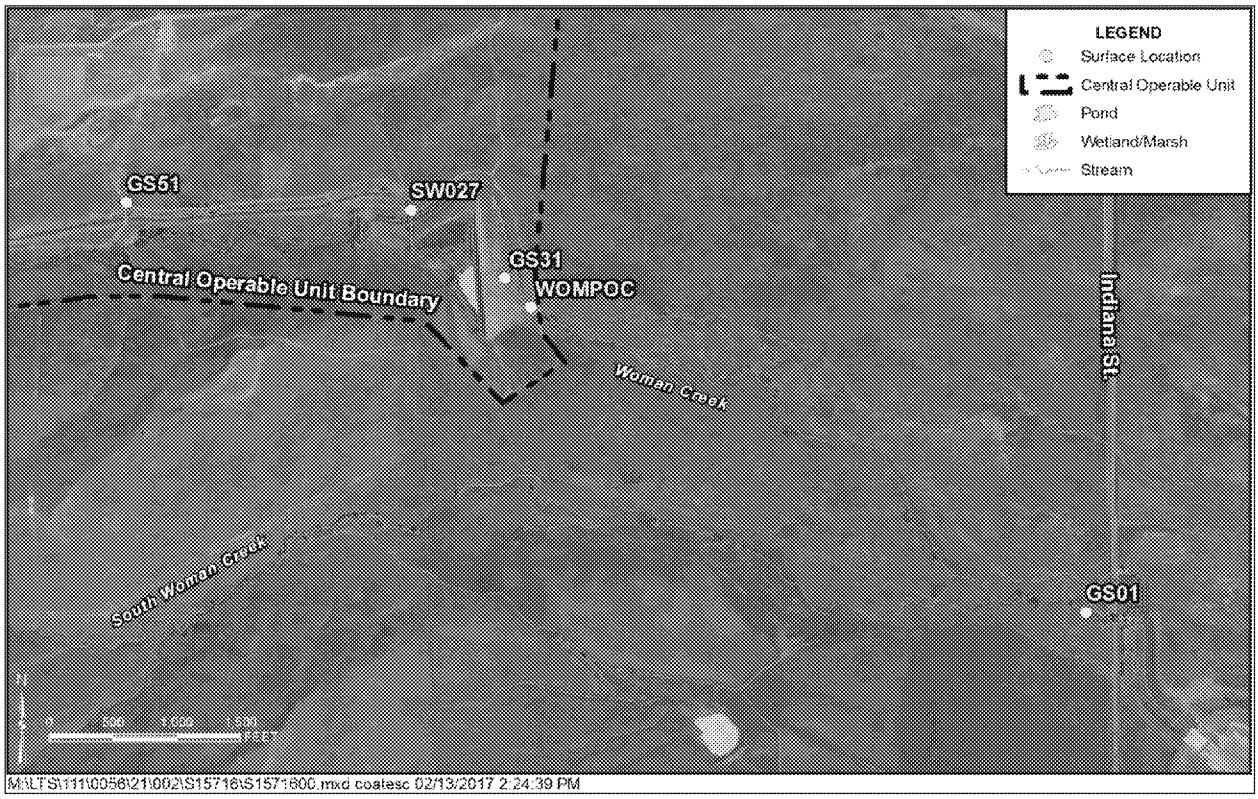
Figure E-12. SW027 and Associated Monitoring Locations

average for Am subsequently exceeded the standard in June 2015. Following consultation, additional measures were implemented to enhance the vegetation and erosion controls implemented in 2010 and 2011. These measures were mostly completed by August 2015 and included the addition of straw wattles, GeoRidge berms, and woodstraw in the SID drainage area; additional erosion matting and GeoRidge berms in the SID was completed in March 2016. The 12-month rolling averages for Pu at SW027 continued to exceed the RFLMA standard through the end of this FYR period. Americium concentrations continued to exceed the RFLMA standard until June 2016; since June 2016 and through the end of this FYR period Am has been below the standard.

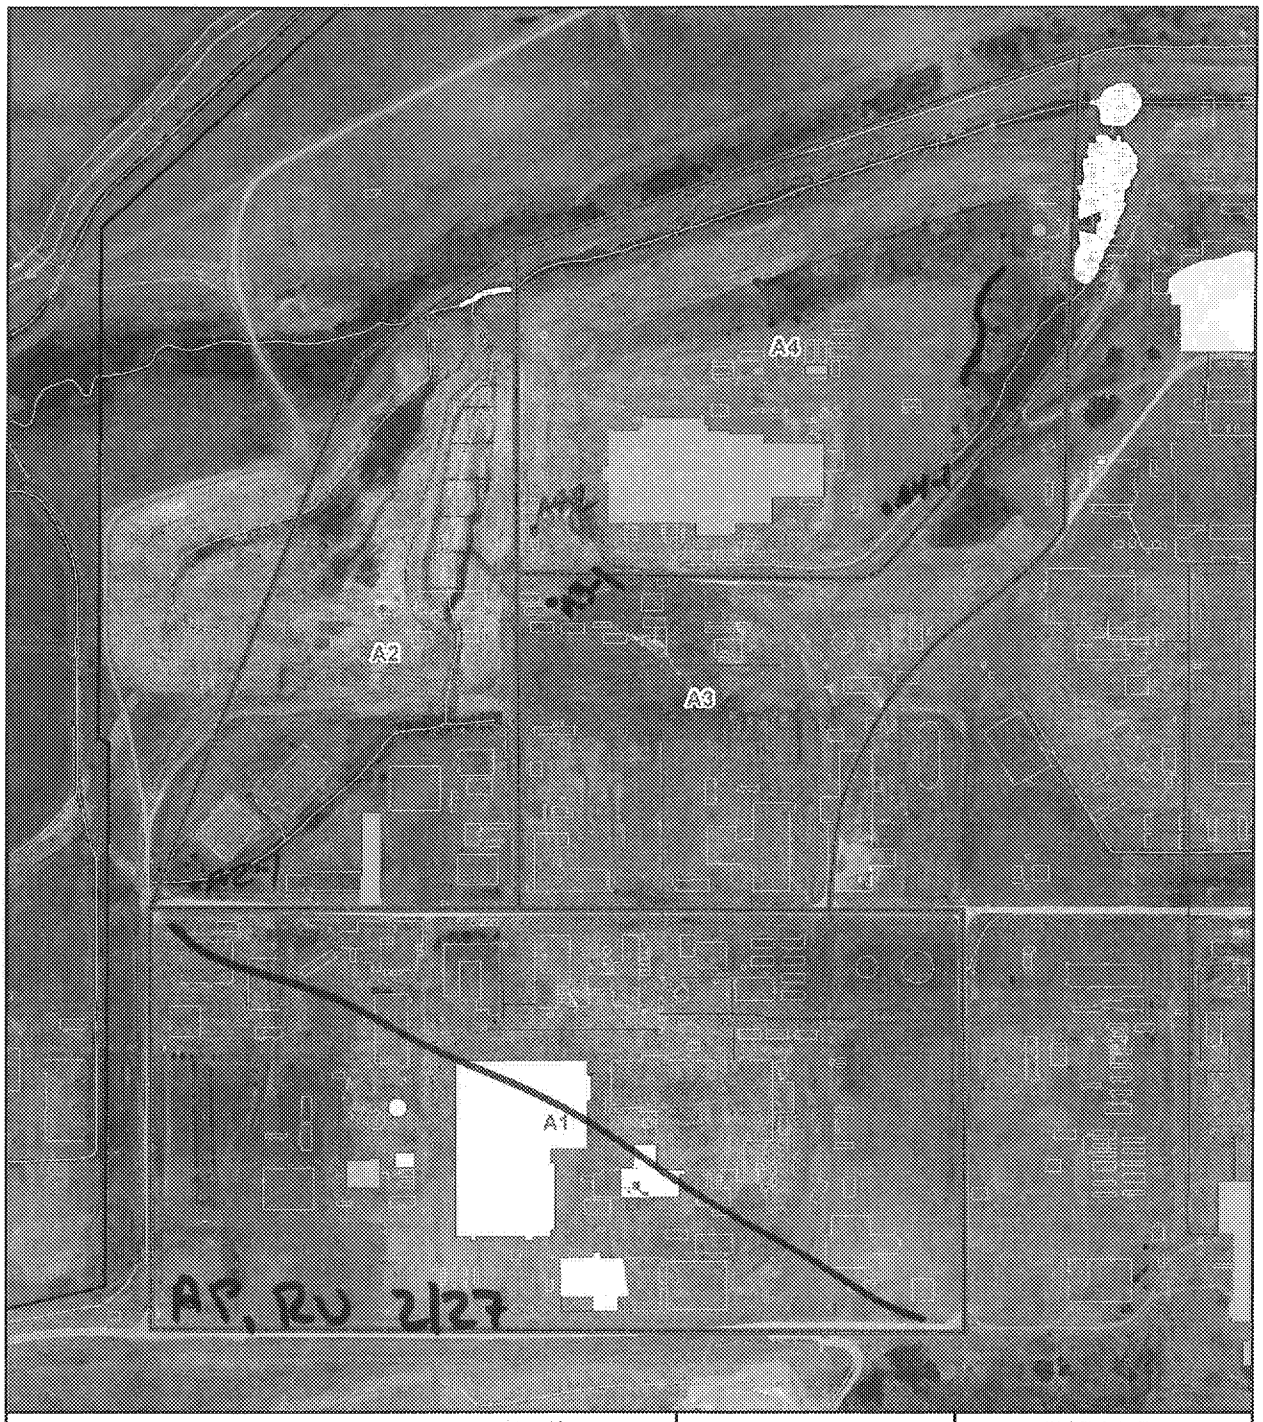
A4-2 - STEEL PIPE AND CONDUIT IN GROUND WEST OF 371
