DRAFT
Fourth Five-Year Review Report for the Rocky Flats Site Jefferson County, Colorado

July 2017

U.S. DEPARTMENT OF ENERGY | Legacy Management

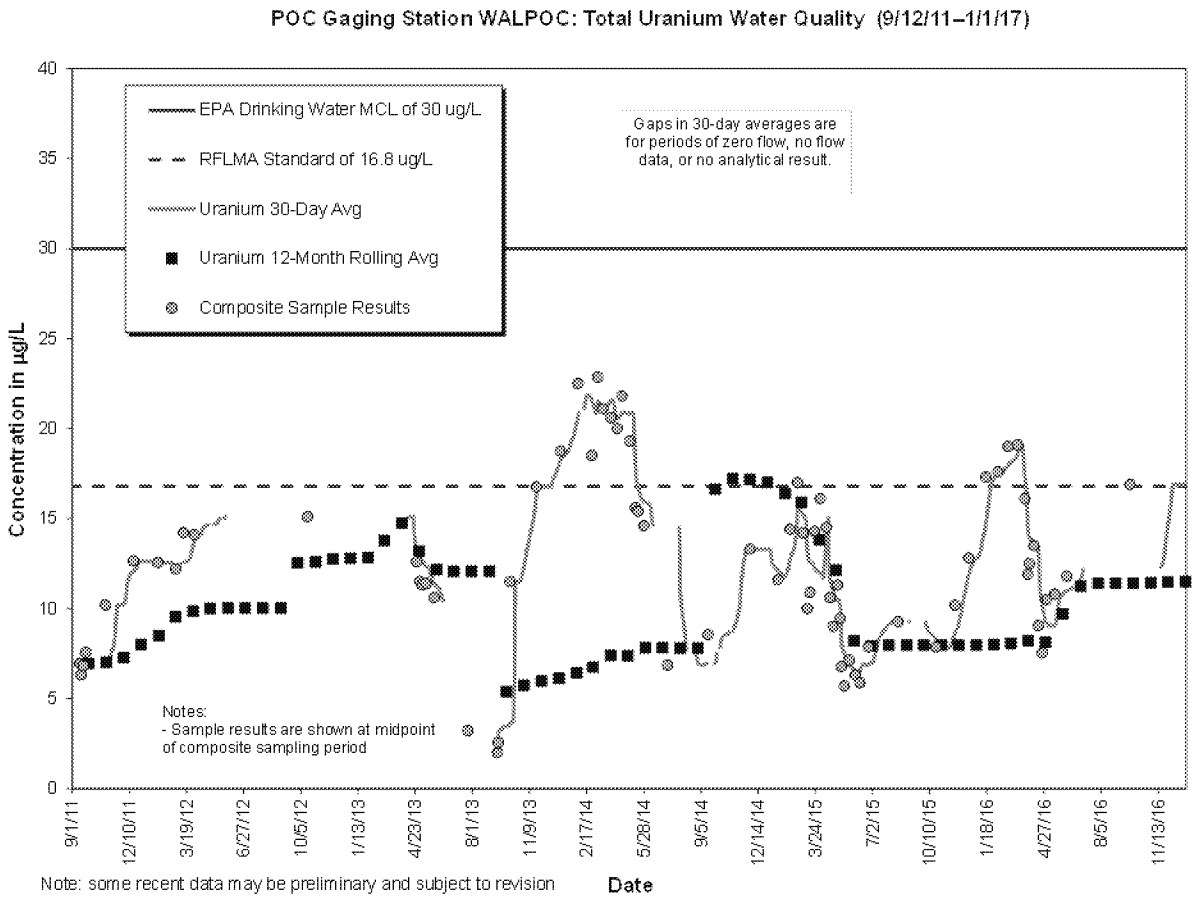
Figure 5. Uranium Concentrations at WALPOC

Figure 5 presents the uranium data for WALPOC from 2011 through the end of 2016. For each reportable condition, DOE consulted with EPA and CDPHE and developed a plan for responding to the condition (CRs 2014-05, 2015-01, 2016-01, and 2017-02). The plans included the collection of additional surface water samples from WALPOC and locations upstream and the addition of high-resolution isotopic uranium analyses for selected samples. Data collected prior to mid-2015 to evaluate these reportable conditions were included in a comprehensive evaluation of the distribution, transport mechanisms, sources, and isotopic composition of U in North and South Walnut Creeks (Wright Water Engineers 2015). Among other things, the study suggests a predictable relationship between precipitation and U concentrations in surface water. Specifically, heavy precipitation events (1) increase the mobility of U in soil which allows increased migration of U to groundwater, (2) increase groundwater discharge to surface water, and (3) increase U concentrations in surface water once direct runoff has diminished. Assessment of the Walnut Creek data shows that significant precipitation events such as those experienced in 2013 and 2015 result in an initial lowering of uranium concentrations in surface water due to increased runoff, followed by an increase in uranium concentrations over a prolonged period due to increased mobilization of uranium via geochemical mechanisms and increased volumes of groundwater reaching surface water. This effect was seen after the September 2013 event in which 30-day average U concentrations were first detected at reportable levels in December 2013 and did not return to concentrations below the RFLMA standard until approximately 5 months later in May 2014 (Figure 5). As of the end of this FYR period (December 2016), the 30-day average for U is above the RFLMA standard and the 12-month rolling average for U is below the standard.

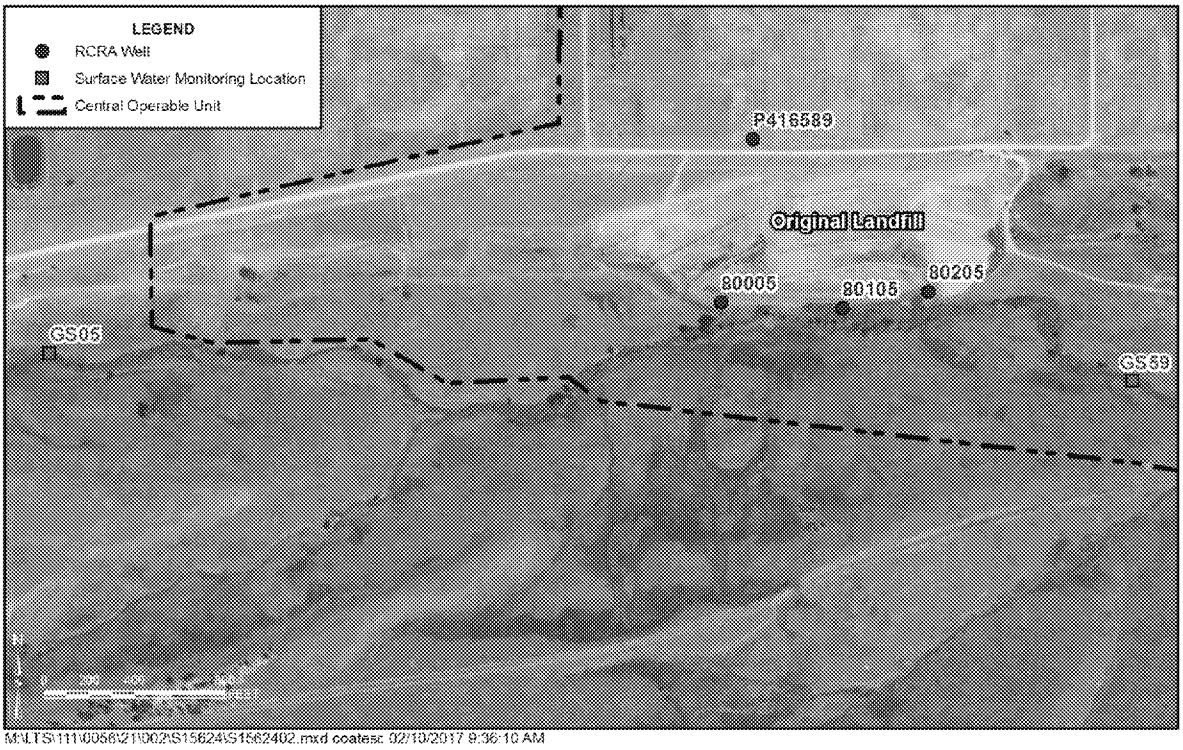
Figure 7. OLF Monitoring Locations

In summary, routine and weather-related inspections at the OLF identified substantial, localized slumping and cracking along the eastern and western edges of the landfill during this FYR period. While hillside movement was more extensive than in the previous FYR period (2007–2012), the central portion of the OLF has remained stable. Repair and maintenance activities have occurred throughout this FYR period in response to OLF conditions and will continue as necessary. While the majority of the cracking and slumping has occurred on the periphery of the OLF, seeps and cracks have been identified within the waste footprint. The remedy at the OLF remains protective. No unacceptable exposures to personnel working at the COU have occurred as a result of these conditions. Occupational exposure to personnel working at the OLF to implement the various repairs and maintenance operations is closely monitored and documented in the site records. Physical controls required by the remedy effectively control access to the COU, minimizing the potential for inadvertent access to the OLF by unauthorized parties. Institutional controls specific to the two landfills in the COU, including the OLF, prohibit unauthorized activities on the landfill covers to ensure that unacceptable exposures do not occur. Furthermore, groundwater and surface water monitoring data collected during this FYR period suggest the hillside instability at the OLF has not negatively affected groundwater or surface water quality in the long term.

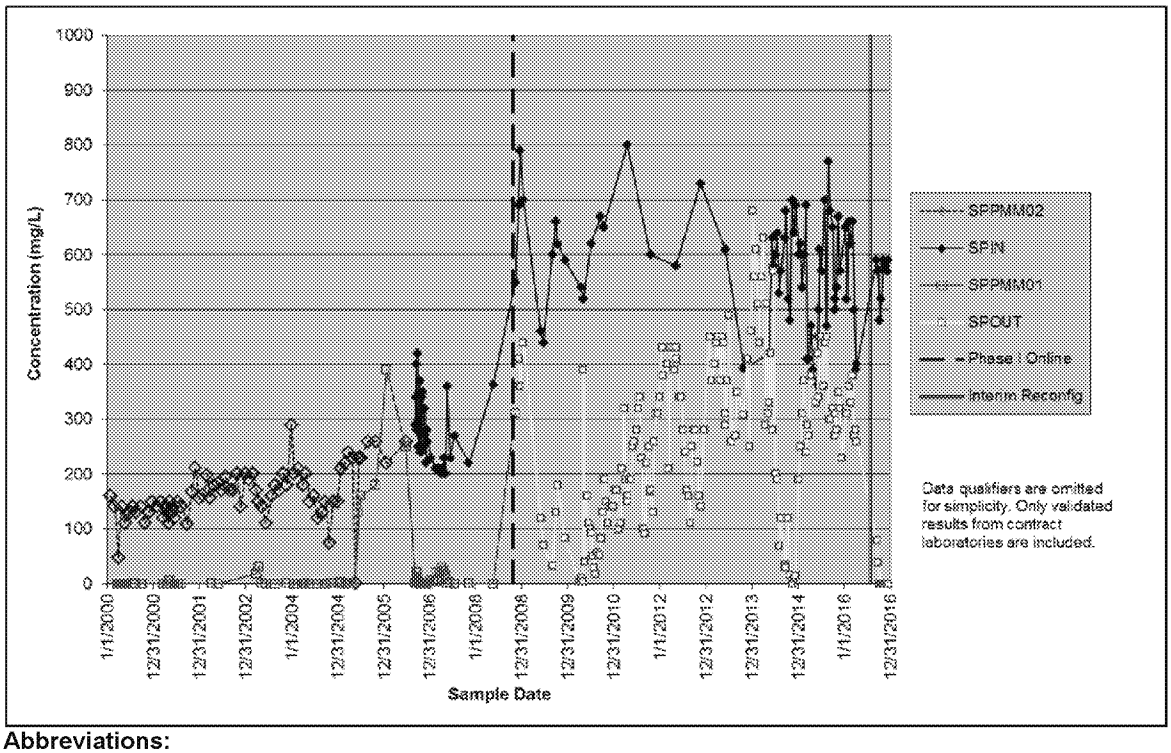
Figure E-3. Total Nitrate Concentrations in SPPTS Influent and Effluent (2000–2016)

In general, effluent conditions at the SPPTS did not show improvement during this FYR period until completion of the SPPTS interim reconfiguration project in late 2016, which focused on constructing a full-scale, test nitrate treatment component. Since reconfiguration completion, nitrate concentrations in SPPTS effluent have consistently been below RFLMA standards, with nitrate typically not detected in the effluent. The results of uranium treatment to date have proven less encouraging; however, efforts to identify an effective long-term system configuration continue through the RFLMA consultative process.

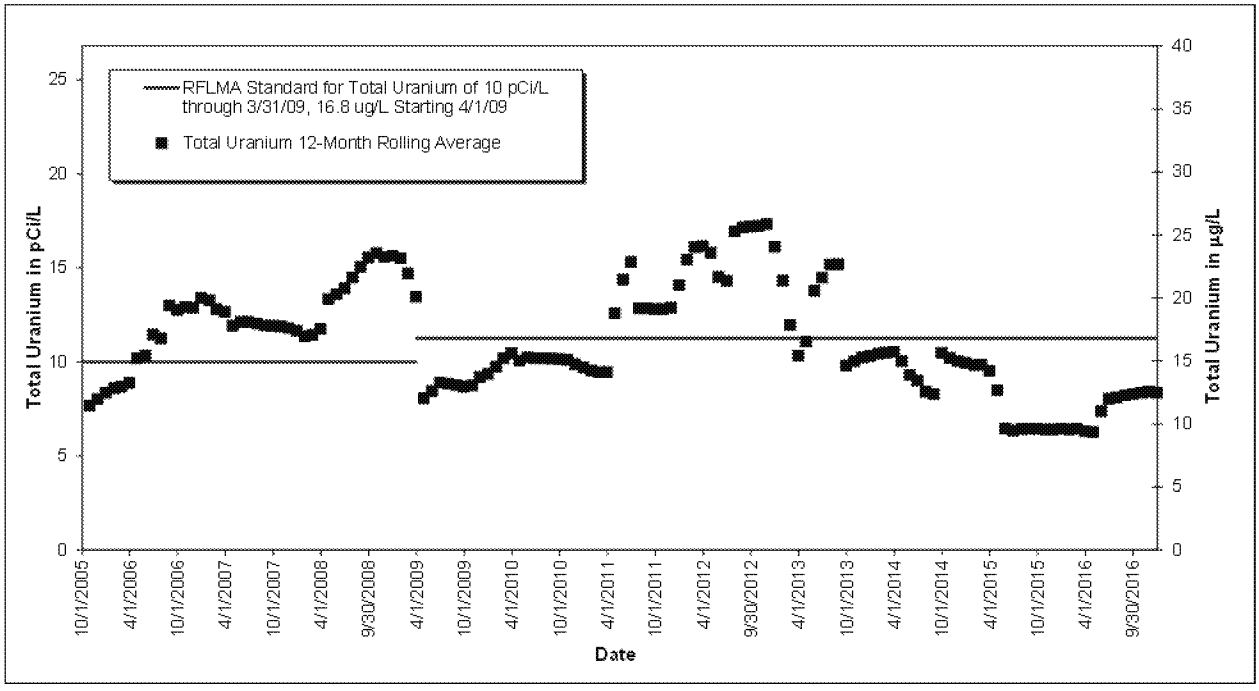
Figure E-7. Volume-Weighted 12-Month Rolling Average Total Uranium Concentrations at GS10: Post-Closure Period

GS10 did not fall below the RFLMA standard until March 2013. The average remained below the standard until the end of May, when the standard was again exceeded. In September 2013, the 12-month rolling average for uranium (14.6 µg/L) fell below the RFLMA standard and remained below the standard through the end of this FYR period. Figure E-7 presents the 12-month rolling average data for total U at GS10 from 2005–2016.

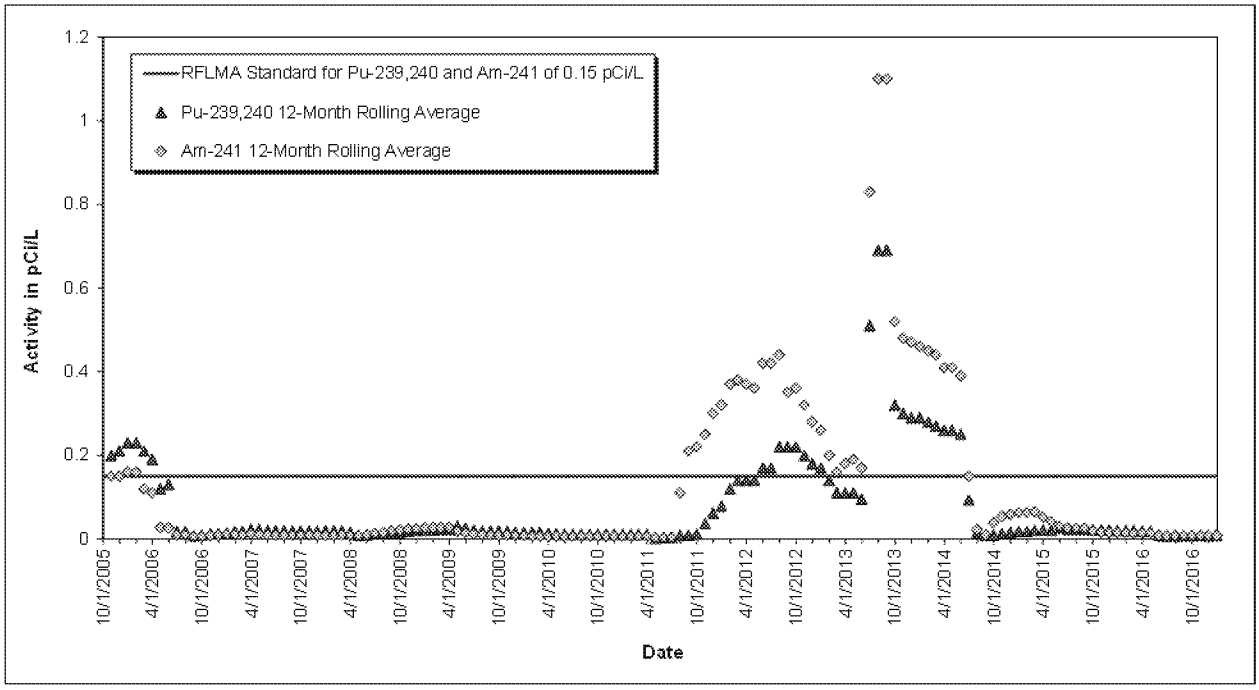
Figure E-8. Volume-Weighted 12-Month Rolling Average Plutonium and Americium Activities at Location GS10: Post-Closure Period

rolling average for Pu at location GS10 (0.17 pCi/L) exceeded the RFLMA standard of 0.15 pCi/L and became a reportable condition. Figure E-8 presents the 12-month rolling averages for Am and Pu from 2005 through 2016.

The evaluation of the Am and Pu reportable conditions focused on assessment of the potential transport mechanisms for these radionuclides, namely, soil erosion and transport in water via various mechanisms. Inspection of the location GS10 drainage did not identify any obvious soil erosion that could potentially impact surface water quality. This observation, coupled with the fact that the elevated Pu/Am results for GS10 were obtained during relatively dry conditions at the site, suggested that soil/sediment transport was not a primary contributor to the reportable condition at GS10. Sampling of several seeps identified upstream of GS10 (DOE 2014) suggested that seeps may be contributing some Pu/Am to surface water at location GS10; however, seep contributions alone could not adequately explain the measured Pu/Am concentrations at GS10. Evaluation of data for colloidal transport did not provide additional insight into the reportable condition evaluation at GS10.

Mitigating actions were not required to address these reportable conditions because downstream conditions remained well below the RFLMA standards for Pu and Am during the evaluation period. The downstream locations associated with GS10 at the time are shown in Figure E-9; monitoring data for these locations are shown in Figures E-10 and E-11. Pu and Am 12-month averages at GS10 have remained below the RFLMA standards from mid-2014 through the end of this FYR period.

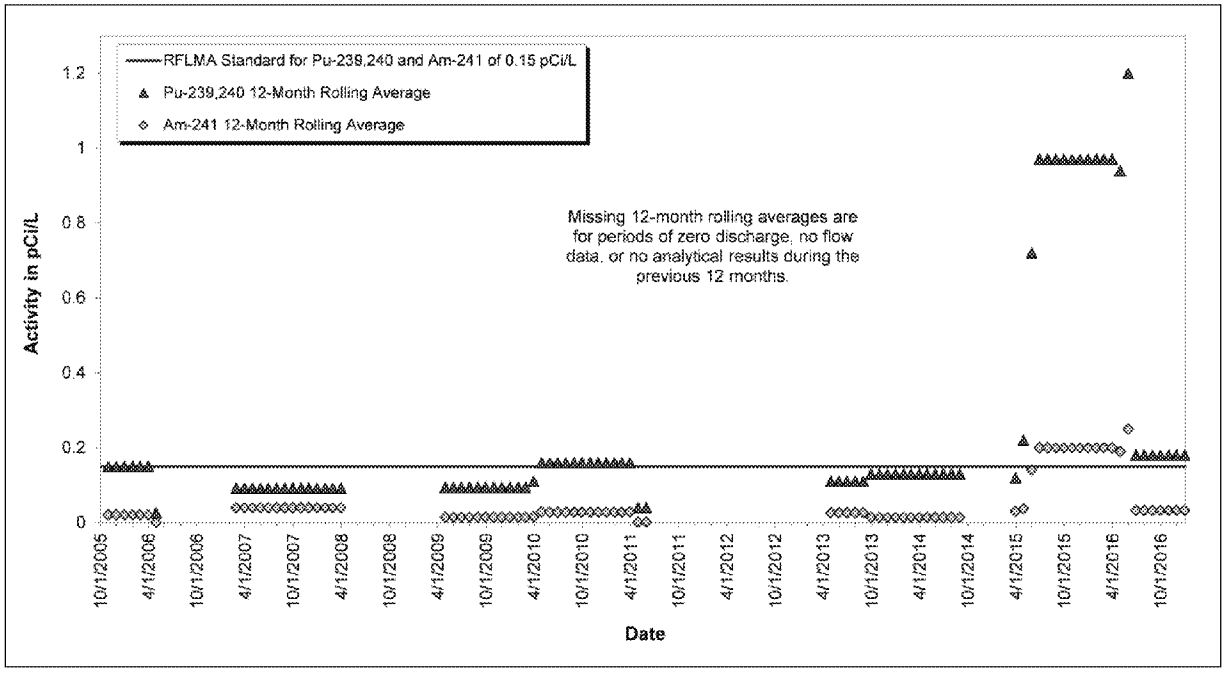
Figure E-13. Volume-Weighted 12-Month Rolling Average Plutonium and Americium Activities at Location SW027: Post-Closure Period Ending CY 2016

average for Am subsequently exceeded the standard in June 2015. Following consultation, additional measures were implemented to enhance the vegetation and erosion controls implemented in 2010 and 2011. These measures were mostly completed by August 2015 and included the addition of straw wattles, GeoRidge berms, and woodstraw in the SID drainage area; additional erosion matting and GeoRidge berms in the SID was completed in March 2016. The 12-month rolling averages for Pu at SW027 continued to exceed the RFLMA standard through the end of this FYR period. Americium concentrations continued to exceed the RFLMA standard until June 2016; since June 2016 and through the end of this FYR period Am has been below the standard.

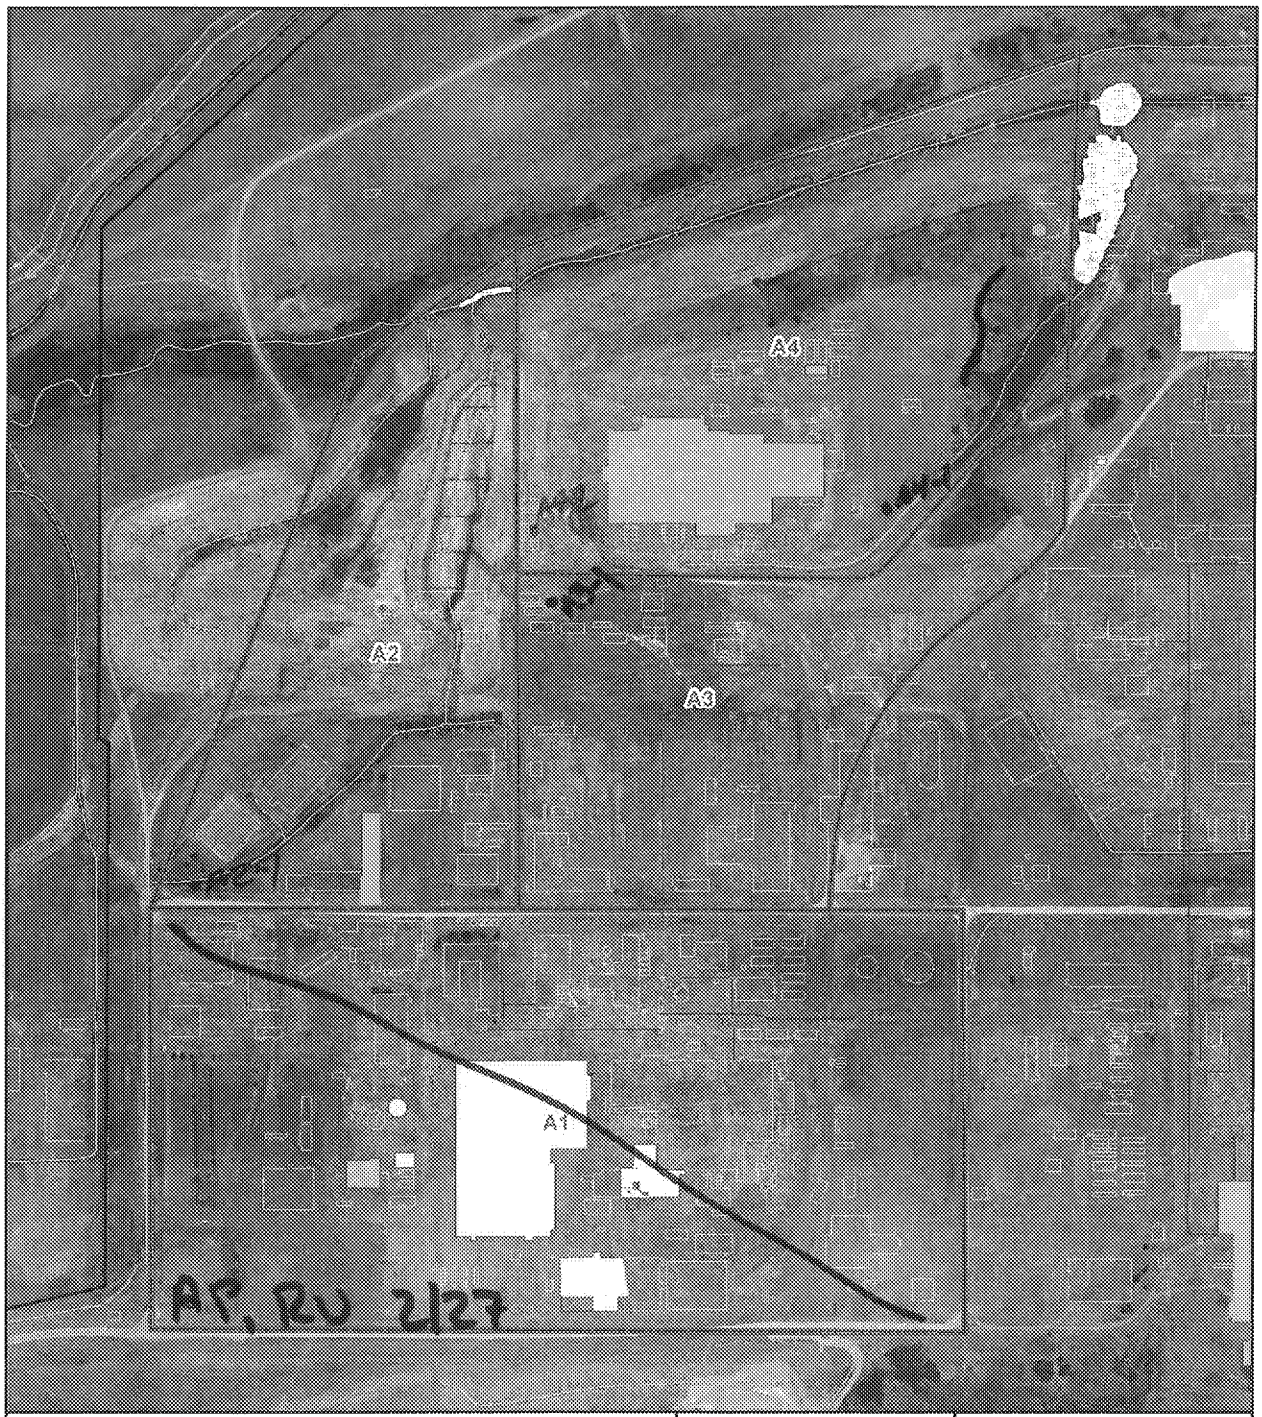
A4-2 - Steel pipe and conduit in ground west of 371

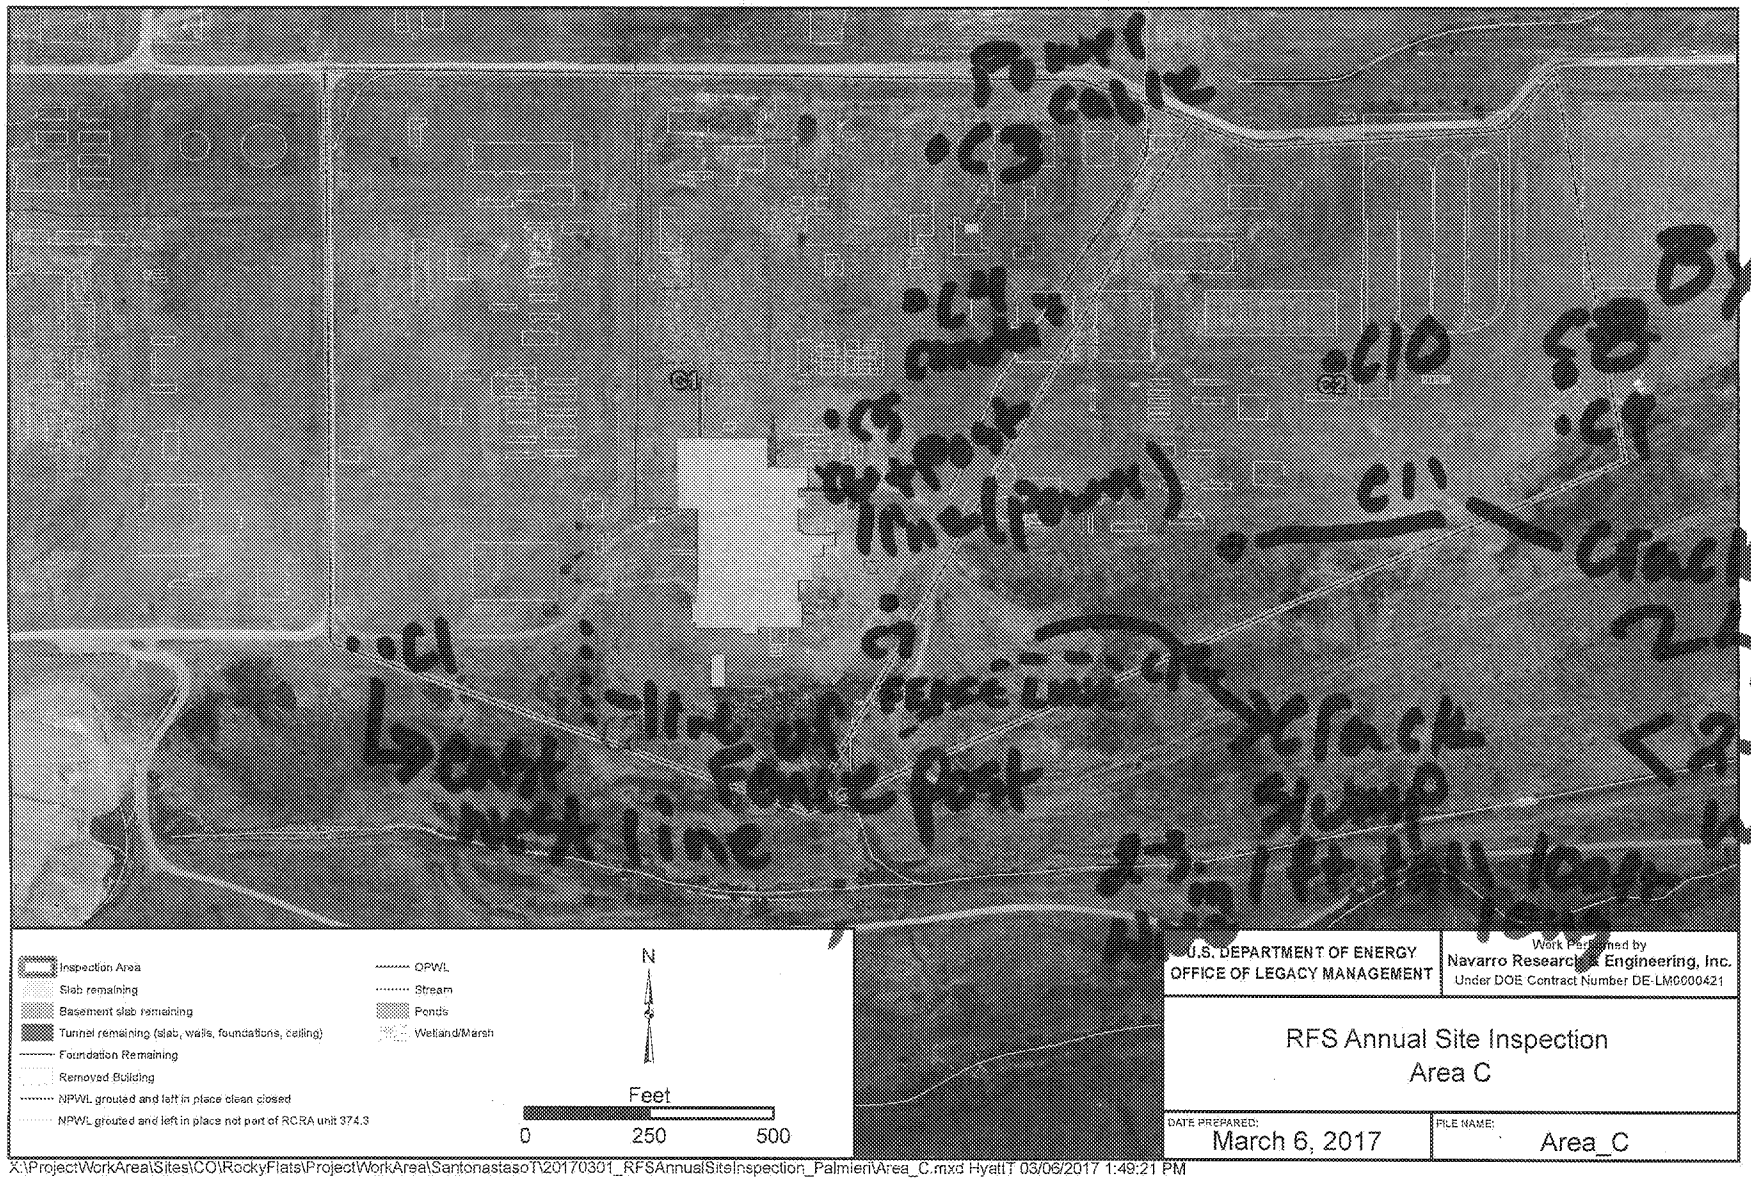
Notes (Reference Flag ID#): C-8 - metal debris
C-9 - Concrete gutter drain
C-10 - metal debris
C-11 - Crack, ~45 ft long < 2 in wide
C-12 - Crack, Slump, highest 1 ft tall, 100 ft long, 2-3 in wide
