Hexavavalent Chromium Detections in Phase 1 Soil Samples

Lane Plating Works, Inc. Superfund Site
Dallas, Dallas County, Texas

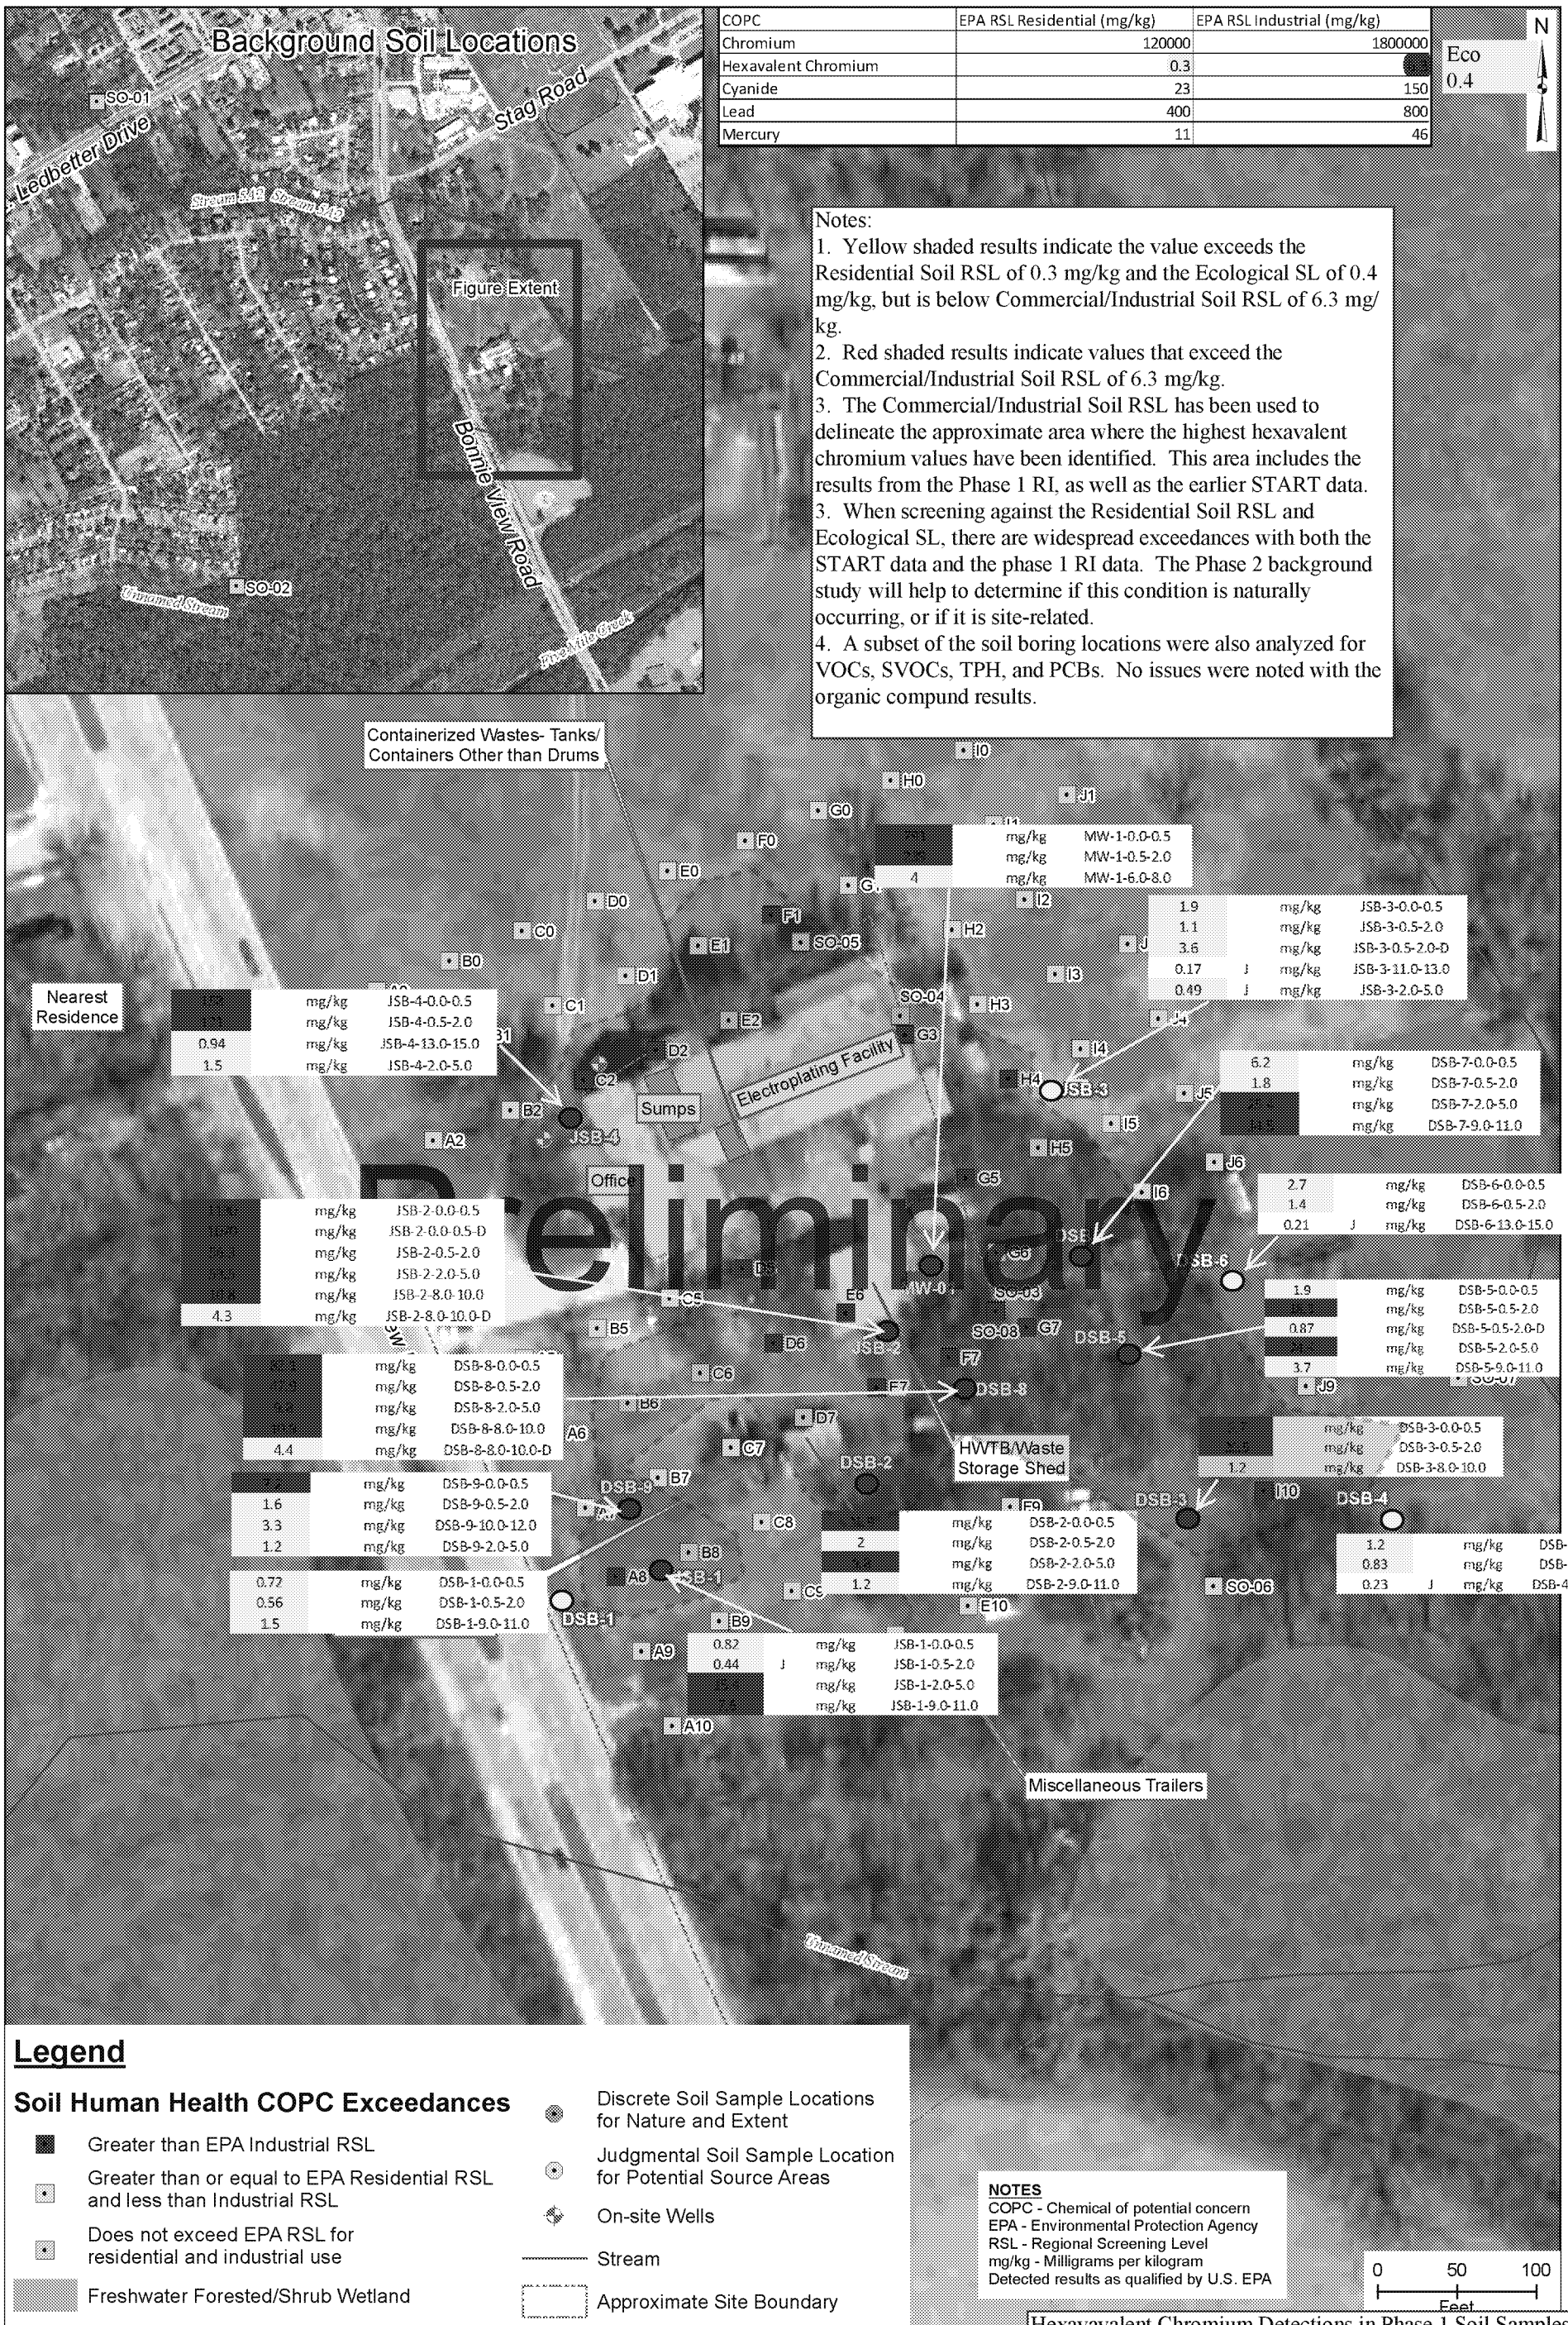
Notes:
1. Yellow shaded results indicate the value exceeds the Residential Soil RSL of 0.3 mg/kg and the Ecological SL of 0.4 mg/kg, but is below Commercial/Industrial Soil RSL of 6.3 mg/kg.

2. Red shaded results indicate values that exceed the Commercial/Industrial Soil RSL of 6.3 mg/kg.
3. The Commercial/Industrial Soil RSL has been used to delineate the approximate area where the highest hexavalent chromium values have been identified. This area includes the results from the Phase 1 RI, as well as the earlier START data.

3. When screening against the Residential Soil RSL and Ecological SL, there are widespread exceedances with both the START data and the phase 1 RI data. The Phase 2 background study will help to determine if this condition is naturally occurring, or if it is site-related.

4. A subset of the soil boring locations were also analyzed for VOCs, SVOCs, TPH, and PCBs. No issues were noted with the organic compund results.
