ROLLING KNOLLS LANDFILL SUPERFUND SITE
FEASIBILITY STUDY ASSESSMENT

The Office of Environmental Policy and Compliance

Department of the Interior

KMPower Consulting, Inc

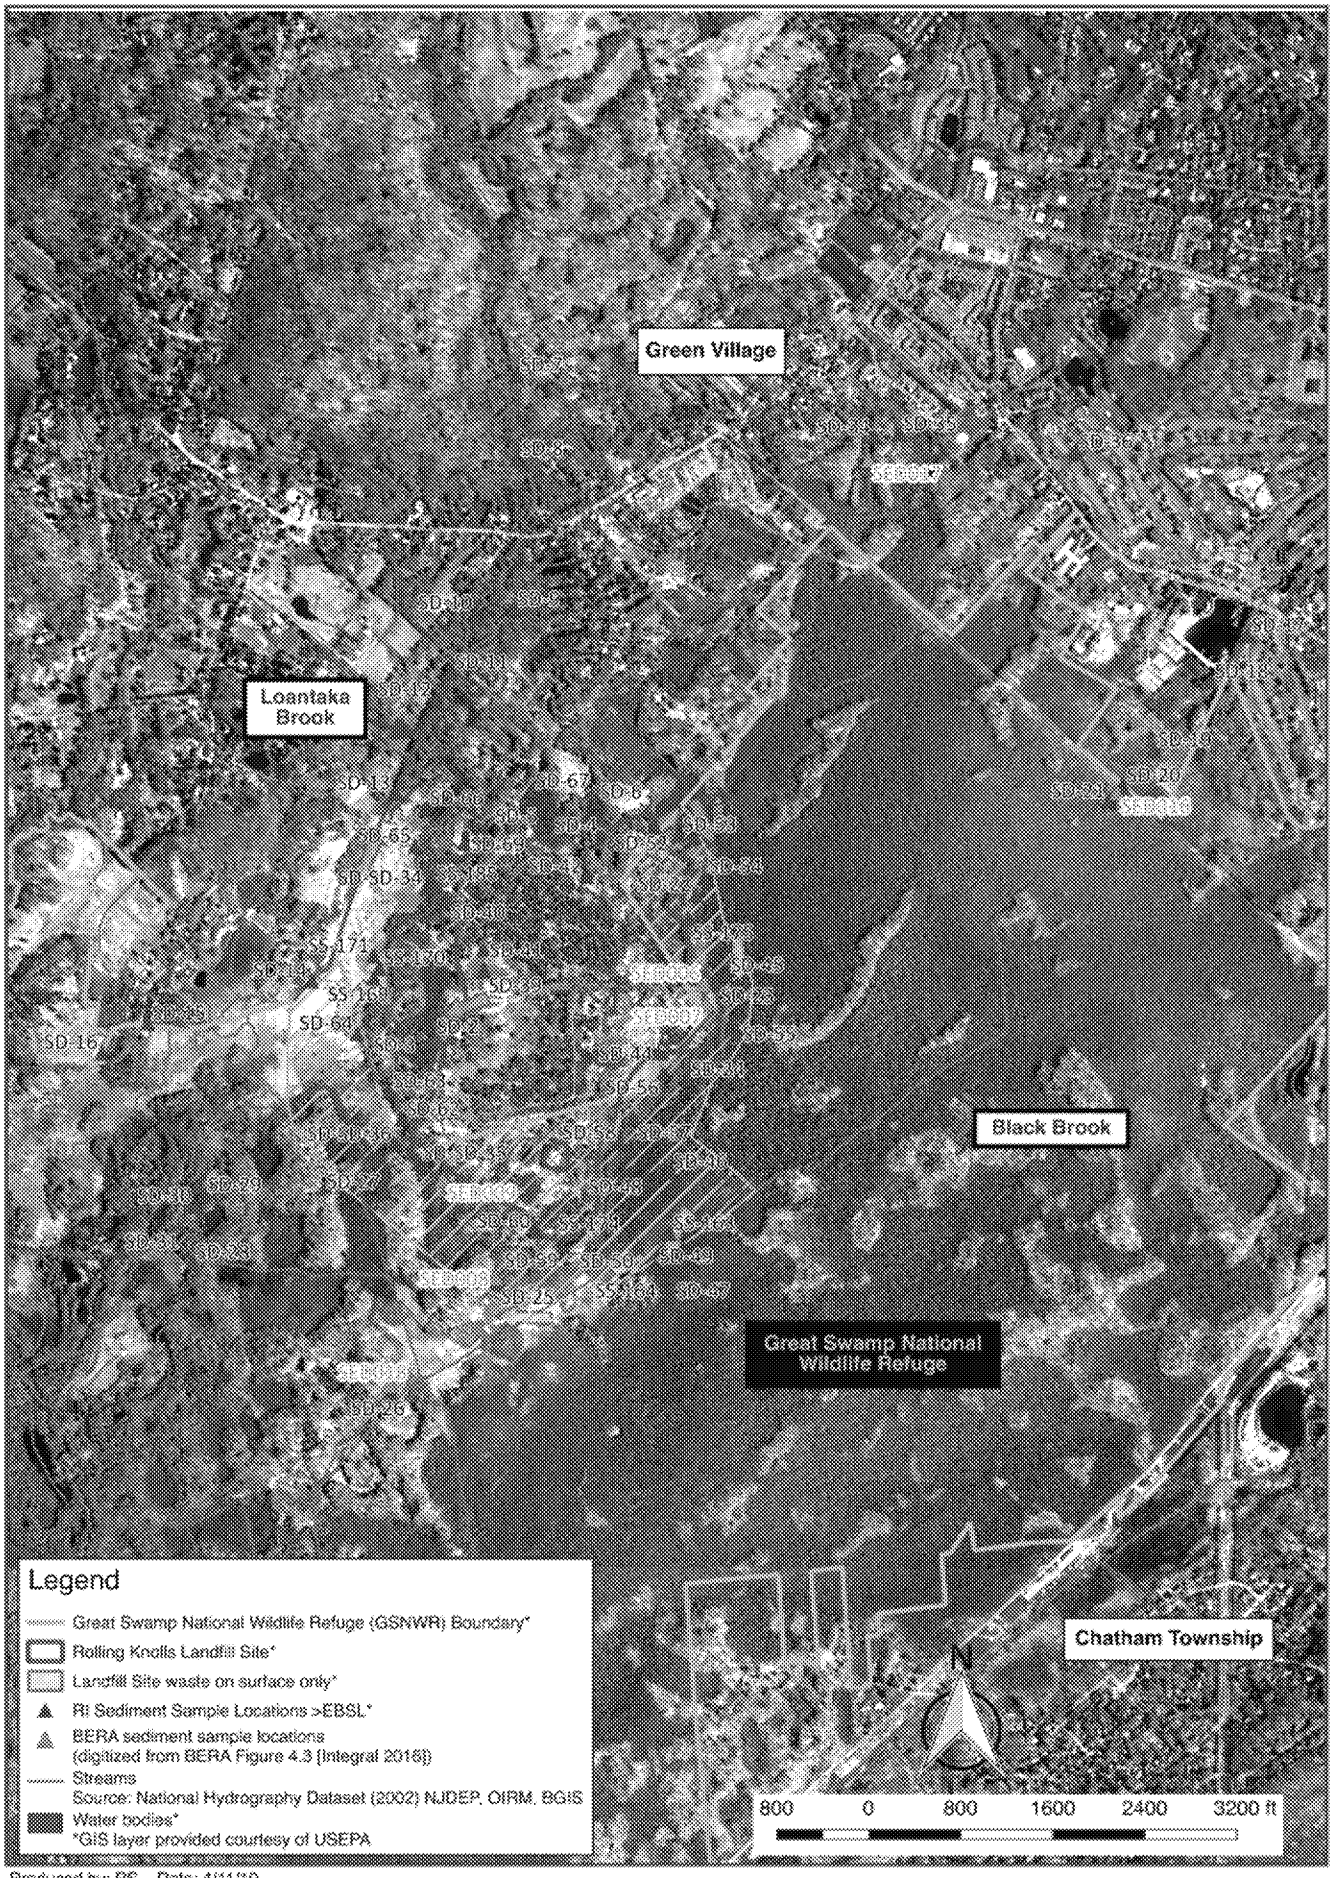
FIGURE 6 - Sediment Sample Locations

Sediment sample locations from the BERA and RI sediment sample locations that exceeded the RI ecologically based screening level (EBSL)
