ROLLING KNOLLS LANDFILL SUPERFUND SITE
FEASIBILITY STUDY ASSESSMENT

April 2019

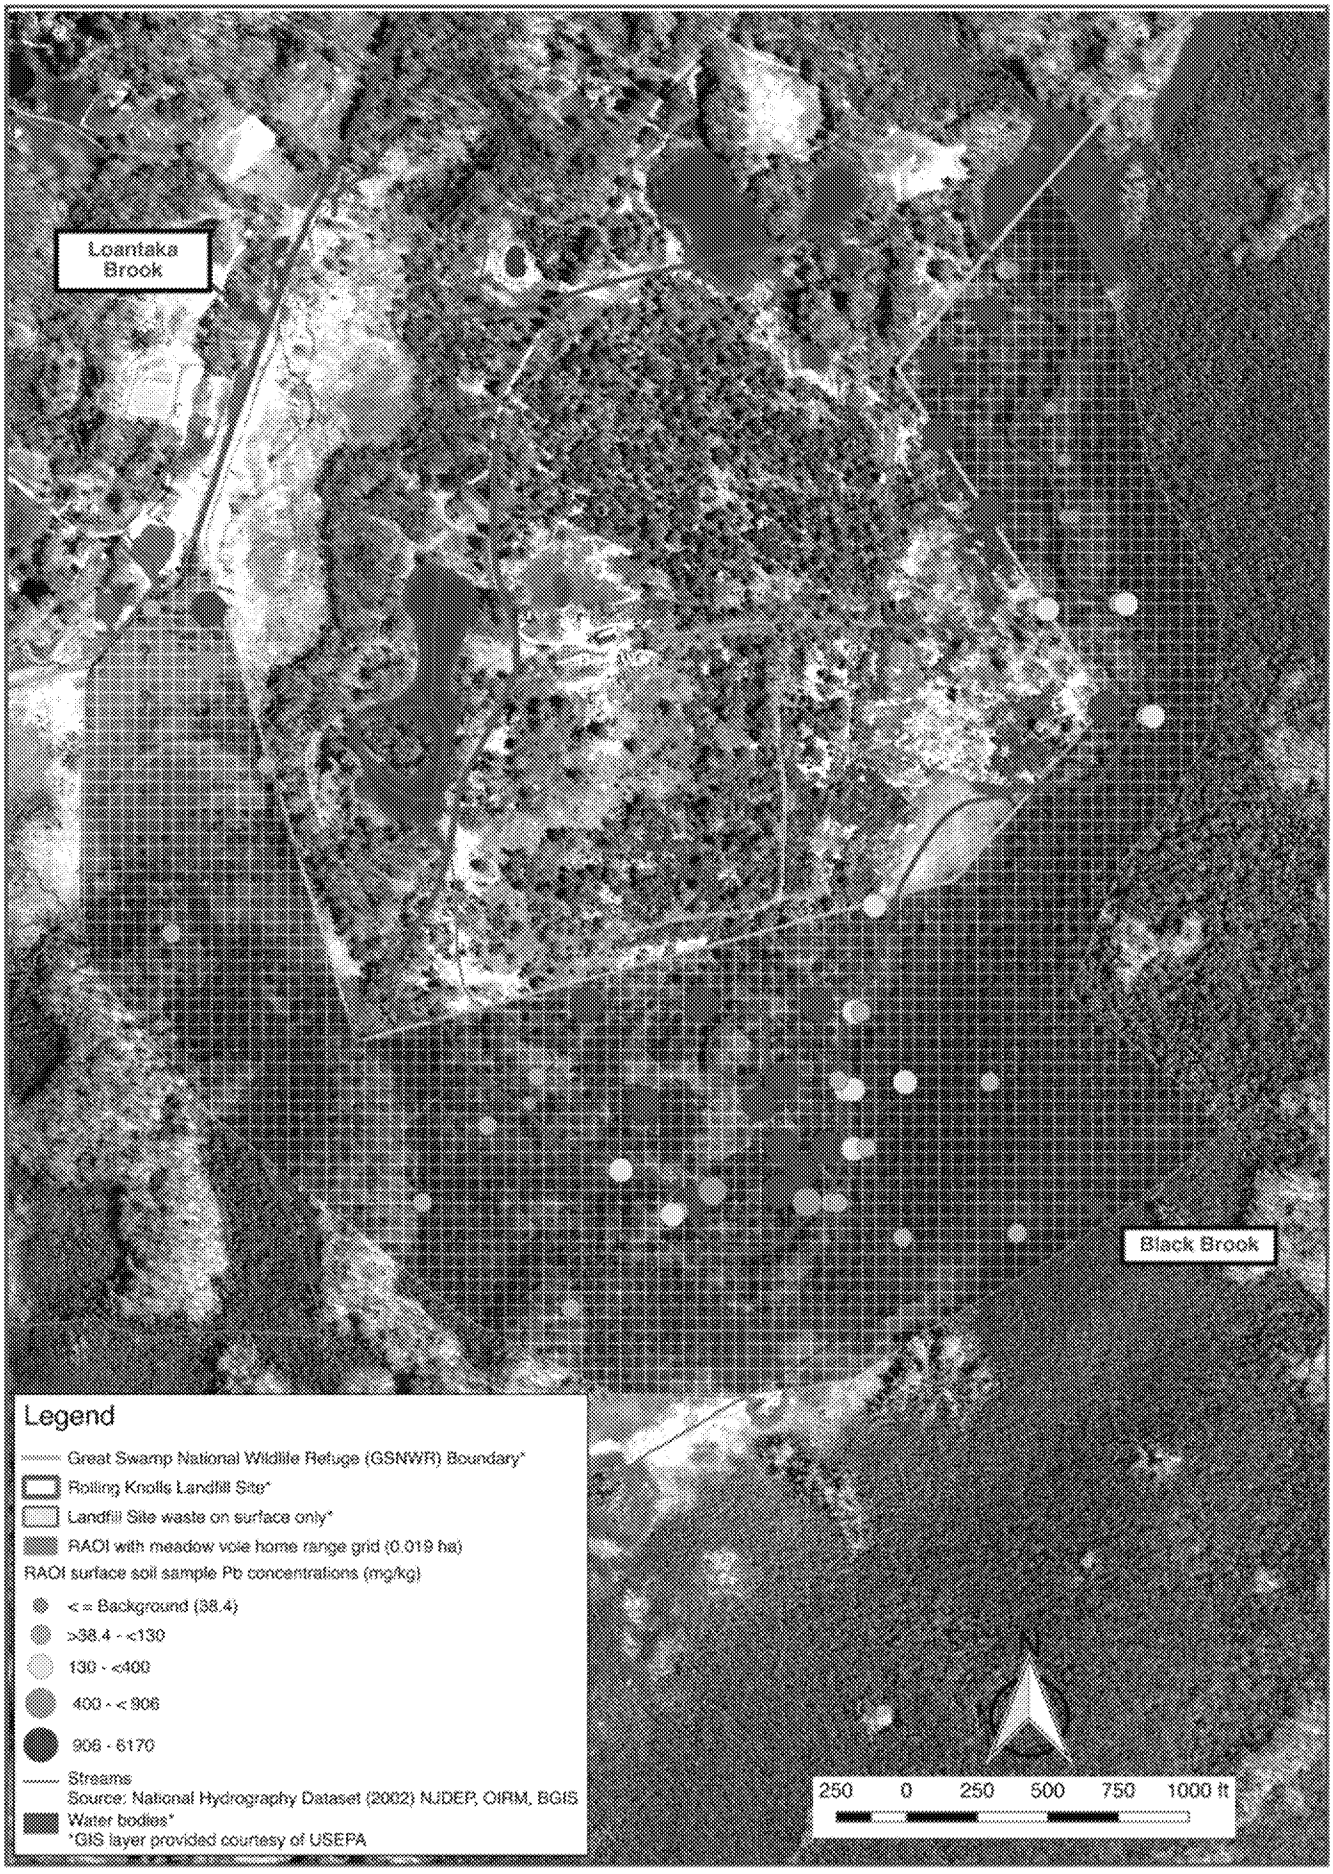
FIGURE 3 - Refuge Area of Interest
Pb Surface Soil Soil Concentrations

Figure 3 – Figure 3 illustrates several main points of impact revealed by the assessment on the RAOI property from Table 1. Features of Figure 3 include:

- A gradient of Pb concentrations across the RAOI is apparent. As indicated in the legend, and marked by the colors of the lead sample results, four general groupings of results are identified:

- Green dot: Results less than or equal to background (38.4 mg/kg);
    - Blue dot: Results greater than background and less than 130 mg/kg (Short-tailed shrew NOAEL Benchmark);
    - Yellow dot: Results greater than 130 mg/kg and less than 400 mg/kg;
    - Orange dot: Results greater than the proposed benchmark Pb concentration 400 mg/kg and less than 906 mg/kg (the concentration estimated to be protective of the meadow vole based the NOAEL);
    - Red dot: Results greater than 906 mg/kg.

- Based on this assessment, the RAOI has been adversely impacted by Pb contamination associated with the landfill wastes and that the impact is significant. Proposed remedial alternatives in the draft FS that do not fully contain the source landfill waste to prevent further migration of Pb into the Refuge do not adequately address contamination on the RAOI. The selection of any of these alternatives for the Site would not comply with NJDEP remediation requirements, the Refuge CCP, the DOI ECM requirements, or other Refuge ARARs (DOI 2018).

- As indicated above and illustrated on Figure 3 a significant portion of the soils with Pb contamination exceeding the Table 1 benchmarks on the RAOI are found in the South/Southeast impacted area of the RAOI. An area of approximately 17.8 acres contains all the sample locations with Pb concentrations higher than the 400 mg/kg benchmark concentration and includes measured concentrations as high as 6,170 mg/kg. Furthermore, this area is only characterized by 23 samples (i.e., approximately only 1.3 samples per acre; see also discussion below regarding Figure 4). Potentially, localized regions or 'hot spots' could be present that have not been identified. As indicated on Figure 3, relative to the herbivorous mammal exposure areas (the 2045 ft^2 cells, voluminous uncharacterized areas are present in the South/Southeast impacted area of the RAOI.

**Question marks (?) show areas where elevated Pb concentrations are not delineated.

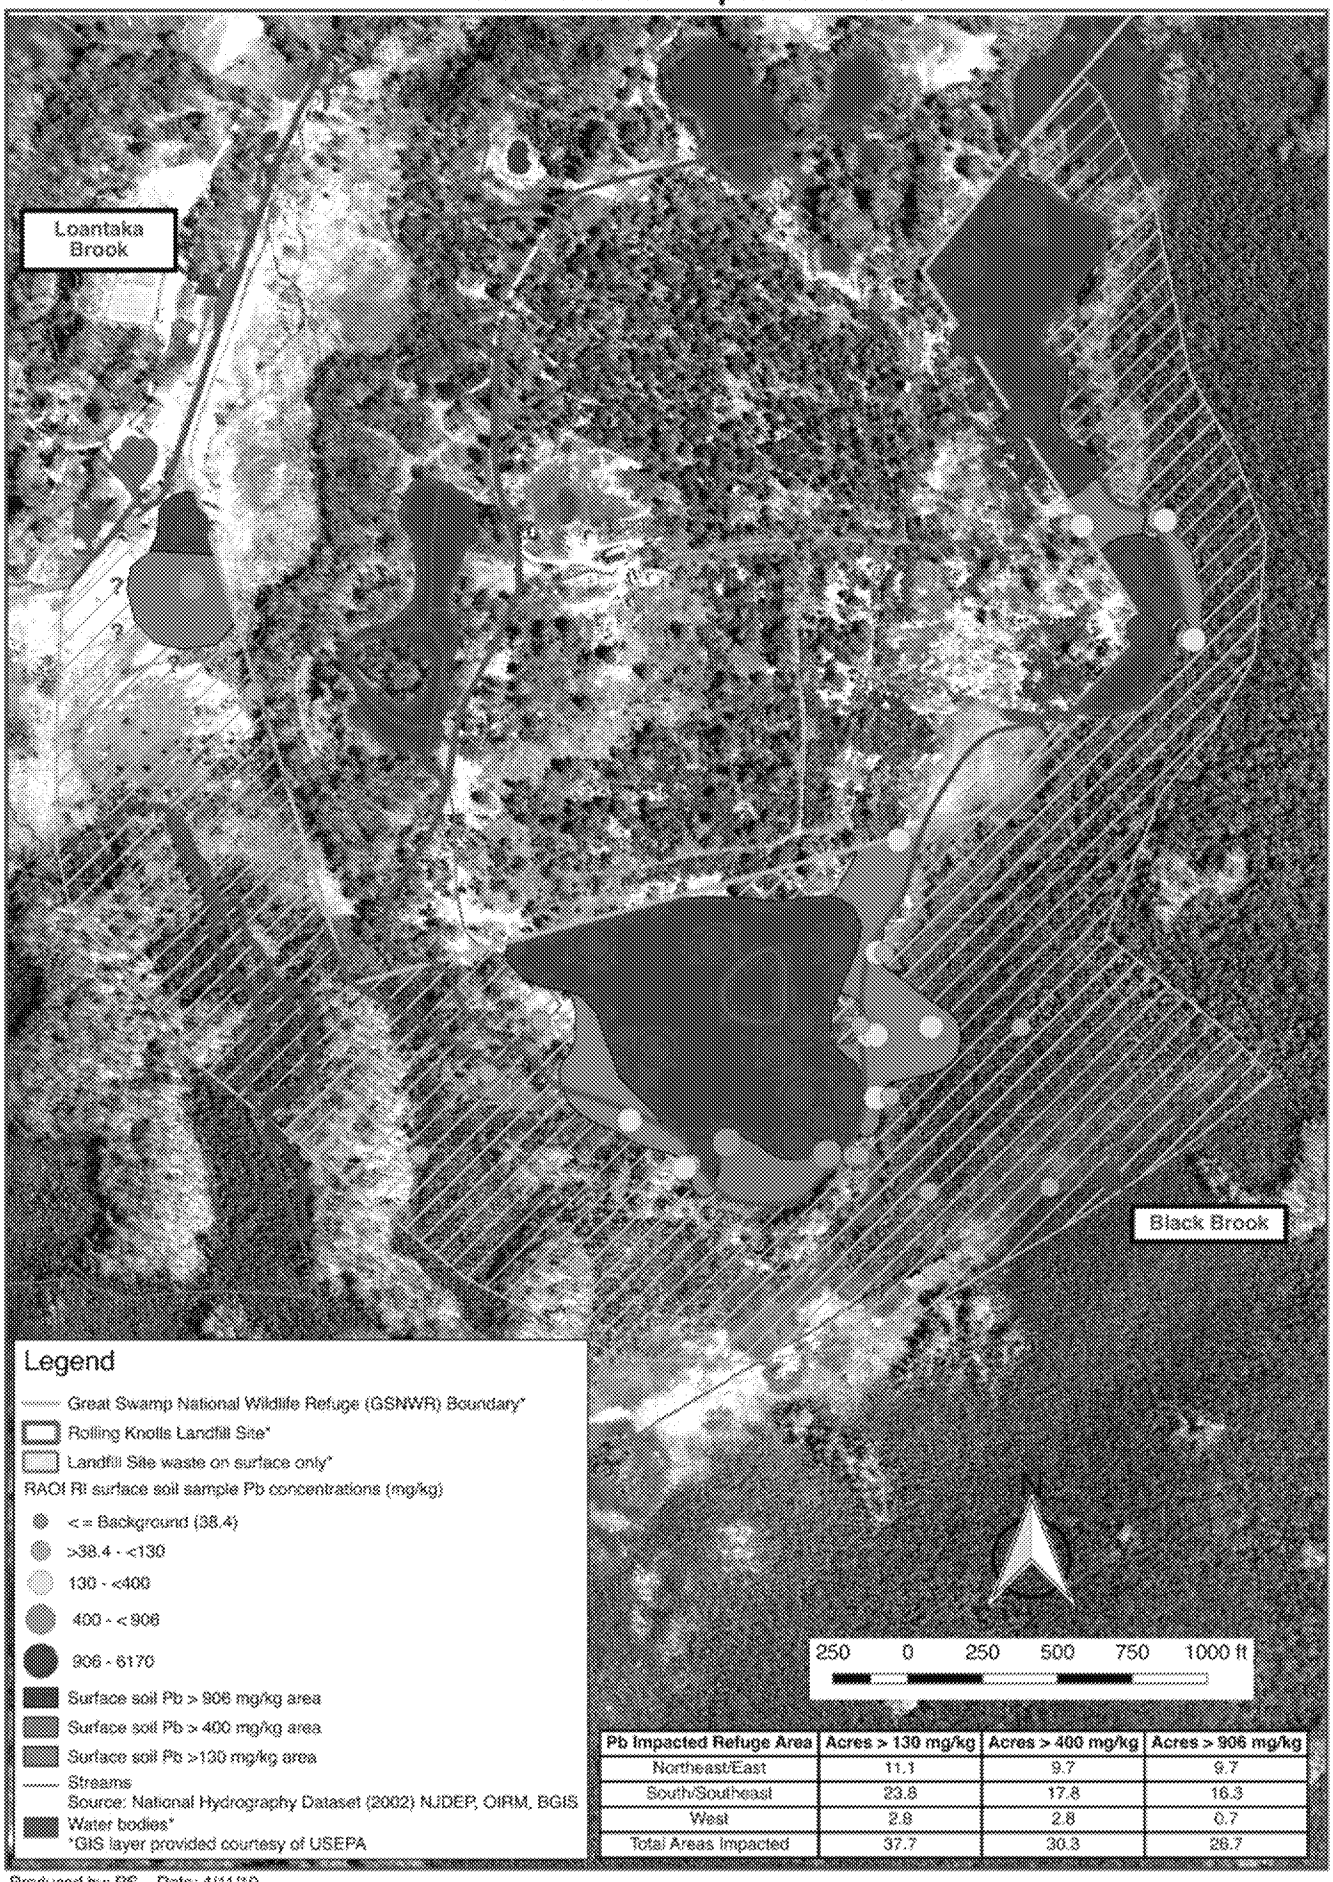
FIGURE 4 - Refuge Area of Interest
Pb Surface Soil Impacted Areas

Figure 4 – The extent of lead contamination in the RAOI is further illustrated in Figure 4. Polygons were created to delineate approximate areas of contamination exceeding the key benchmarks. The polygon boundaries were determined based on their proximity to adjacent samples, the Pb concentrations of adjacent samples, and professional judgment. A review of the data illustrated on Figure 4 results in the following observations.

- Three main areas of Pb contamination are delineated on the RAOI: Northeast/East, South/Southeast, and West areas

1. It appears that a significant area of the impacted RAOI area surface soils may contain Pb concentrations exceeding the meadow vole NOAEL-based protective benchmark concentration of 906 mg/kg, including:
    - The Northeast/East (9.7 acres).
    - The South/Southeast portion (16.3 acres).
    - The West area (0.7 acres), which is located outside of the landfill boundary/currently-defined Site.

Overall, it is estimated that approximately 26.7 acres of soil could be impacted on the RAOI with Pb concentrations exceeding the meadow vole NOAEL-based protective benchmark concentration of 906 mg/kg. Given the relatively small meadow vole home range and the large RAOI area impacted, it is conceivable that a significant portion of the small mammal population, as represented by the meadow vole, could be at risk from Pb concentrations above the NOAEL benchmark.

2. Based on the distribution of contaminant concentrations, it is likely that a sizable portion of the RAOI may contain areas where Pb surface soil concentrations exceed the assessment benchmark concentration of 400 mg/kg including:

- The Northeast/East portion (9.7 acres).
    - The South/Southeast portion (17.8 acres).
    - The West area may contain up to 2.8 acres of soils at concentrations exceeding 400 mg/kg (the contamination was not bounded through sampling to the west). This location is also outside of the landfill boundary.

Overall, it is estimated that approximately 30.3 acres of impacted soil could exist on the RAOI with Pb concentrations exceeding the benchmark Pb concentration of 400 mg/kg.

Pb Impacted Refuge Area	Acres > 130 mg/kg	Acres > 400 mg/kg	Acres > 906 mg/kg
Northeast/East	11.1	9.7	9.7
South/Southeast	23.8	17.8	16.3
West	2.8	2.8	0.7
Total Areas Impacted	37.7	30.3	28.7

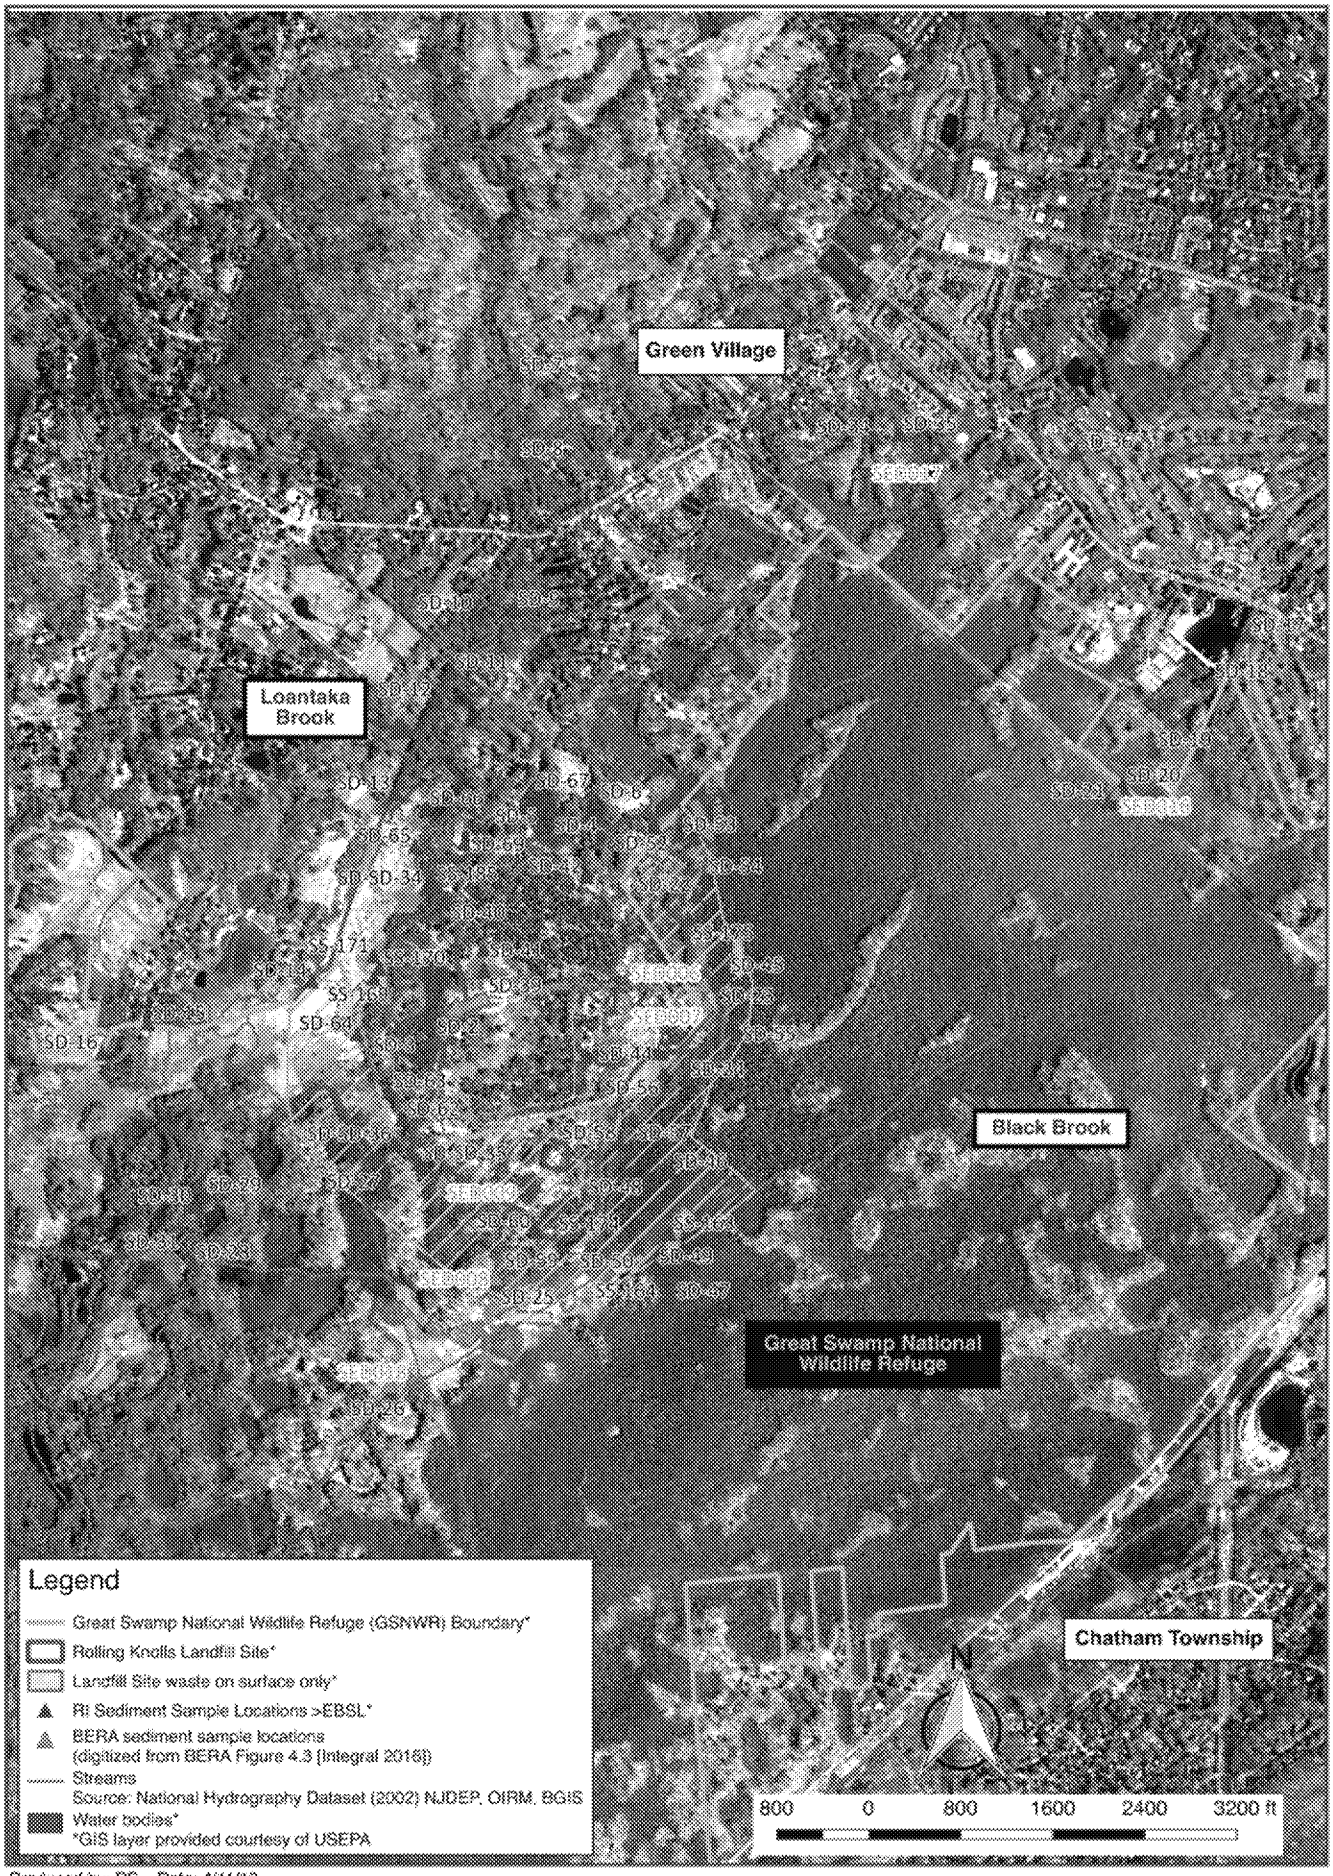
FIGURE 6 - Sediment Sample Locations

Sediment sample locations from the BERA and RI sediment sample locations that exceeded the RI ecologically based screening level (EBSL)
