2018 ANNUAL SUMMARY REPORT

Operation, Maintenance, and Monitoring Report for the Bethpage Park Soil Gas Containment System

Operable Unit 3 (Former Grumman Settling Ponds)
Bethpage, New York
NYSDEC ID # 1-30-003A

March 22, 2019

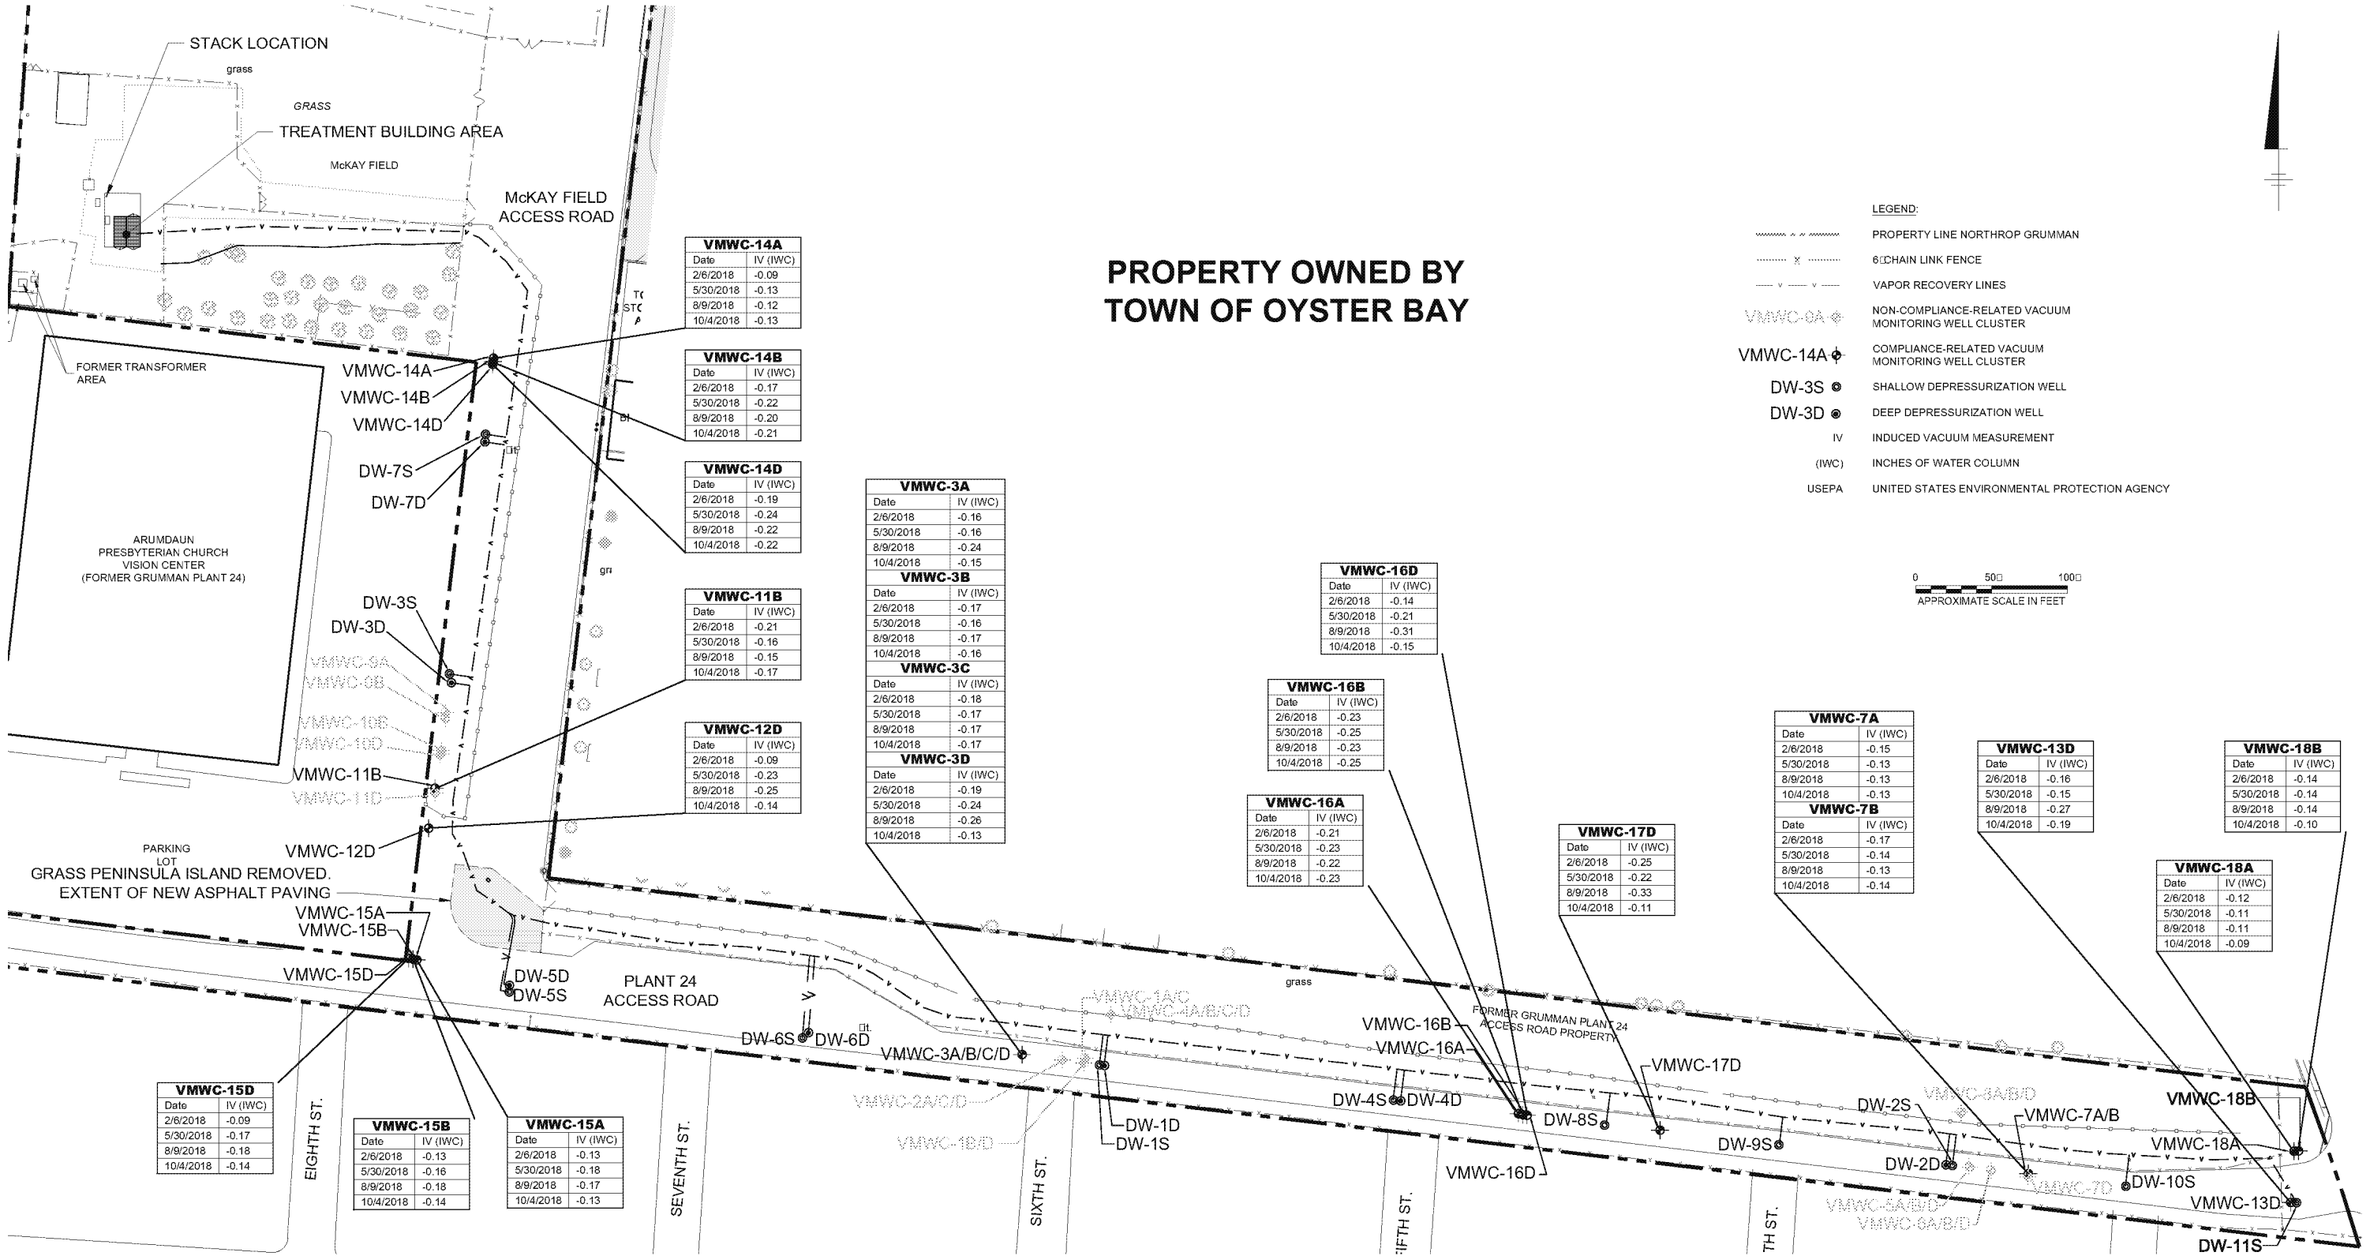
FIGURE
2

Instantaneous vacuum measurements in compliance monitoring wells from the annual reporting period and annual time-weighted rolling averages are summarized in Table 2. Quarterly vacuum measurement data from the annual reporting period are also shown on Figure 2.

As shown on Table 2, during the annual reporting period, the instantaneous induced vacuum at all compliance-related monitoring points met or exceeded the minimum performance standard (greater than or equal to -0.1 iwc), with the exceptions of VMWC-12D, VMWC-14A, VMWC-15D, and VMWC-18A. Although these instantaneous induced vacuum measurements were slightly lower than -0.1 iwc, the annual time-weighted rolling average of induced vacuum readings at all compliance-related monitoring points were maintained at greater than or equal to -0.1 iwc. Therefore, the BPSGCS is meeting the operational compliance objectives.

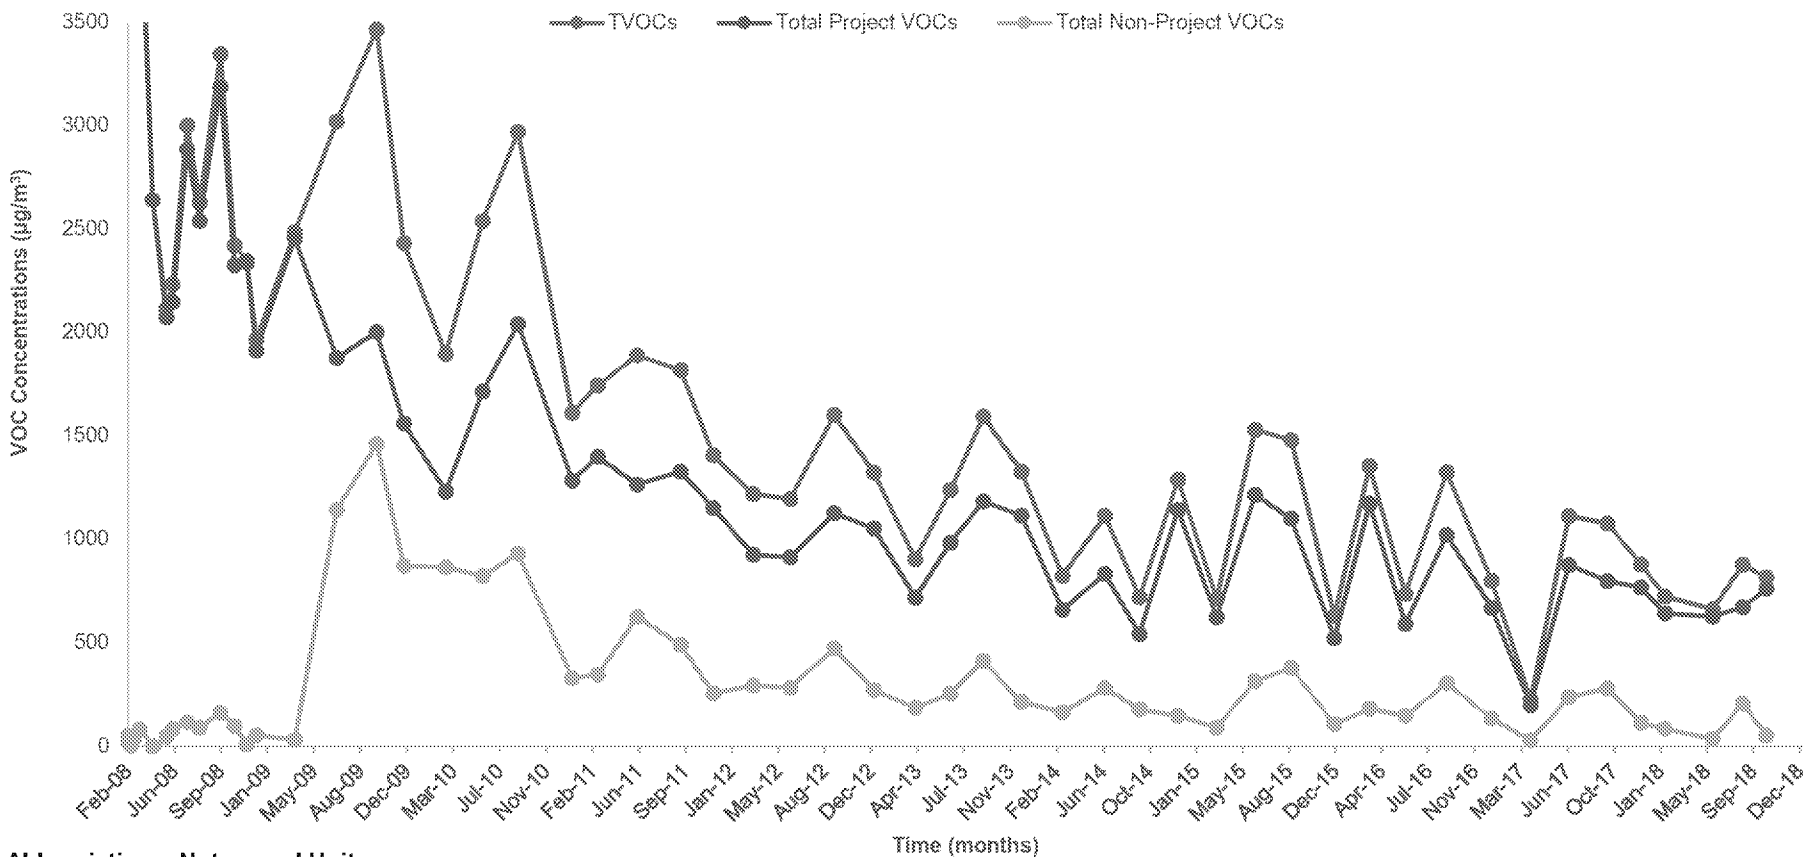
FIGURE
4

The TVOC concentration in effluent vapor has generally declined since system startup. Figure 4 provides an overview of the concentration trend over the report period. During the reporting period the containment system has removed 14.6 pounds of TVOCs, with 12.9 pounds of Project TVOCs (88.4%) and 1.7 pounds of Non-project TVOCs (11.6 %). The containment system has removed a total of 360.4 pounds of TVOCs, 287.5 pounds of Project TVOCs (78.8%), and 72.9 pounds of Non-project TVOCs (20.2%) since startup in February 18, 2008, as shown on Figure 5. Figure 6 presents the mass removal rate, which has declined since system startup.
