RM 10.9 Sediment Deposit and Removal Areas
Lower Passaic River Study Area, New Jersey

RM 10.9 TIME CRITICAL REMOVAL ACTION
CIVIL
Post-Dredge Summary
(2 of 2)

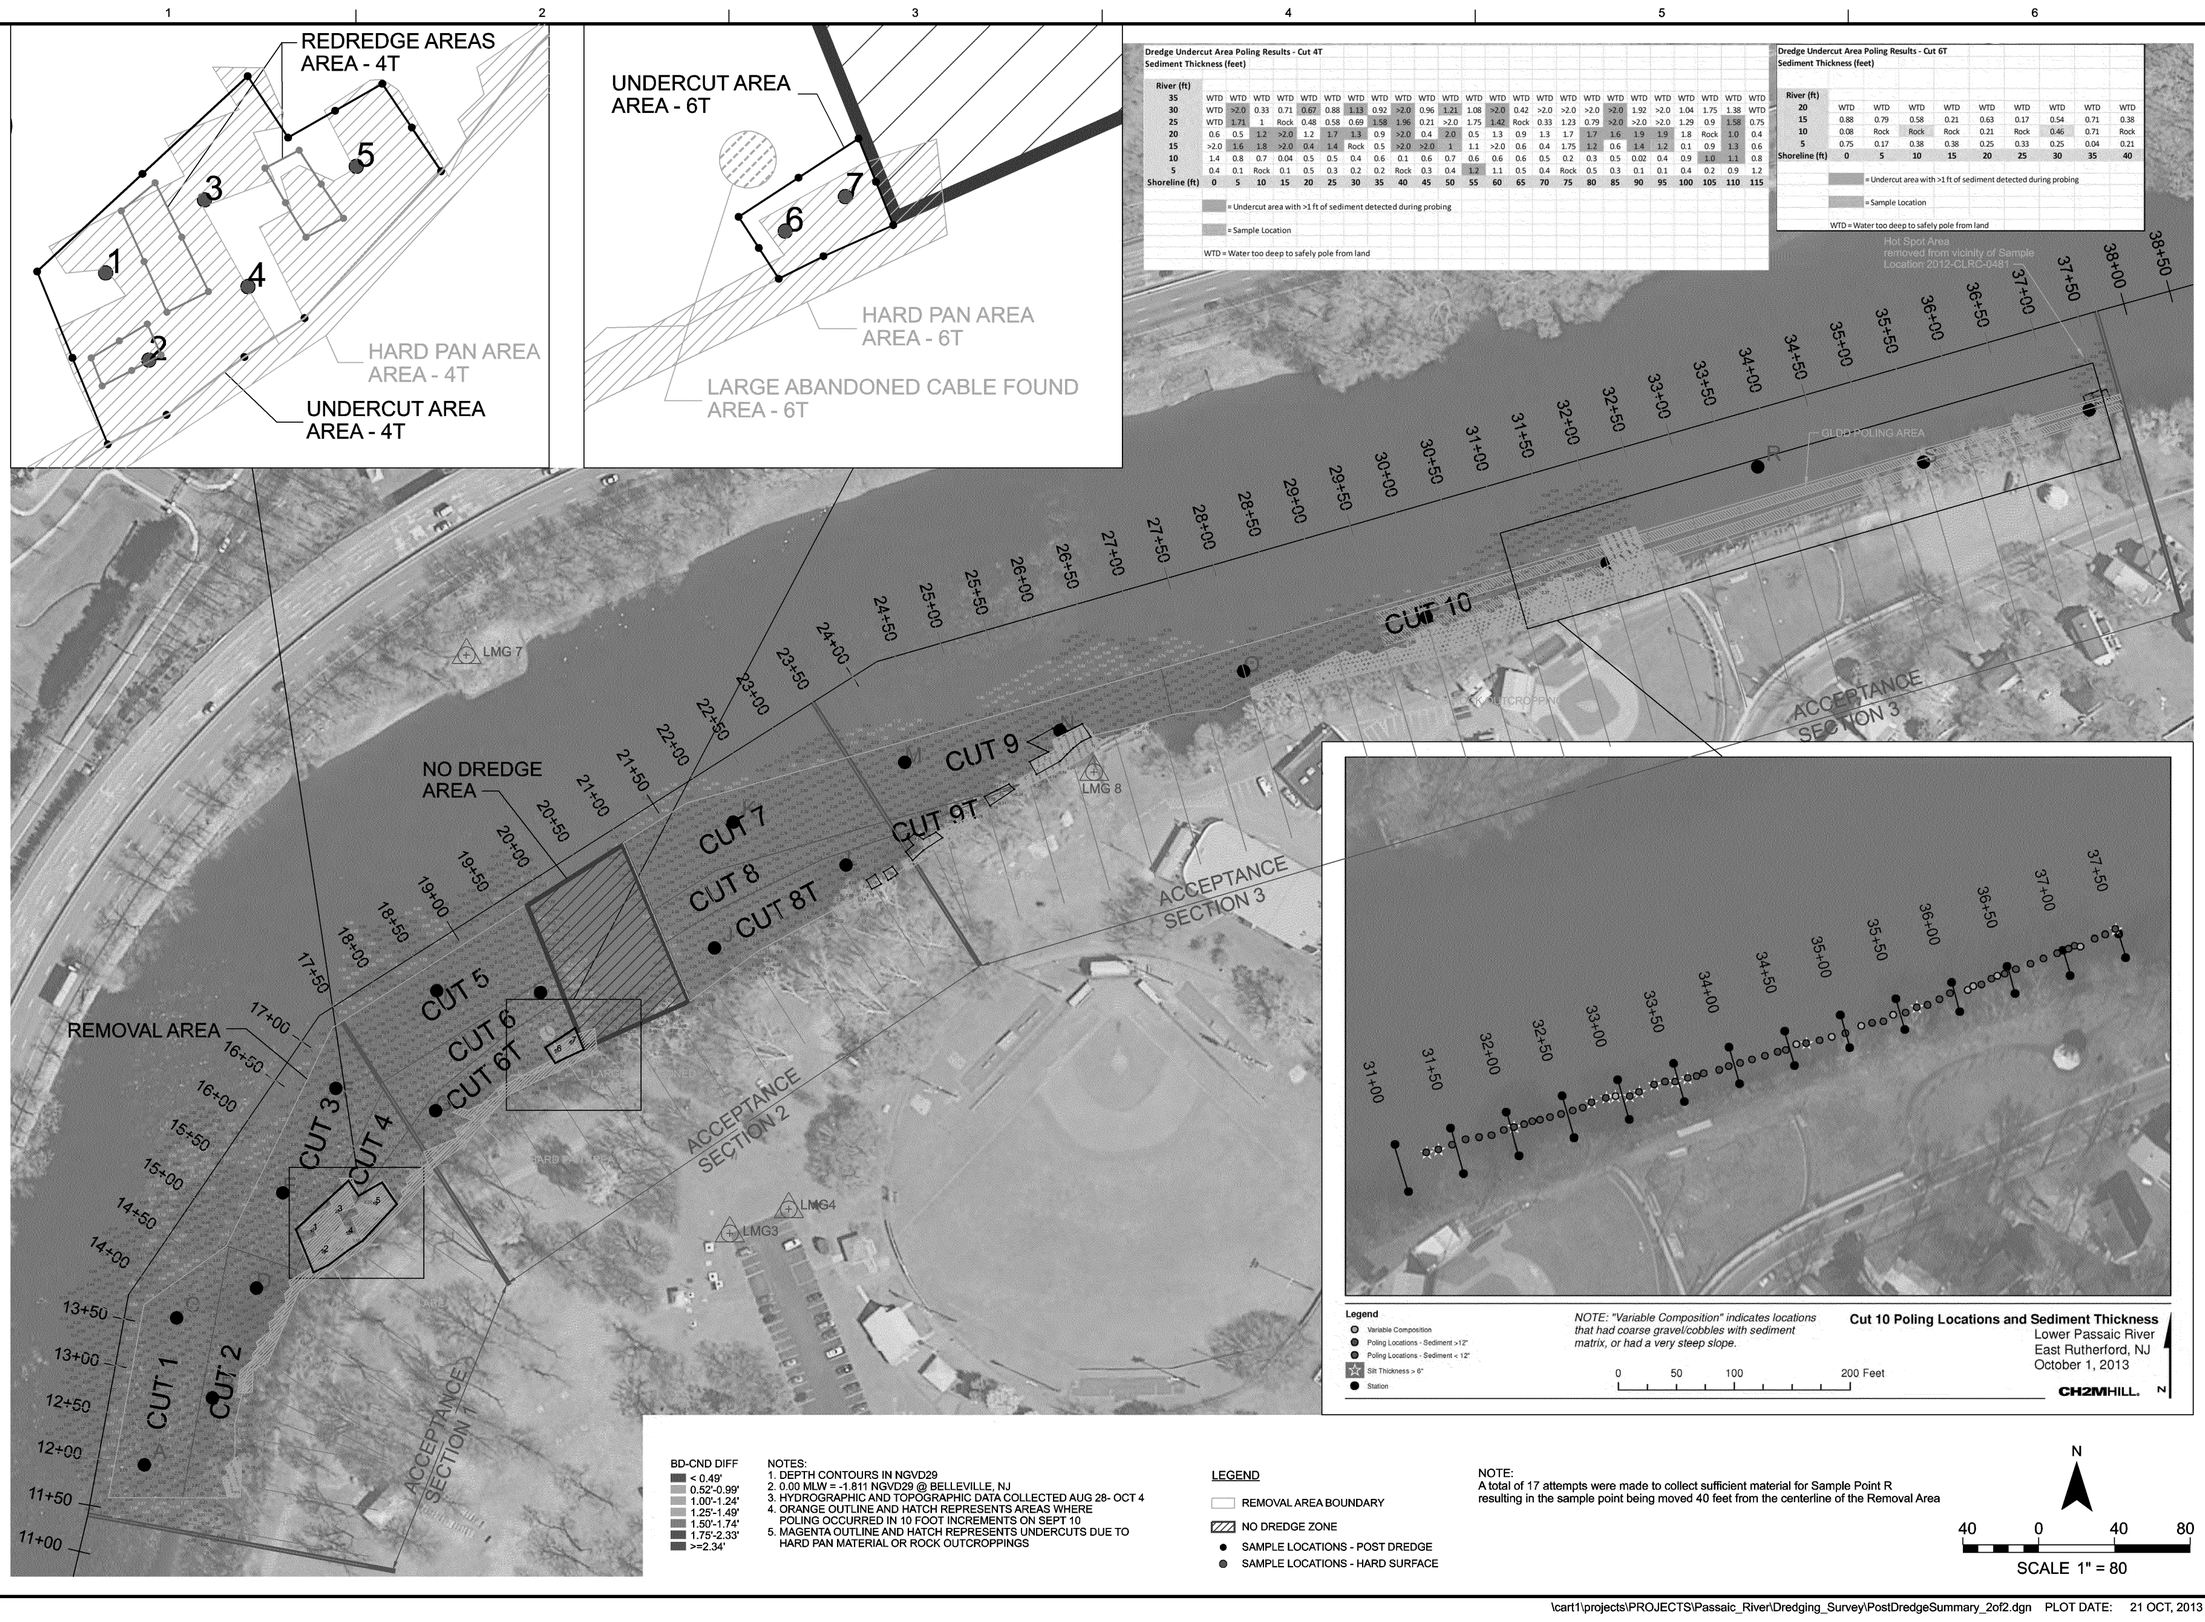
Dredge Undercut Area Poling Results - Cut 4T
Sediment Thickness (feet)

Dredge Undercut Area Poling Results - Cut 6T
Sediment Thickness (feet)

NOTE:
A total of 17 attempts were made to collect sufficient material for Sample Point R resulting in the sample point being moved 40 feet from the centerline of the Removal Area
