Facility Name: Georgia-Pacific Corporation (One Folder Site)			
Facility Identification Number: MID 042 441 022			
A.1 General Correspondence	X	**B.2 Permit Docket (B.1.2)**	
A.2 Part A / Interim Status	X	.1 Correspondence	
.1 Correspondence	X	.2 All Other Permitting Documents (Not Part of the ARA)	
.2 Notification and Acknowledgment	X	**C.1 Compliance - (Inspection Reports)**	
.3 Part A Application and Amendments		**C.2 Compliance/Enforcement**	
.4 Financial Insurance (Sudden, Non Sudden)		.1 Land Disposal Restriction Notifications	
.5 Change Under Interim Status Requests		.2 Import/Export Notifications	
.6 Annual and Biennial Reports	X	**C.3 FOIA Exemptions - Non-Releasable Documents**	
A.3 Groundwater Monitoring		**D.1 Corrective Action/Facility Assessment**	X
.1 Correspondence		.1 RFA Correspondence	
.2 Reports		.2 Background Reports, Supporting Docs and Studies	
A.4 Closure/Post Closure		.3 State Prelim. Investigation Memos

FIGURE 1
FACILITY LOCATION
GEORGIA-PACIFIC CORPORATION

FIGURE 2
FACILITY LAYOUT
GEORGIA-PACIFIC CORPORATION

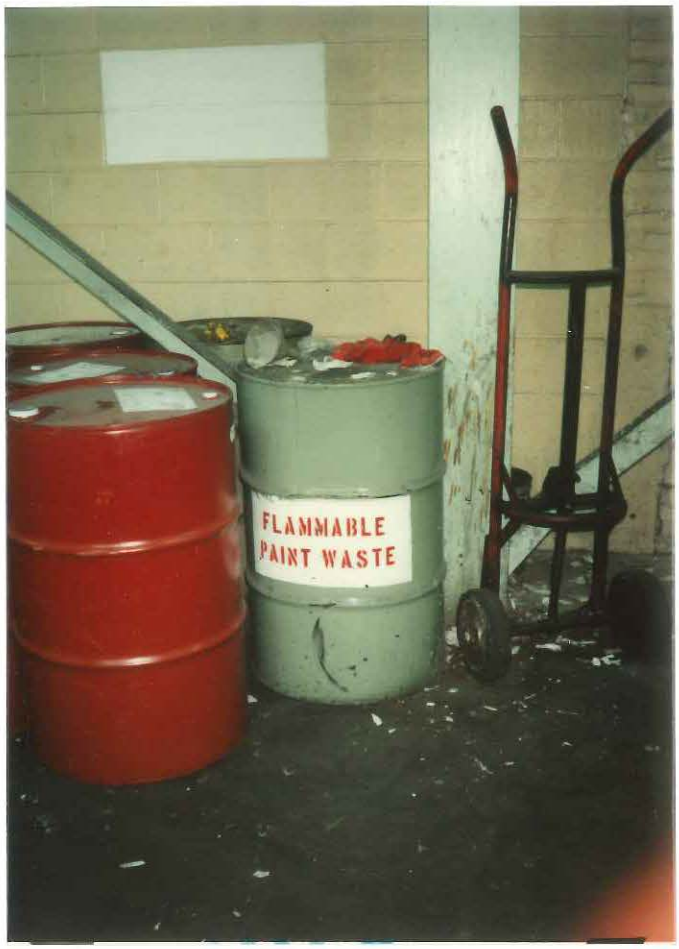
Photo No.	:	5
Location	:	SWMU No. 3
Orientation	:	Northwest
Date	:	November 13, 1991
Description	:	Paint thinner

waste satellite accumulation drum located on ground floor level of Mill No. 1.

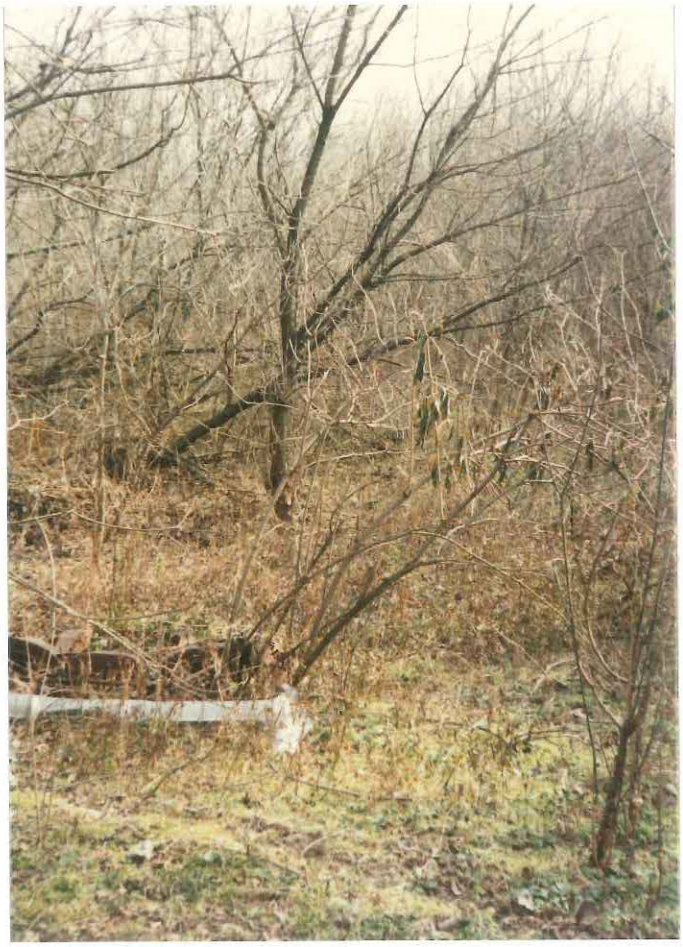
Photo No. : 10
Location : SWMU No. 6
Orientation : Southwest
Date : November 13, 1991
Description: Carframe and vegetation on Willow Boulevard Landfill.

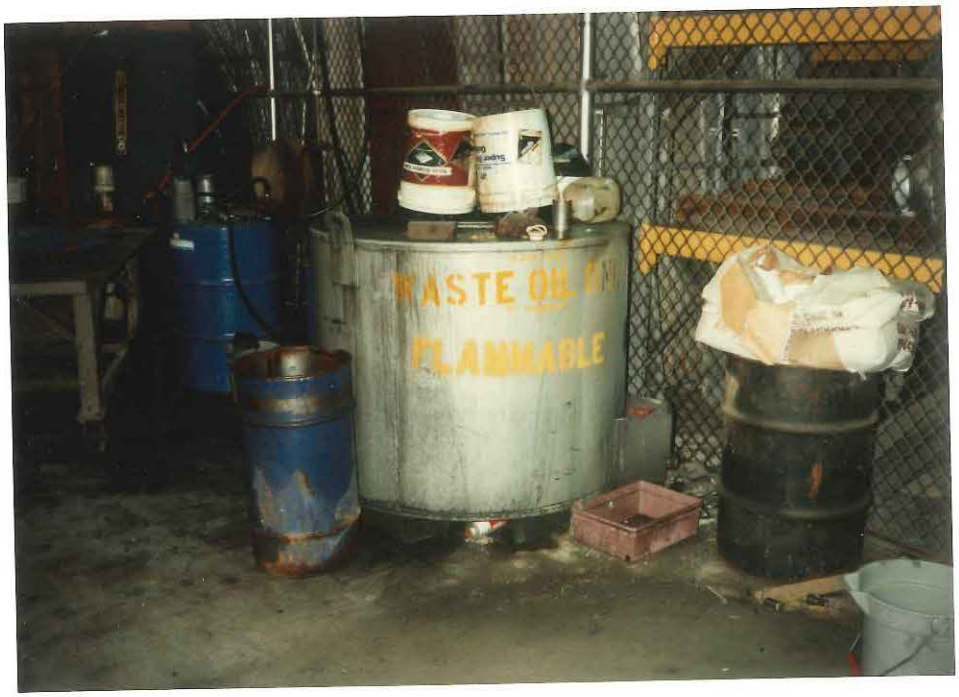
Photo No.: 16 **Location:** SWMU No. 10
Orientation: North **Date:** November 13, 1991
Description: Portable 250-gallon waste oil tank located in maintenance area of Mill No. 4.

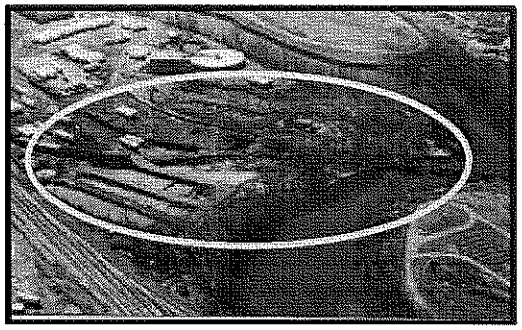
Georgia-Pacific Mill Lagoons Before Action

approximately 33,000 cubic yards of materials were removed from five Mill Lagoons
approximately 5,000 cubic yards of materials (to the edge of the river) were removed from the floodplain area as an interim response
several soil piles adjacent to Mill Lagoons 1, 2, and 3, (as well as debris in the lagoons) were removed
the lagoons were excavated down to native soils to achieve the industrial cleanup criteria (9.9 mg/kg)
material was removed based on visual cleanup criteria
ten drums were found in Mill Lagoon 1 in November of 1998; the drums were moved off-site for disposal, lab results showed that the material was non-hazardous
two clarifiers were discovered at the east end of Lagoon 1 in December 1998, the contents were removed and the clarifiers were backfilled with approved clean material
water from excavation activities was treated on site and discharged
all material was transported to the King Highway Landfill
