RECOMMENDATIONS FOR FURTHER ACTION

DATE: August 26, 1988

SITE: Proto Mold Manufacturing
1390 Old Bayshore Road
San Jose, California 95112

EPA ID#: CAD 98 235 9101
ASPIS ID#: 43-32-0041

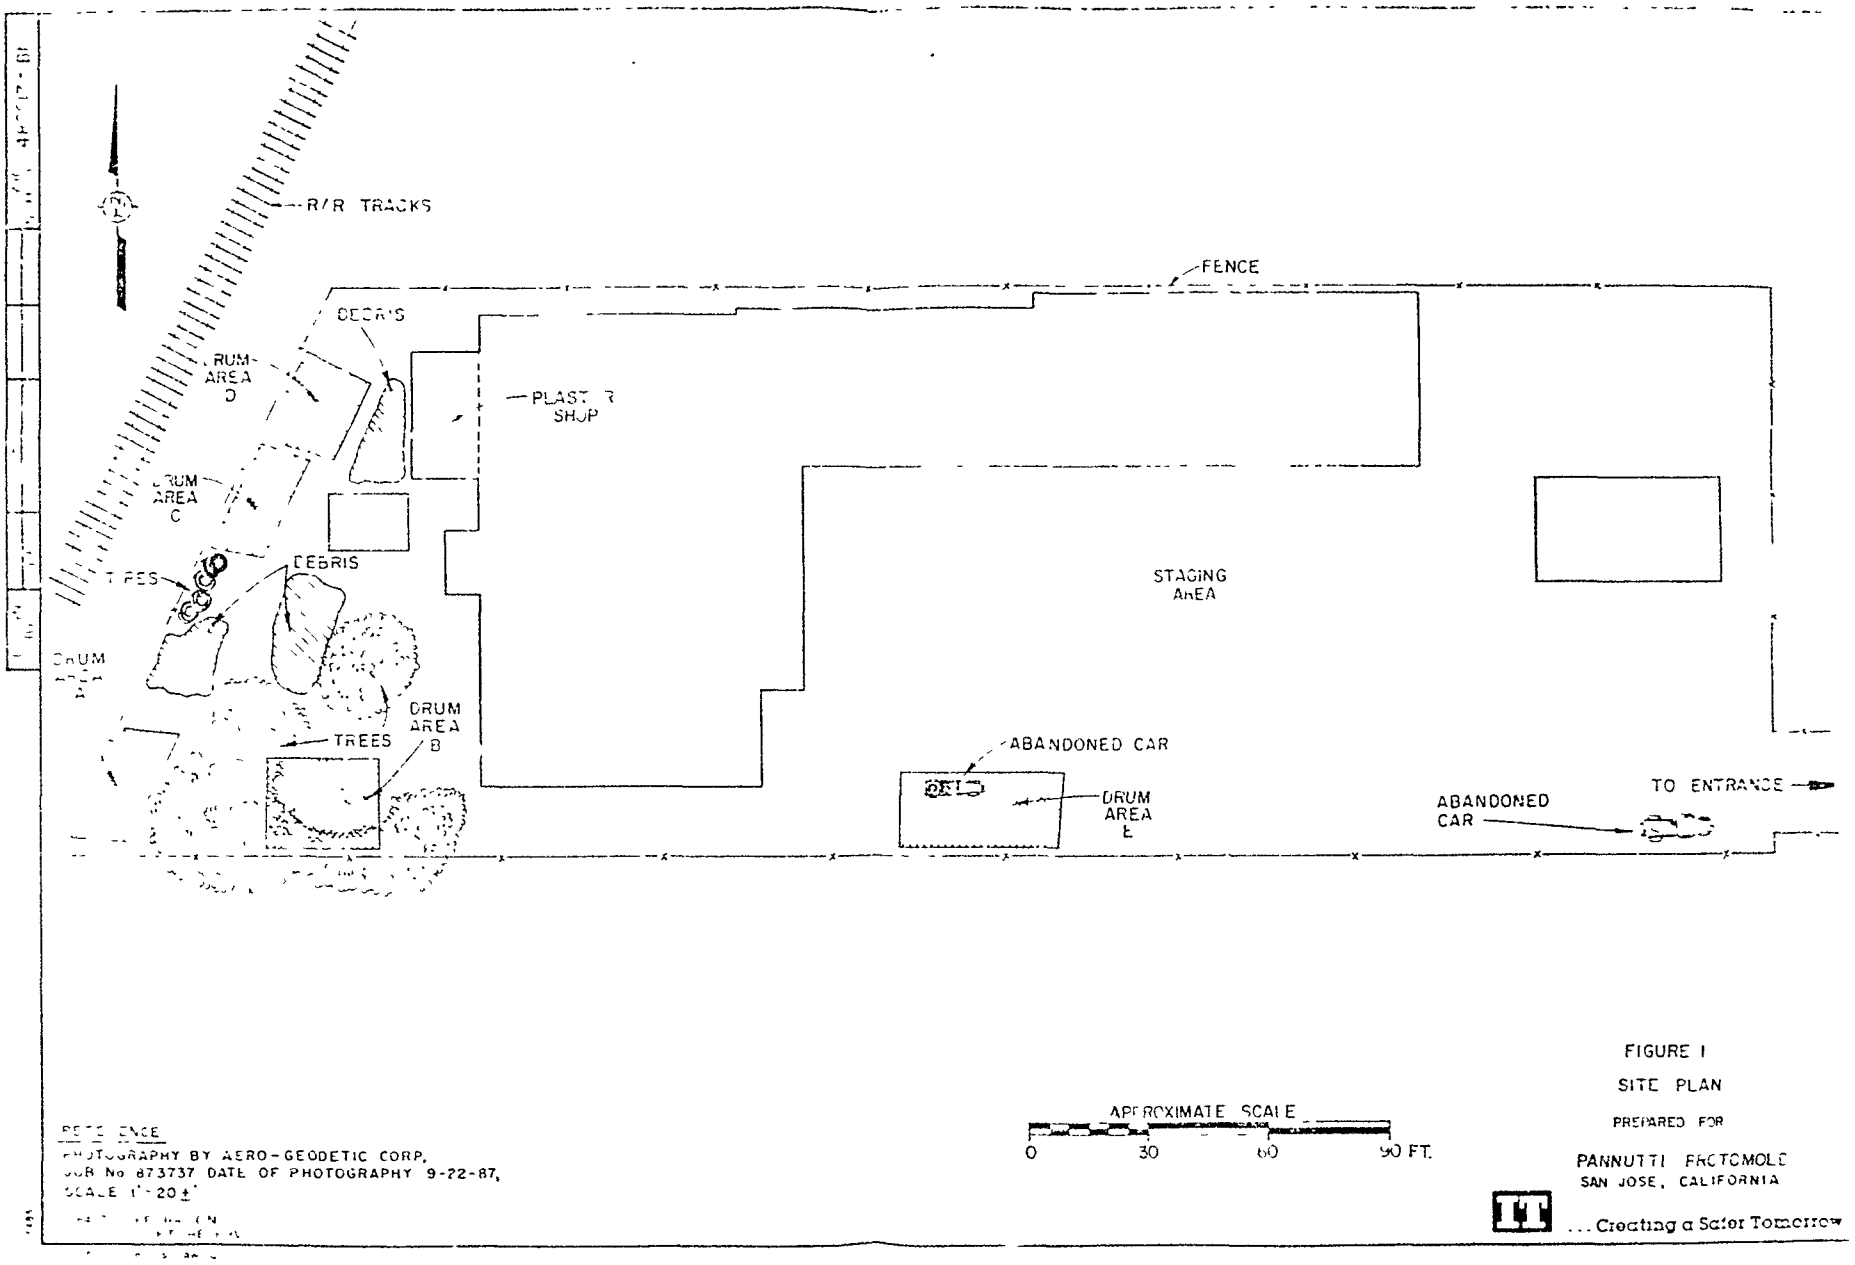
FIGURE 2: SITE MAP

Proto Mold Manufacturing is located at 1390 Old Bayshore Road, San Jose, CA (see Figure 1, Site Location Map). The site encompasses approximately 1.25 acres of land in an industrial area of San Jose (1). There are two buildings on the property, which have been used in the past by a variety of businesses, and an open rear portion of the property (see Figure 2, Site Map) (2). There are currently no operations at the site.

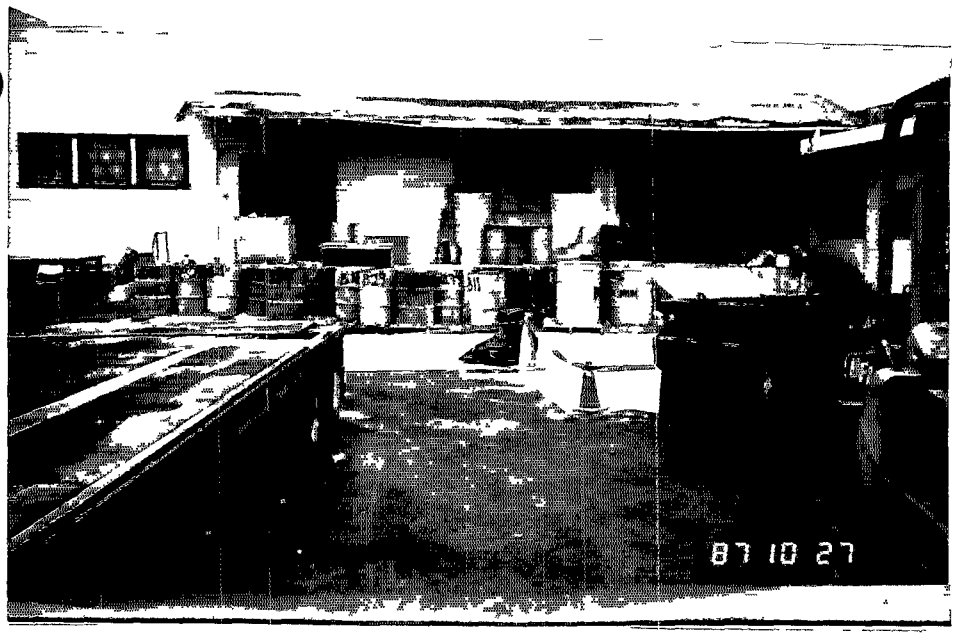
DESCRIPTION: DRUM STAGING AREA PRIOR TO HAZCATTING & CHARACTERIZATION; FRONT PORTION OF MAIN BUILDING

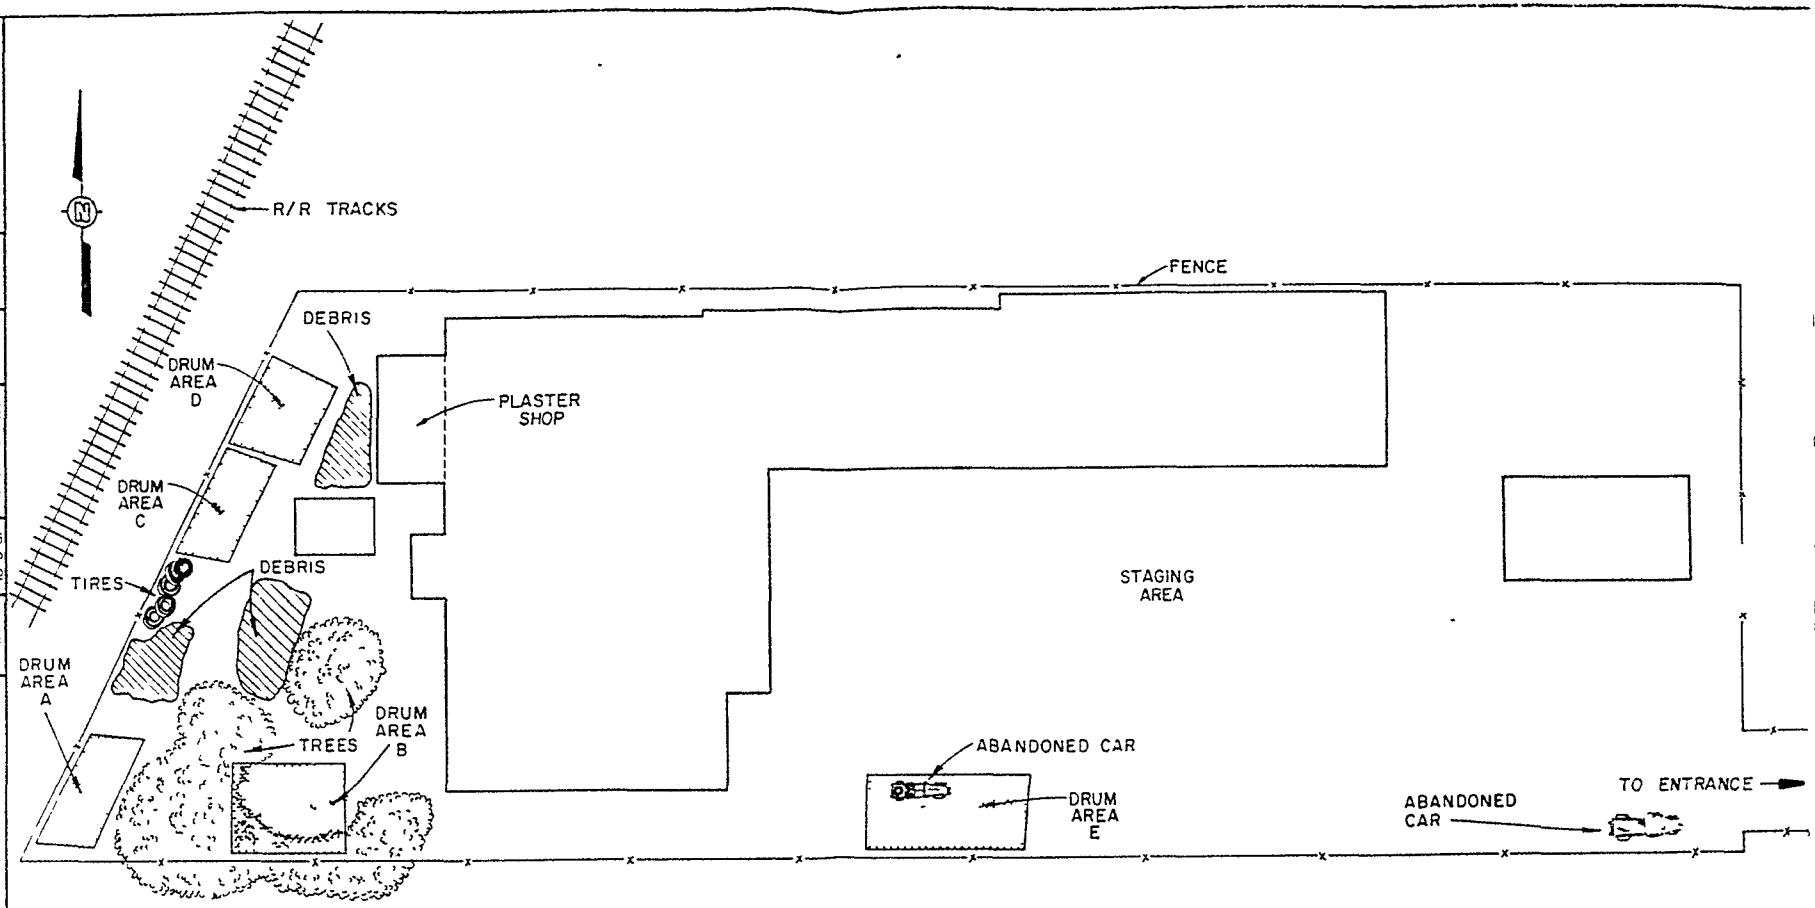
SITE MAP

A topographic map of the site was prepared and the drum areas segregated into five locations. The drums were labeled and removed to a staging area. The staging area was covered with visqueen to avoid ground contamination from leaks or spillage. At the staging area, drums were visually inspected, opened, and contents described. Samples were taken from each drum using a glass thieving rod. The samples were categorized and segregated according to physical inspection. "Haz-cat" testing was performed on disparate samples. "Haz-cat" results were used as a qualitative measurement of compatability for compositing samples. The drum samples were sent to the IT Vine Hill Laboratory, composited and run through a "predisposal" suite of analyses. The "predisposal" analyses were used to determine disposal sites. The drum disposal was seperated into three categories:
