State of Washington Department of Ecology

INSPECTION REPORT

Name of Entity Hoquiam Sanitary Landfill

Hoquiam Sanitary Landfill 8-3-84 Photos by Betts

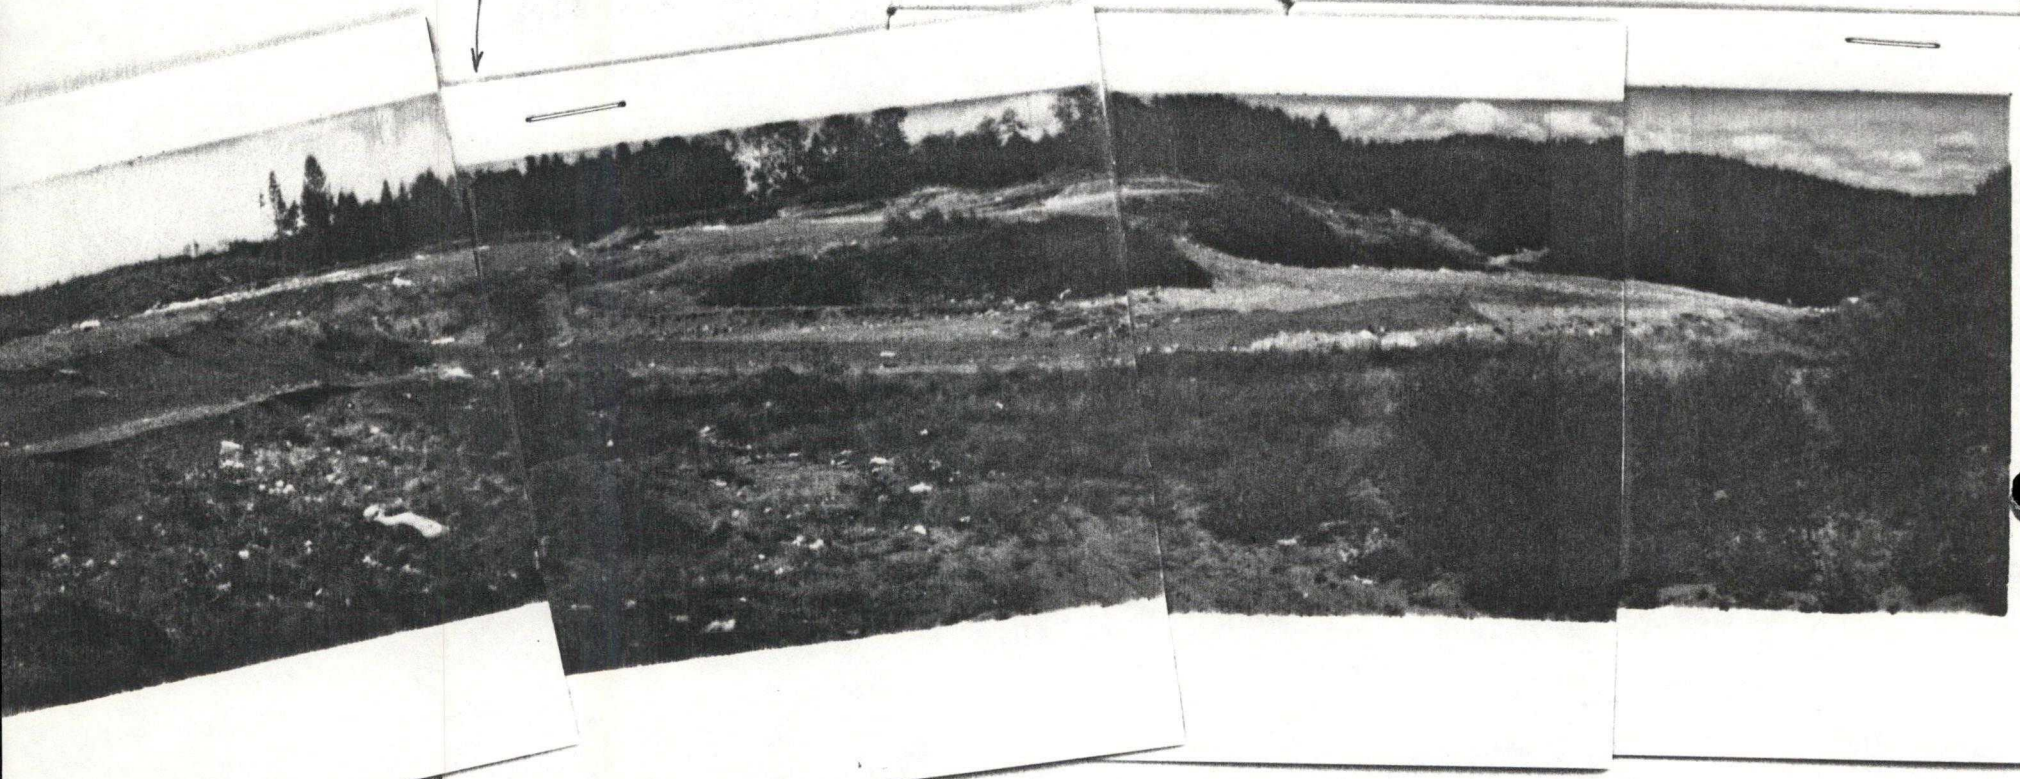
▲ Looking from south perimeter drainage ditch northwest at landfill, Note vague red-brown leachate seep under arrow on 2nd photo from left

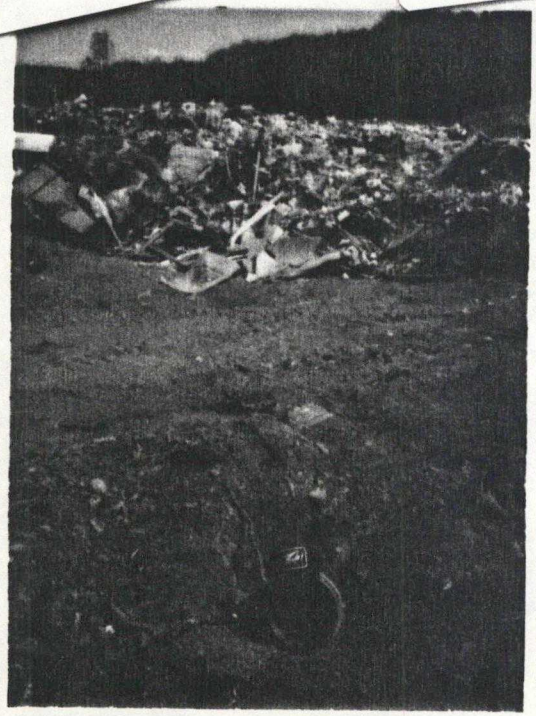
→ Clean stormwater diversion pipe (10"?) inlet above landfill operations, Dike needed to channel water into inlet
