Attachment 3 - TSCA

FACILITY NAME British Petroleum (formerly ARCO PERMIAN)

As we discussed by telephone on July 11, 2000, ARCO Permian, a Business Unit of BP Amoco, has discovered the presence of PCBs at our Block 31 Gasoline and Pressure Maintenance Plant in Crane County, Texas. As required by 40 CFR 761.61(a)(3), this letter provides the 30 day notice for remediation of PCBs. Remediation at this site will include the following:

Sample Results
Block 31 PCB Analyses

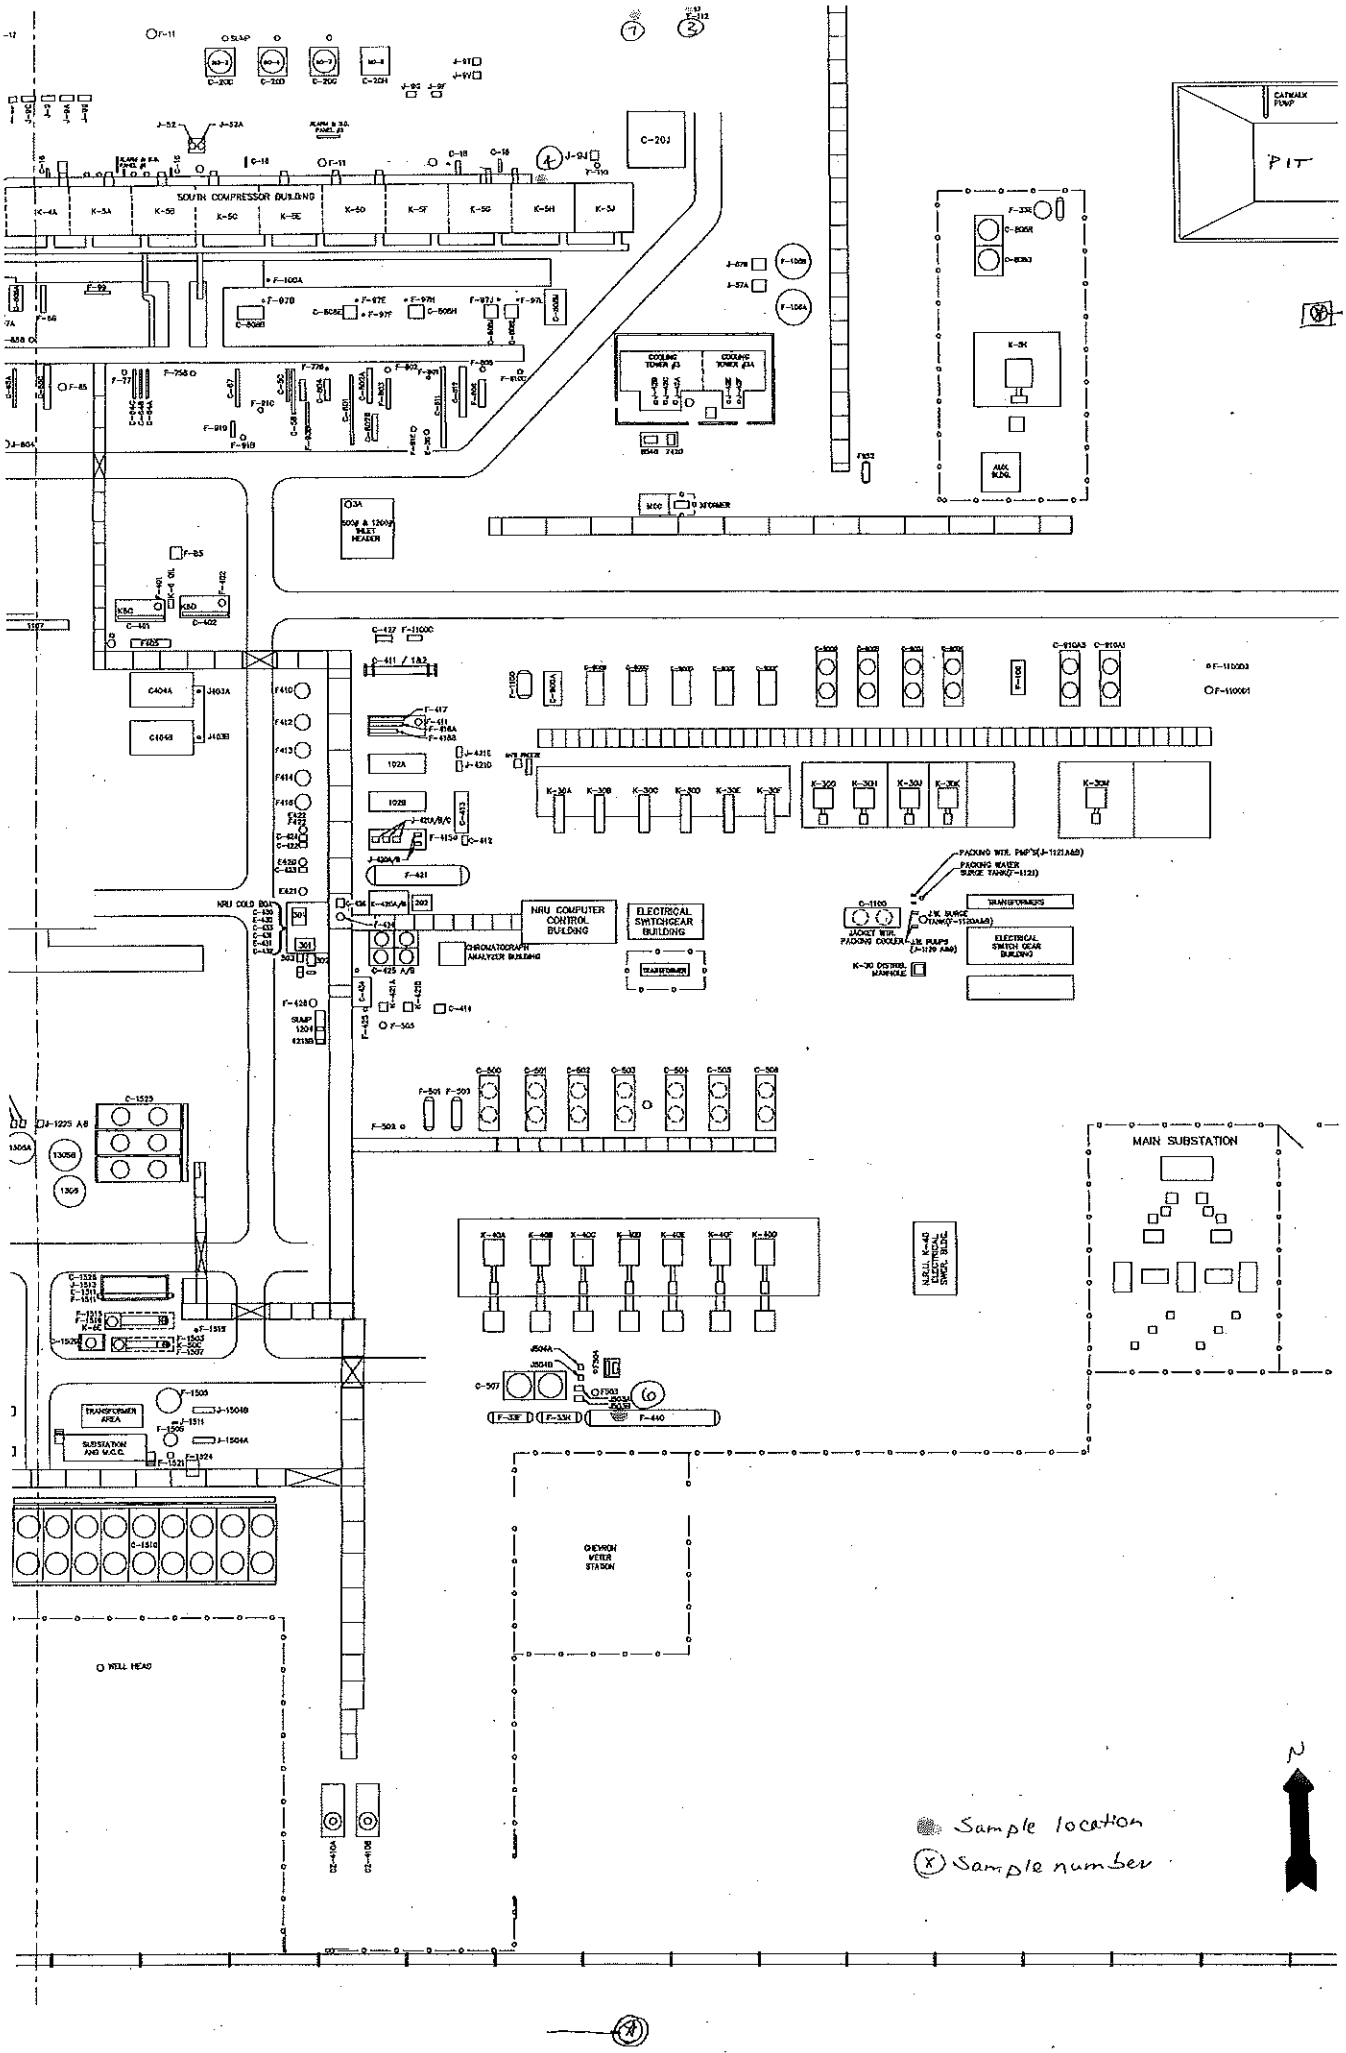
SOUTH COMPRESSOR BUILDING
PIT
MAIN SUBSTATION
NRU COMPUTER CONTROL BUILDING
ELECTRICAL SWITCHGEAR BUILDING
CHROMATOGRAPH ANALYZER BUILDING
TRANSFORMER AREA
SUBSTATION AND M.C.C.
OLEFIN METER STATION
WELL HEAD
Sample location
Sample number
N

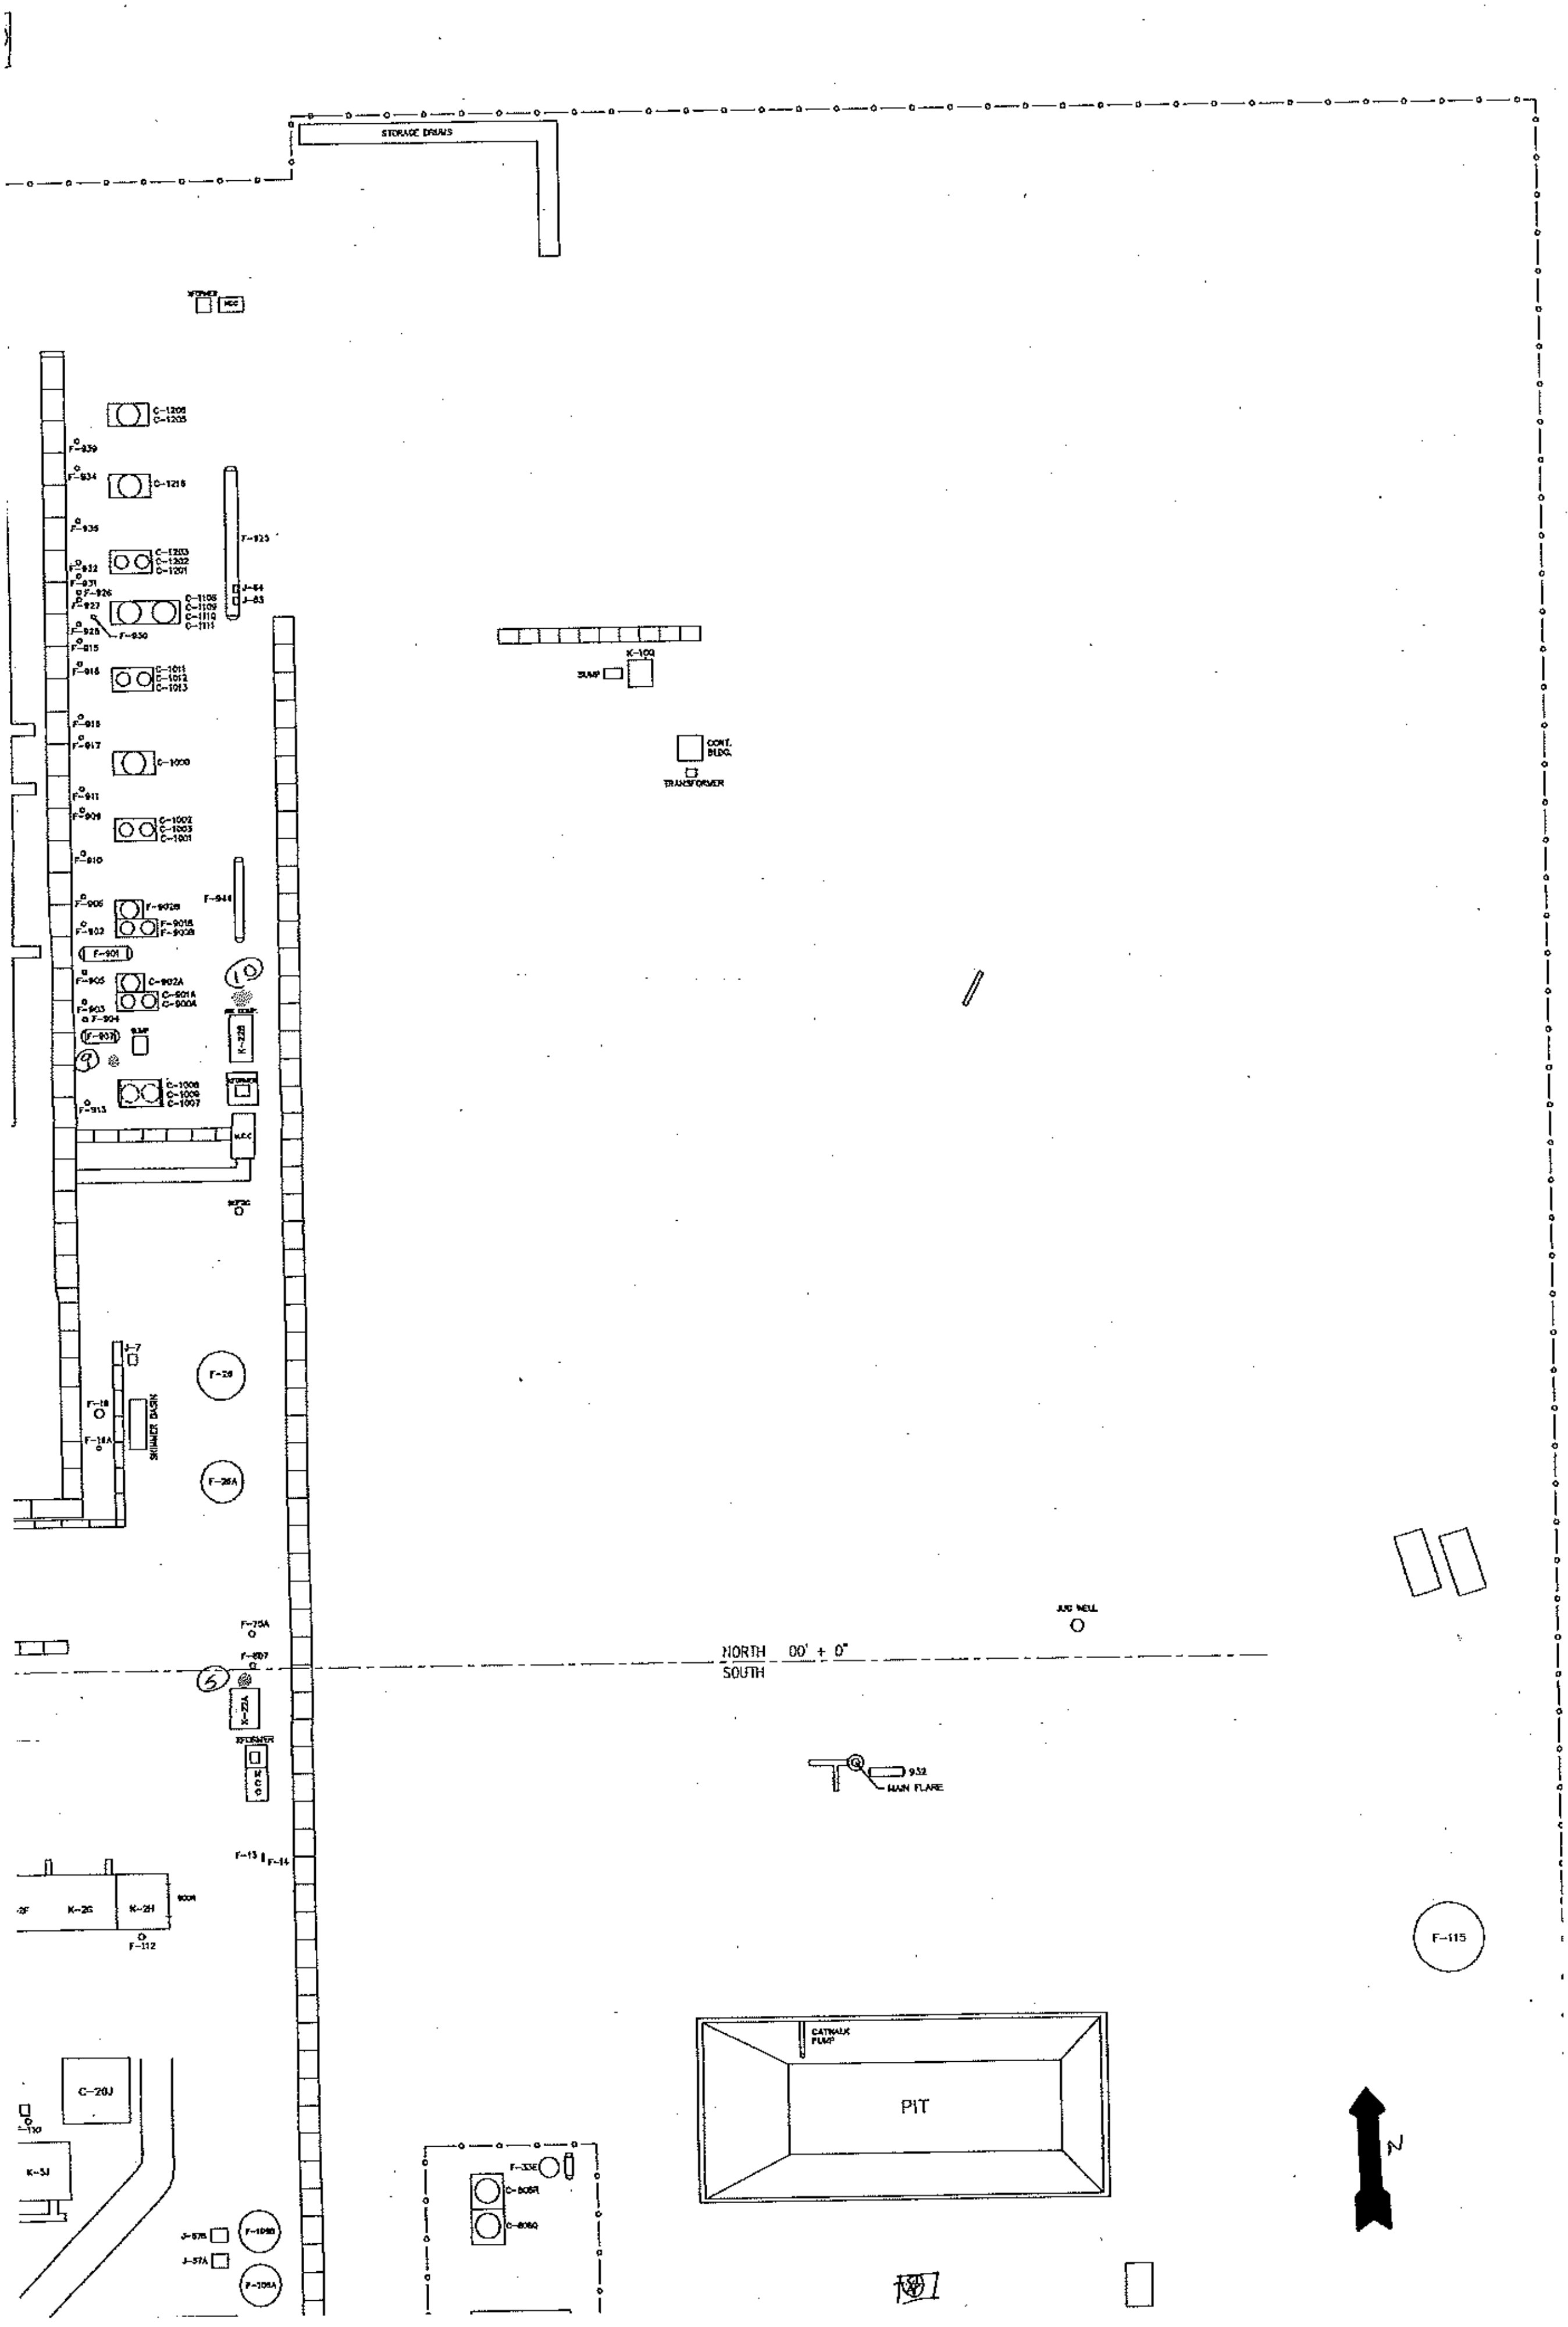
proposed remediation sites

sample locations

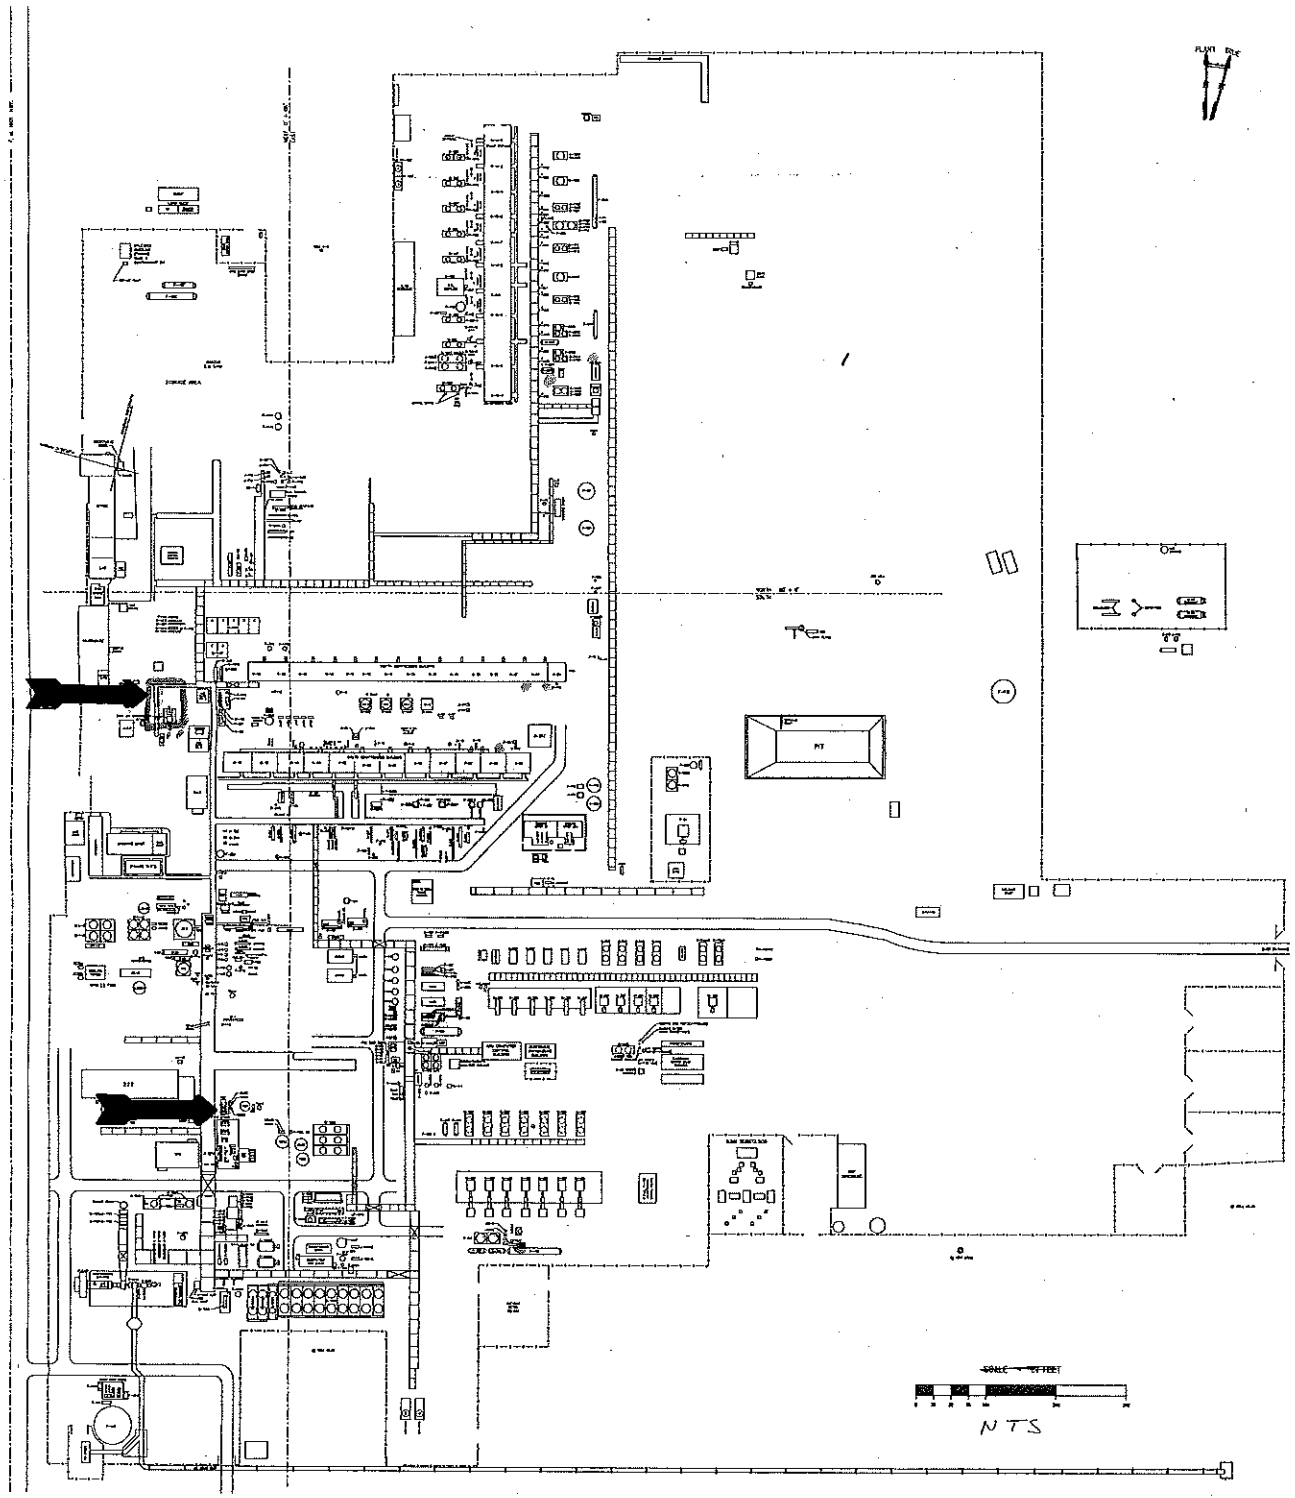
The soil was tested for PCBs if it was suspected of contamination due to location and operating practices as remembered by long-time employees. Sample results are shown on the attached table. As required by 40 CFR 761.61(a)(4)(i)(B)(1) defining cleanup level for low occupancy areas, we will remove soil that is above 25 ppm PCBs. Clean-up of the soil will require removal of the surface gravel (which was added in the 1990's) and removal of soil. The estimated area of soil to be removed is 27' by 36', and expected average depth is 3" - 6". We plan to use Dexsil's Chlor-n-Soil test kits, which test positive when the PCB concentration exceeds 50 ppm, to help define the contaminated soil. Laboratory analyses will ultimately be used to show that the soil left in place contains less than 25 ppm PCBs. Work will be performed by ARCO Permian personnel.

- Excavating soil that is contaminated at >25 ppm PCBs. Excavated soil will be sent to Waste Control Specialists' hazardous waste landfill in Andrews, Texas. (40 CFR 761.61(a)(5)(i)(B)(2)(iii))
- Using Philip Services to employ their patented process to wash the plant's air system, removing PCBs still contaminating the lines.
