Subject: **Emergency Response Activity Report**
Bridgeton Brush Fire Response, Bridgeton, Missouri
U.S. EPA Region 7 START 4, Contract No. EP-S7-13-06
Task Order No. 0001.024
Task Monitor: Tom Mahler, On-Scene Coordinator

EMERGENCY RESPONSE ACTIVITY REPORT
BRIDGETON BRUSH FIRE RESPONSE, BRIDGETON, MISSOURI

Superfund Technical Assessment and Response Team (START) 4
Contract No. EP-S7-13-06, Task Order No. 0001.024

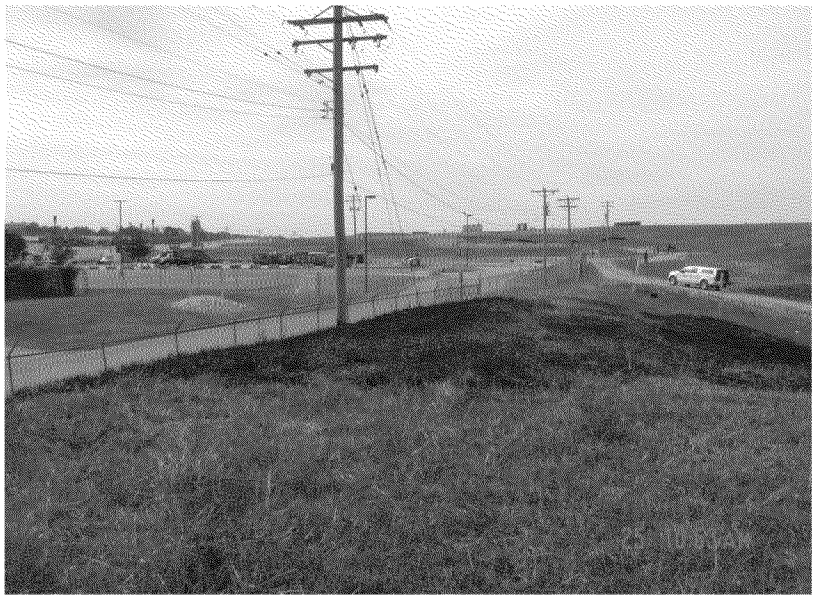
TETRA TECH PROJECT NO. X9025.14.0001.024 DIRECTION: East/Northeast	DESCRIPTION	This photograph shows an overview of the brush fire burn area looking down the fenceline along the entrance driveway to the Republic Services transfer station.	1
	CLIENT	Environmental Protection Agency - Region 7	DATE 10/25/15
	PHOTOGRAPHER	Dave Kinroth

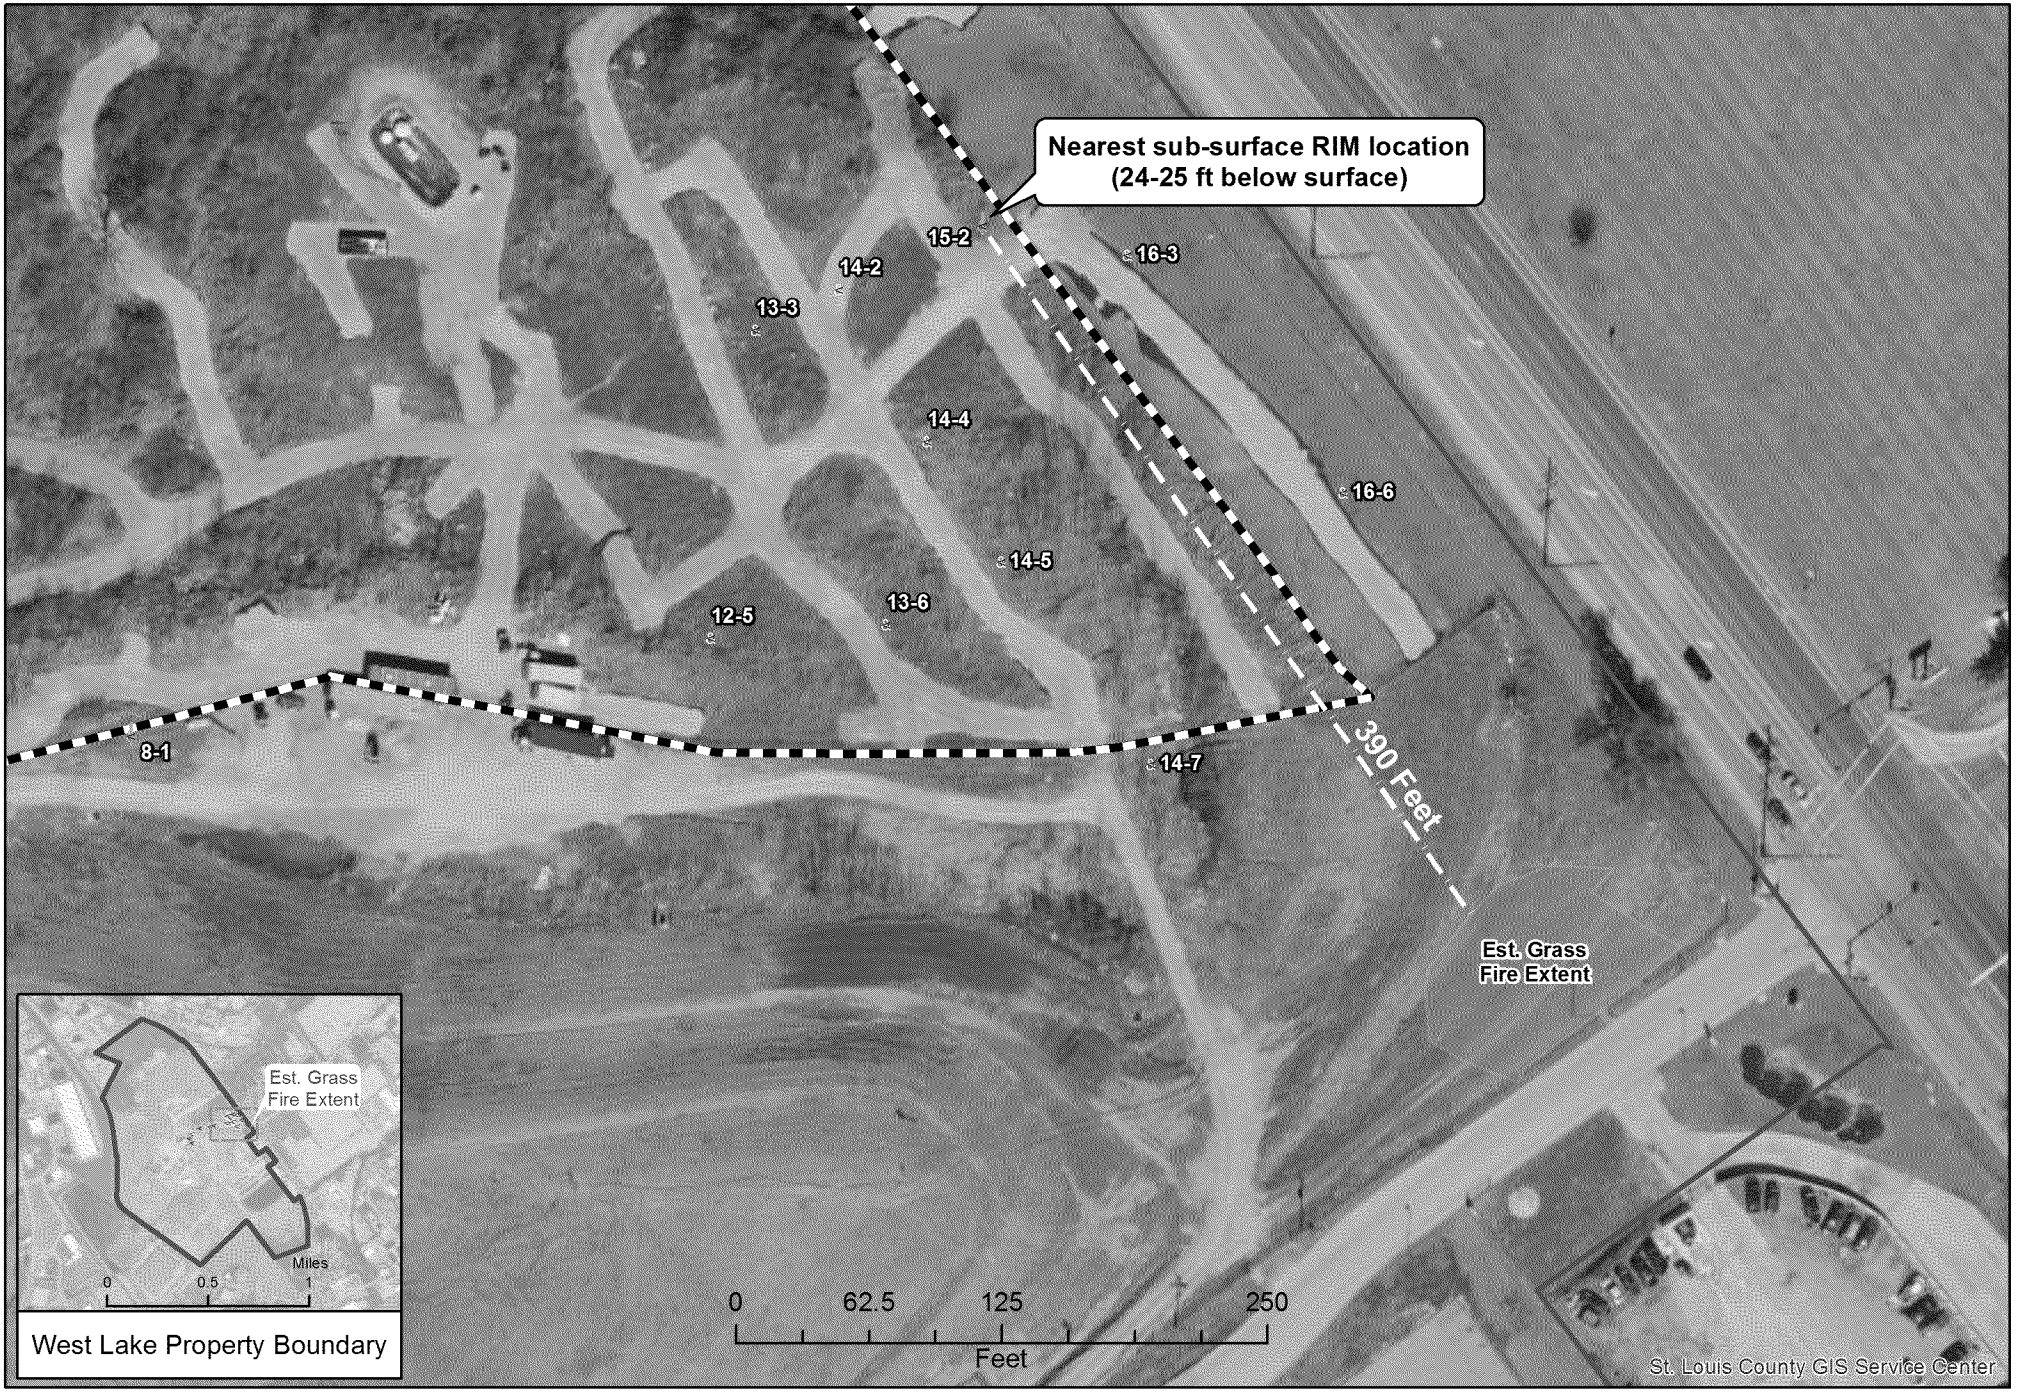
EPA FIGURE SHOWING GRASS FIRE BURN AREA IN RELATION TO NEAREST KNOWN LOCATION OF WEST LAKE RADIOLOGICALLY IMPACTED MATERIAL

During the response, EPA had assessed the proximity of the burn area to known locations of sub-surface West Lake RIM, and had estimated that the nearest sub-surface RIM was approximately 390 feet northwest of the burn area within the fenced West Lake OU 1 (see Appendix D).
