Site Name: Libbey-Owens-Ford

City, County, State: Kanawha County WV

EPA POTENTIAL HAZARDOUS WASTE SITE IDENTIFICATION AND PRELIMINARY ASSESSMENT

A. SITE NAME: Libbey Owens Ford

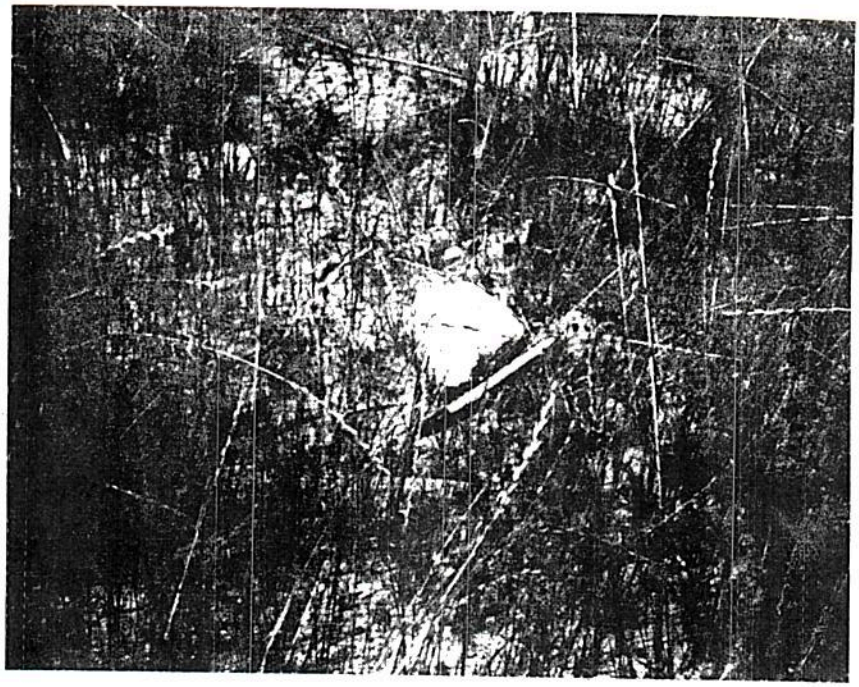
Photo 9 - Waste material as pointed out by Tom Koralewski of Libbey Owens Ford.

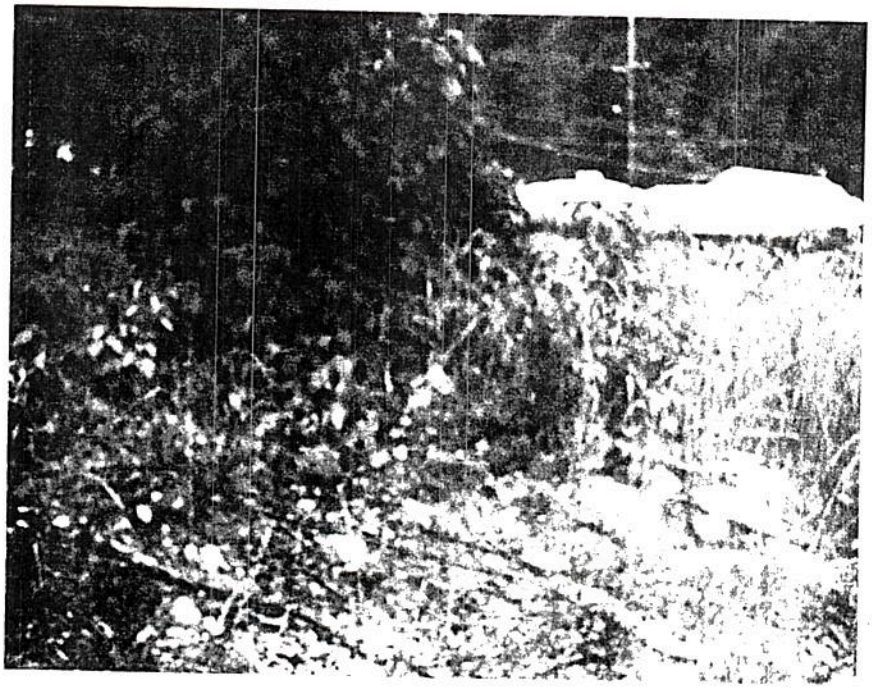
Photo 10 - Old waste pile of bricks, potentially from old stacks.

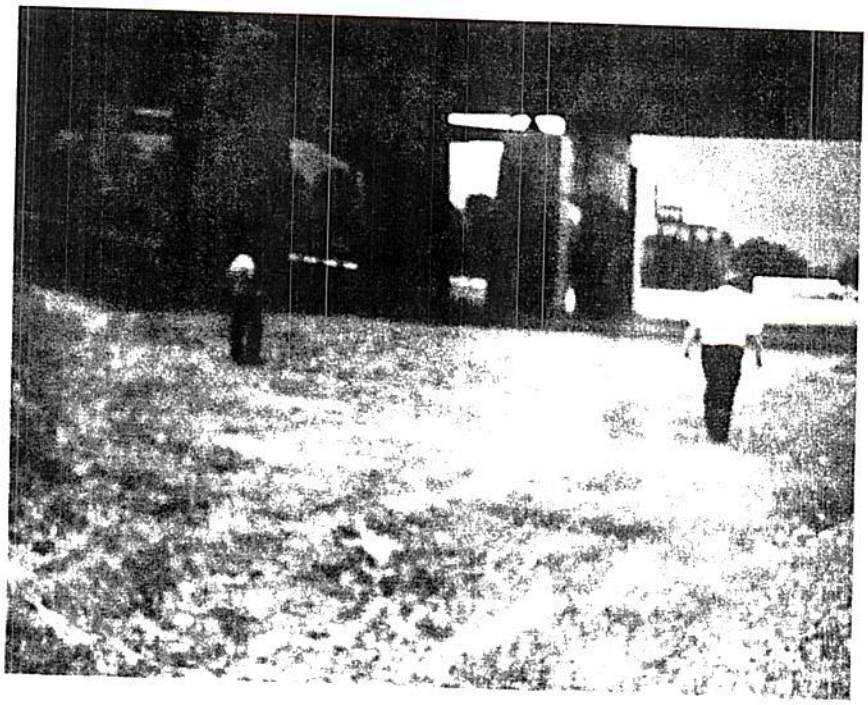
Photo 12 - Location of the largest area of disposal area no. 3.
